Enclosed for your review and comment is a copy of the draft NUREG/CR6412, "Aging and Loss-of-Coolant Accident (LOCA) Testing of Electrical Connections," dated July 31, 1996.

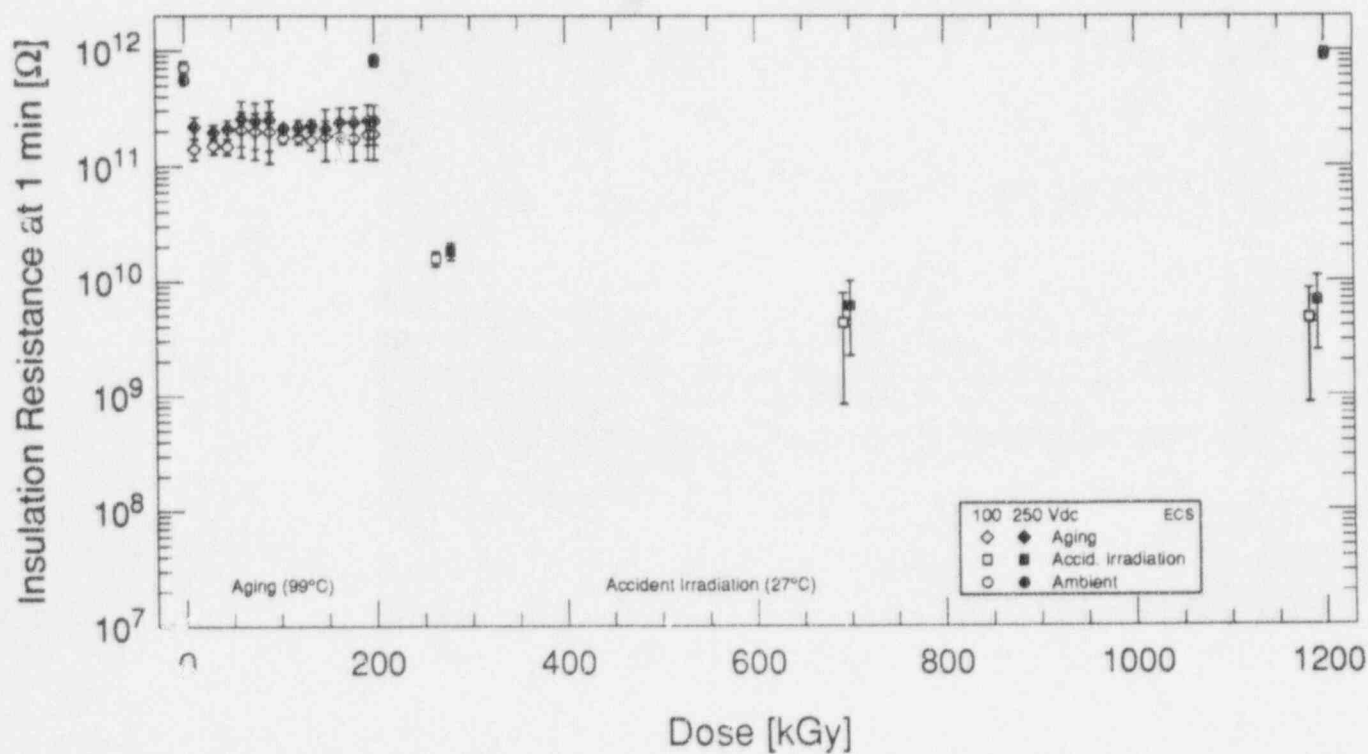
Figure 3.4: IR of EGS conduit seal during aging and accident irradiation.

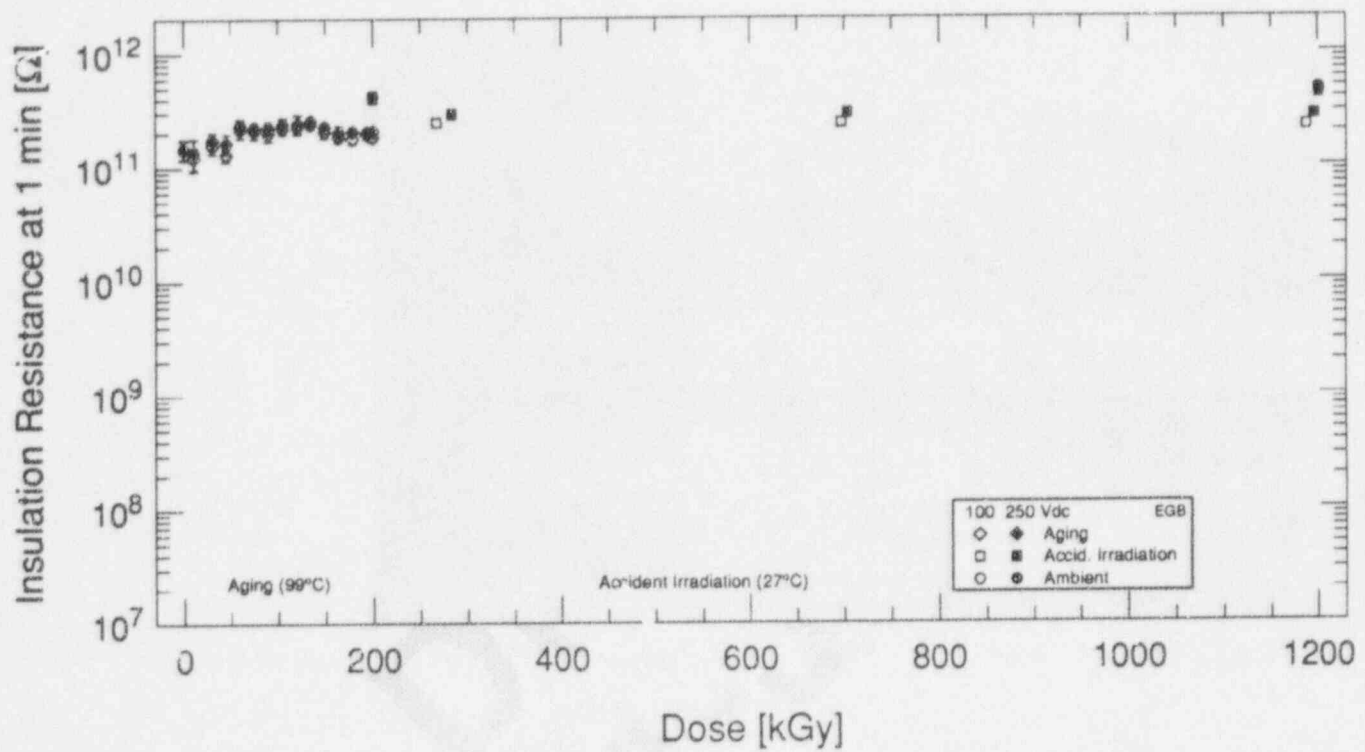
Figure 3.5: IR of EGS Grayboot connector during aging and accident irradiation.

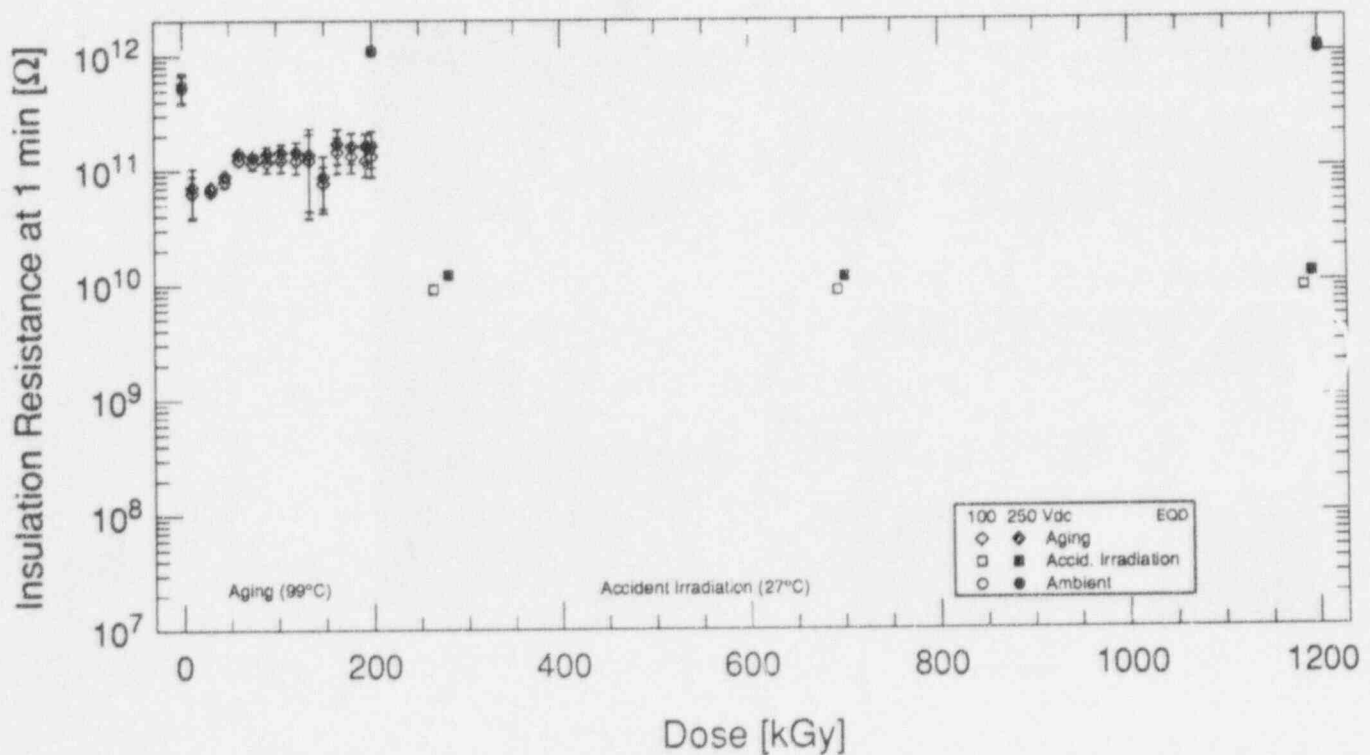
Figure 3.6: IR of EGS quick disconnect connector during aging and accident irradiation.

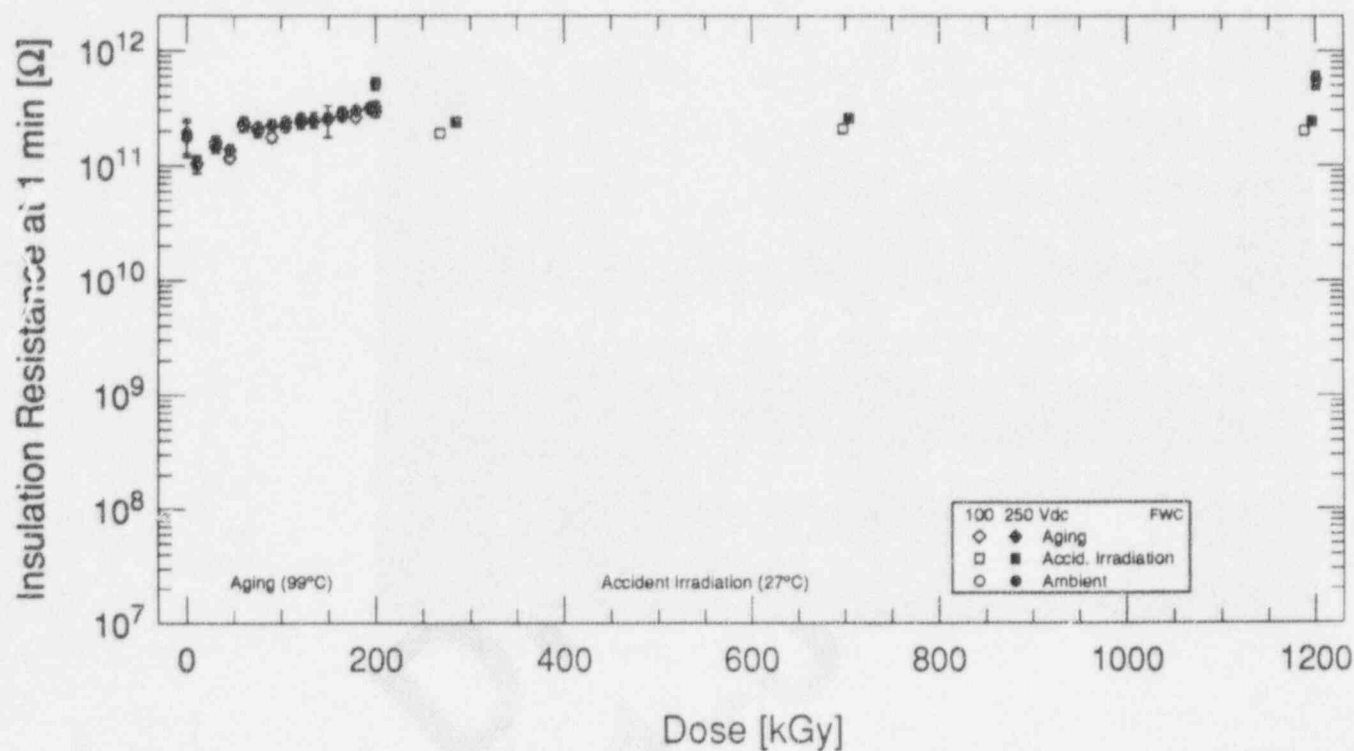
Figure 3.7: IR of Rockbestos Firewall III cable during aging and accident irradiation.

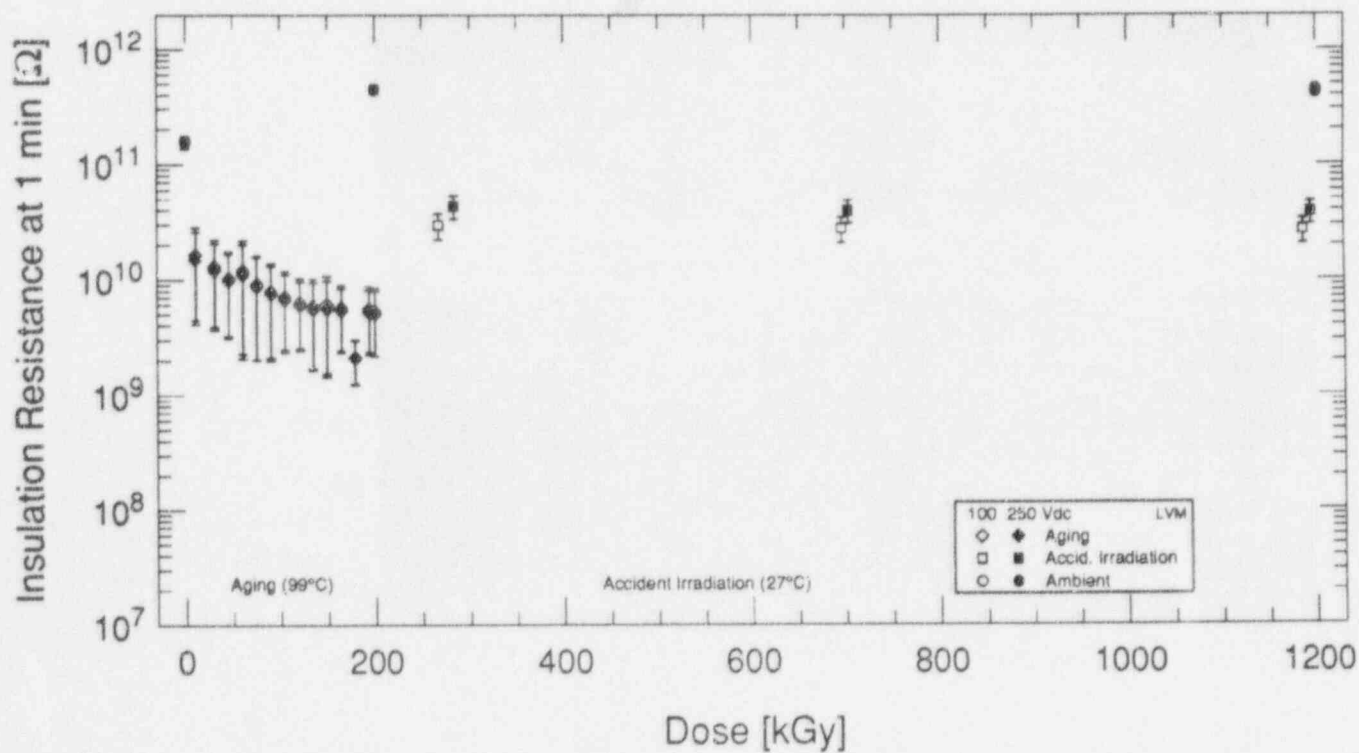
Figure 3.8: IR of Litton-VEAM connector during aging and accident irradiation.

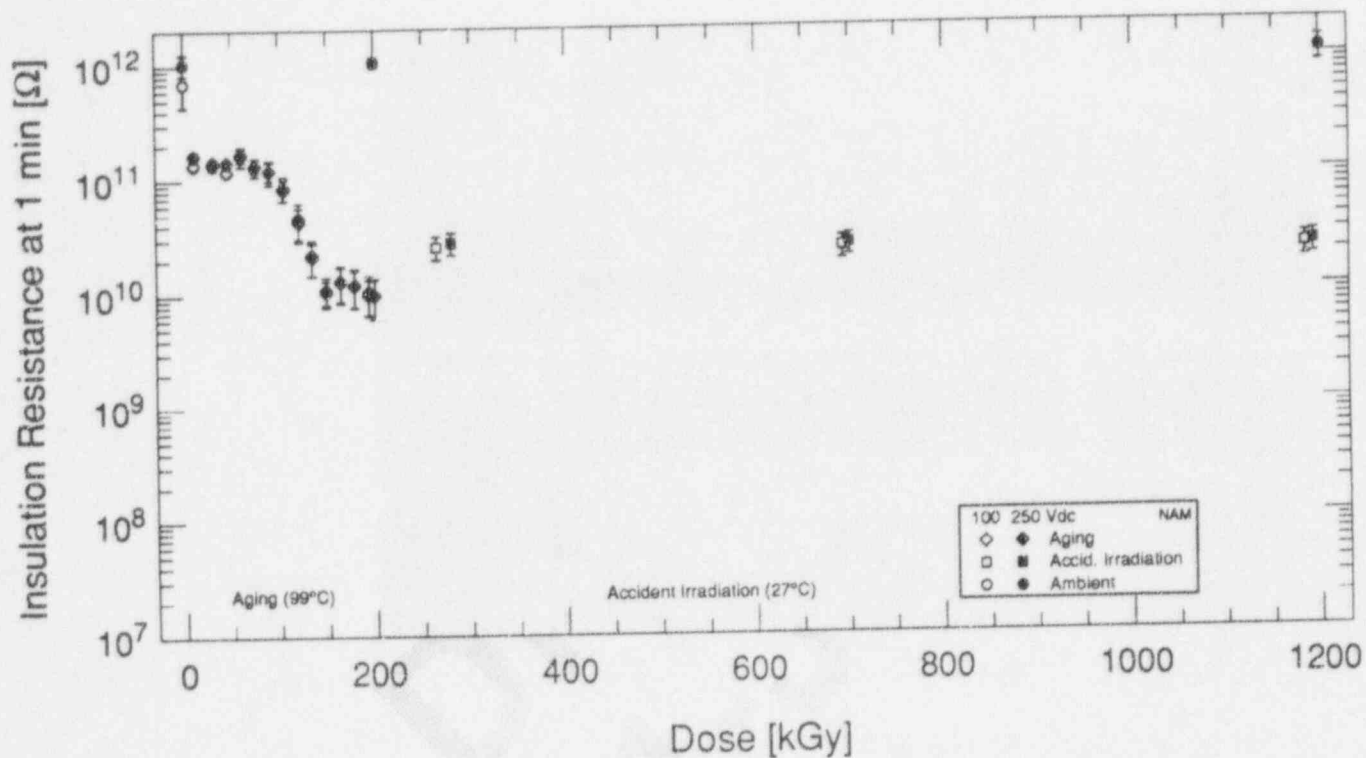
Figure 3.9: IR of NAMCO EC210 connector during aging and accident irradiation.

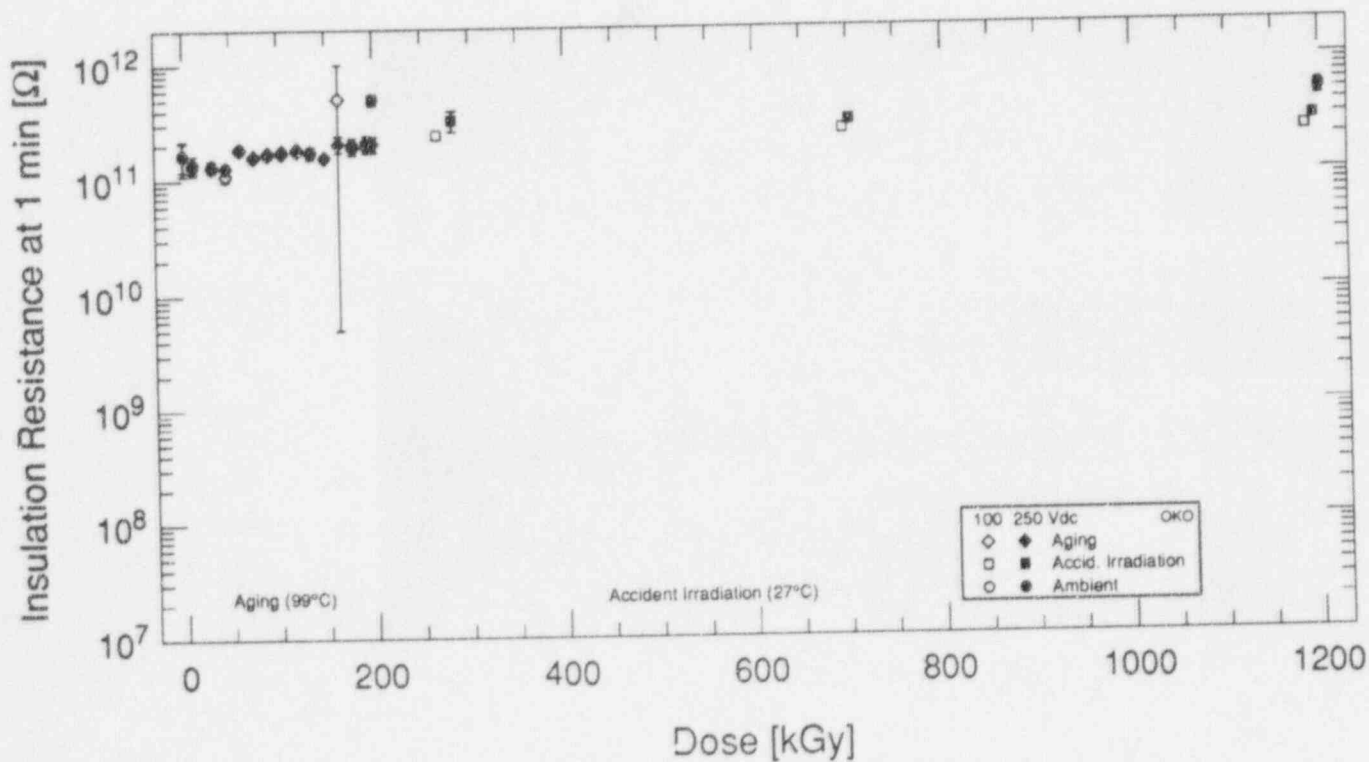
Figure 3.10: IR of Okonite tape splice during aging and accident irradiation.

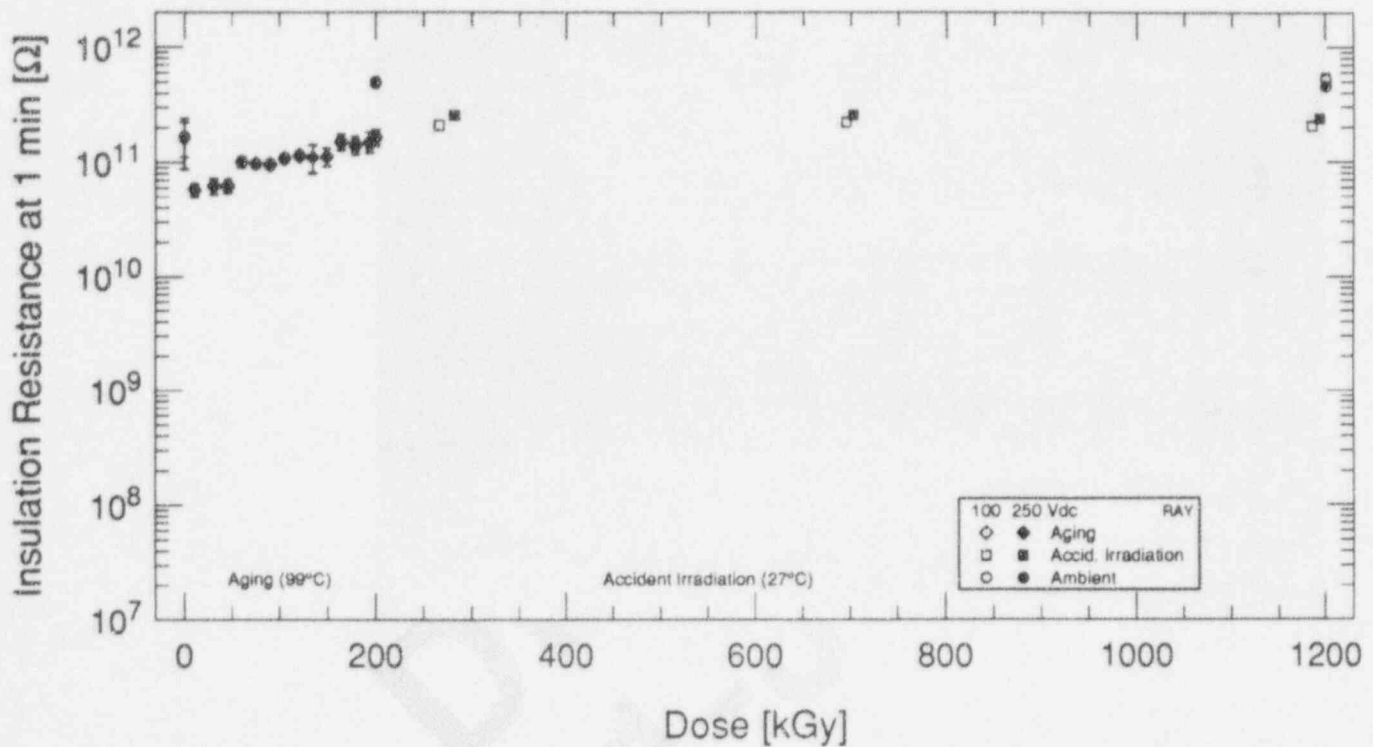
Figure 3.11: IR of Raychem heat shrink splice during aging and accident irradiation.

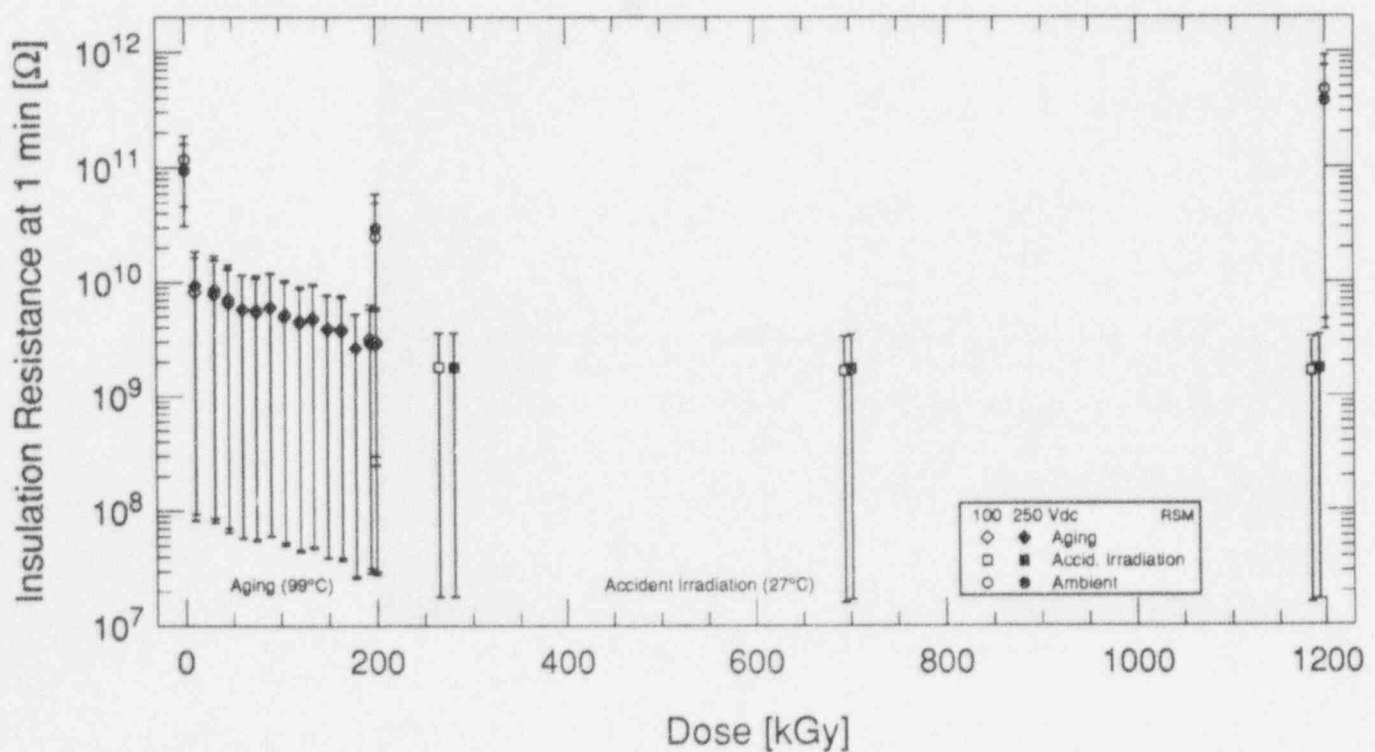
Figure 3.12: IR of Rosemount 353C conduit seal during aging and accident irradiation.

- The lowest IR values during the aging exposure were for the Rosemount 353C conduit seal (see Figure 3.12). The measured IR of conductor 28 fell immediately from an initial value of $8.4 \times 10^{10} \Omega$ to $1.9 \times 10^6 \Omega$ and then slowly increased to approximately $2 \times 10^7 \Omega$ during the remainder of the aging exposure. The other 3 conductors and 2 shields typically had IR values in the range of $5 \times 10^8 \Omega$ and above.

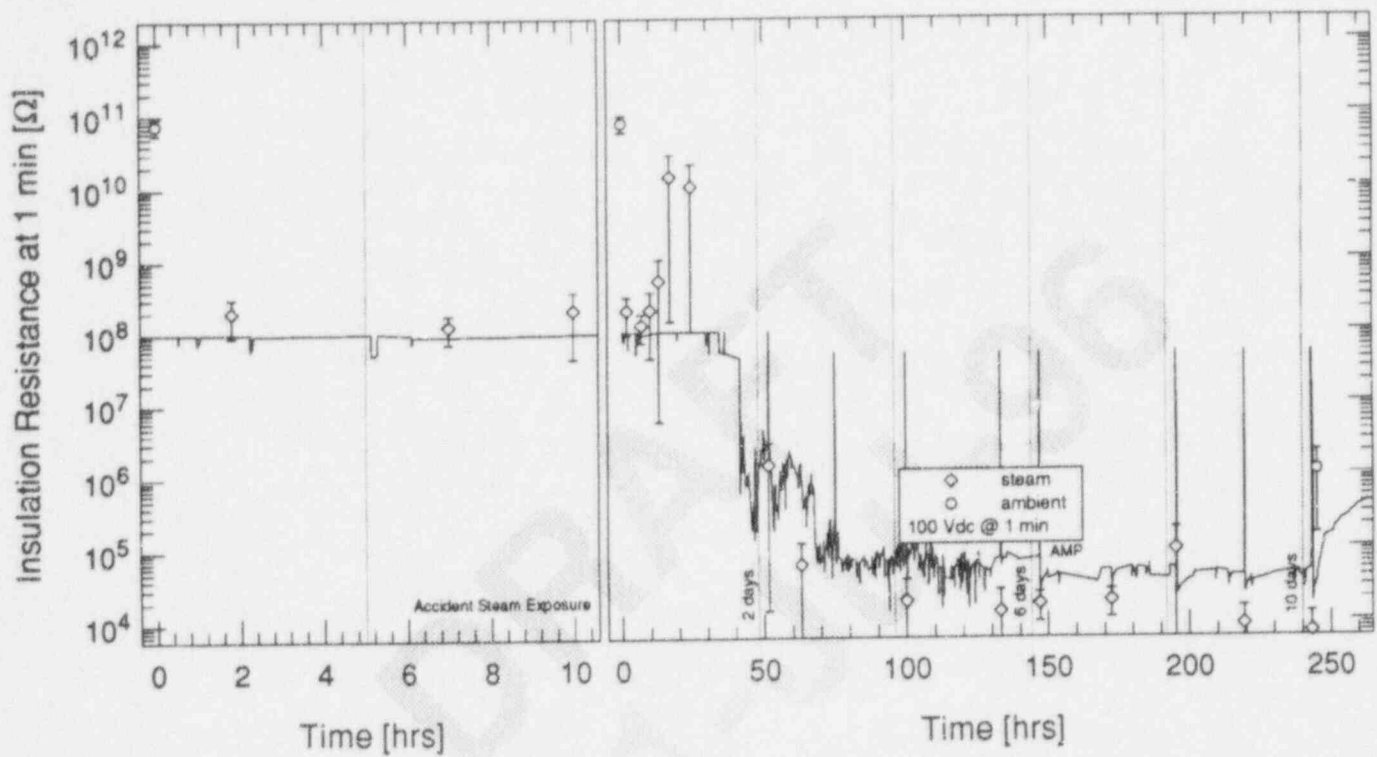
Figure 3.13: IR of Amphenol coaxial connector during accident steam exposure.

A set of IR measurements was performed quickly (3 days) after the completion of the accident steam exposure, these data are tabulated in Tables 3.2 and 3.3 and are also plotted as the ambient data at approximately 245 hr in Figures 3.13–3.24. In general, these data show a recovery in IR from that during the steam exposure.

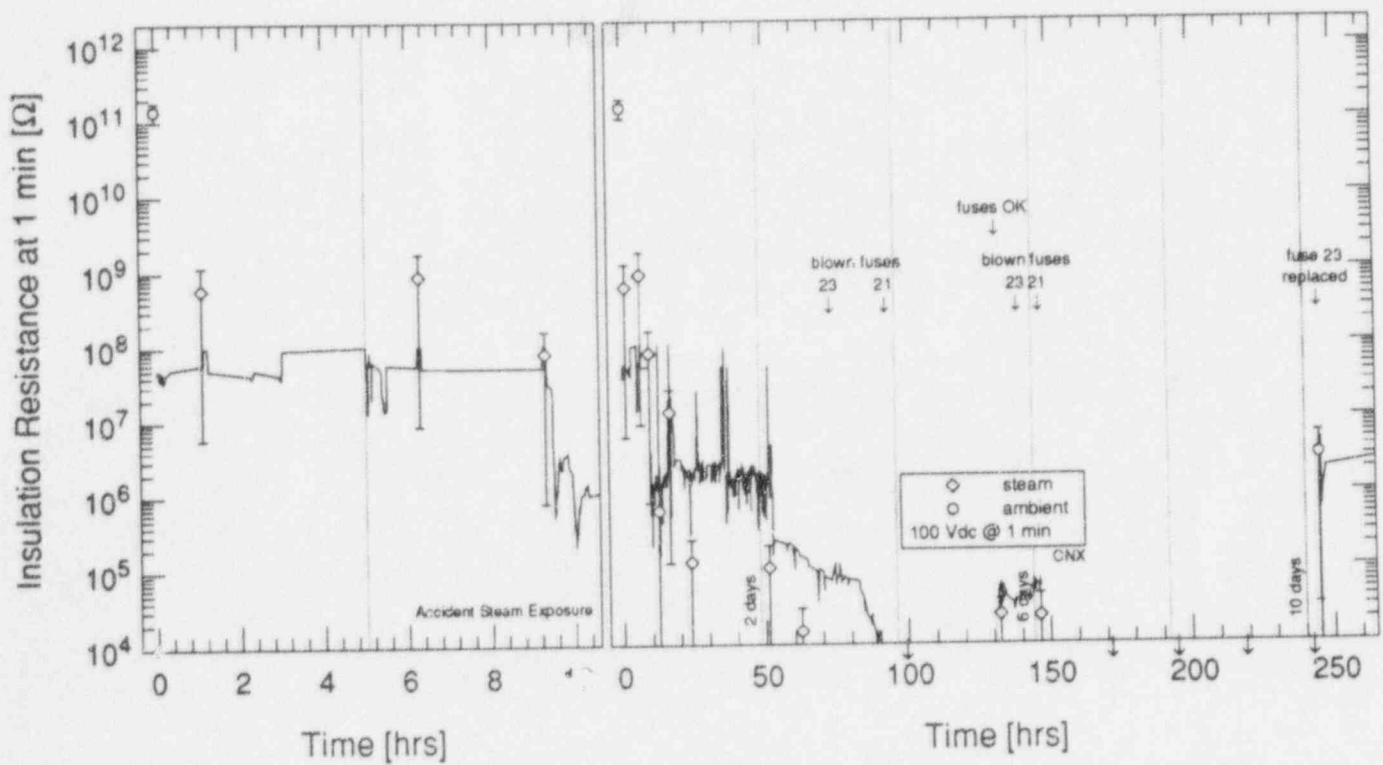
Figure 3.14: IR of Conax ECSA conduit seal during accident steam exposure.

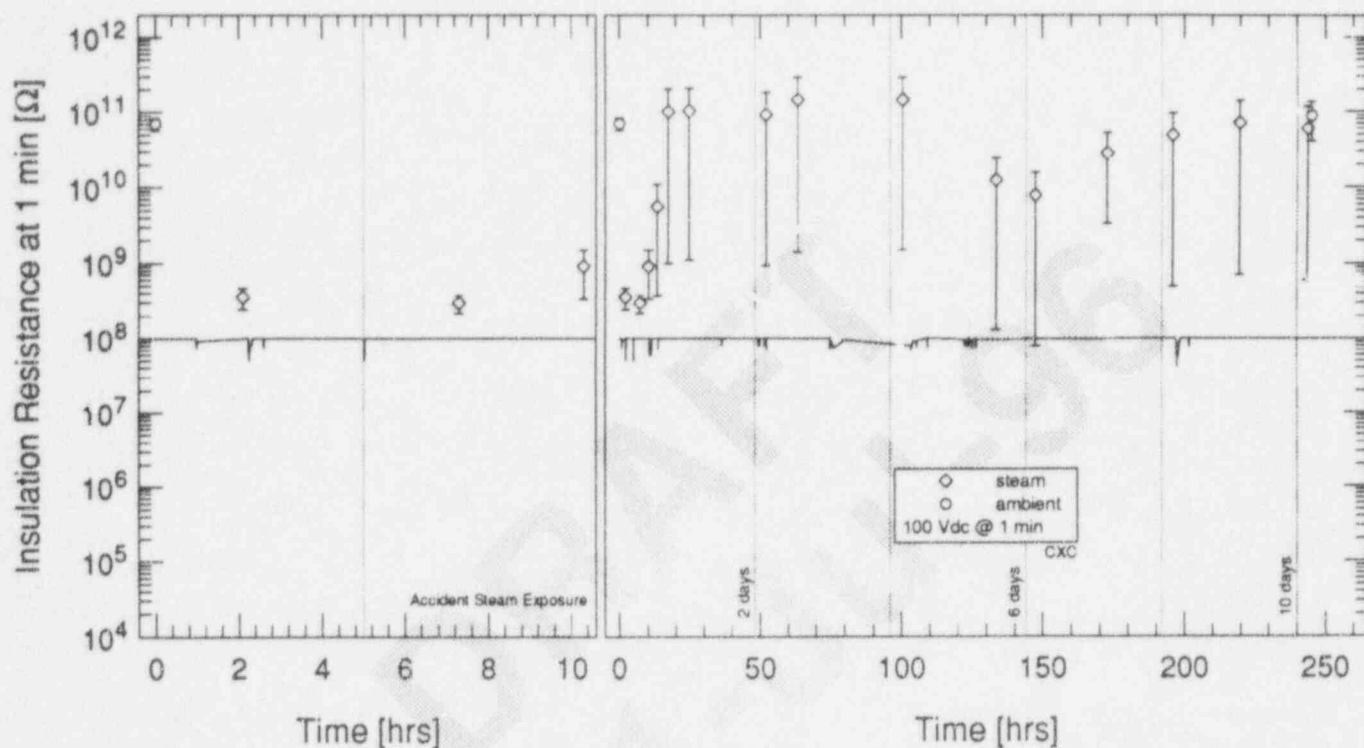
Figure 3.15: IR of Rockbestos coaxial cable during accident steam exposure.

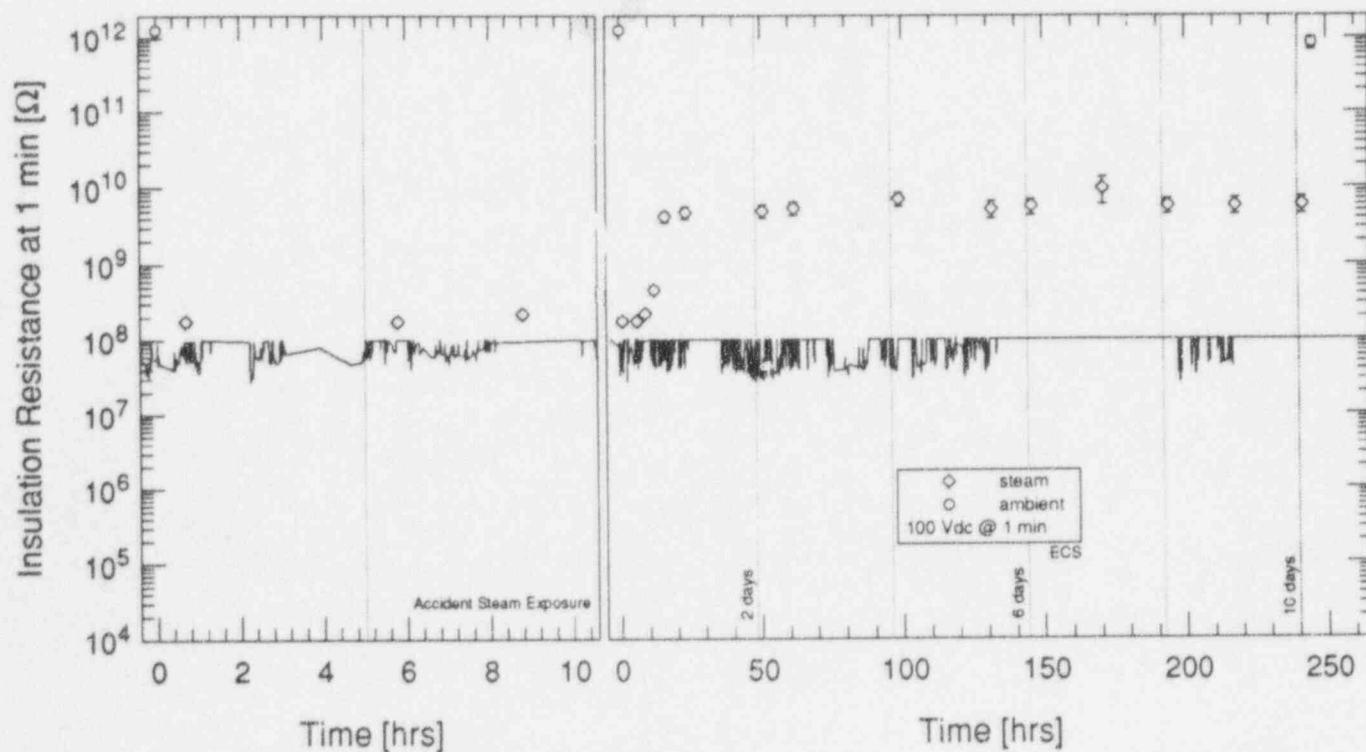
Figure 3.16: IR of EGS conduit seal during accident steam exposure.

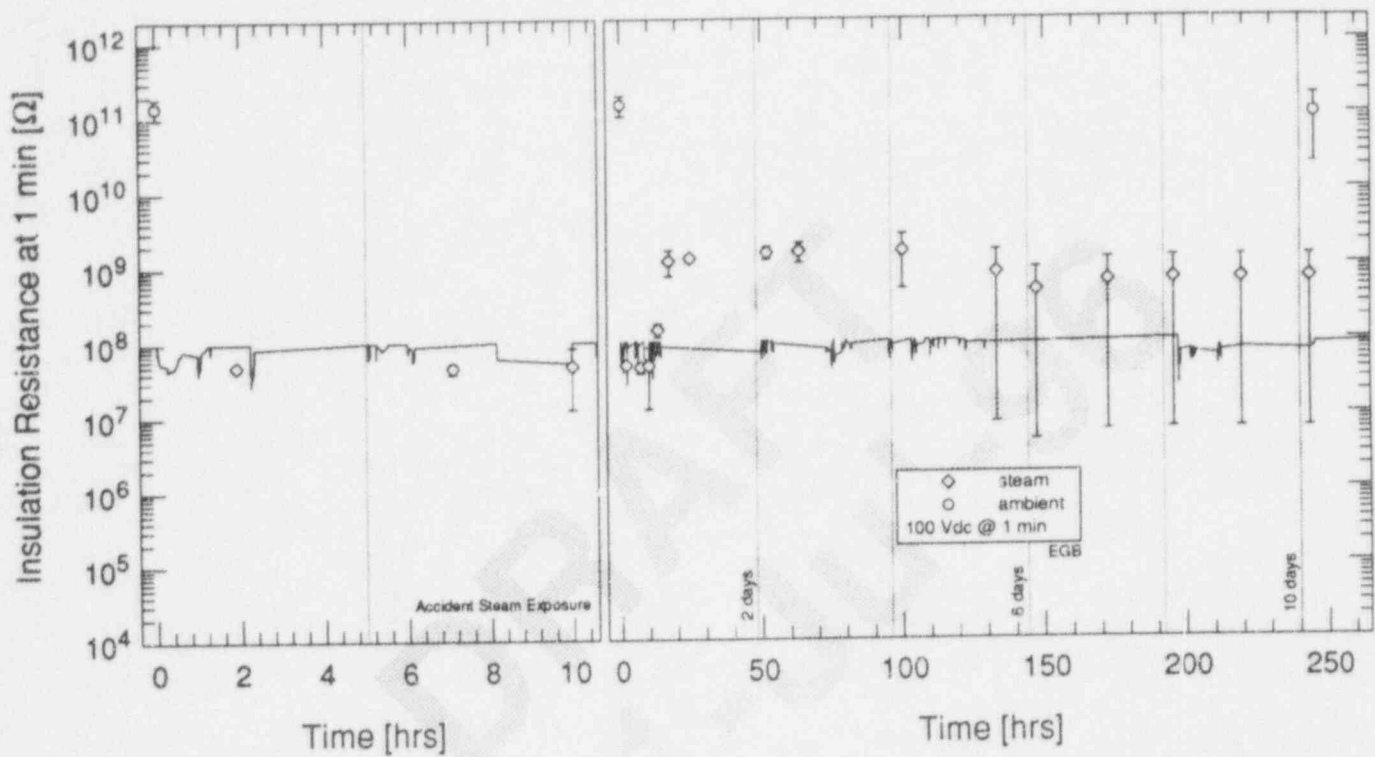
Figure 3.17: IR of EGS Grayboot connector during accident steam exposure.

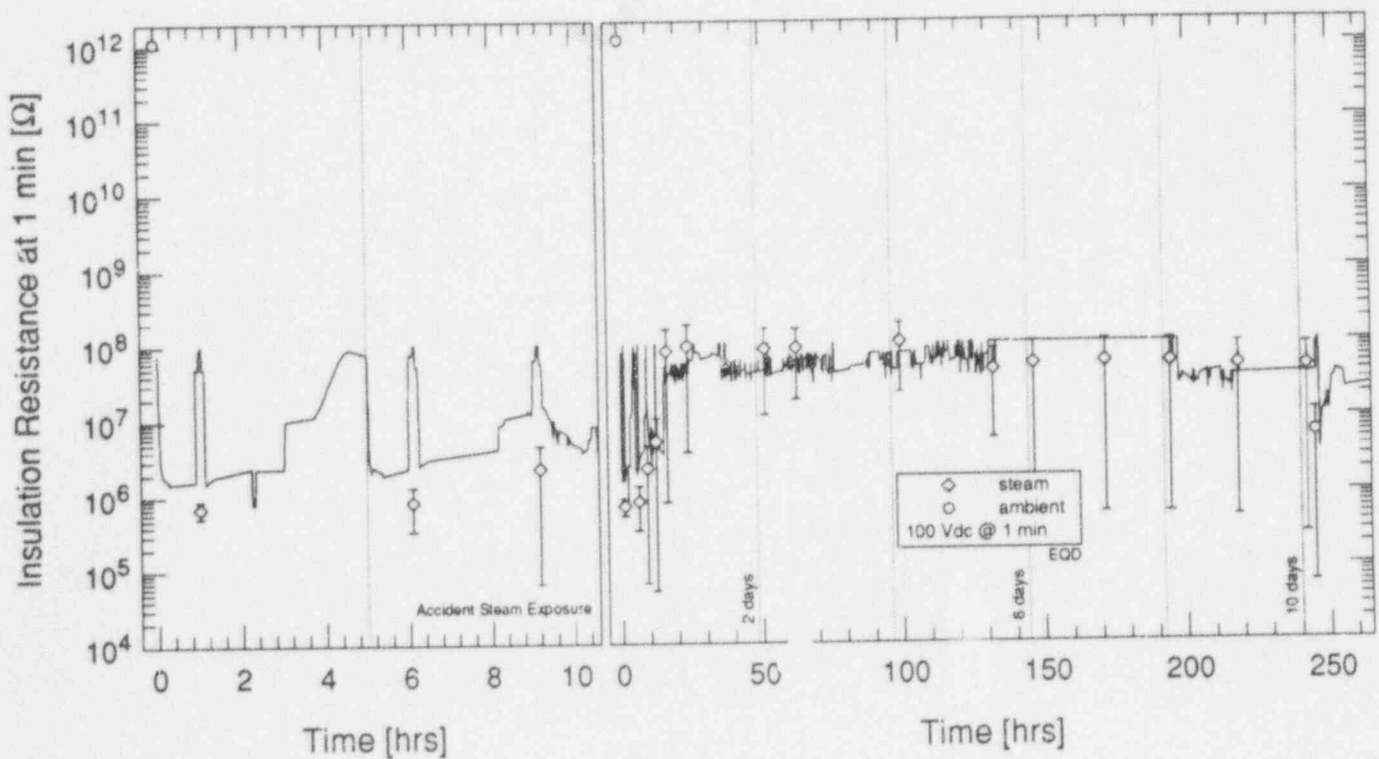
Figure 3.18: IR of EGS quick disconnect connector during accident steam exposure.

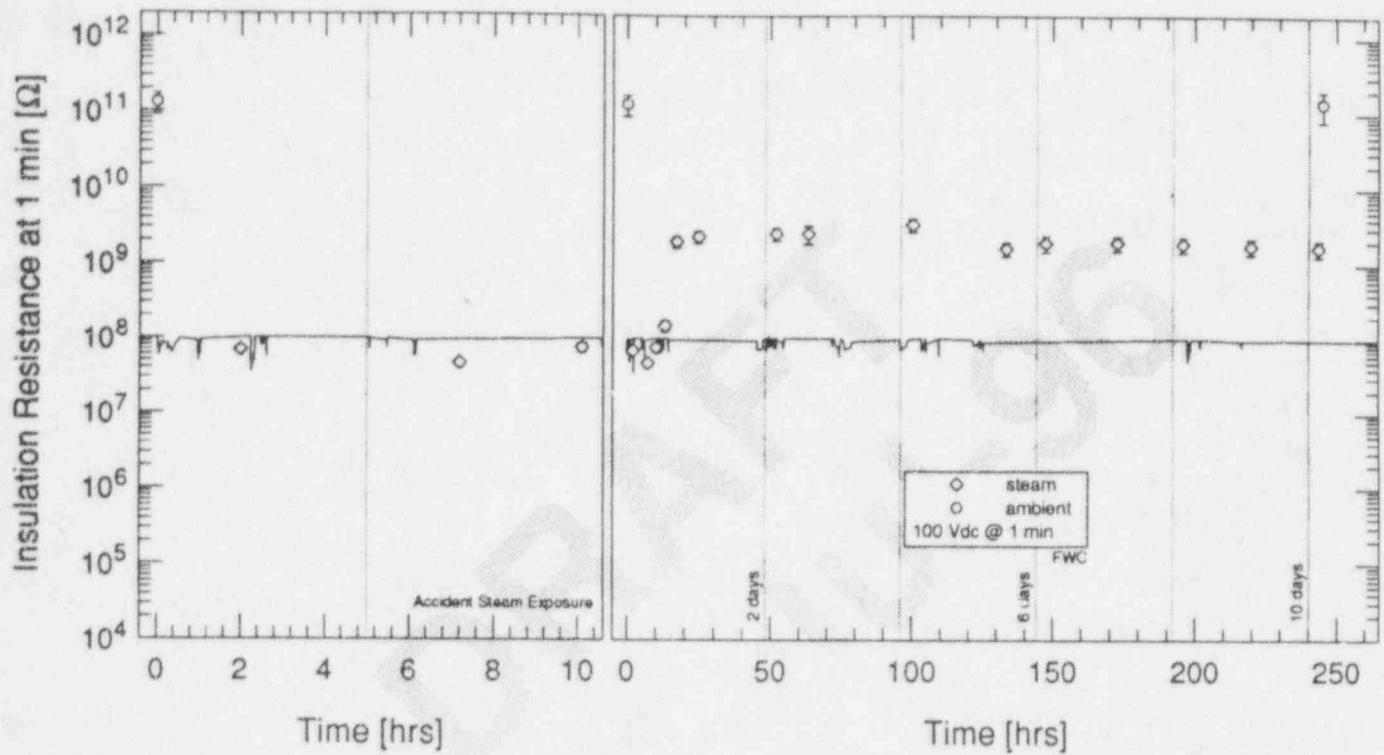
Figure 3.19: IR of Rockbestos Firewall III cable during accident steam exposure.

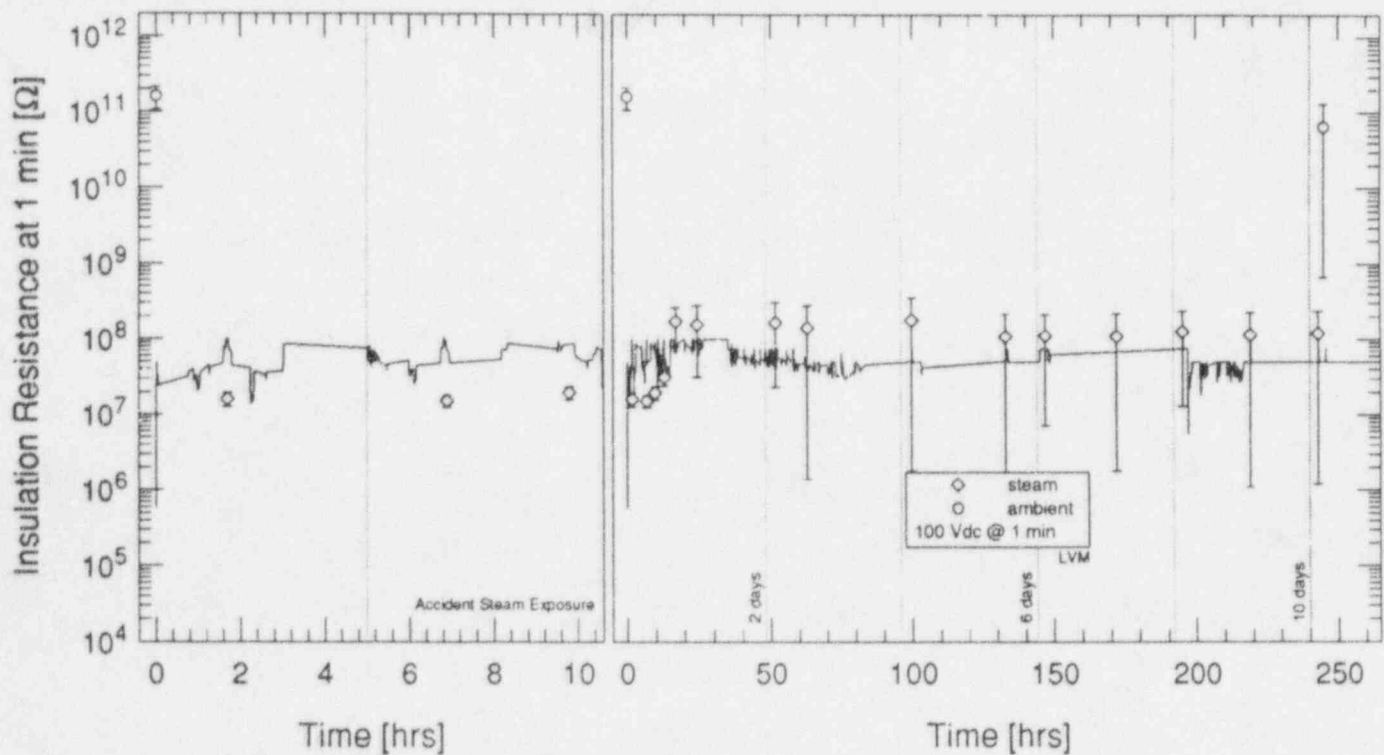
Figure 3.20: IR of Litton-VEAM connector during accident steam exposure.

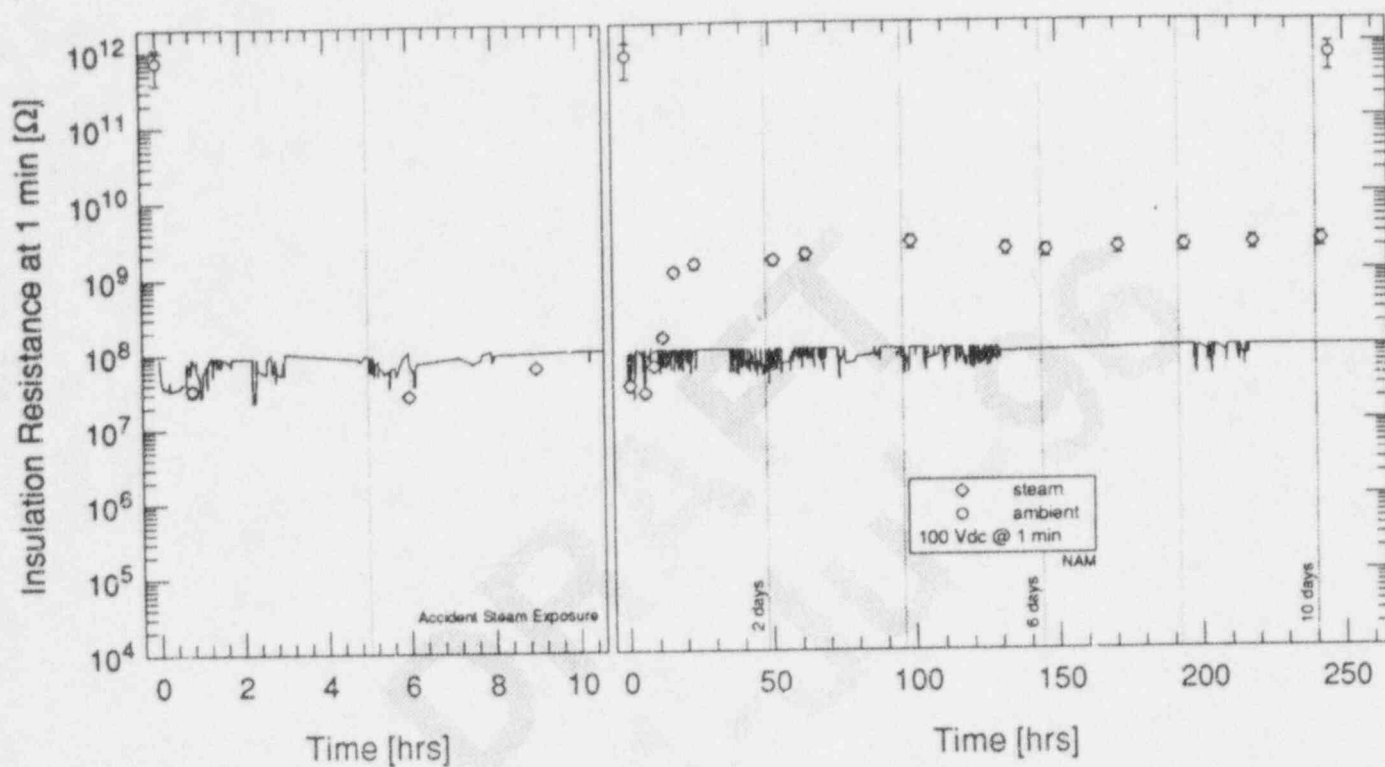
Figure 3.21: IR of NAMCO EC210 connector during accident steam exposure.

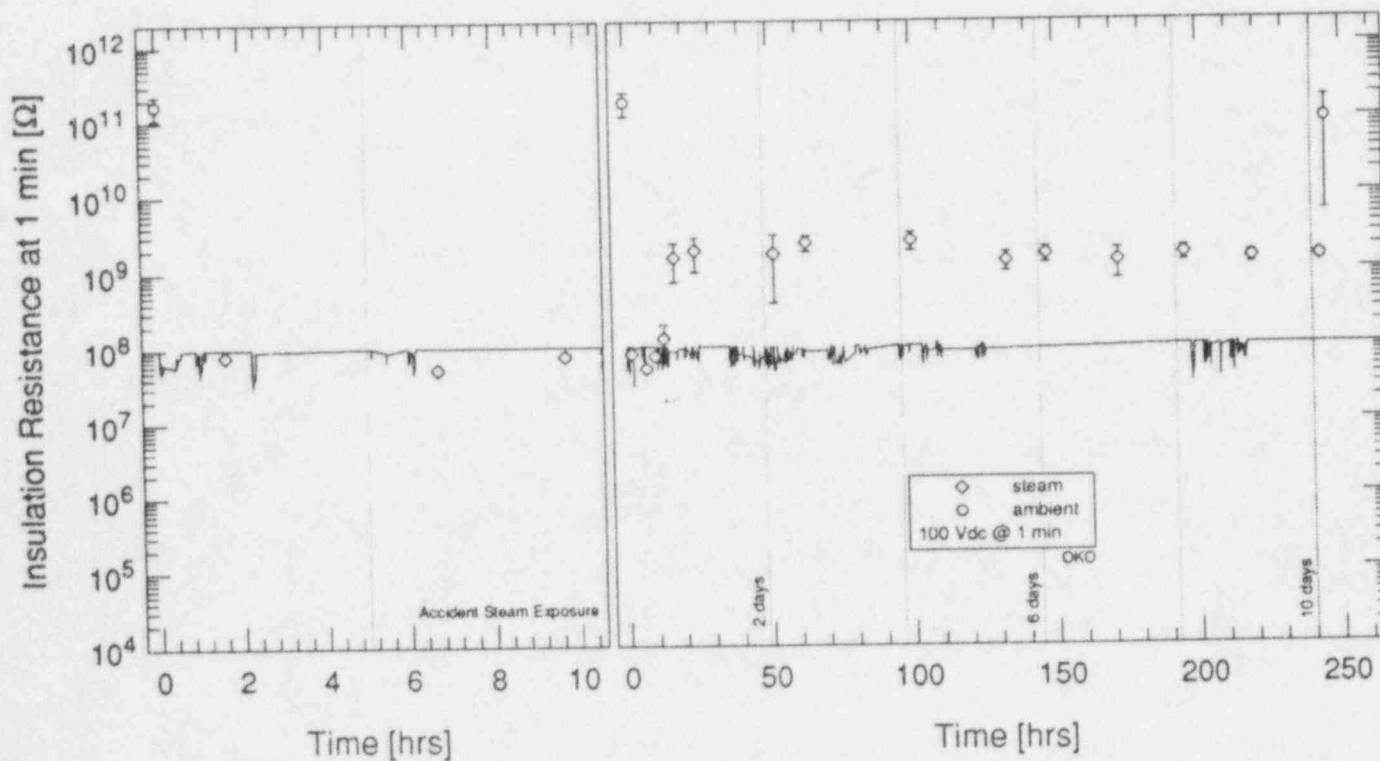
Figure 3.22: IR of Okonite tape splice during accident steam exposure.

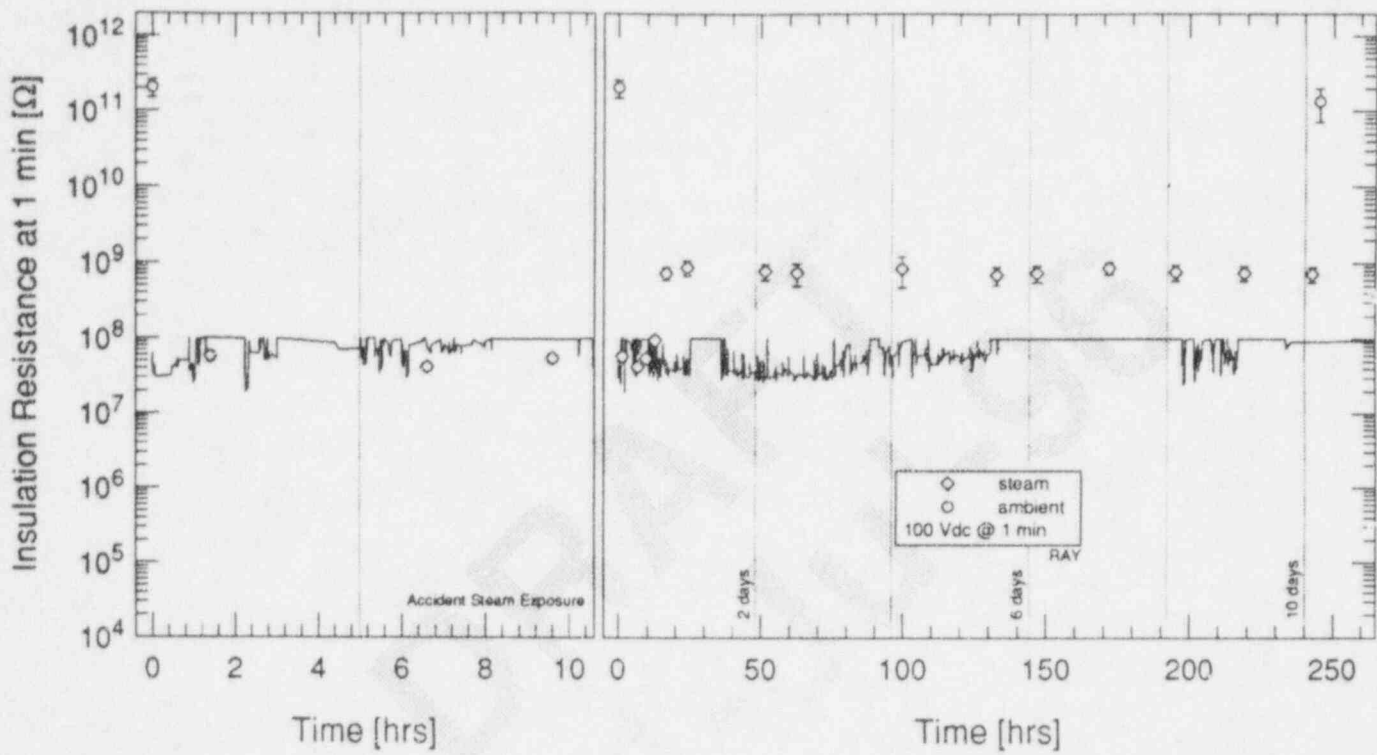
Figure 3.23: IR of Raychem heat shrink splice during accident steam exposure.

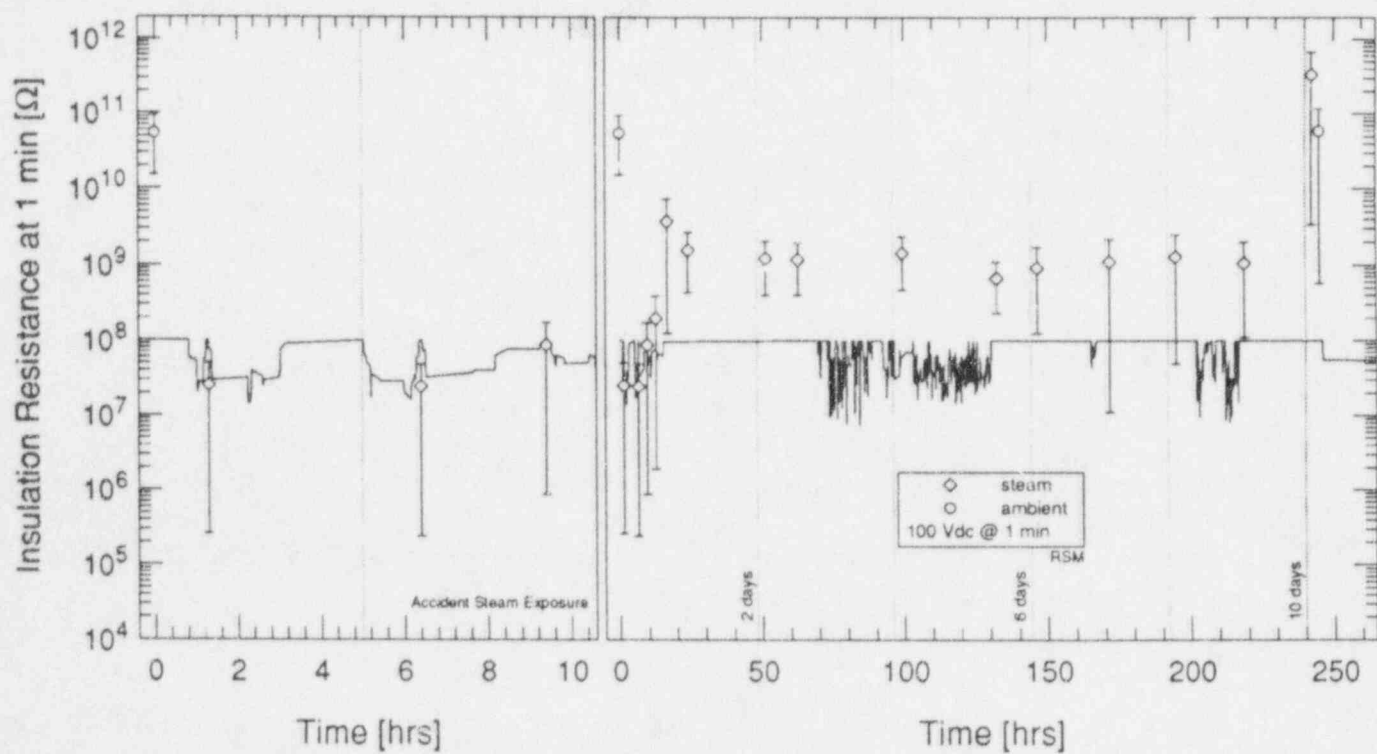
Figure 3.24: IR of Rosemount 353C conduit seal during accident steam exposure.
