Enclosed for your review and comment is a copy of the draft NUREG/CR6412, "Aging and Loss-of-Coolant Accident (LOCA) Testing of Electrical Connections," dated July 31, 1996.

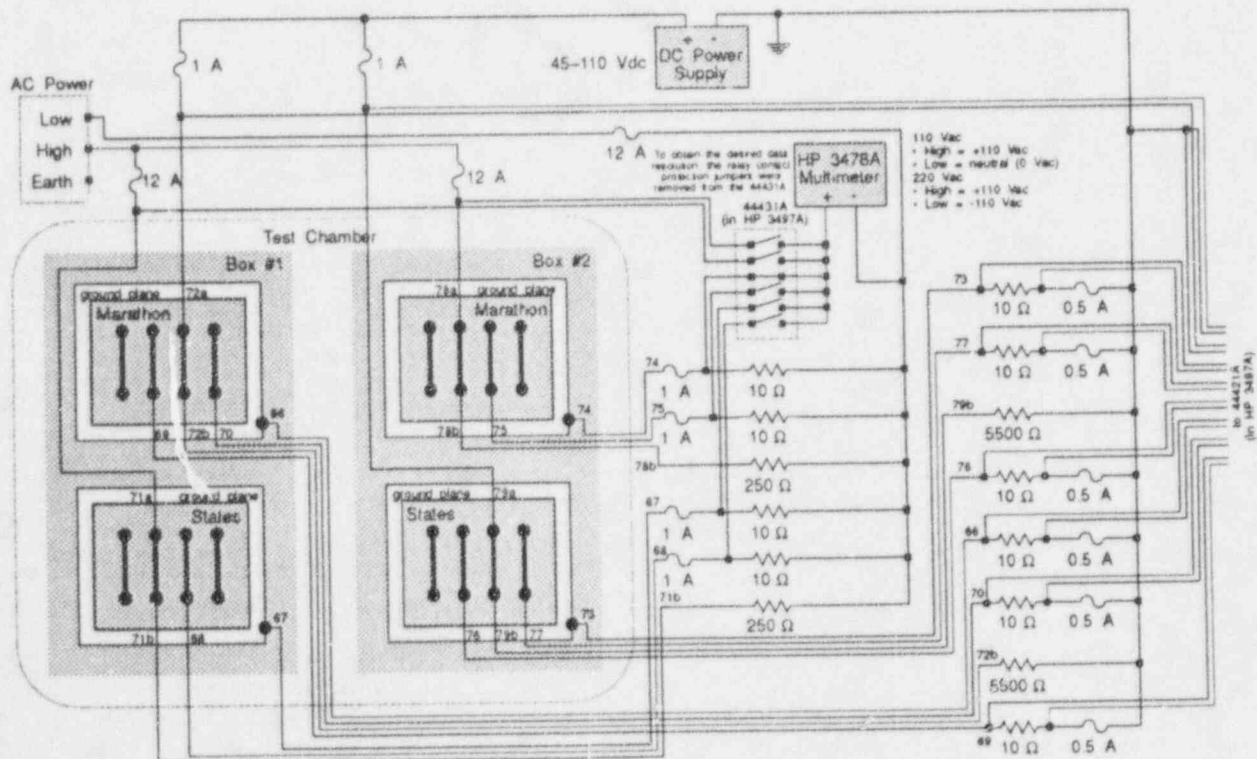
Figure A.2: Circuit used for dc and ac excitation of the terminal block conductors and to measure their "continuous" IRs during the accident steam exposure.

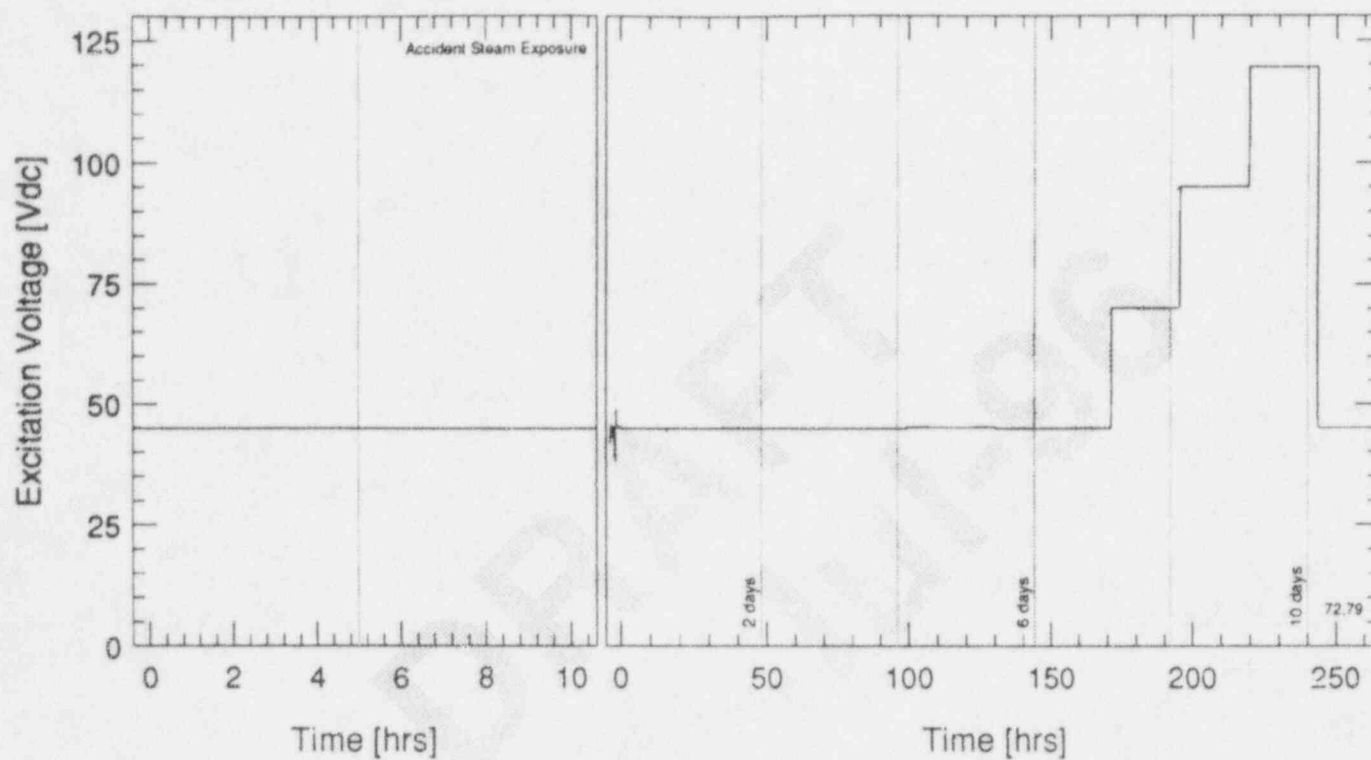
Figure A.3: DC excitation for the terminal block conductors during the accident steam exposure.

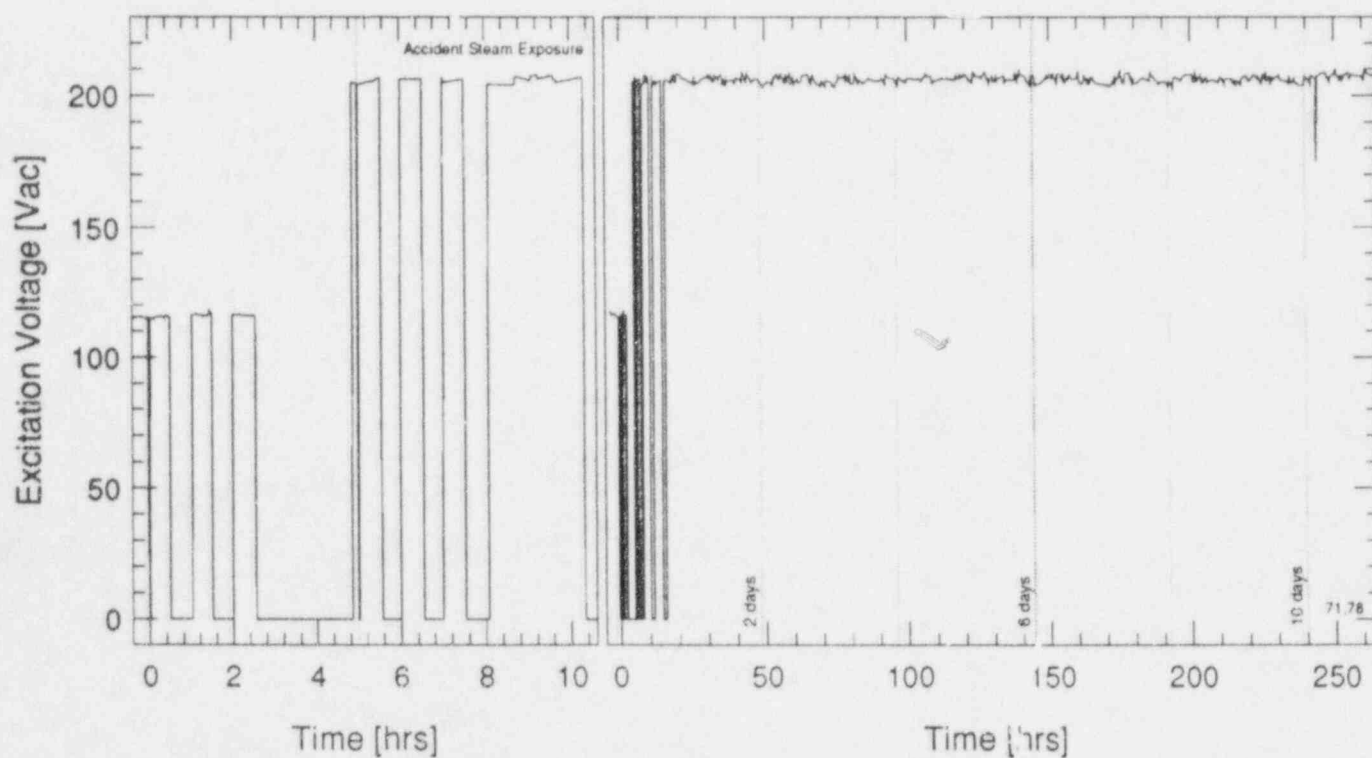
Figure A.4: AC excitation for the terminal block conductors during the accident steam exposure.

the accident steam exposure. The actual ac energization is shown in Figure A.4.

Note that all the discrete IR measurements were dc measurements. However, only the continuous IR measurements for the conductors from the dc energized terminal blocks were dc measurements. The continuous IR measurements for the conductors from the ac energized terminal blocks were ac measurements; thus, these measurements really measure the leakage and charging current for these conductors, much like an ac dielectric test set measurement.

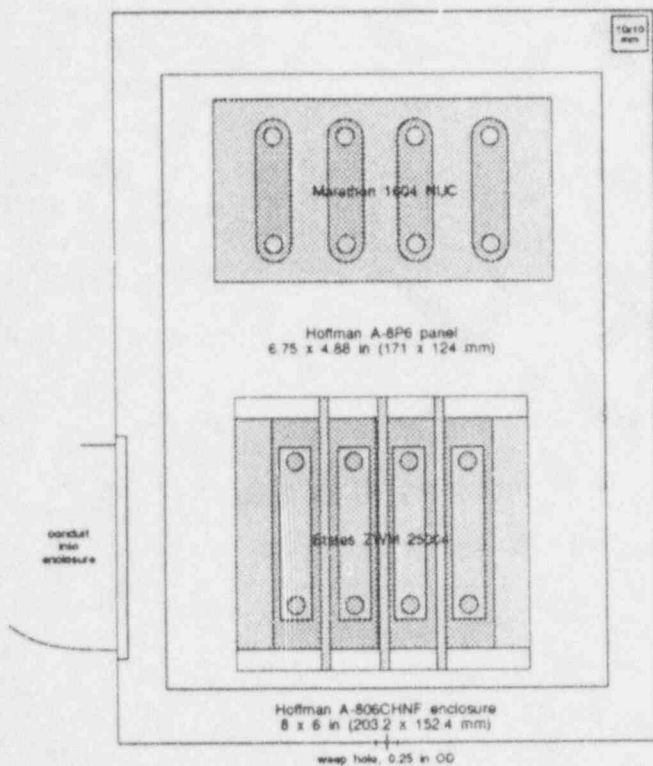
Figure A.1: Sketch of the two terminal blocks inside an enclosure (to scale).

IR values because water could enter the terminal block enclosures through the weep hole and unsealed conduit entry and submerge the bare terminal blocks. The terminal block enclosures were also mounted lower in the test chamber than the other connections, which caused the terminal blocks to be submerged before the other connections. The data does not show any change in the measured IR when an initially unpowered terminal block has power suddenly applied while in a steam environment; it had been hypothesized that this might cause electrical shorting because of surface moisture that might form on the cold terminal block. Previous testing had utilized continuously powered terminal blocks and the resulting I^2R heat generation might have reduced the amount of surface moisture that formed on the terminal blocks.

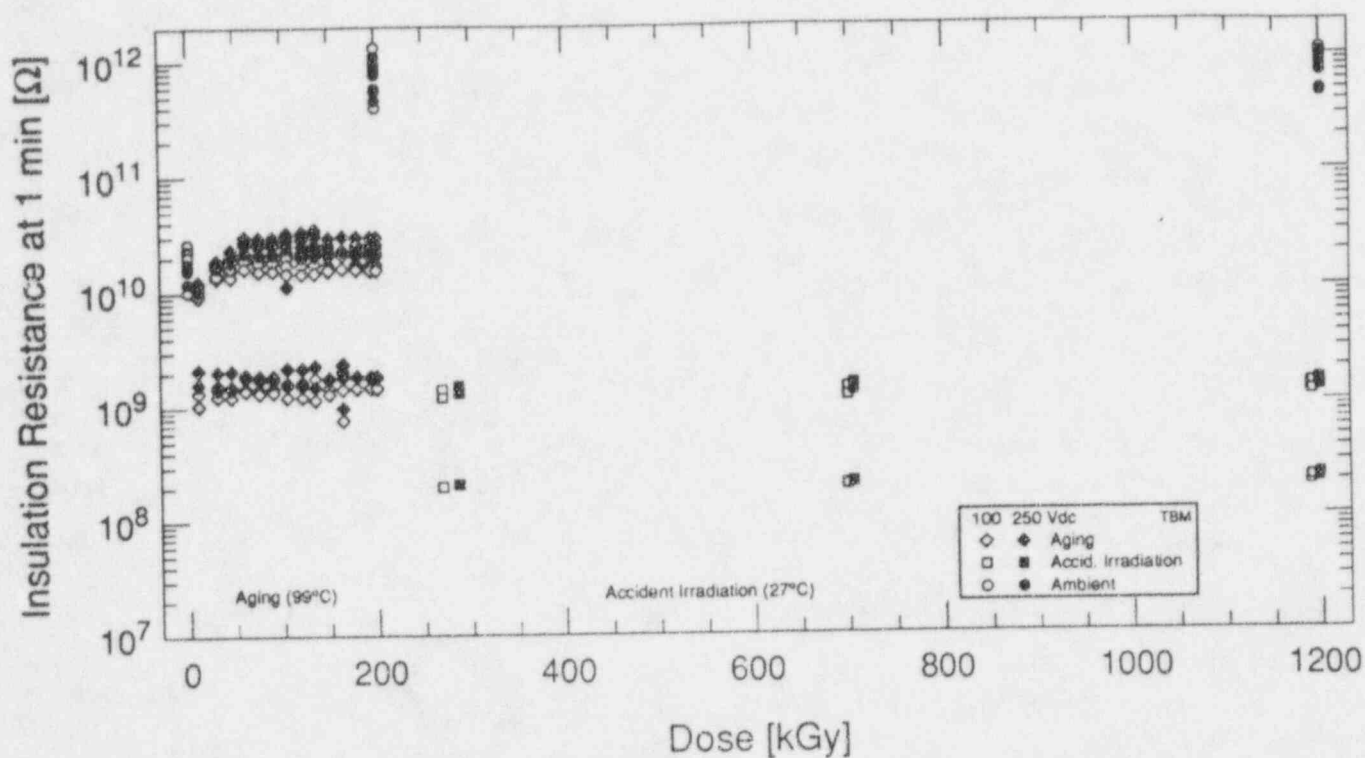
Figure A.5: IR of the 7 Marathon terminal block conductors during aging and accident irradiation.

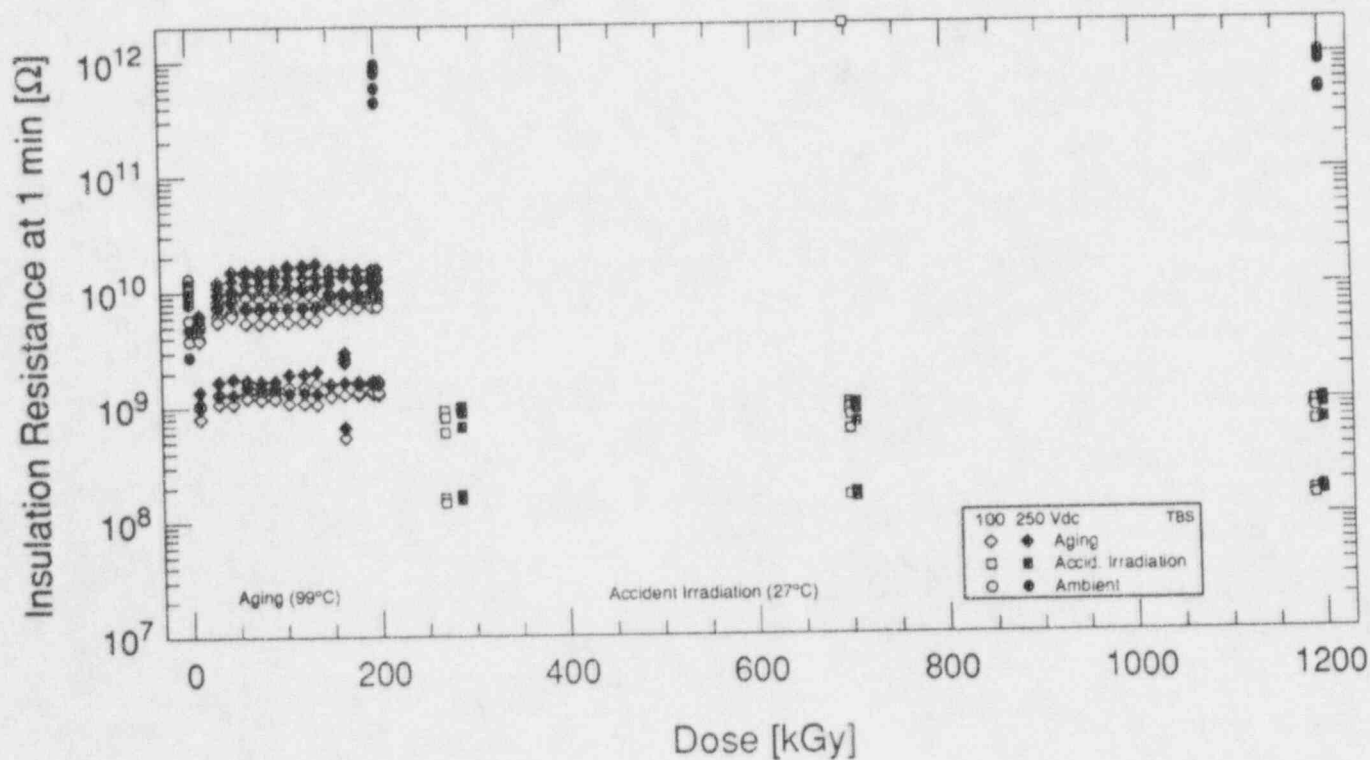
Figure A.6: IR of the 7 States terminal block conductors during aging and accident irradiation.

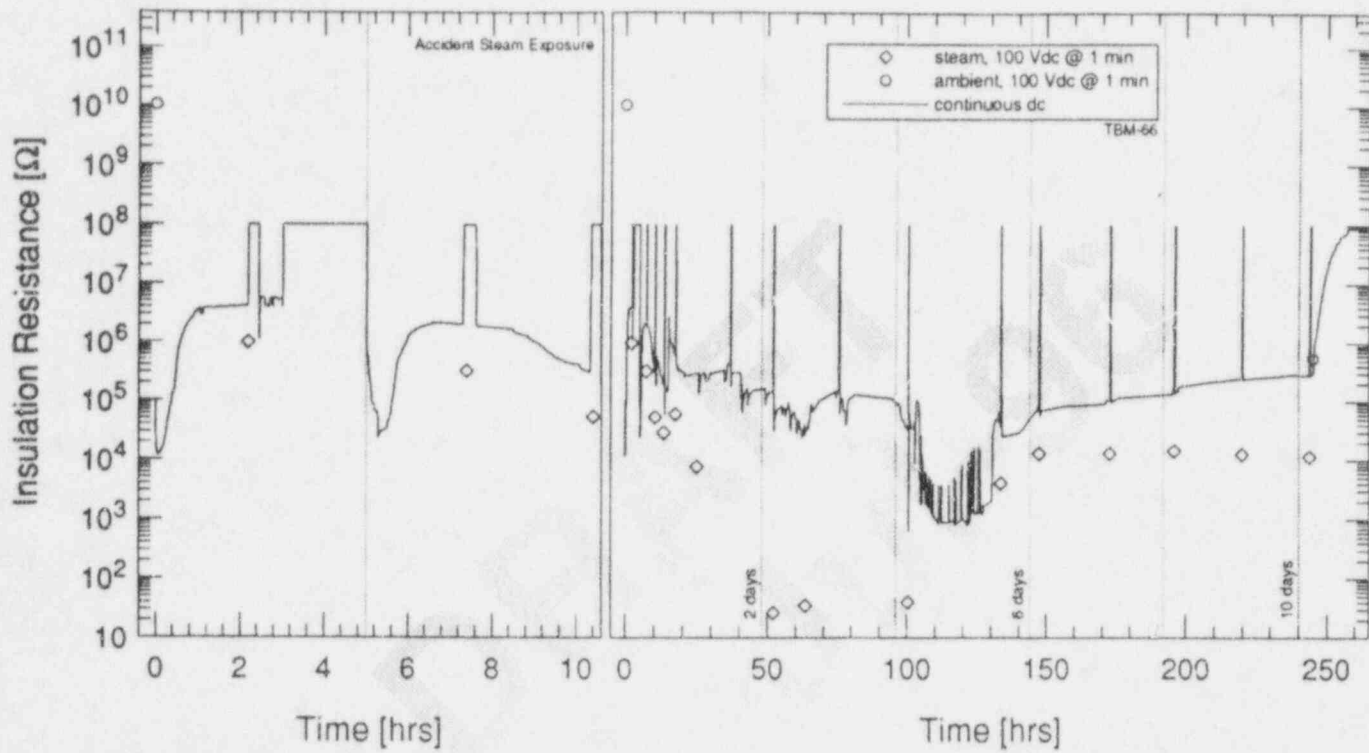
Figure A.7: IR of conductor 66 during the accident steam exposure (Marathon dc ground plane, enclosure 1).

Measured terminal block conductor IR data during the accident steam exposure are shown in Figures A.7-A.20. The IR values fell to low values due to the presence of moisture during the steam exposure. The slow test chamber flooding that occurred through day 5 caused even larger reductions in the measured

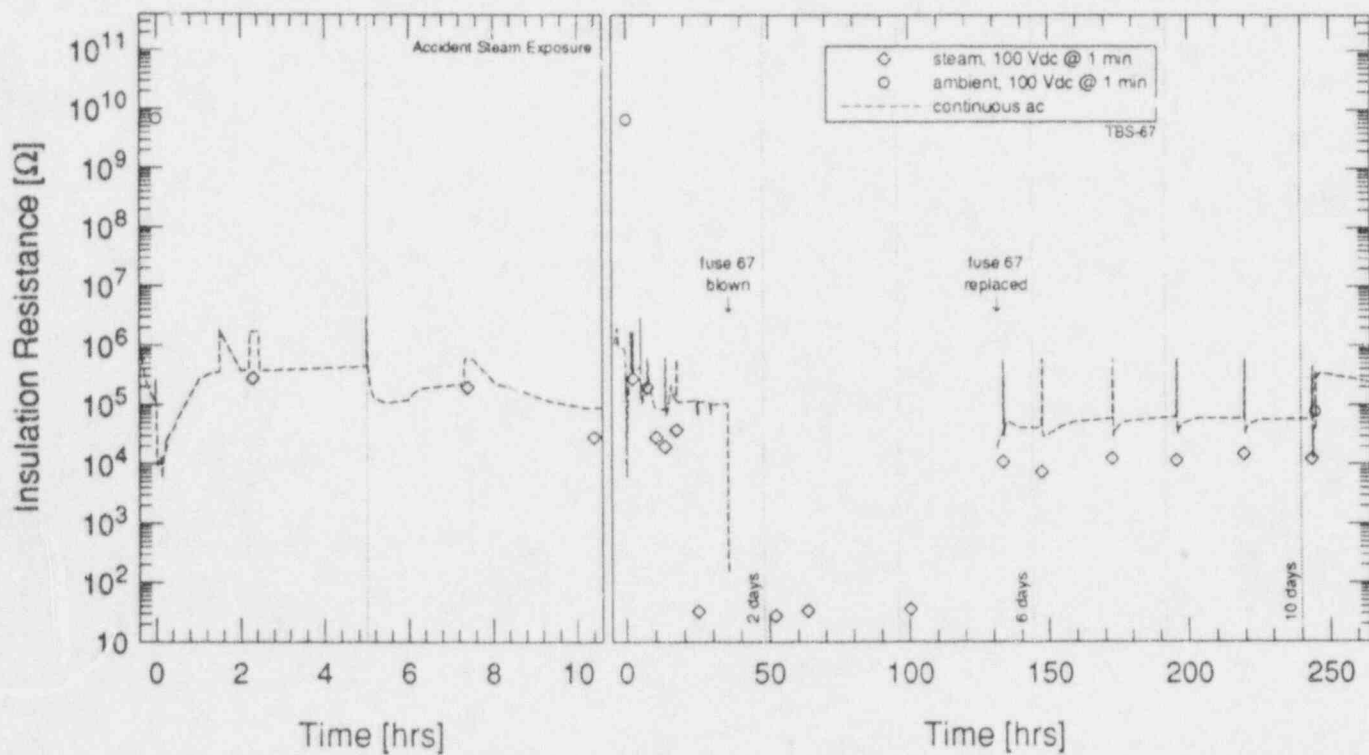
Figure A.8: IR of conductor 67 during the accident steam exposure (States ac ground plane, enclosure 1).

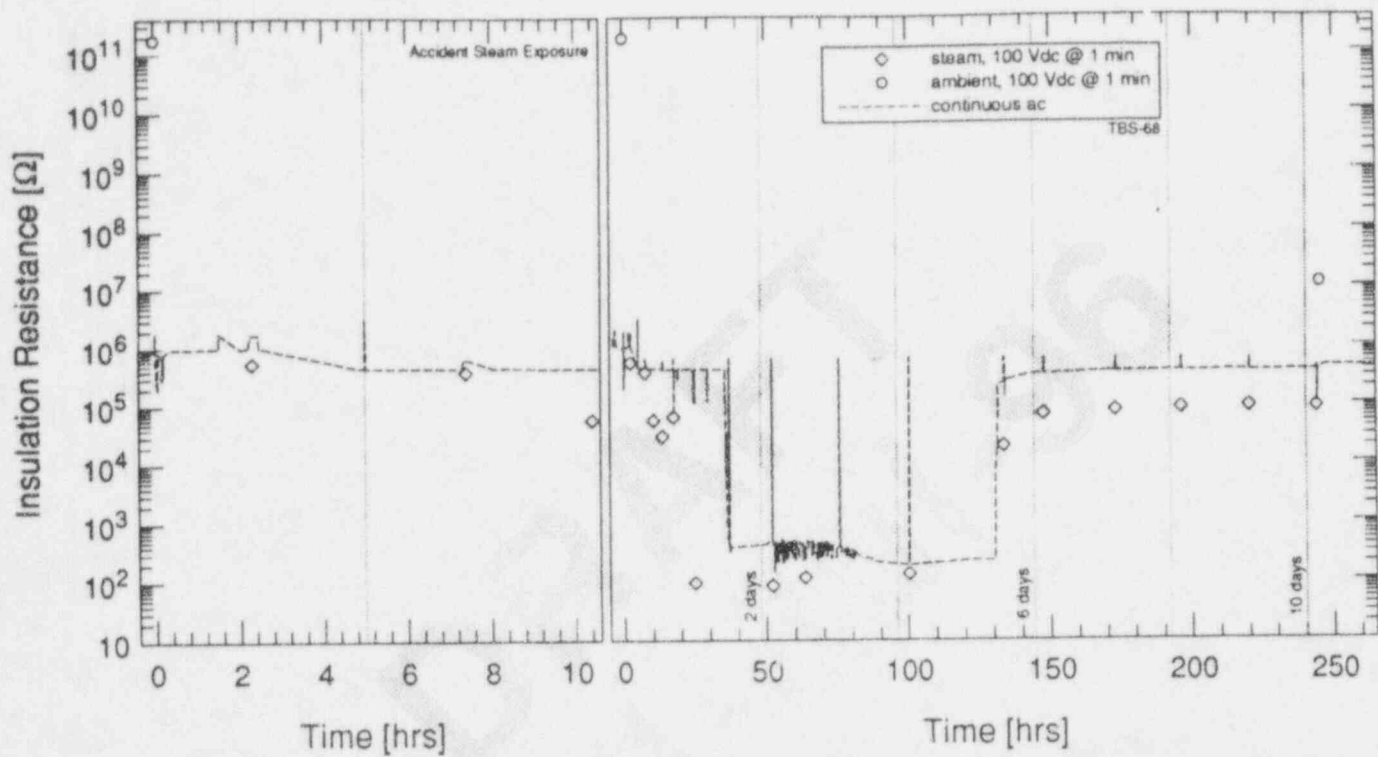
Figure A.9: IR of conductor 68 during the accident steam exposure (States ac adjacent terminal, enclosure 1).

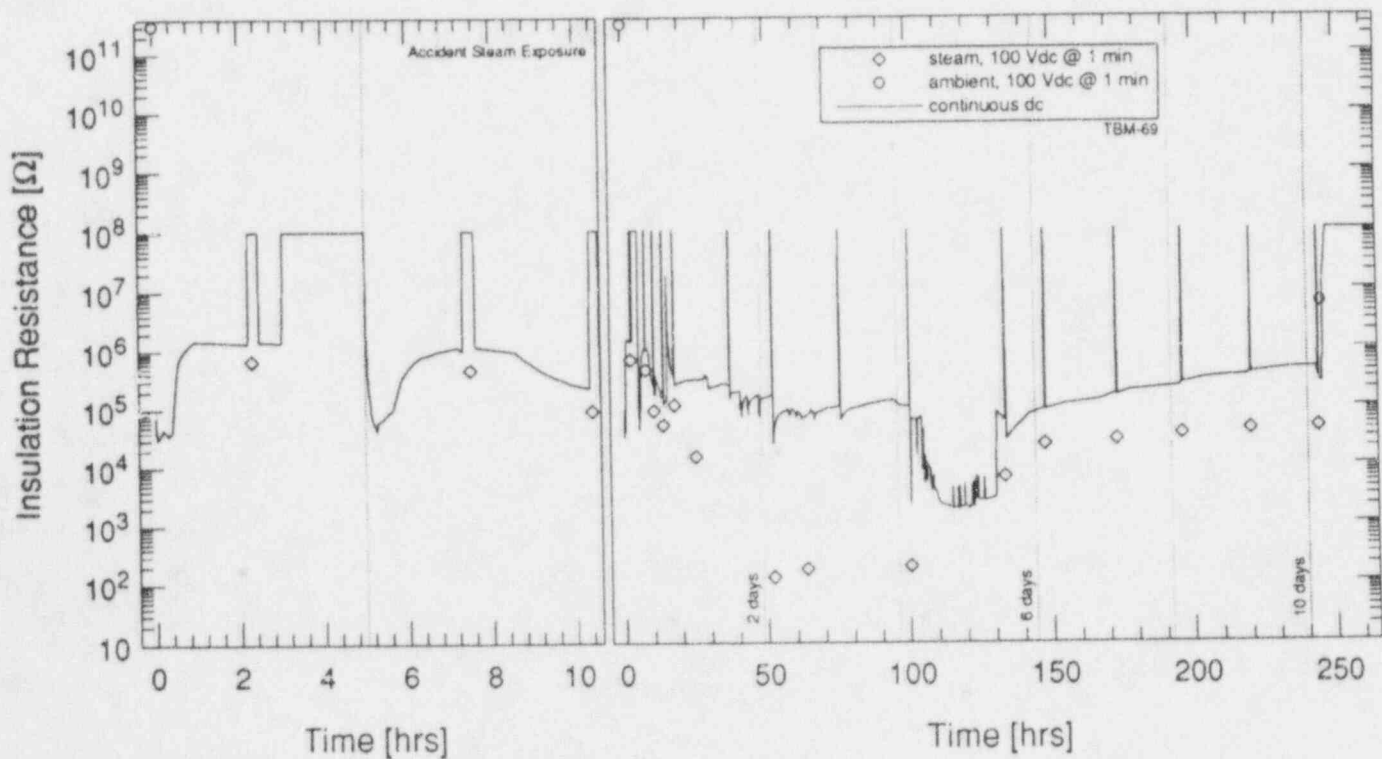
Figure A.10: IR of conductor 69 during the accident steam exposure (Marathon dc adjacent terminal, enclosure 1).

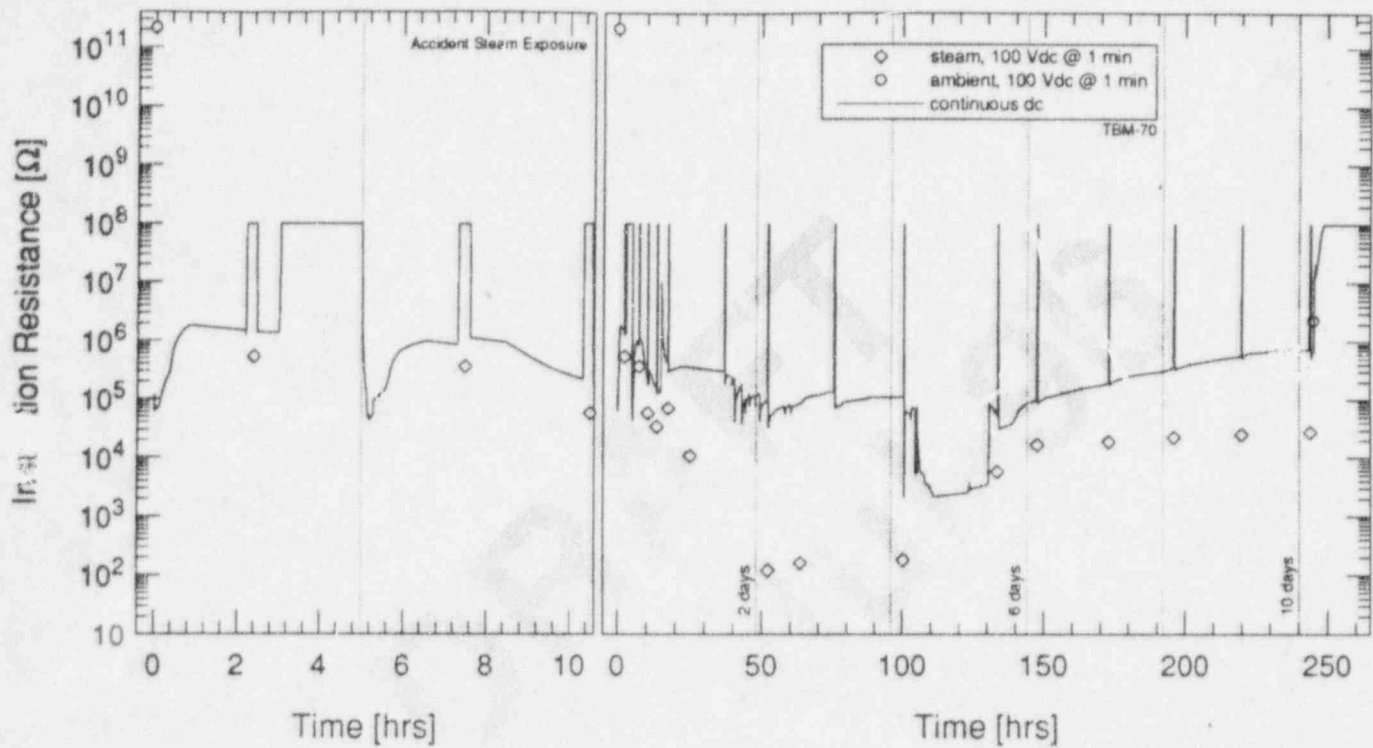
Figure A.11: IR of conductor 70 during the accident steam exposure (Marathon dc adjacent terminal, enclosure 1).

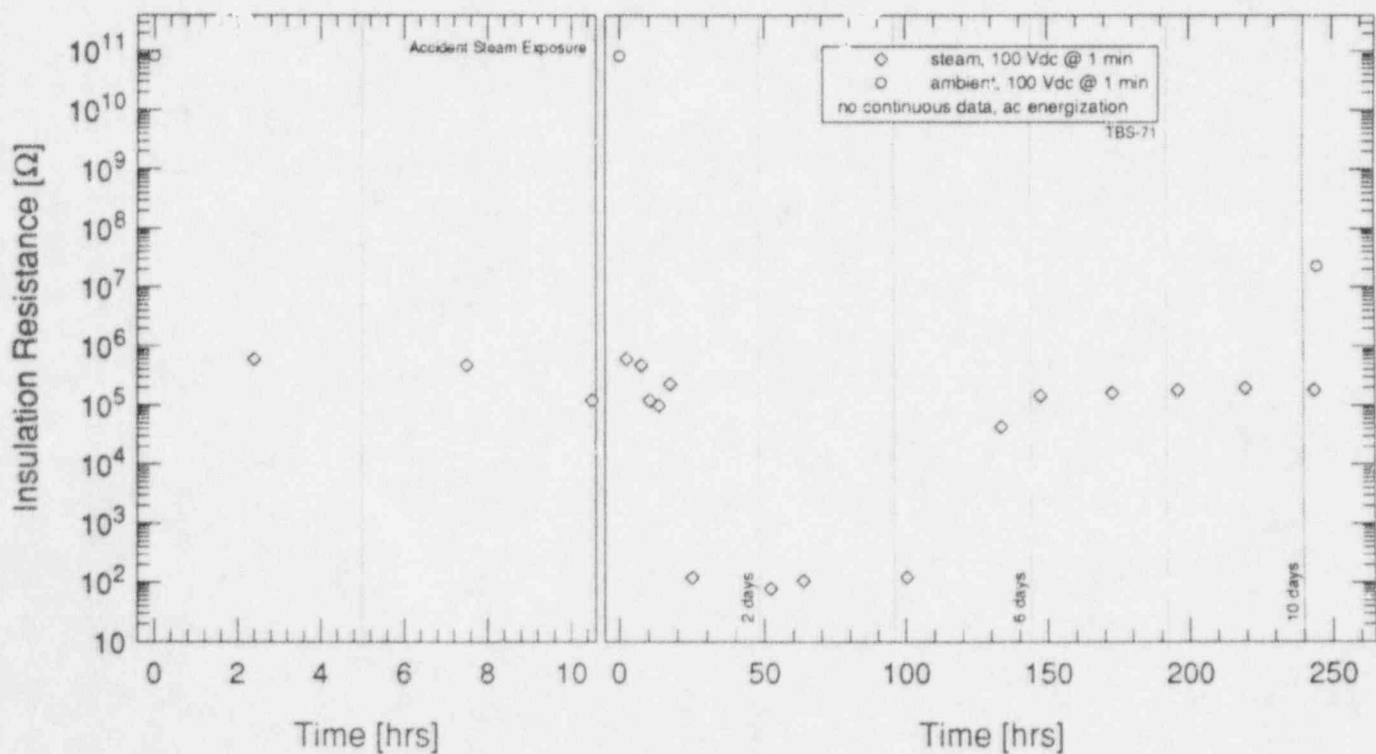
Figure A.12: IR of conductor 71 during the accident steam exposure (States ac energization, enclosure 1).

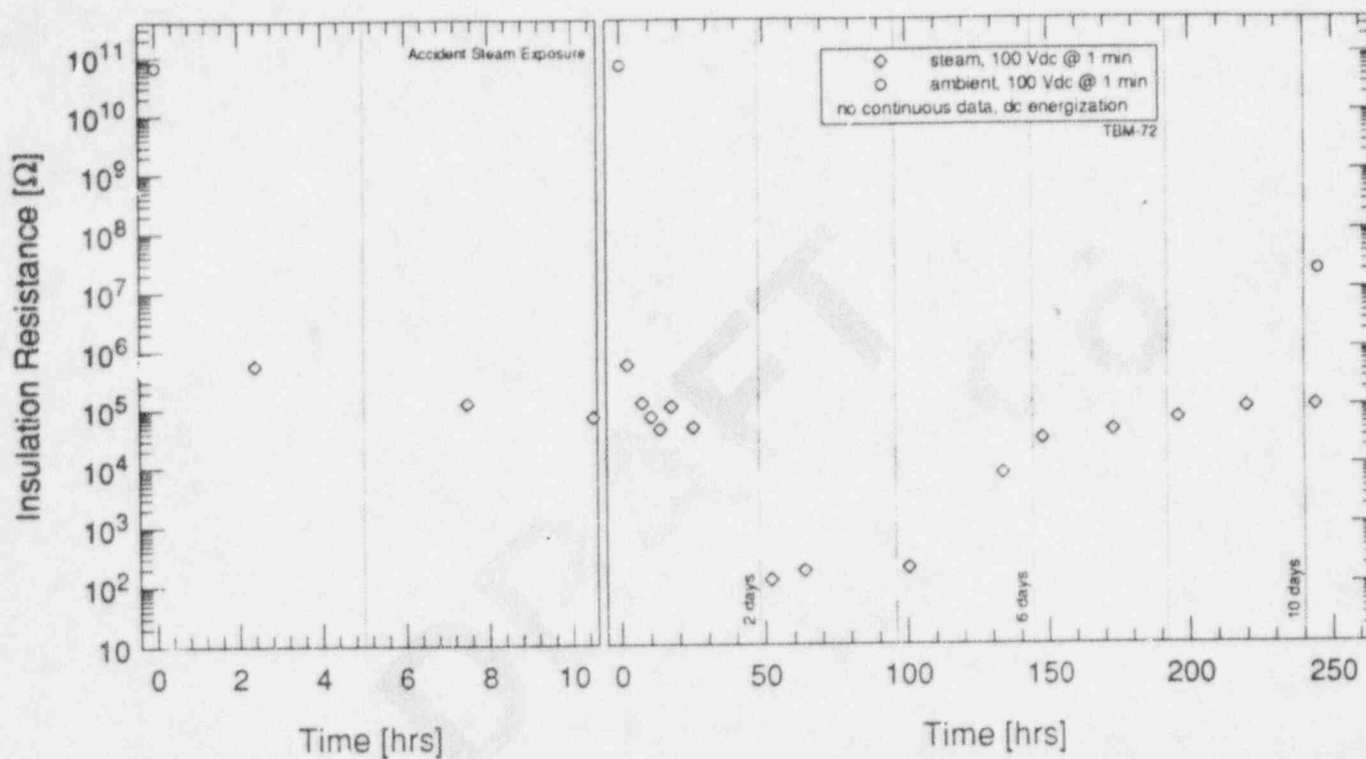
Figure A.13: IR of conductor 72 during the accident steam exposure (Marathon dc energization, enclosure 1)

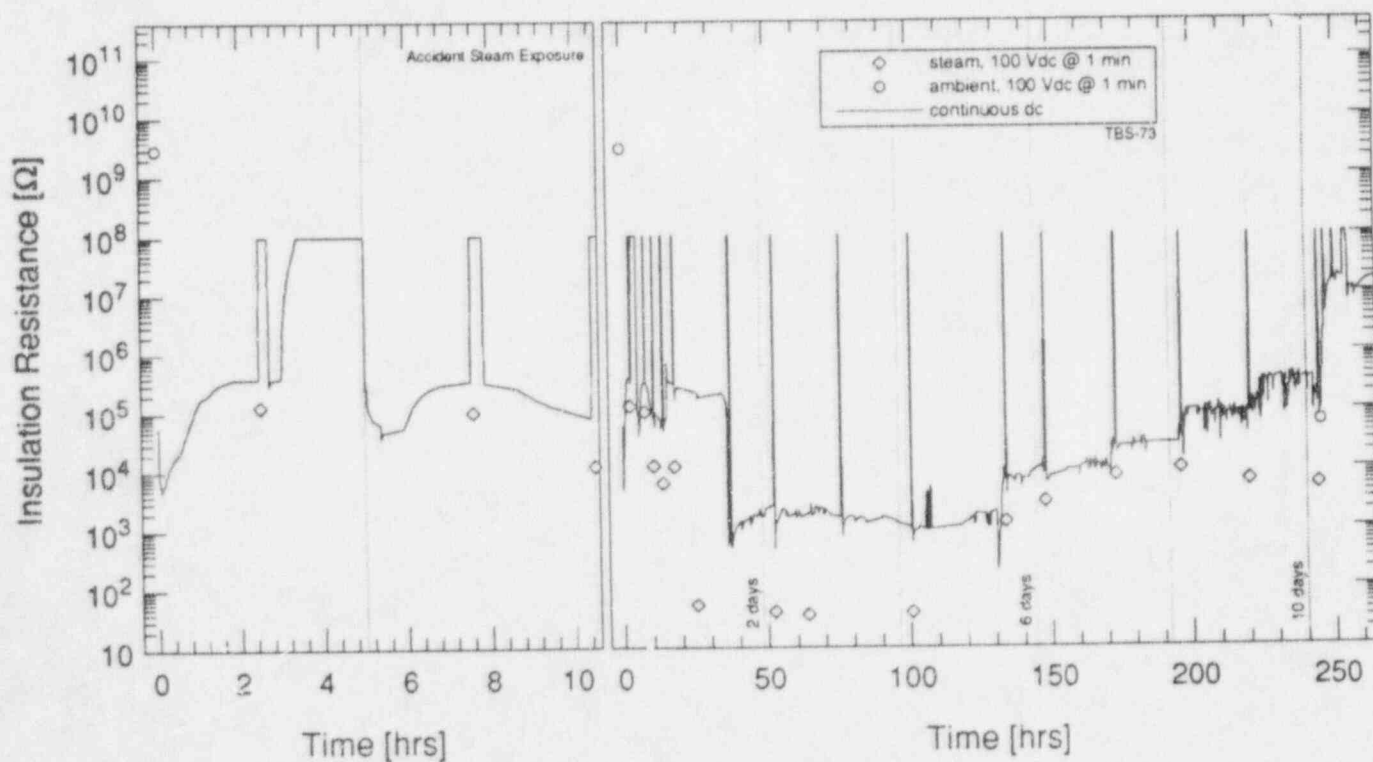
Figure A.14: IR of conductor 73 during the accident steam exposure (States dc ground plane, enclosure 2).

²The very high IR for the States terminal block conductor 73 at a dose of 698 kGy was considered a test anomaly.

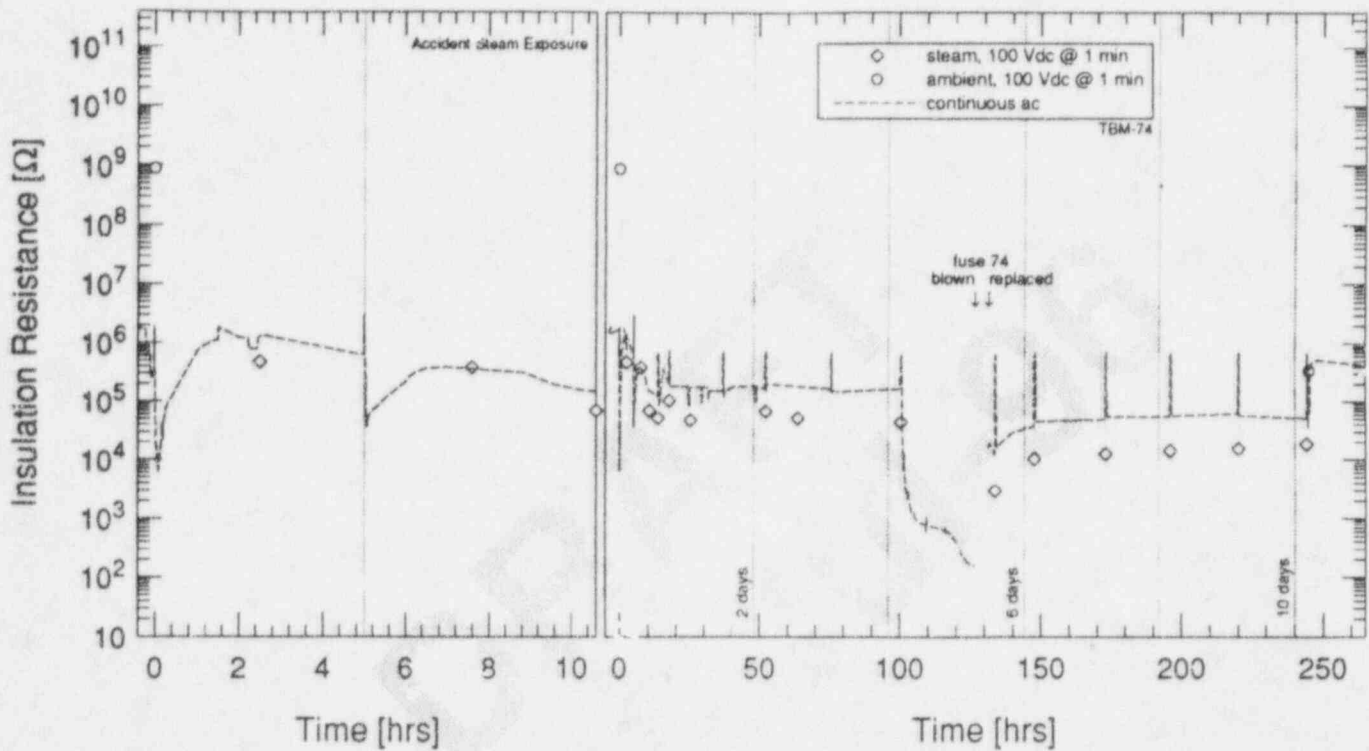
Figure A.15: IR of conductor 74 during the accident steam exposure (Marathon ac ground plane, enclosure 2).

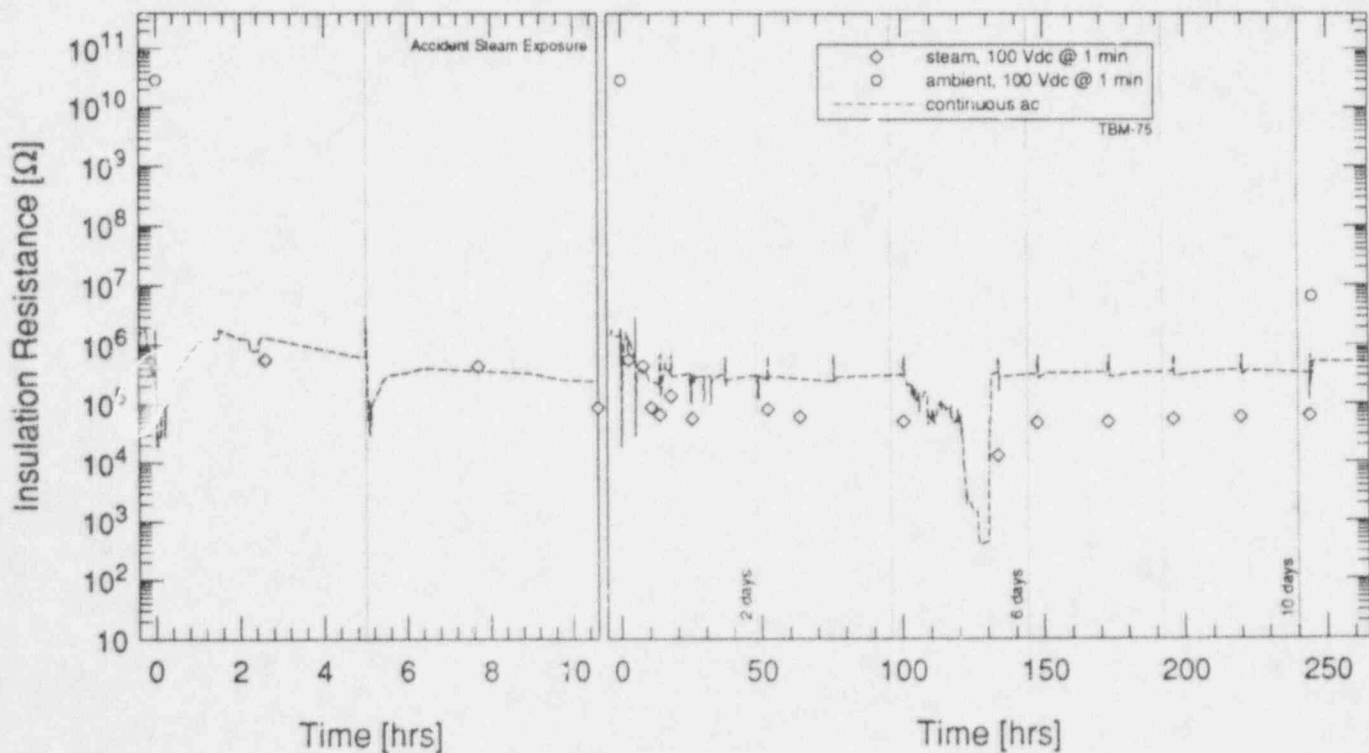
Figure A.16: IR of conductor 75 during the accident steam exposure (Marathon ac adjacent terminal, enclosure 2).

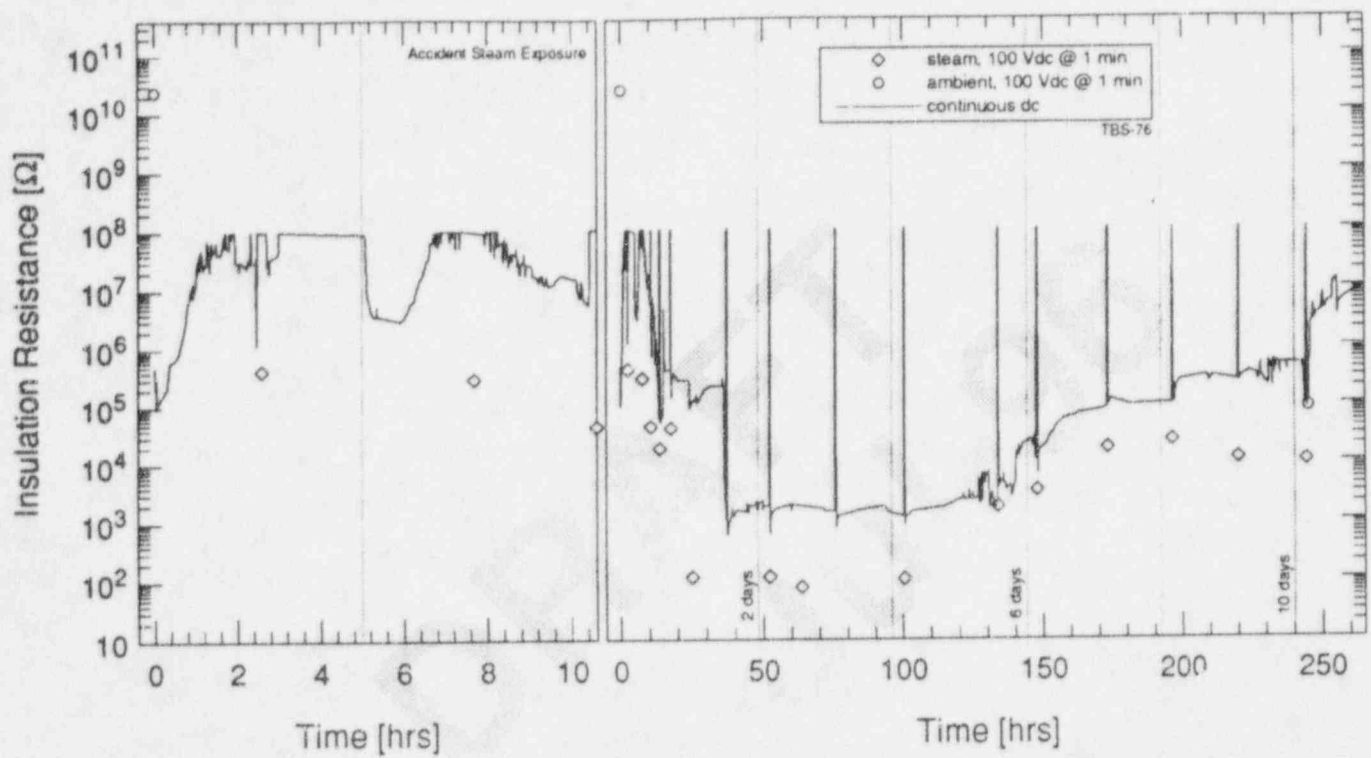
Figure A.17: IR of conductor 76 during the accident steam exposure (States dc adjacent terminal, enclosure 2).

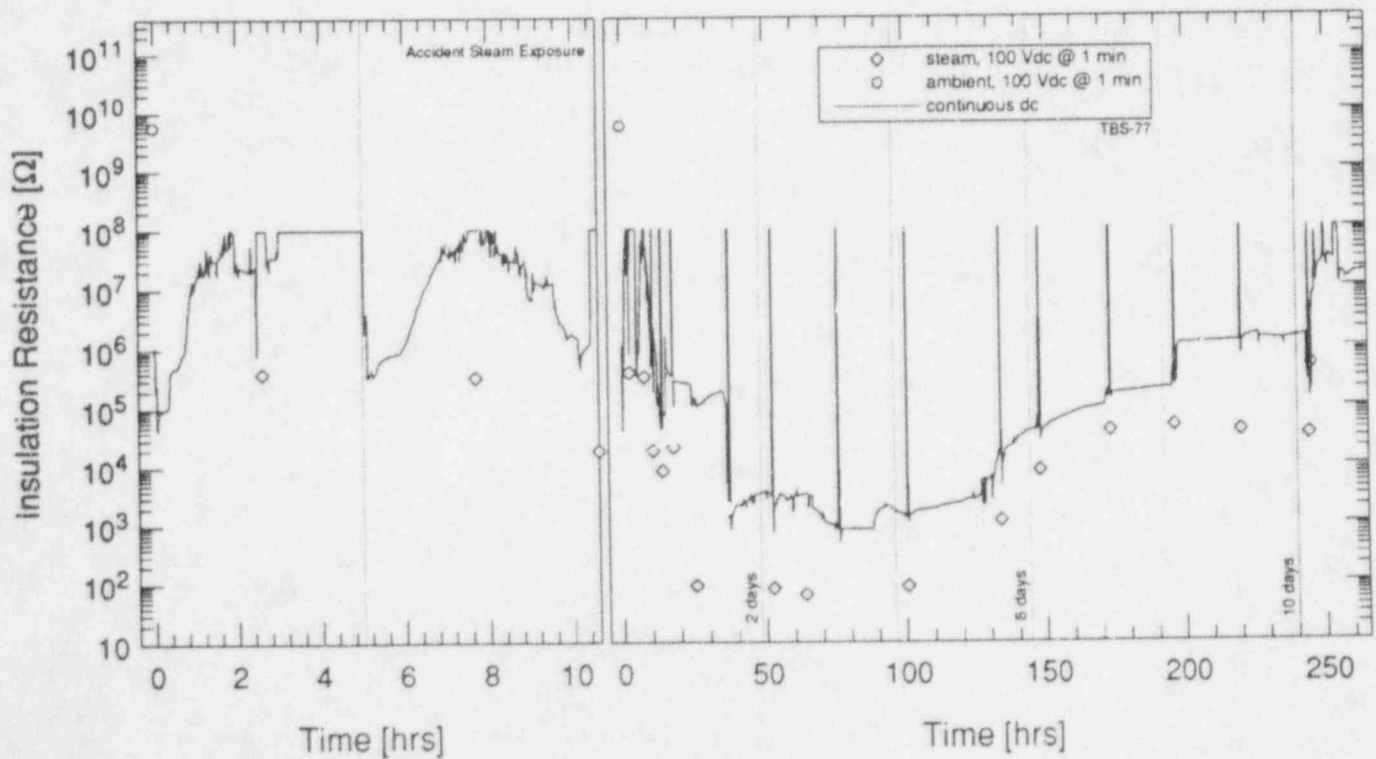
Figure A.18: IR of conductor 77 during the accident steam exposure (States dc adjacent terminal, enclosure 2).

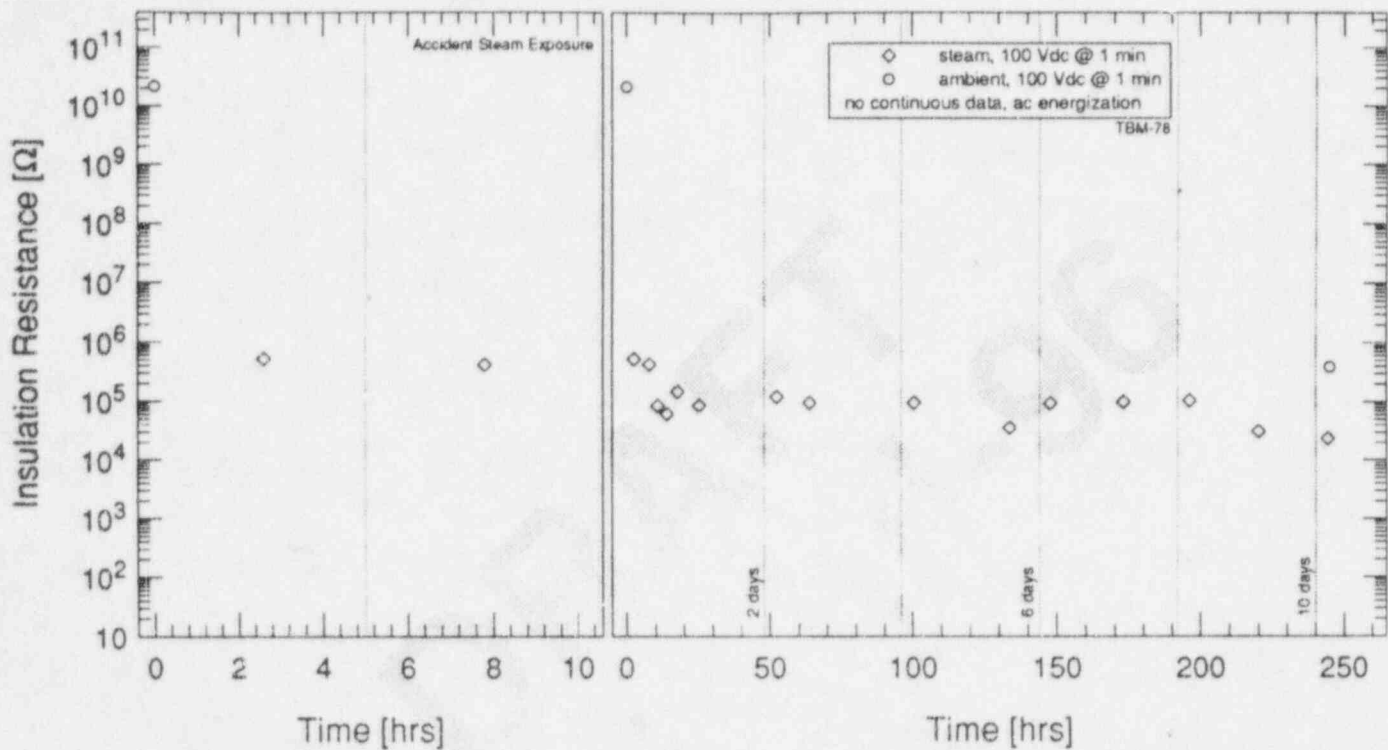
Figure A.19: IR of conductor 78 during the accident steam exposure (Marathon ac energization, enclosure 2).

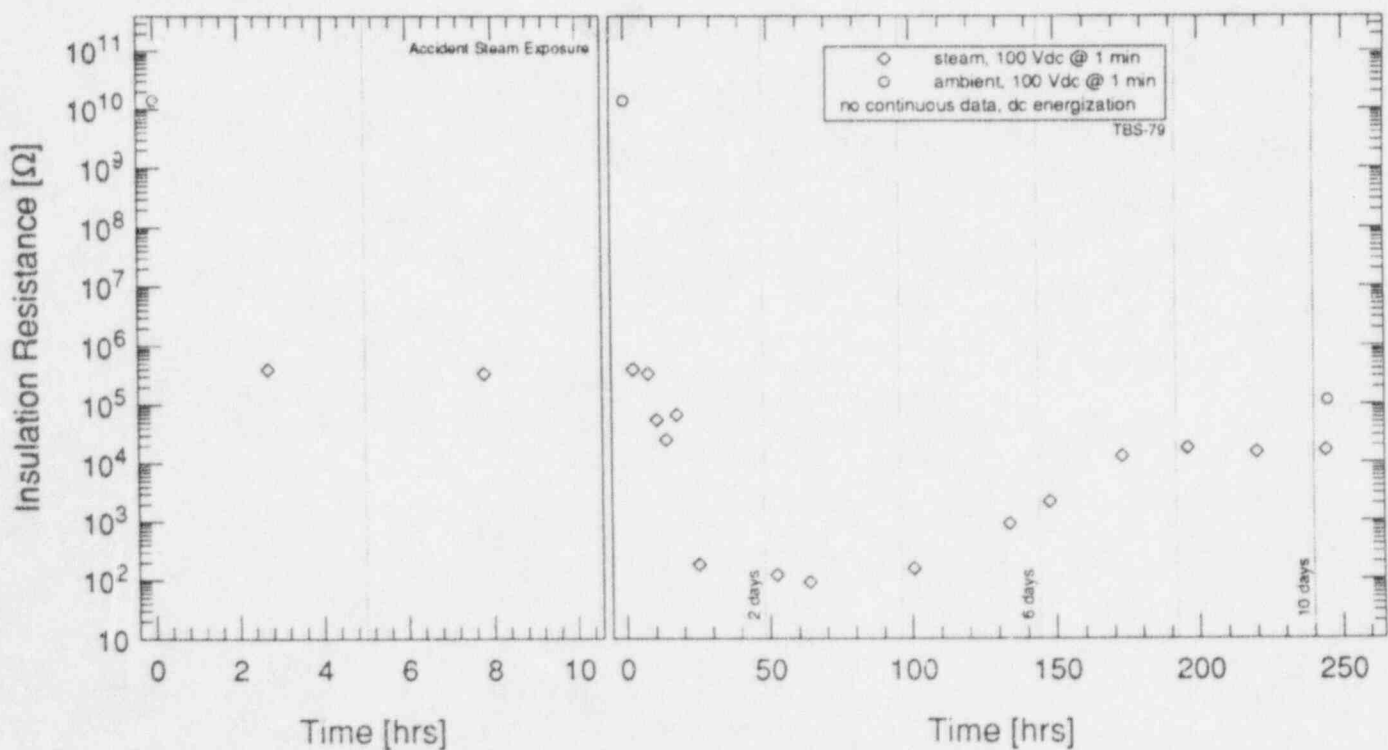
Figure A.20: IR of conductor 79 during the accident steam exposure (States dc energization, enclosure 2).

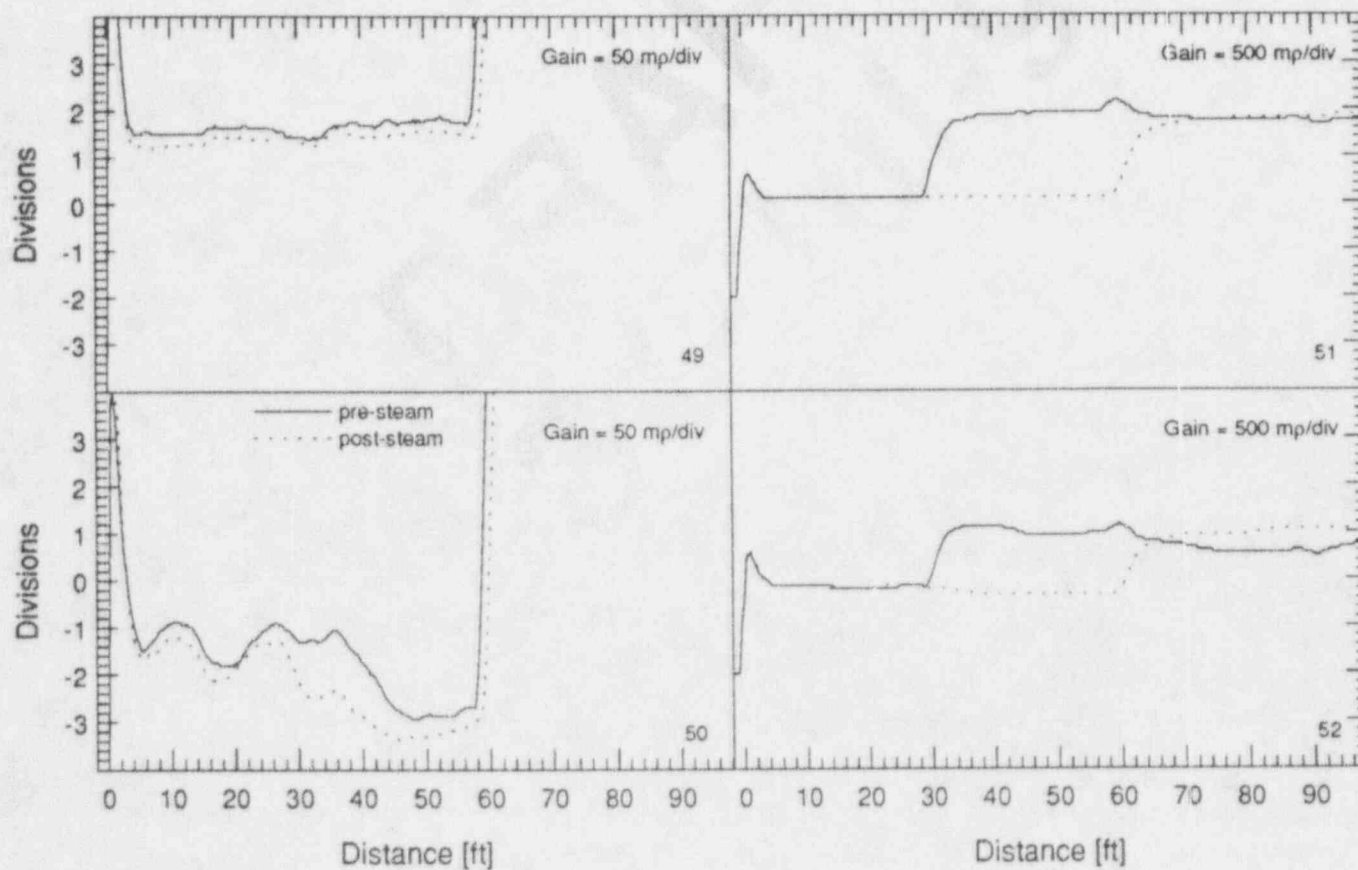
Figure B.1: TDR of the Amphenol coaxial connector conductors before and after the accident steam exposure.
