Enclosed for your review and comment is a copy of the draft NUREG/CR6412, "Aging and Loss-of-Coolant Accident (LOCA) Testing of Electrical Connections," dated July 31, 1996.

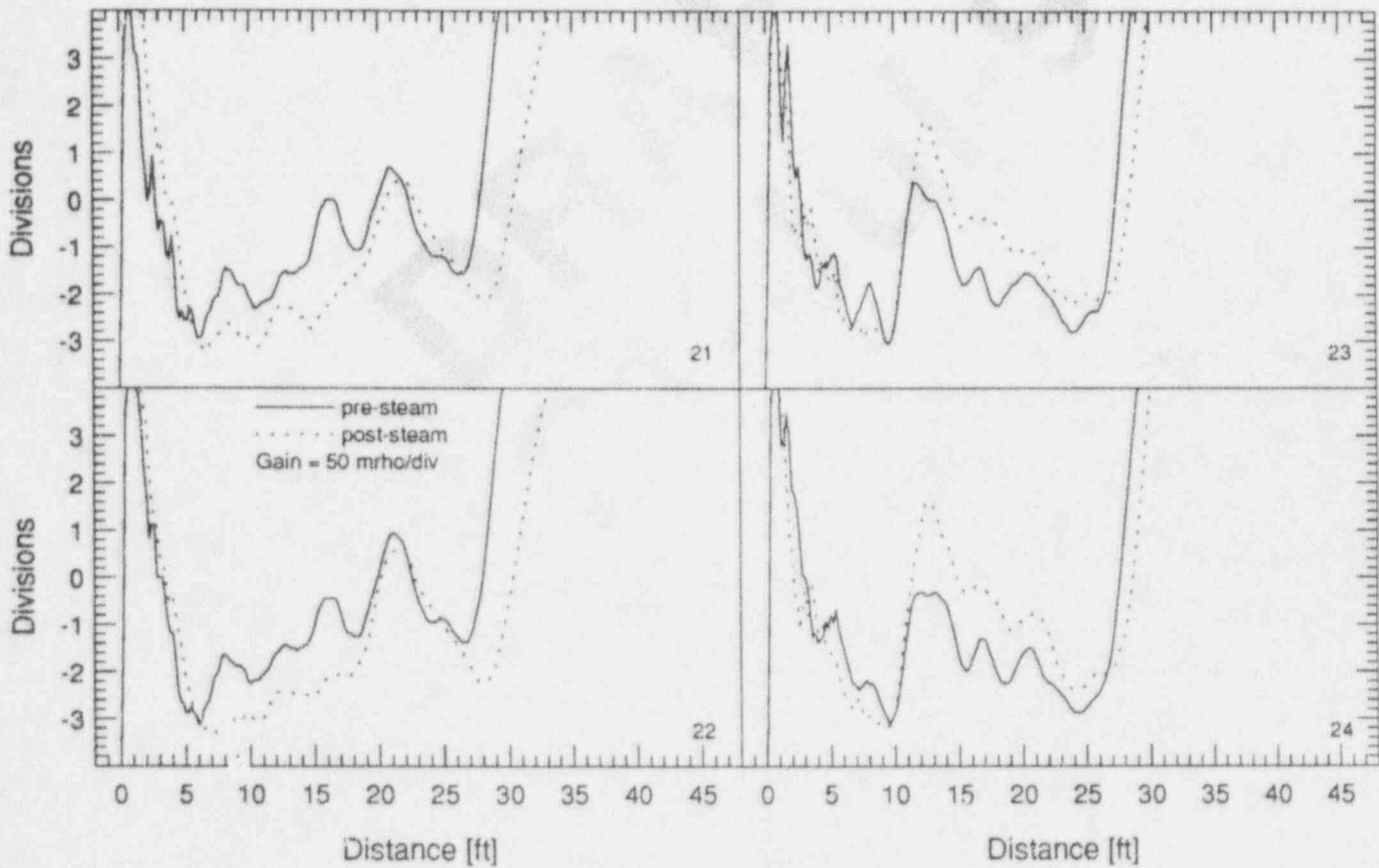
Figure B.2: TDR of the Conax ECSA conduit seal conductors before and after the accident steam exposure.

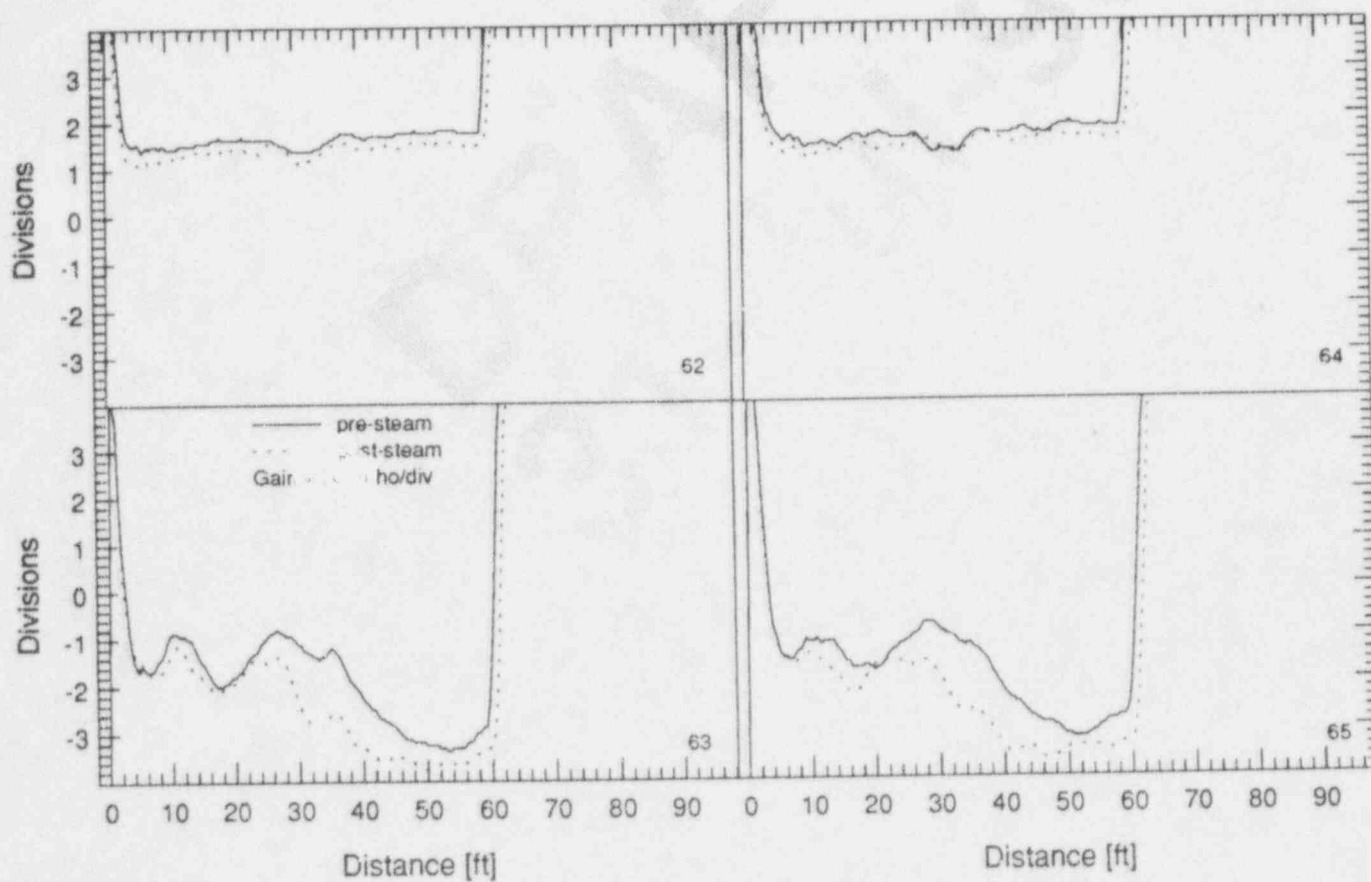
Figure B.3: TDR of the Rockbestos coaxial cable conductors before and after the accident steam exposure.

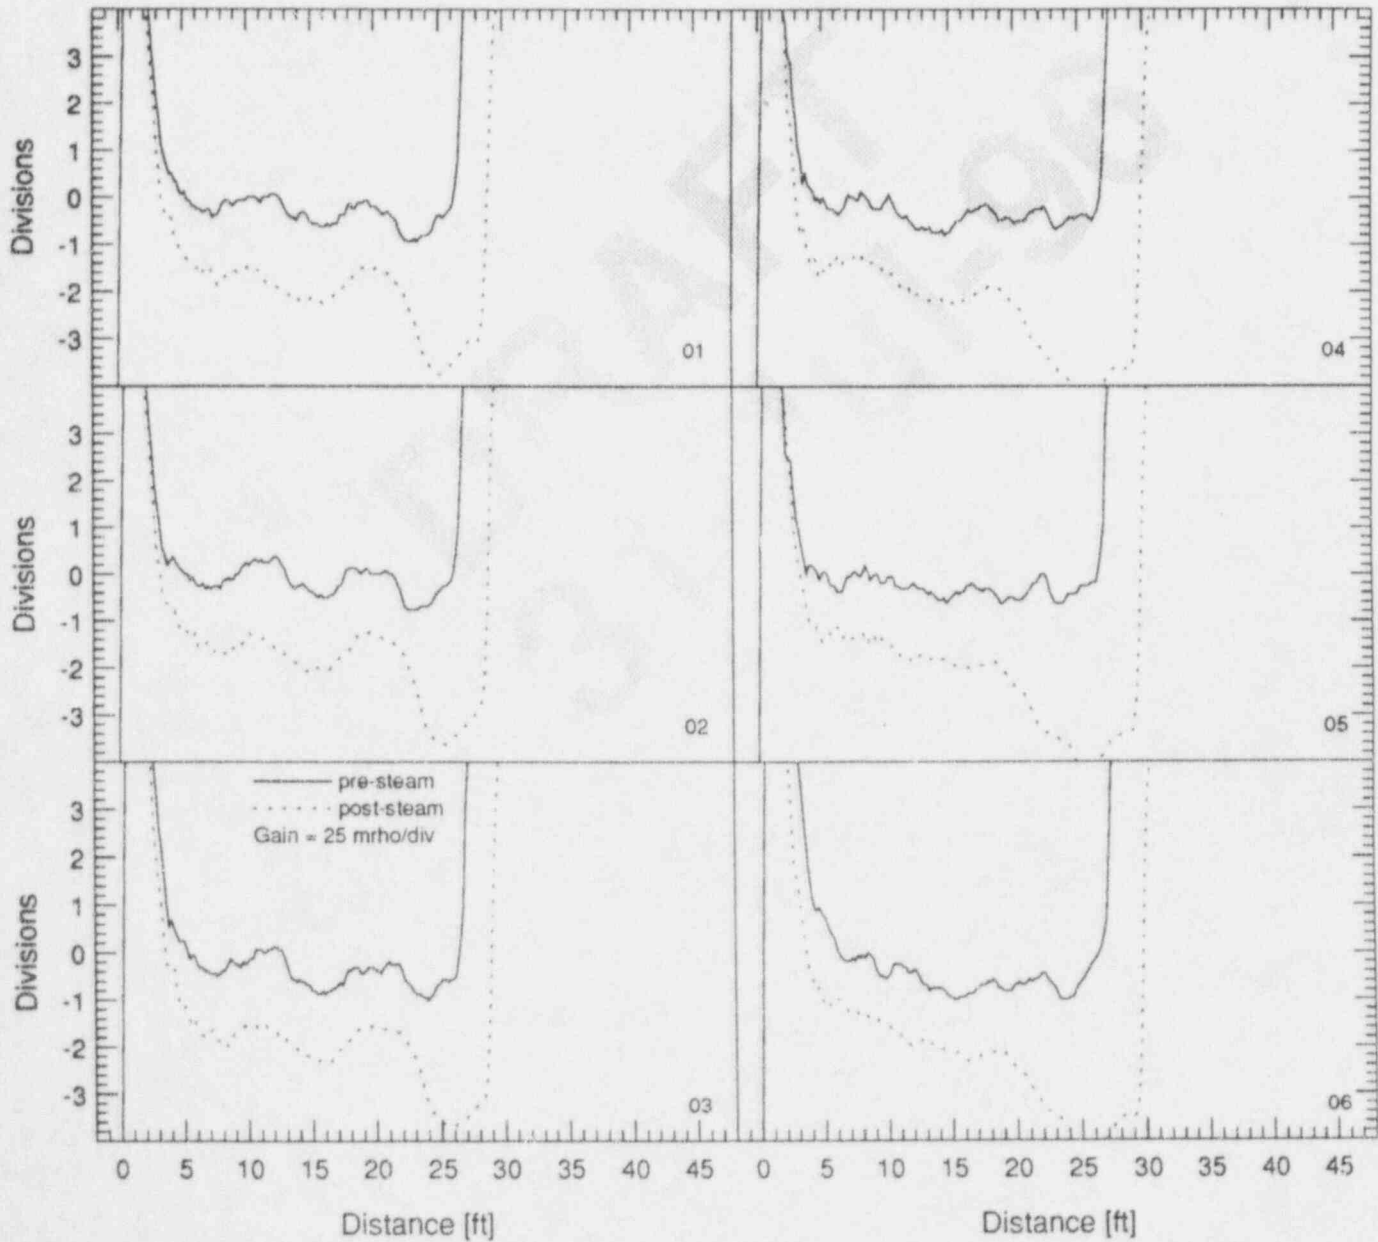
Figure B.4: TDR of the EGS conduit seal conductors before and after the accident steam exposure.

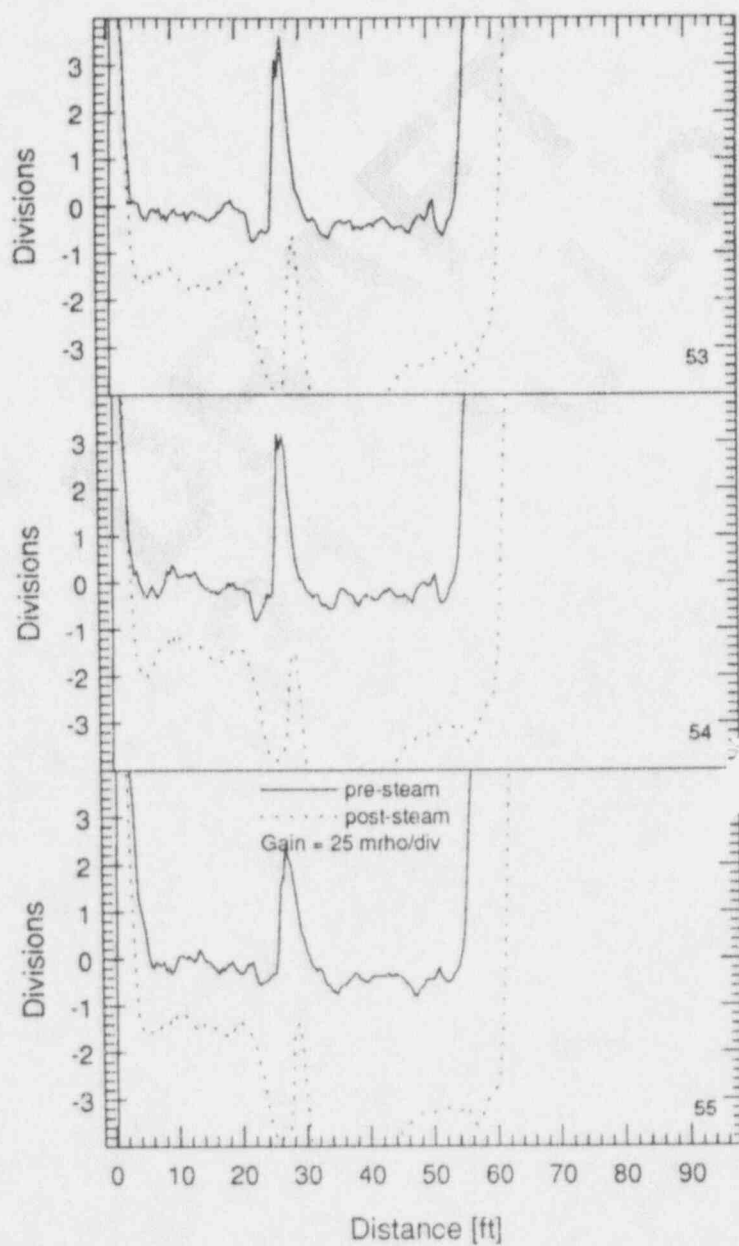
Figure B.5: TDR of the EGS Grayboot connector conductors before and after the accident steam exposure.

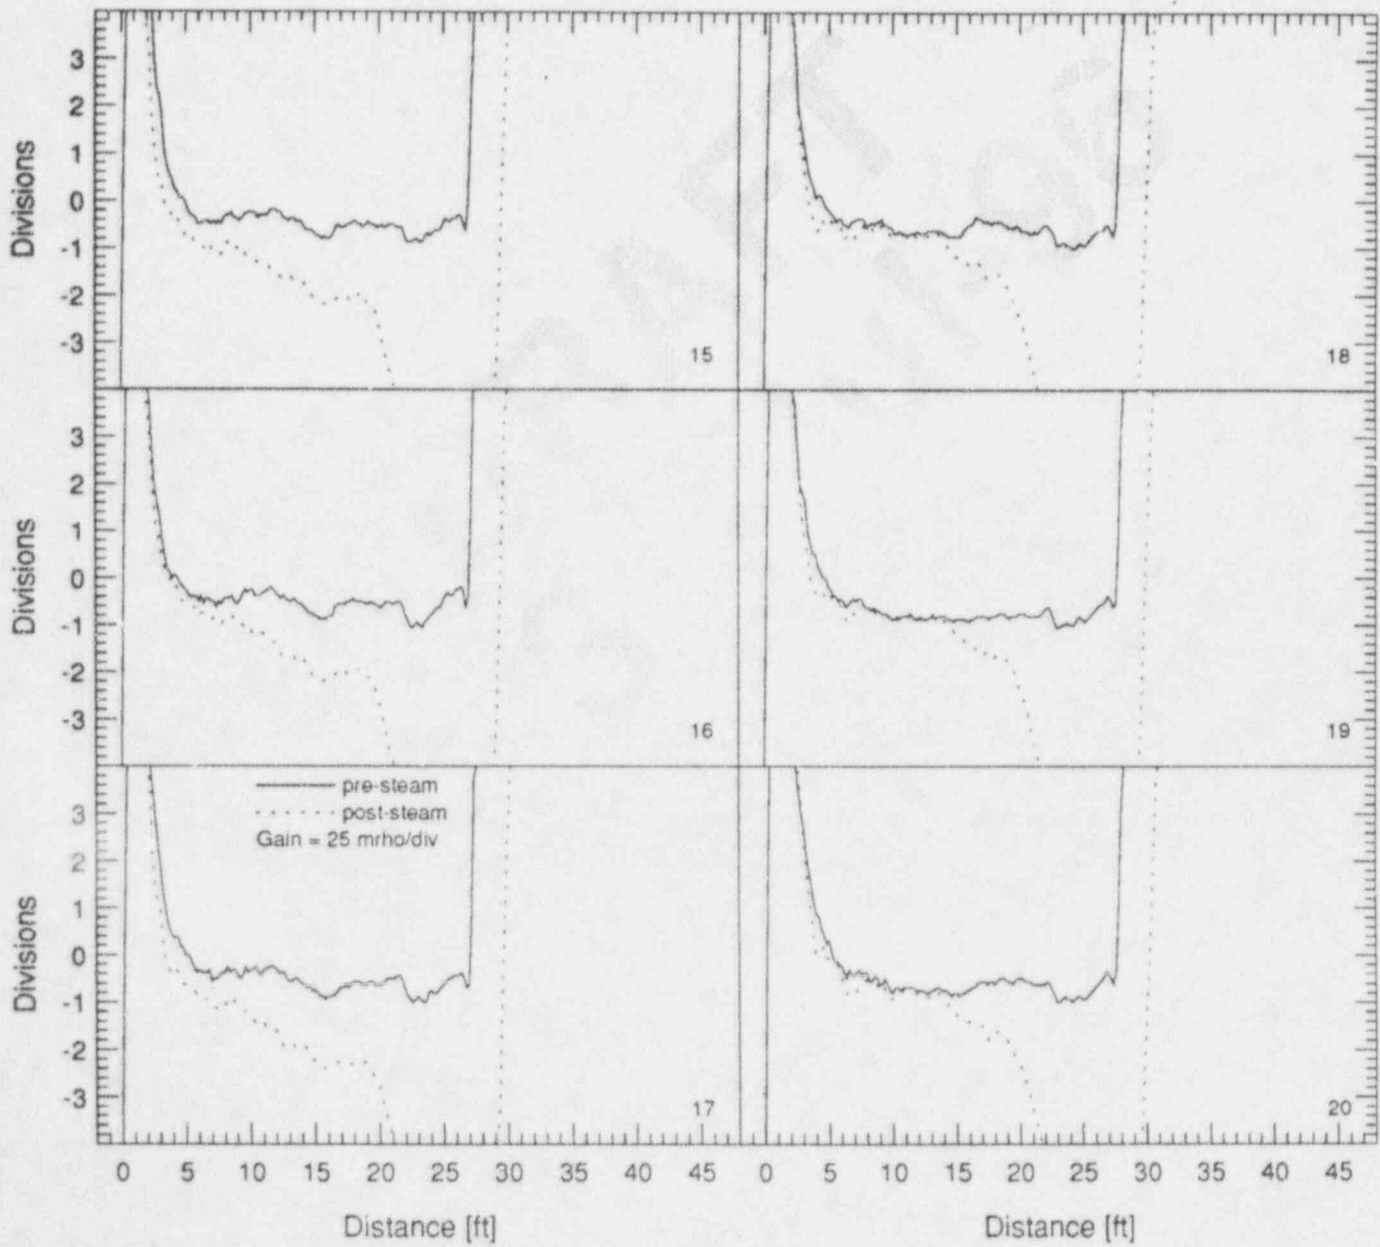
Figure B.6: TDR of the EGS quick disconnect connector conductors before and after the accident steam exposure.

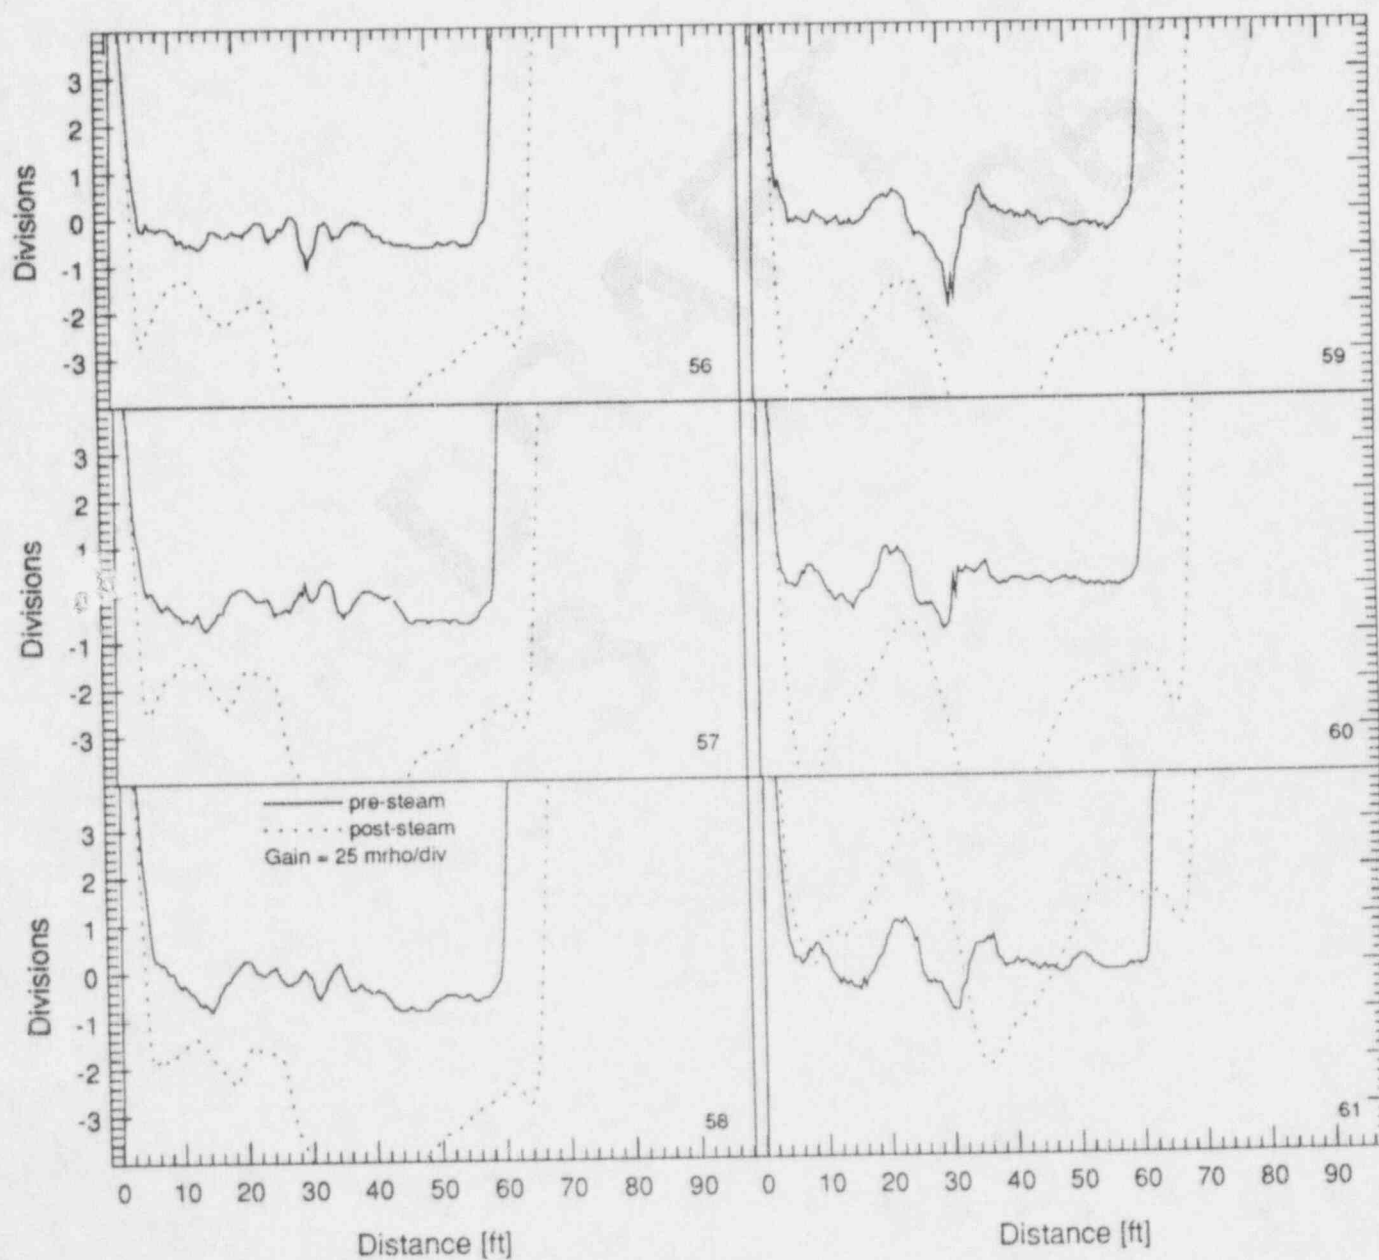
Figure B.7: TDR of the Rockbestos Firewall III cable conductors before and after the accident steam exposure.

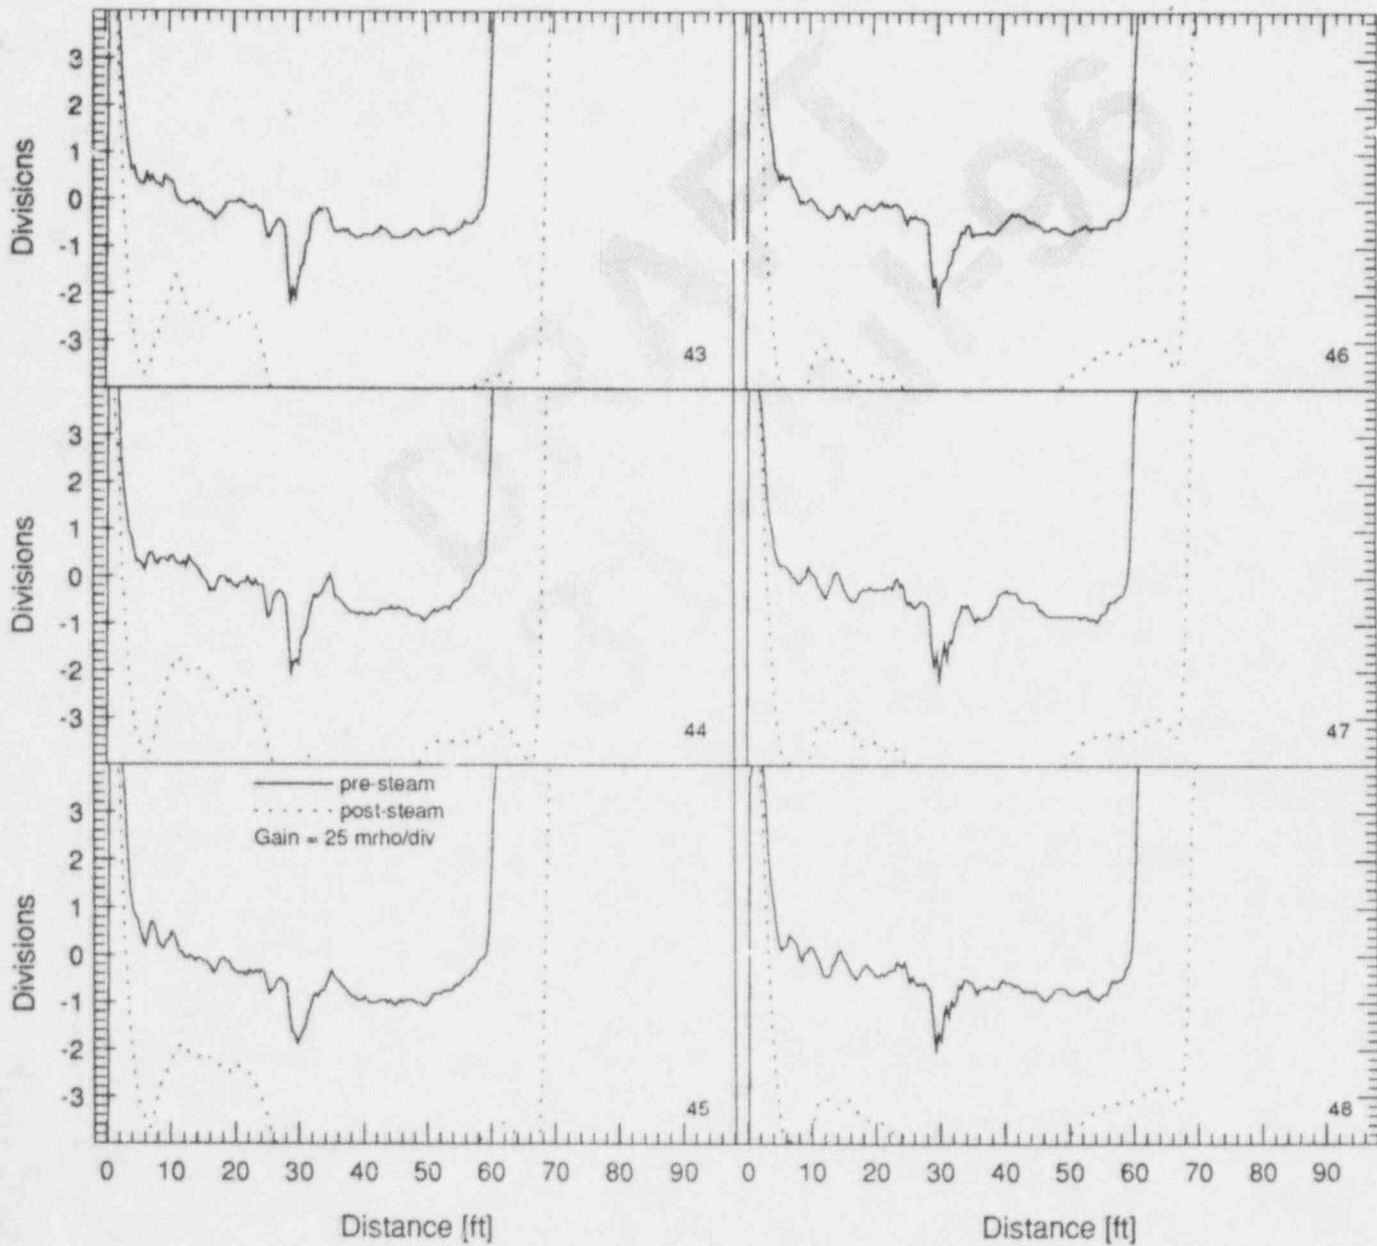
Figure B.8: TDR of the Littlen-VEAM connector conductors before and after the accident steam exposure.

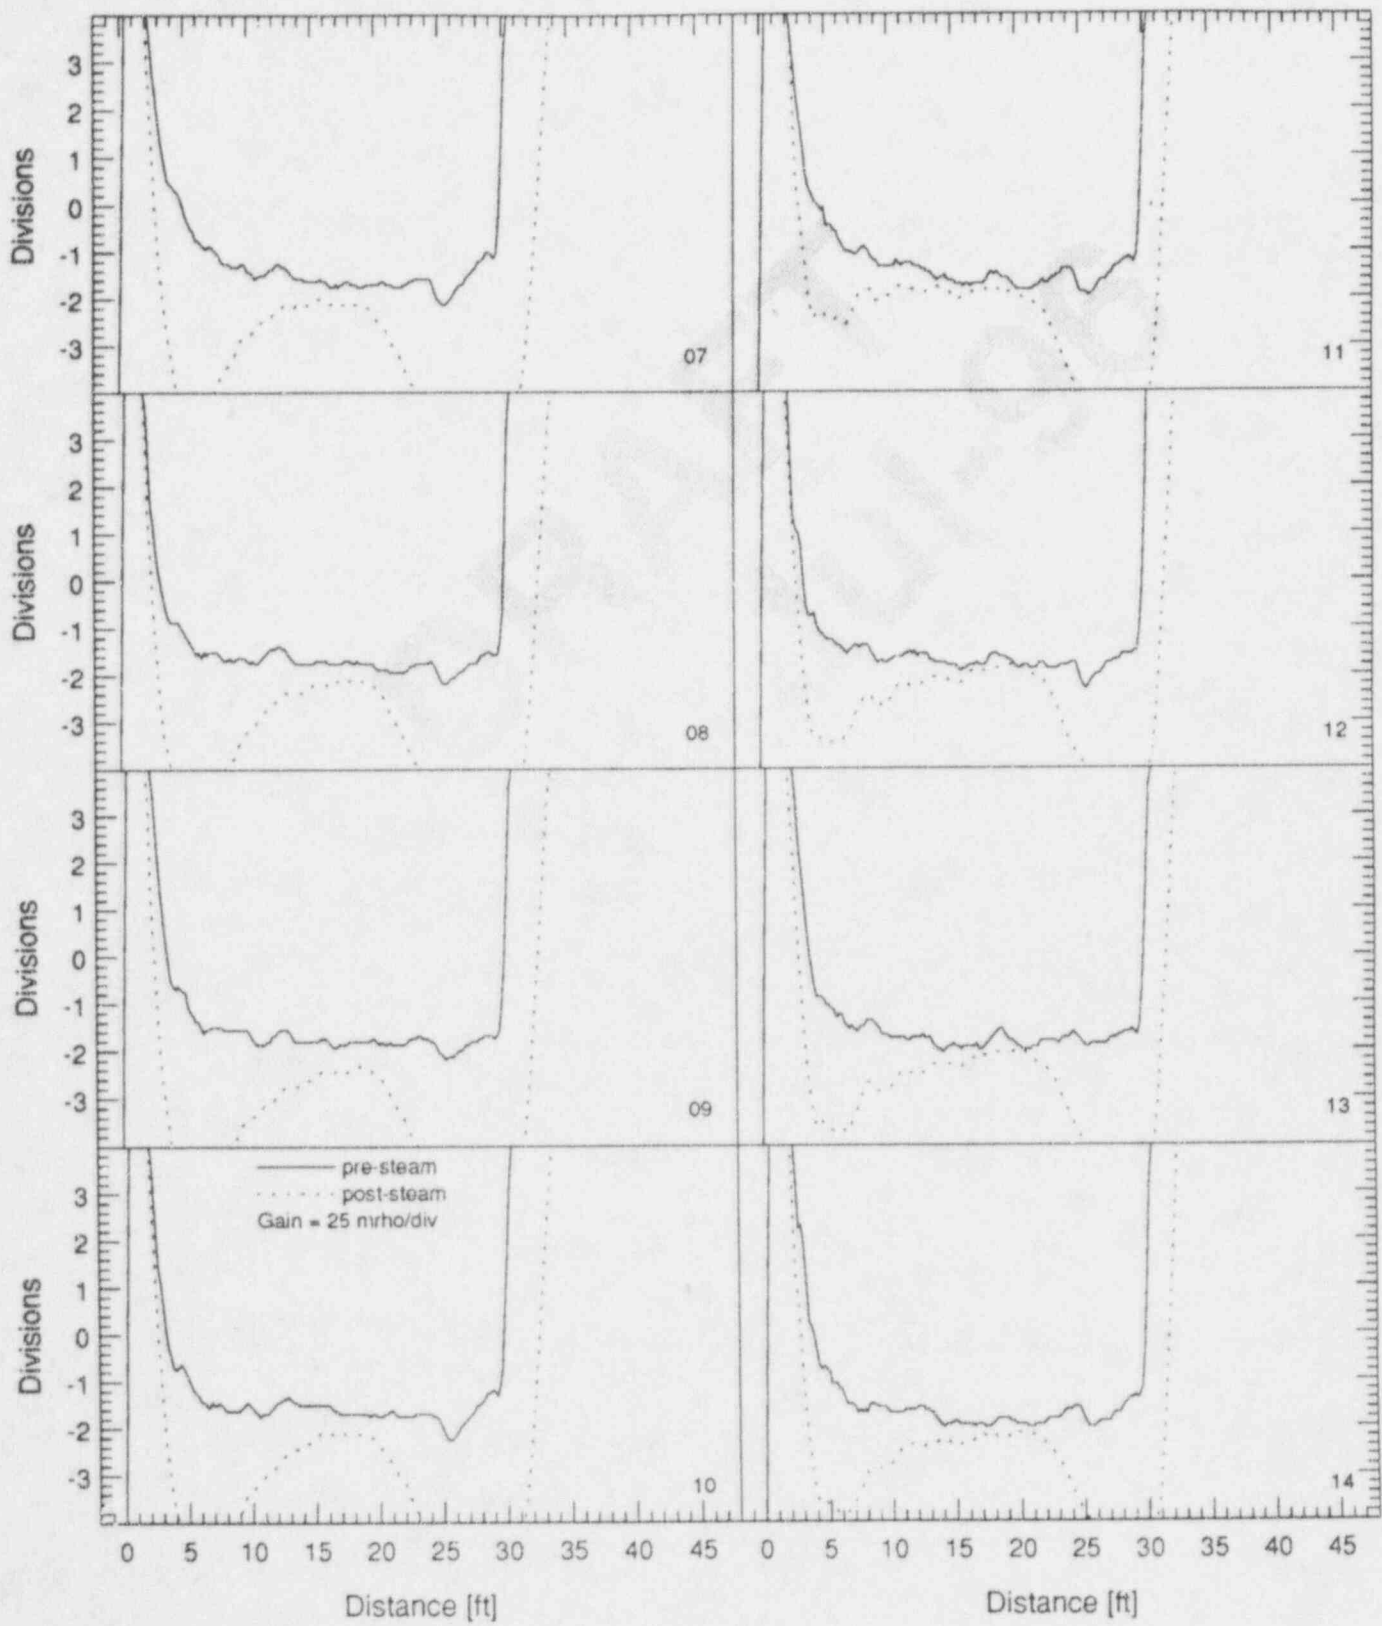
Figure B.9: TDR of the NAMCO EC210 connector conductors before and after the accident steam exposure.

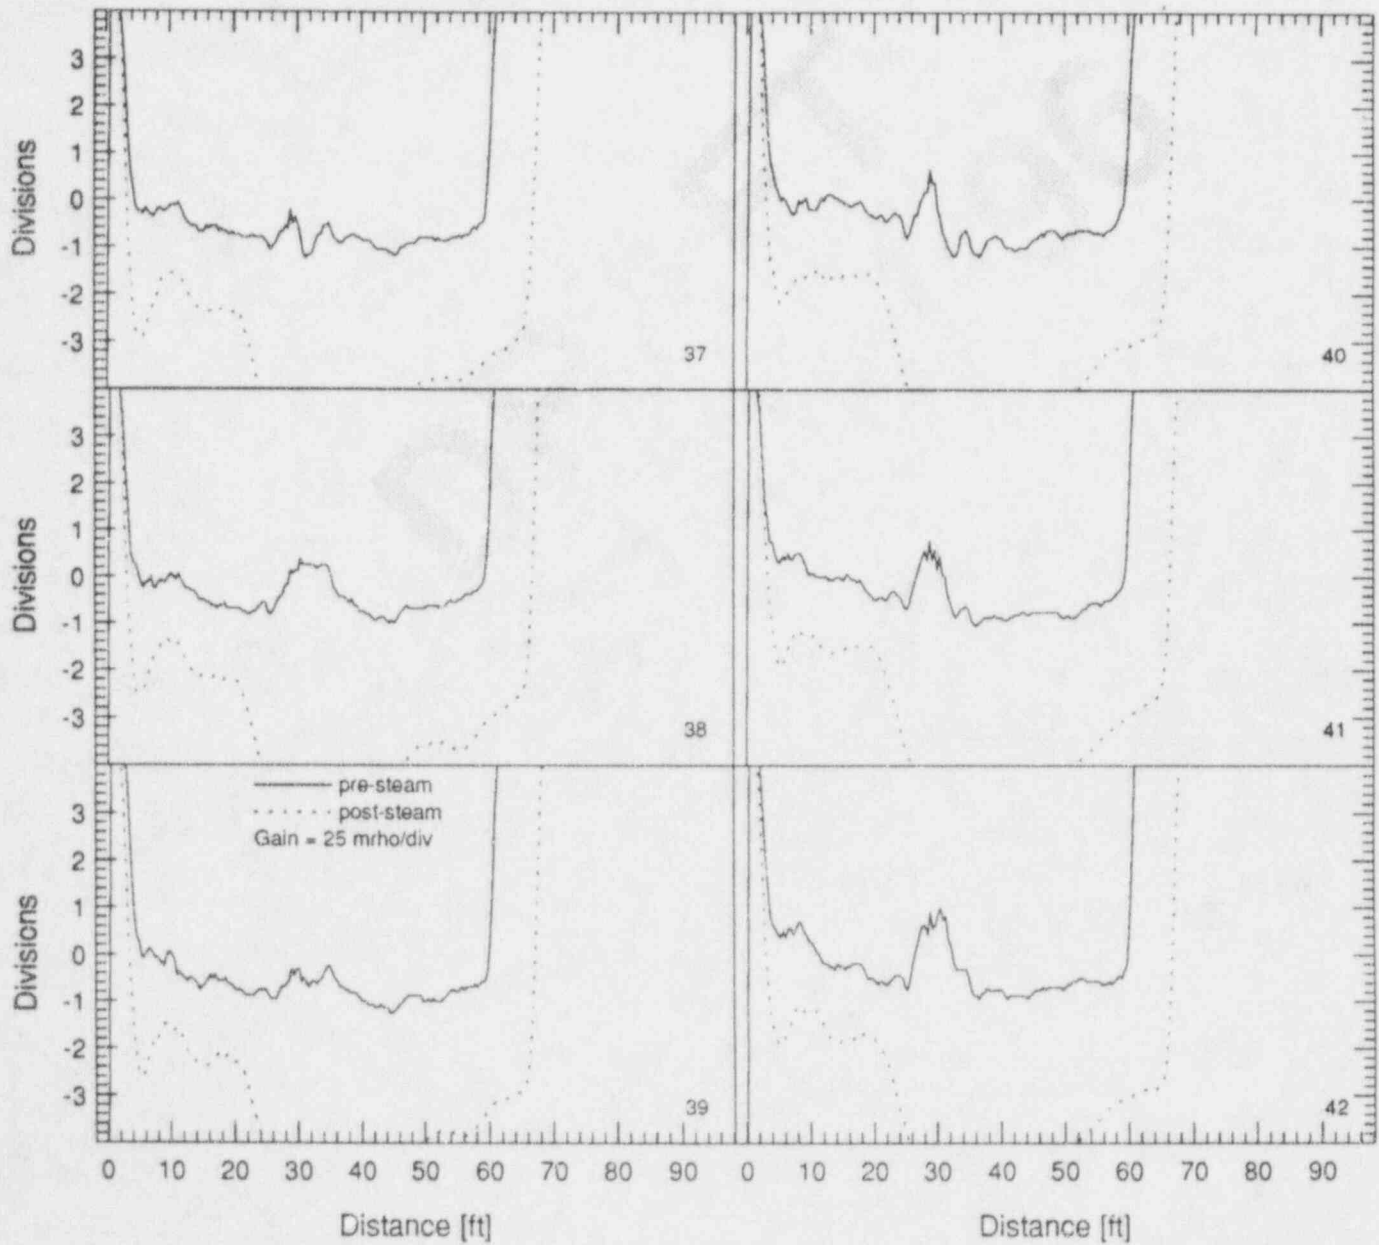
Figure B.10: TDR of the Okonite tape splice conductors before and after the accident steam exposure.

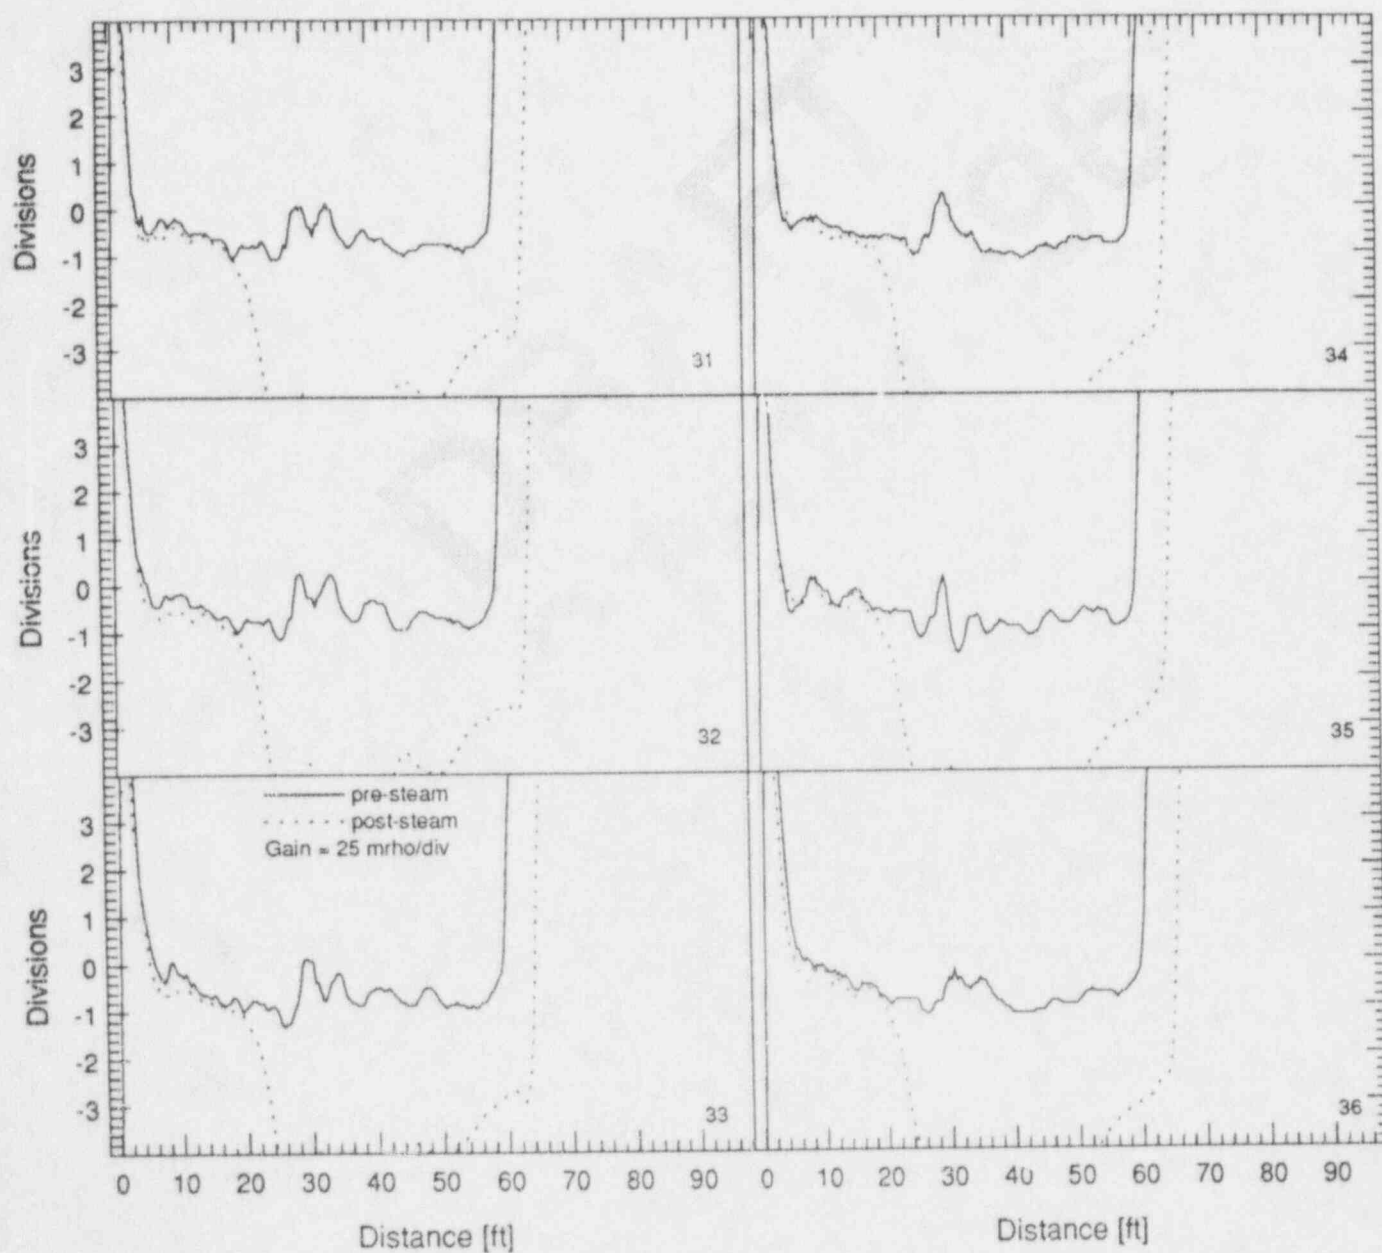
Figure B.11: TDR of the Raychem heat shrink splice conductors before and after the accident steam exposure.

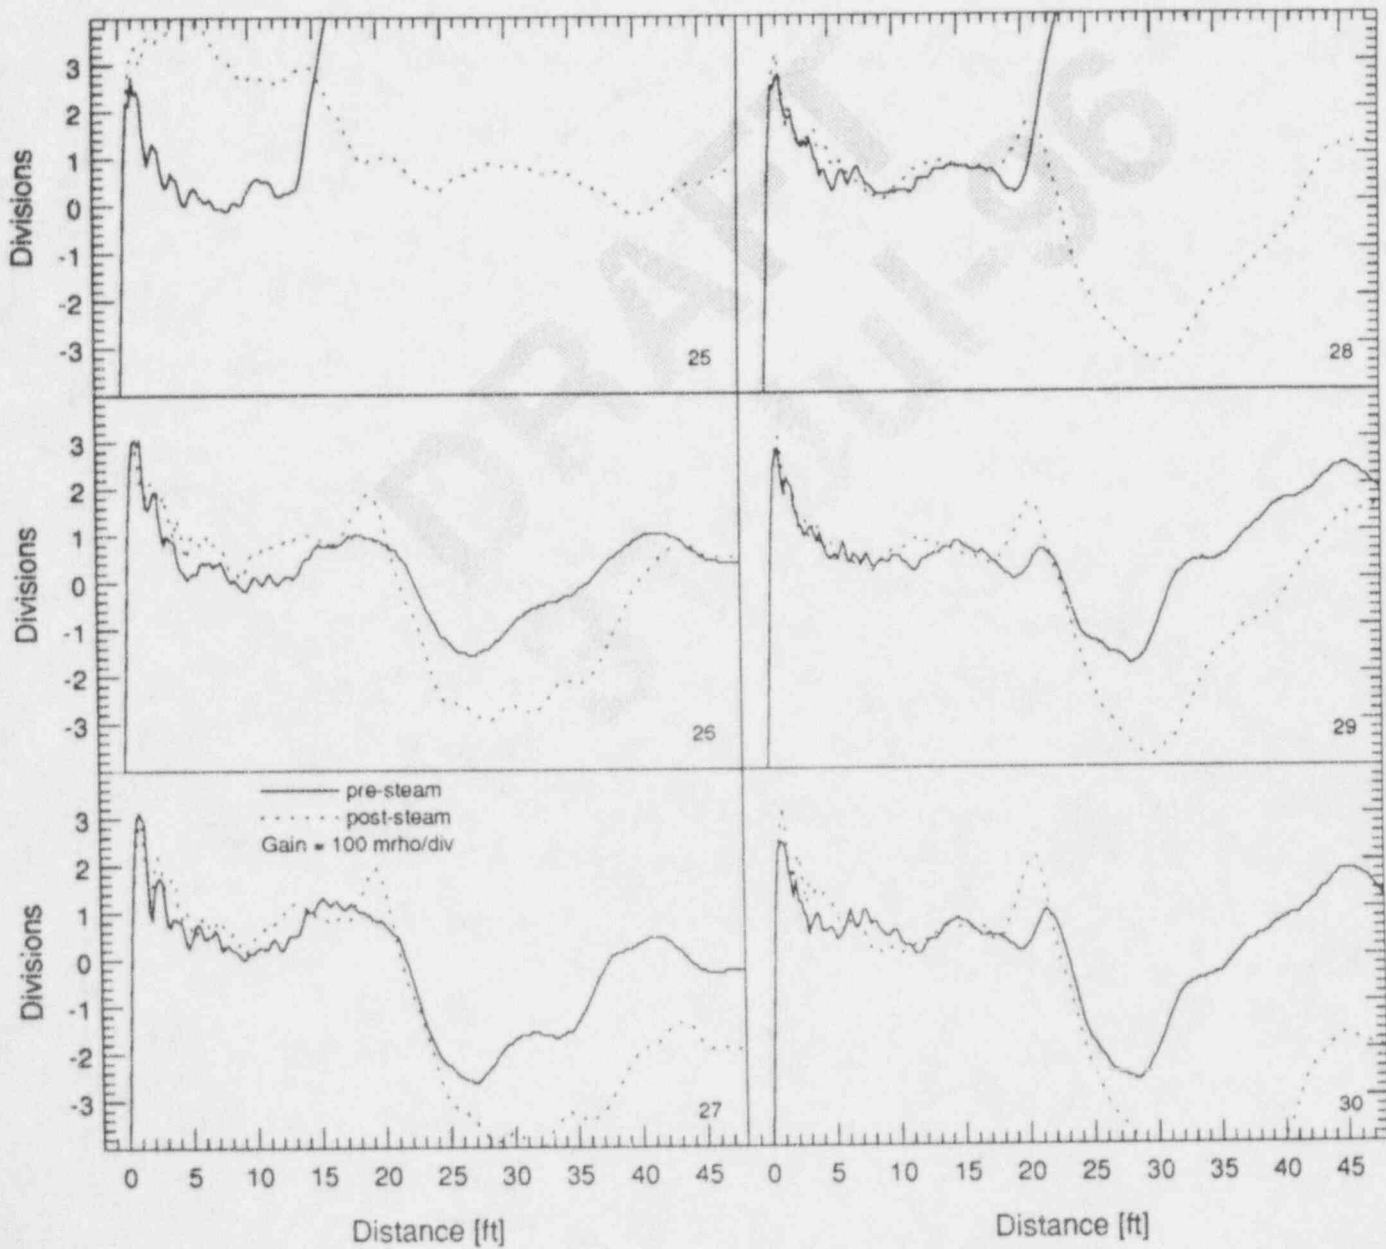
Figure B.12: TDR of the Rosemount 353C conduit seal conductors before and after the accident steam exposure.
