From: [Wilk, Brenda](#)
To: [Cook, Christopher](#); [BidsNrrDorLpl3 Resource](#); [BidsNrrPMClinton Resource](#); [NrrDirslrib Resource](#); [West, Steven](#); [Roberts, Darrell](#); [Skokowski, Richard](#); [Barker, Allan](#); [DRSIII](#); [DRPIII](#); [ROPreports Resource](#)
Subject: CLINTON POWER STATION—NRC INSPECTION REPORT 05000461/2018051 AND PRELIMINARY WHITE FINDING
Date: Tuesday, October 16, 2018 11:50:30 AM
Attachments: [image001.png](#)

[Open ADAMS Document \(CLINTON POWER STATION-NRC INSPECTION REPORT 05000461/2018051 AND PRELIMINARY WHITE FINDING \(public\)\)](#)

Version 8.22 of the Grand Gulf (GG) simplified plant analysis risk (SPAR) model was used to determine the risk significance for this performance deficiency. The GG at-power SPAR model includes shutdown event trees. The shutdown event trees use the same support fault trees as the at-power model, with some modifications. Since the exposure time began one day after shutdown while the plant was in Mode 4, this performance deficiency was modeled using the Mode 4 Early (M4E) event trees in the SPAR-SD model. There are three M4E event trees in the GG SPAR-SD model: loss of inventory outside containment (LOIOC), l

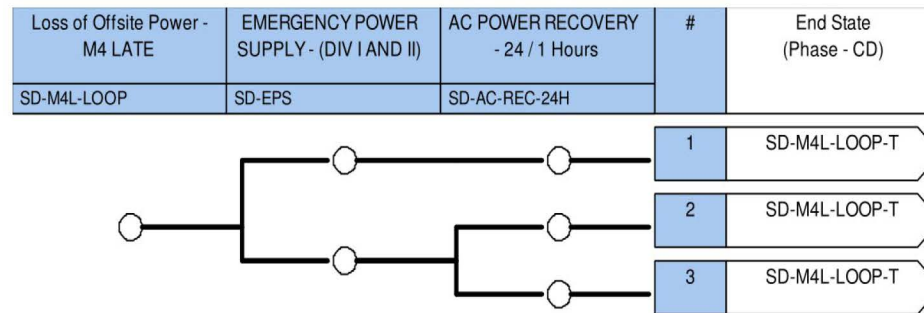
Clinton Event Trees

SDC (no FLEX credit here - Always Fails during ELAP)	MANUAL REACTOR DEPRESS (include credit for FLEX DC Power)	LOW PRESSURE COOLANT INJECTION (no FLEX credit here - Always Fails during ELAP))	ALTERNATE INJECTION - CDS SWS FWS and FLEX	HI PRESSURE INJECTIONS (HCS/CRD)	HEAT REMOVAL USING SUPPRESSION POOL including FLEX	ALTERNATE HEAT REMOVAL (Always Fails during ELAP)	CONTAINMENT VENTING - SD	Electrical Connection Div. 3 to Div. 2	Power Recovery Correction Factor for Different Time to Core	#	End State (Phase - CD)
<DUMMY-FT>	SD-SDC	SD-DEP	SD-LPI	SD-ALT-INJ	SD-HPI	SD-SPC-EXT	SD-ALT-HEAT	SD-CVS	ELEC_XTIE	TTCU Uncovery
