RADIOLOGIC AND ENGINEERING ASSESSMENT

DOE ID NO.: GJ-06551-RS  
ADDRESS: 624 NORTH 15TH STREET

URANIUM MILL TAILINGS REMEDIAL ACTION PROJECT OFFICE

BENDIX FIELD ENGINEERING CORPORATION  
P.O. Box 1569  
Grand Junction, Colorado 81502

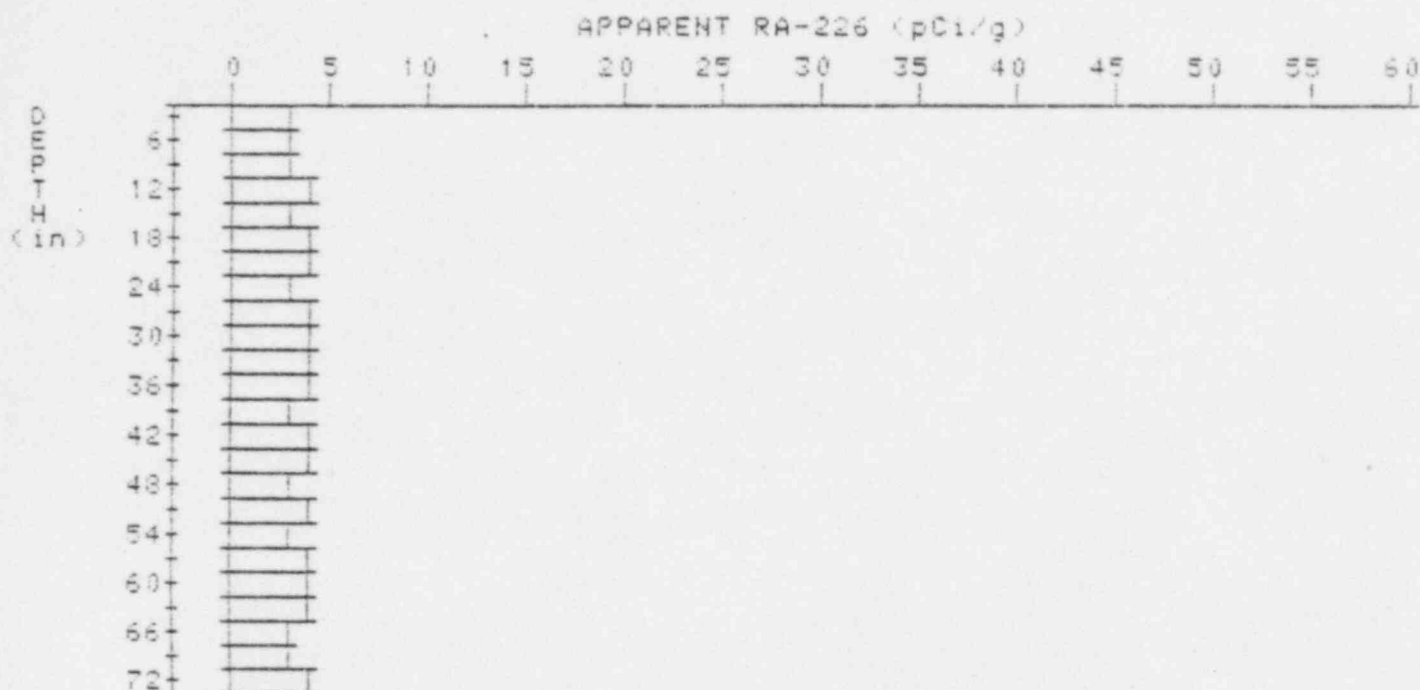
HOLE NUMBER: 5

LOCATION: 169227

Depth (in)	Apparent Radium-226 (pCi/g) Undeconvolved	Apparent Radium-226 (pCi/g) Deconvolved
3	2.8	2.8
6	3.0	3.0
9	3.2	3.2
12	3.4	3.3
15	3.4	3.2
18	3.5	3.5
21	3.6	3.3
24	3.6	3.4
27	3.7	3.7
30	3.8	4.2
33	3.7	3.7
36	3.6	3.6
39	3.6	3.6
42	3.8	3.6
45	3.8	3.7
