CONNECTICUT YANKEE ATOMIC POWER COMPANY

Haddam Neck Plant
Proposed Revision to Technical Specifications
Steam Generators

Connecticut Yankee Steam Generator Tube Repair Safety Evaluation for Structural Integrity

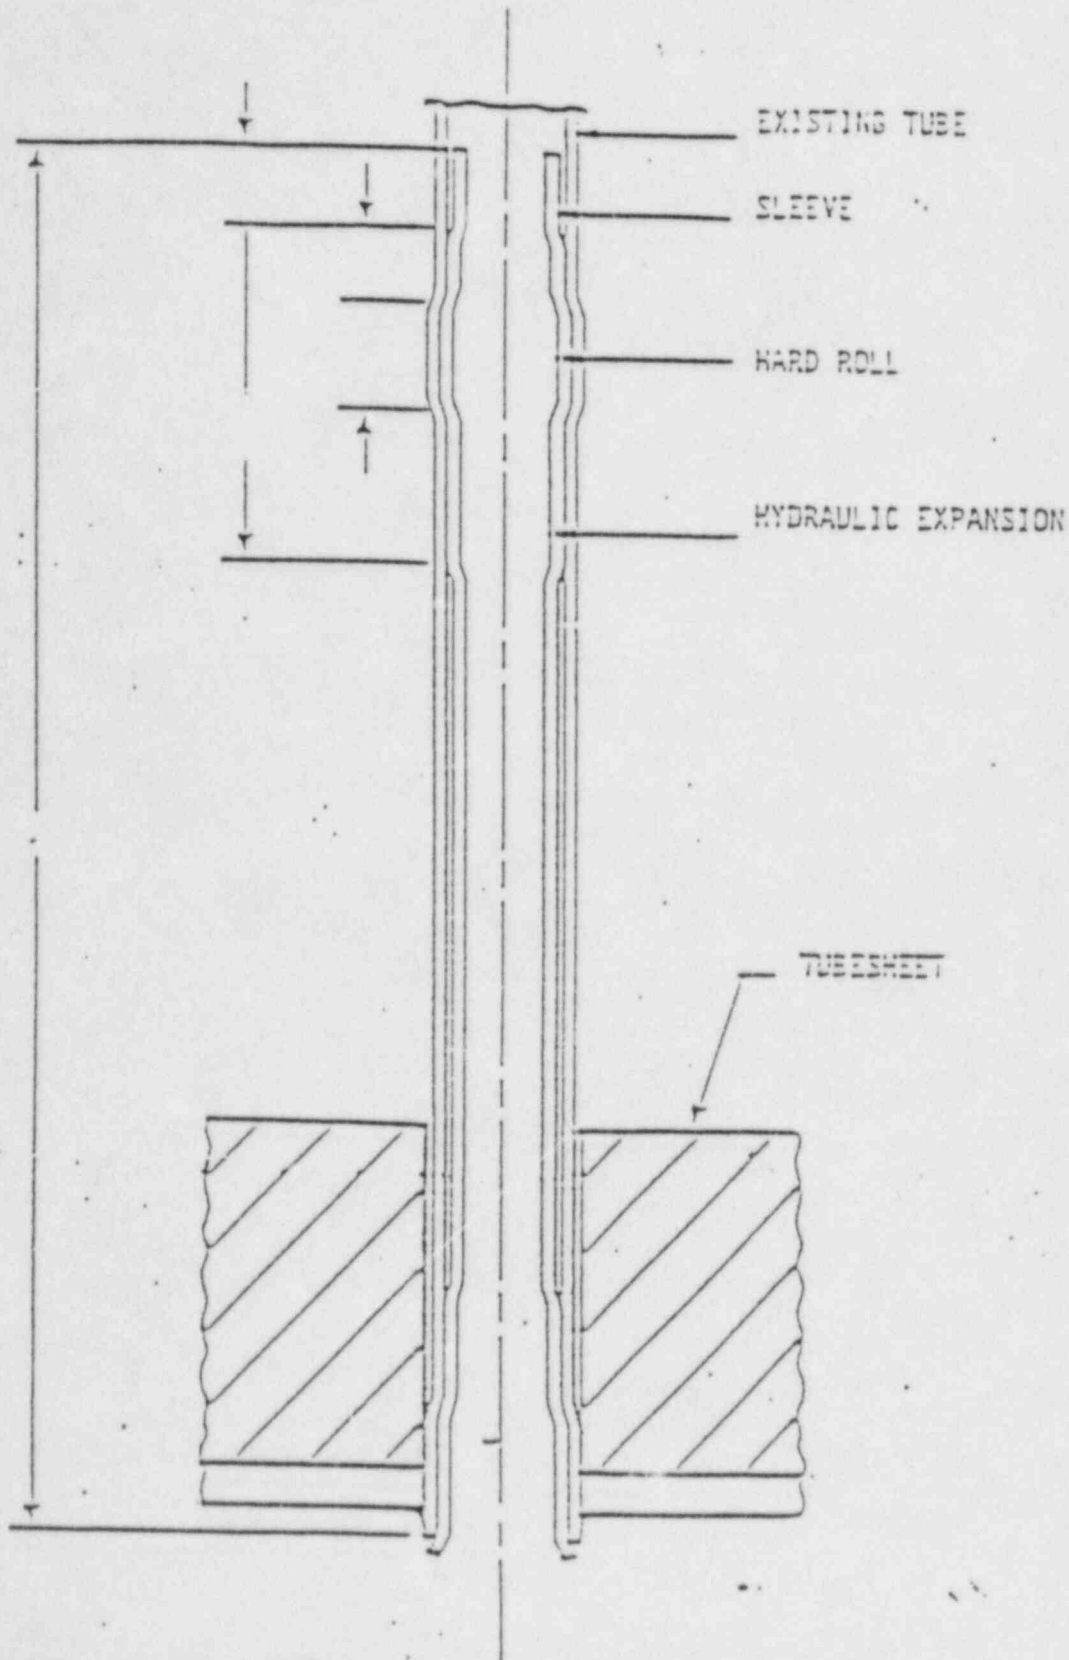
Figure 1: Cross-section of repaired steam generator tube

Plastic expansion of the sleeve against the tube, at the top and bottom of the sleeve, provides a leak limiting joint which exhibits sufficient mechanical strength to withstand normal operating, test and postulated accident loading conditions. Figure 1 shows a typical repair configuration. The expanded sleeve forms a new section of the reactor coolant pressure boundary.
