CONTENTION ITEM 5
(GENERAL)

5. Contrary to Criterion III, "Design Control," of 10 C.F.R. Part 50, Appendix B, Commonwealth Edison Company has failed to establish measures to assure that applicable regulatory requirements and design bases are correctly translated into specifications, drawings, procedures, and instructions including provisions to assure that appropriate quality standards are specified in design documents and that deviations from such standards are controlled. Applicant has also failed to require that measures are established for the identification and control of design interfaces and for the coordination among participating design organizations, that the measures include the establishment of procedures among participating design and revision of documents involving design interfaces; and that the design interfaces; and that the design control measures provide for verifying or checking the adequacy of design, such as by the performance of design reviews, by the use of performance of a suitable testing program.

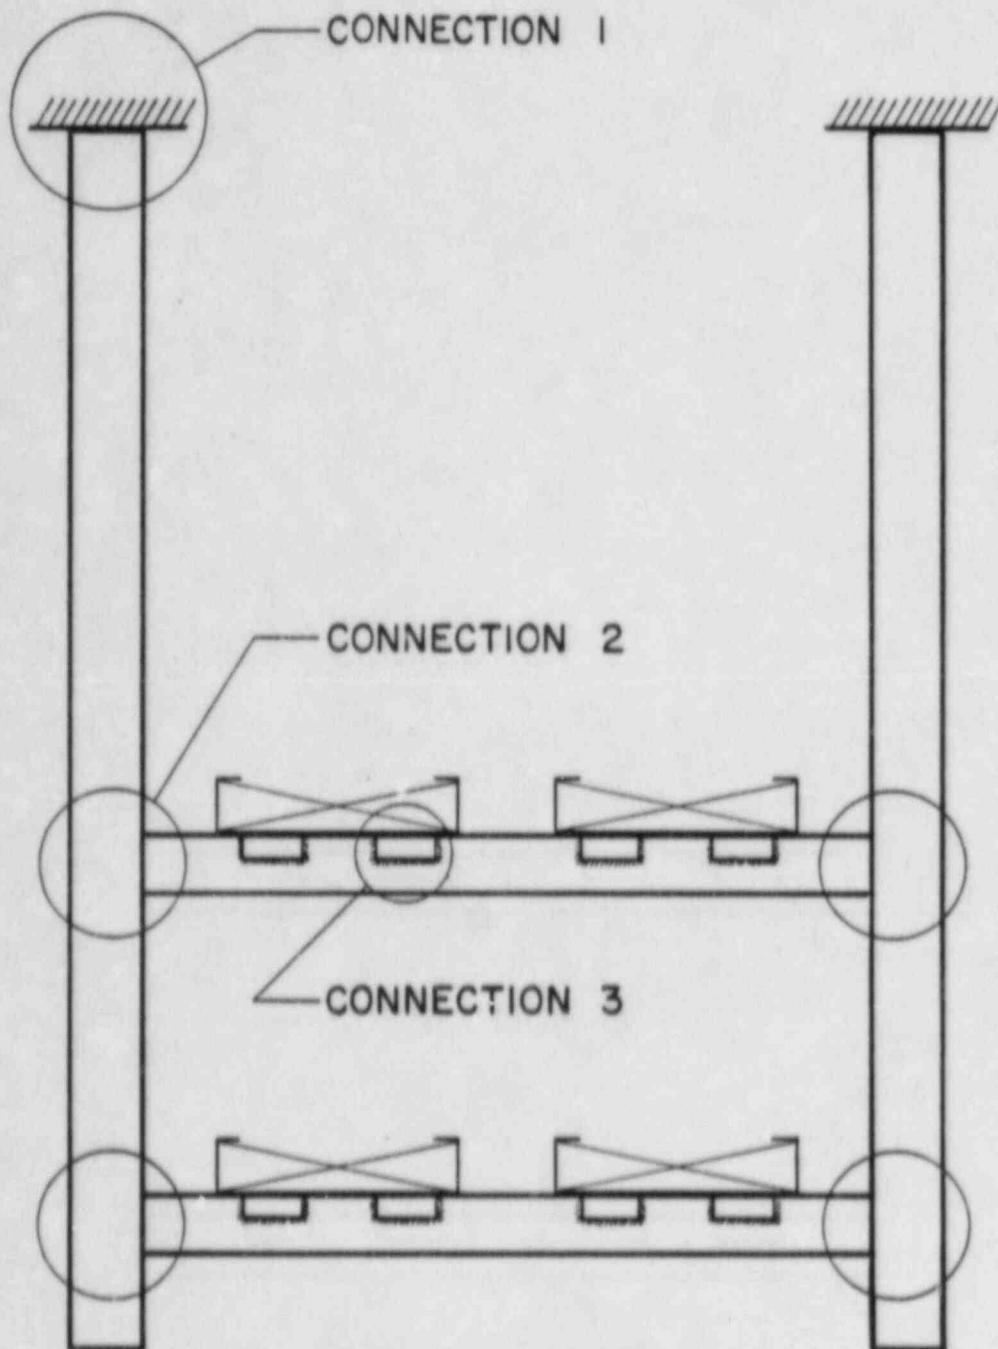
FIGURE 1
E.C. ERNST / L.K. COMSTOCK AWS
WELDING FOR CABLE TRAYS

A.7. The E. C. Ernst/LKC AWS welding covered by the LRP program included conduit supports, junction box supports, cable tray supports, cable tray hold-down welds and auxiliary steel for electrical supports. Figure 1 depicts a typical cable tray support system. The circles on the Figure 1 are around areas that are welded connections. The vertical members are connected at the top by welding to either a plate embedded in concrete or a structural member (connection 1). The connection of the horizontal to vertical members is also a welded connection (connection 2). Figure 2 is a detail of the connection of the

horizontal to vertical connections. Figure 1 also shows the hold-down welds for the connection of the cable tray to the horizontal member (connection 3). Connection 1 in Figure 3 is the attachment of a vertical conduit support to a plate embedded in concrete or a structural steel member.

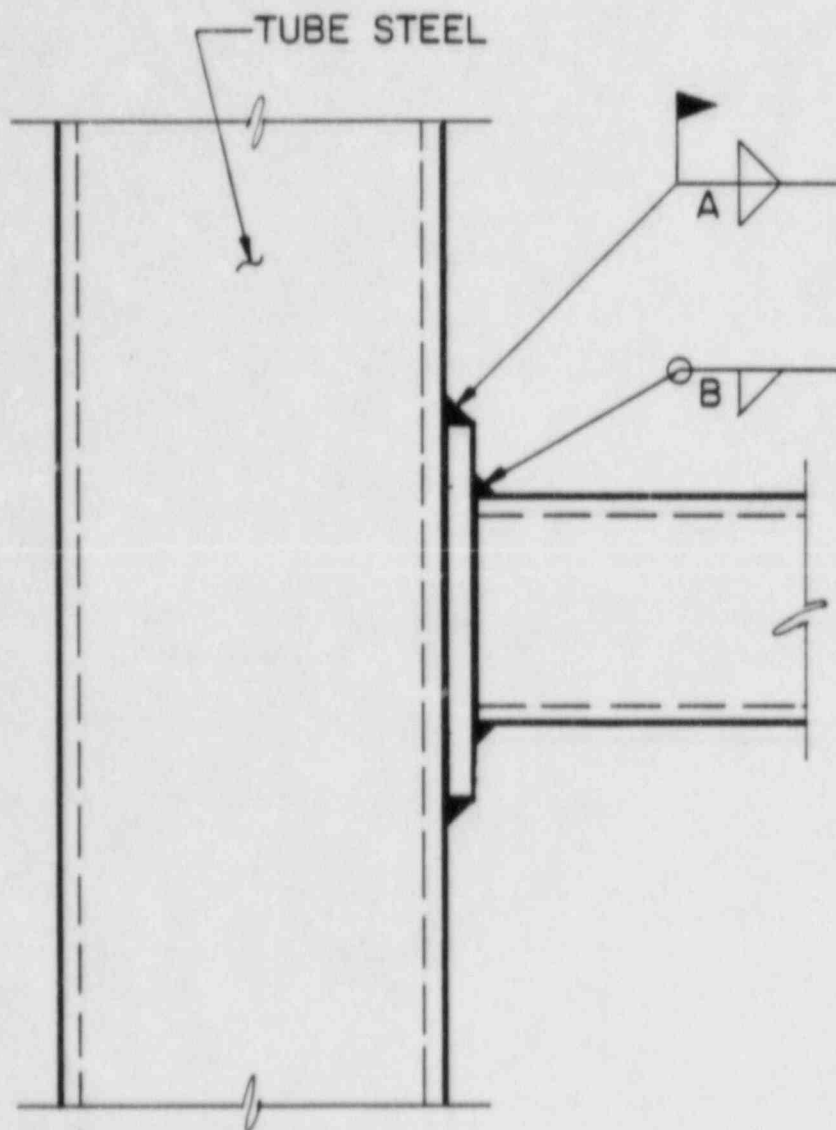
FIGURE 2
E.C. ERNST/ L.K. COMSTOCK AWS
WELDED CONNECTION
FOR CABLE TRAY SUPPORT

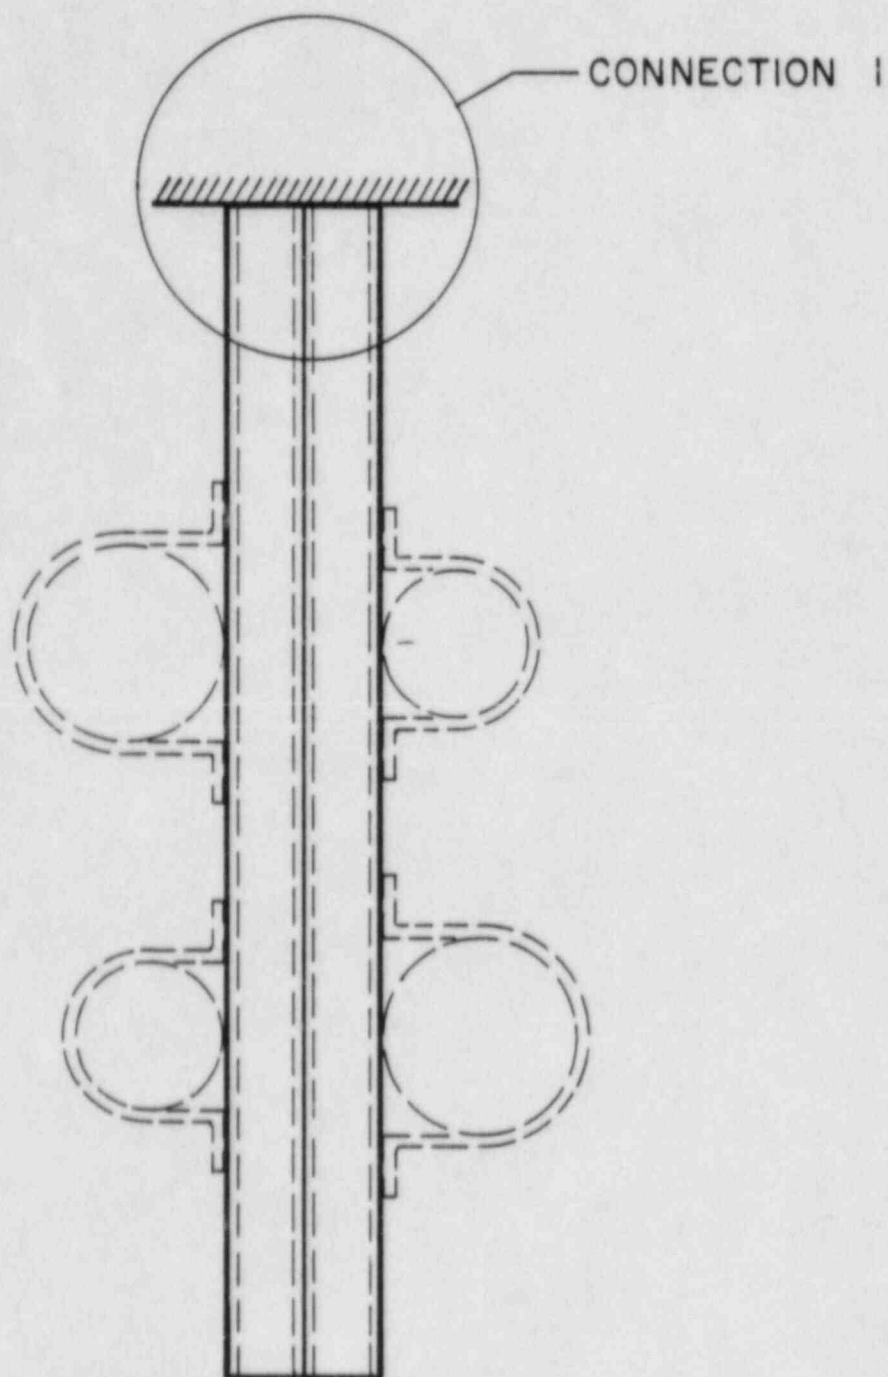
FIGURE 3

E.C. ERNST / L.K. COMSTOCK AWS
WELDING FOR CONDUIT SUPPORTS

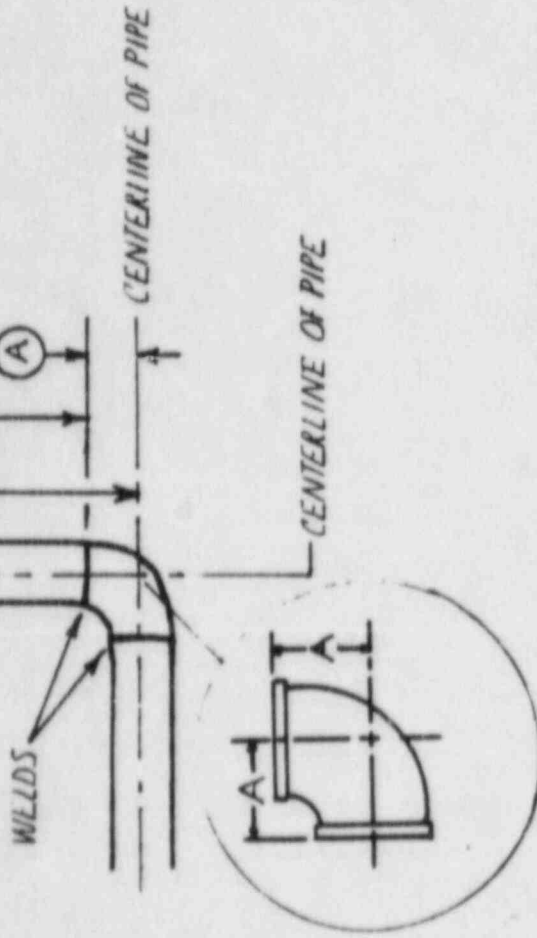
SHEVLIN AFFIDAVIT EXHIBIT A

SEE INSET. NOTE THAT THE PIPE CENTERLINES DO NOT INTERSECT AT THE APPARENT CENTER OF THE FITTING. THEREFORE, THE PREFERRED METHOD OF MEASUREMENT IS:

- ① IS THE DIMENSION SHOWN ON THE DRAWING.
- ② THE INSPECTOR MEASURES THE DISTANCE FROM THE BOTTOM OF THE SLAB TO THE MIDDLE OF THE WELD.
- ③ DIMENSION H IS OBTAINED FOR THE APPROPRIATE SIZE AND TYPE FITTING FROM THE TABLE.

THIS METHOD OVERCOMES THE DIFFICULTY FACED IN LOCATING THE CENTERLINE OF THE FITTING.

EXAMPLE: FOR A SIX INCH NOMINAL PIPE DIAMETER, 90 DEGREE LONG RADIUS ELBOW, THE "TAKE-OUT", OR DIMENSION A, IS NINE INCHES. IF DIMENSION 1 FROM THE DRAWING IS 1 FOOT - NINE INCHES, DIMENSION 2 SHOULD BE 1 FOOT.

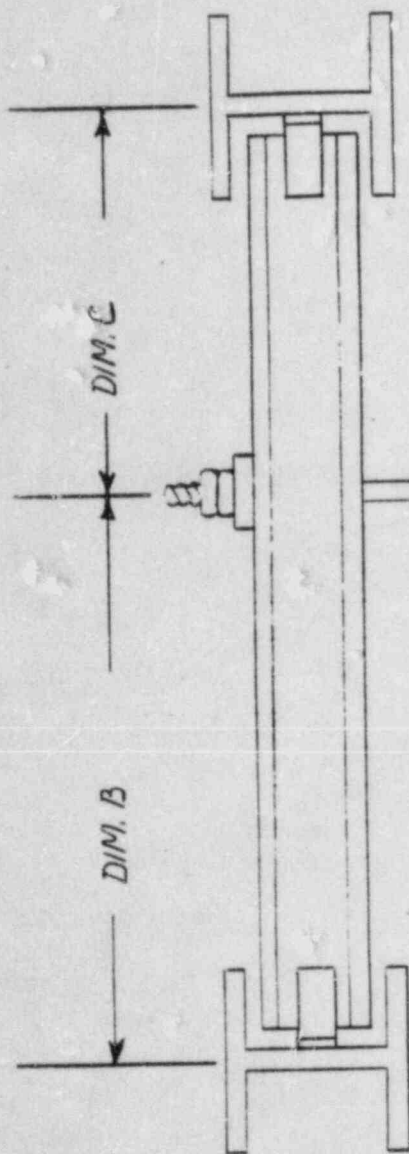
SHEVLIN AFFIDAVIT
EXHIBIT C

DIM. A WAS VERIFIED BY BCAP TO BE ACCEPTABLE. THIS IS THE DIMENSION REQUIRED BY THE INSTRUCTIONS TO BE USED TO DETERMINE WHETHER OR NOT THE SUPPORT WAS CORRECTLY LOCATED. DIM. A HAS A TOLERANCE OF PLUS OR MINUS 0.1-0.2".

5/8 INCHES OF THE 6 INCH ALLOWANCE WAS USED, WHICH LENGTHENED DIM. B AND SHORTENED DIM. C.
