ACRST-1468

ORIGINAL
UNITED STATES
NUCLEAR REGULATORY COMMISSION

ADVISORY COMMITTEE ON REACTOR SAFEGUARDS

307TH GENERAL MEETING

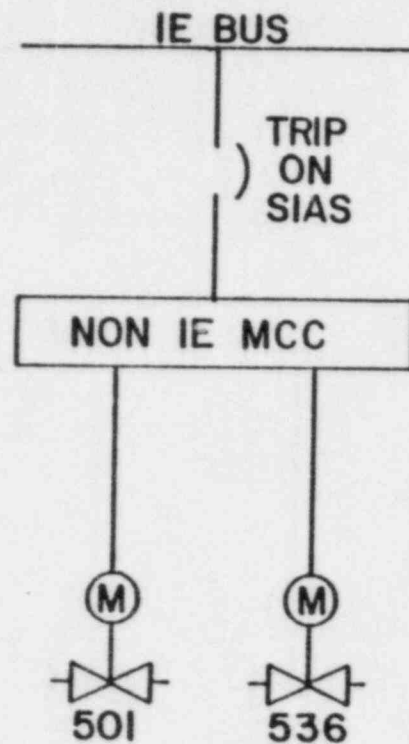
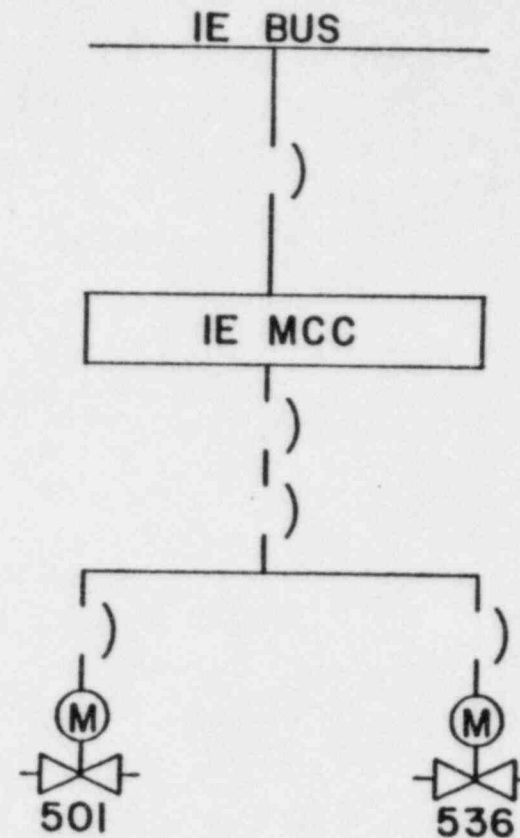
VALVE POWER SUPPLY CHANGE

EXISTING

MODIFIED

CHANGE ENSURES OPERABILITY FROM CONTROL ROOM AFTER SIAS AND LOP SUCH THAT SUCTION COULD BE ALIGNED TO RWT FROM VCT.
