UNITED STATES OF AMERICA
NUCLEAR REGULATORY COMMISSION

In the Matter of)
COMMONWEALTH EDISON COMPANY)
(Braidwood Station Units 1 and 2)

APPLICANT'S FIRST PARTIAL RESPONSE TO ROREM'S
SECOND SET OF QUALITY ASSURANCE INTERROGATORIES
AND REQUESTS TO PRODUCE

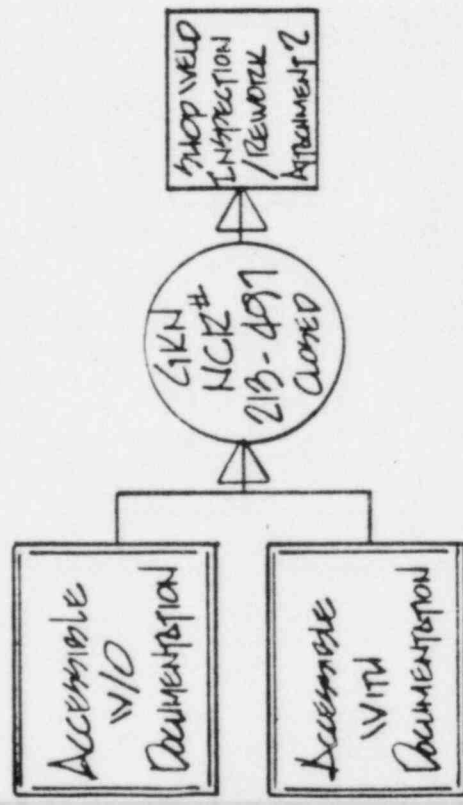
(SEE ATTACHMENT 3 FOR PROCEDURE CRITERIA)

The reinspection and repair of identified inaccessible bolted and welded connections was conducted under GKN Procedure 57. This procedure was initially issued for this purpose on December 14, 1984 and was approved by Sargent & Lundy on January 8, 1985 and by CECO PCD on January 8, 1985. Under GKN Procedure 57, work was started in the lower levels of the Auxiliary Building and proceeded upward from those locations.
