# SLAG EXCAVATION AND REMOVAL PLAN FOR PROPERTIES NEAR CAMBRIDGE, OHIO

*Prepared for*

Cyprus Foote Mineral Company  
Kings Mountain, North Carolina

May 14, 1997

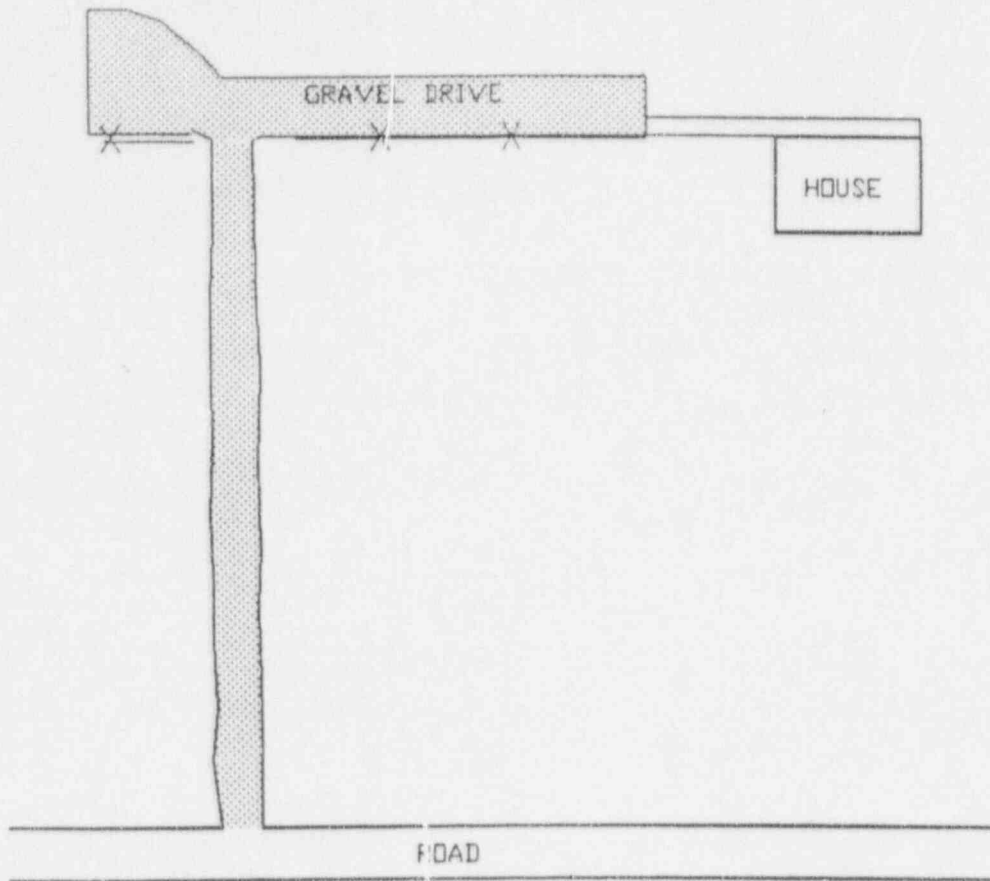
<b>Consultants</b> <small>Engineering &amp; sciences applied to the earth &amp; its environment</small>		
DRN. BY: JST DSGN. BY: JST CHKD. BY:	<b>Property Layout and Slag Locations, Property O-5</b>	FIG. NO. <b>3</b>

Location of Slag to be Removed

Source: modified from August 19, 1994  
ORISE Survey Report

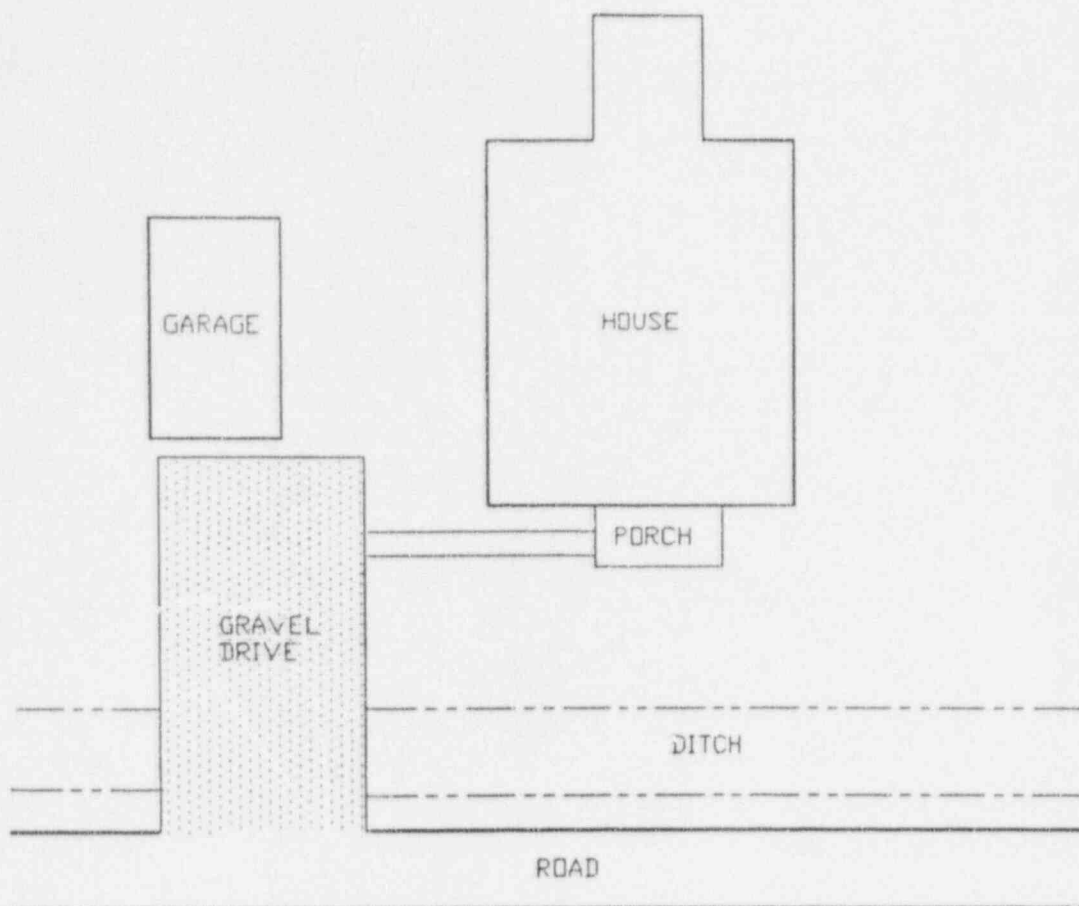
FIG. NO.  
4

Location of Slag to be Removed

Property Layout and  
Slag Locations, Property O-7

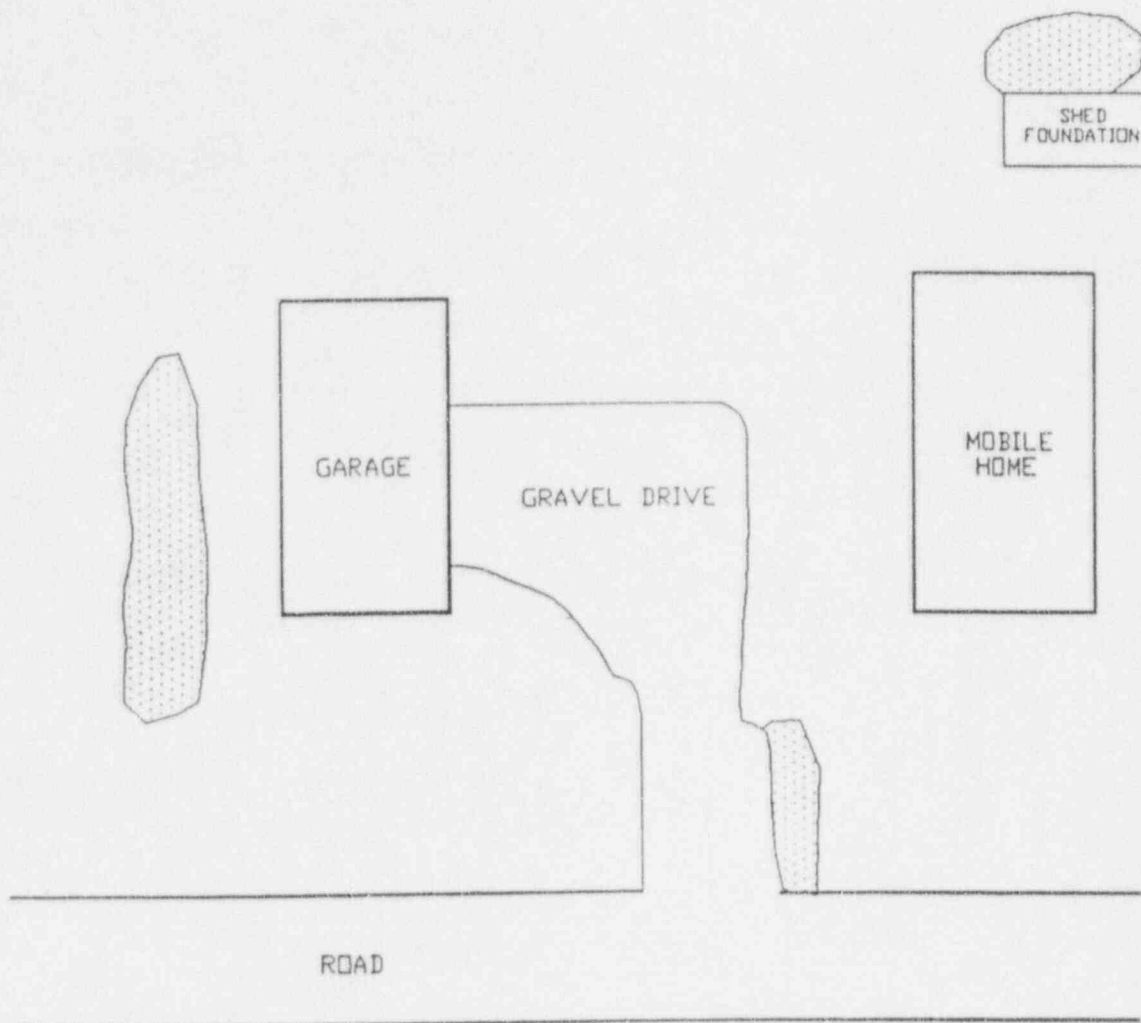
Property Layout and Slag Locations, Property O-17	FIG. NO. 5

Location of Slag to be Removed

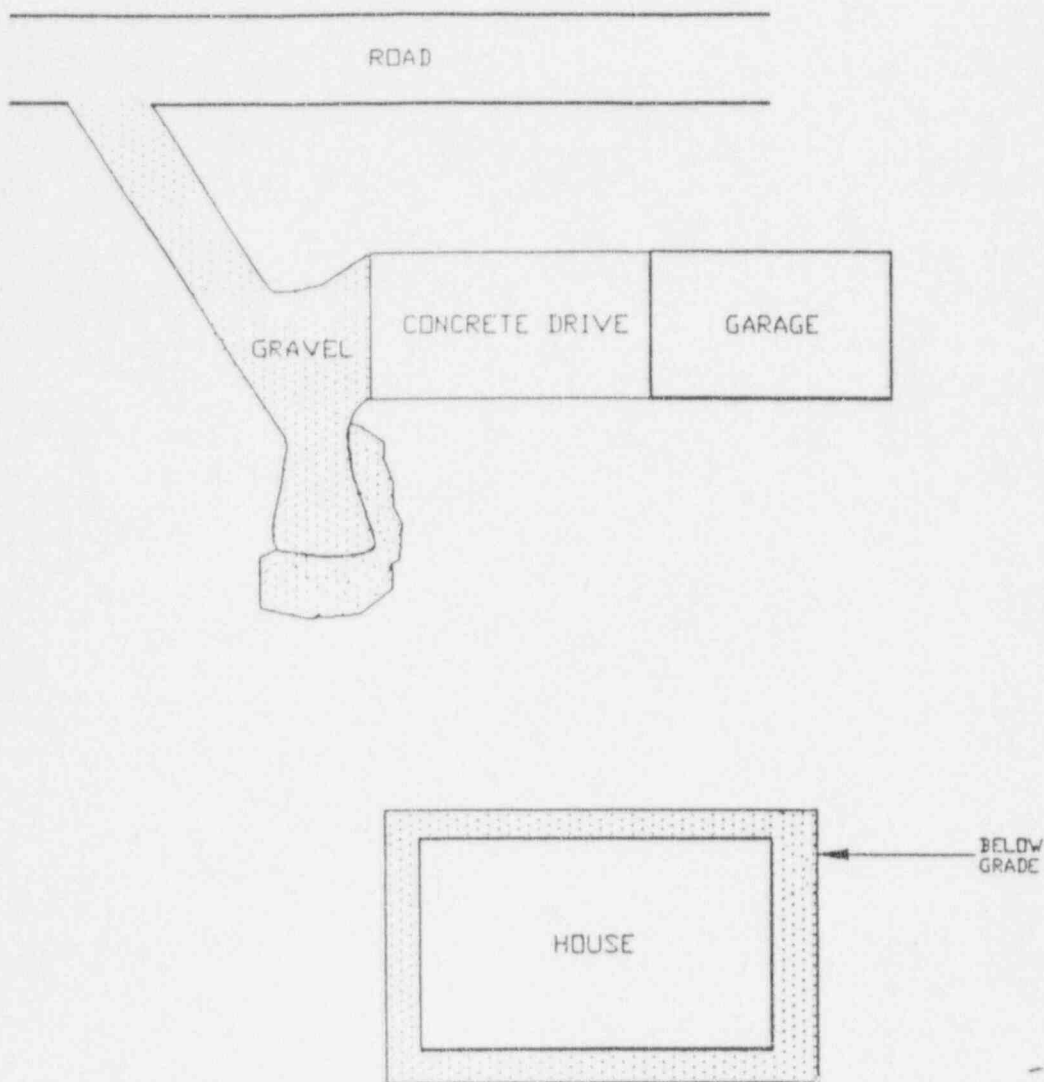
Engineering & sciences applied to the earth & its environment		
DRN. BY: RET DSGN. BY: RET CHKD. BY:	<b>Property Layout and Slag Locations, Property O-19</b>	FIG. NO. <b>6</b>

Location of Slag to be Removed

The majority of areas from which slag is to be removed are easily accessed driveways or parking areas. At property STRAW (Figure 2), the slag is located beneath the concrete floor of a small home annex. Slag removal from this property will, at a minimum, require demolition and replacement of the concrete floor. At property O-19 (Figure 6), slag is located in a driveway and

around the home foundation. The extent of demolition required at property O-19, if any, will depend on the extent of slag beneath the home foundation.

At property O-19 (Figure 6), slag is located around the home foundation. The extent of slag beneath the footers and basement floor has not been determined. During the site preparation phase, exploratory boreholes and test pits will be made at property O-19 to evaluate the extent of slag beneath the foundation. The ultimate disposition of the house will depend on the vertical and horizontal extent of the slag around the foundation. Demolition of the house or its components (e.g., basement floor) will be performed only to the extent necessary to access the slag and only after consultation with the home owner.

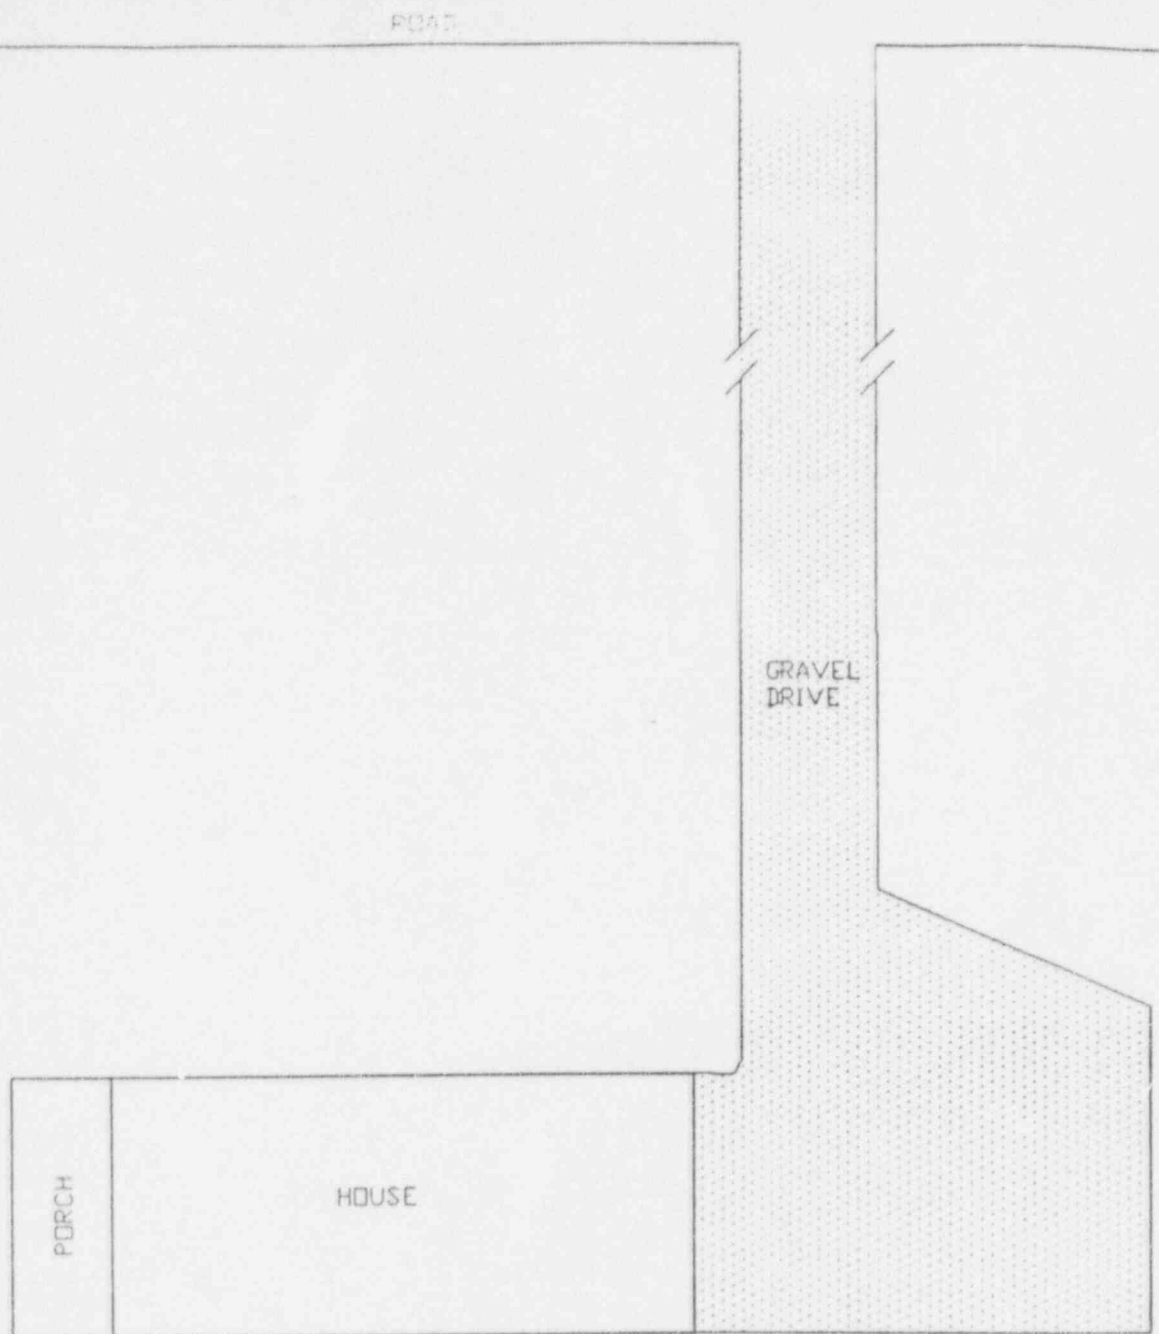
FIG. NO.  
7

Property Layout and  
Slag Locations, Property O-29
