The purpose of this letter is to bring to your personal attention my concern that Florida Power and Light (FPL) is not yet taking adequate steps to improve nuclear performance at Turkey Point 3 and 4. I base my concern on the results of the SALP report, forwarded to FPL by the Region II Administrator on February 7, 1985, as further substantiated by the enclosed report of a special NRC inspection, dated October 7, 1985.

Enclosure:
Inspection Report Nos.
50-250/85-32 and 50-251/85-32

REA-TPN 85-30 AUXILIARY FEEDWATER SYSTEM DESIGN REVIEW
AND OPTIMIZATION

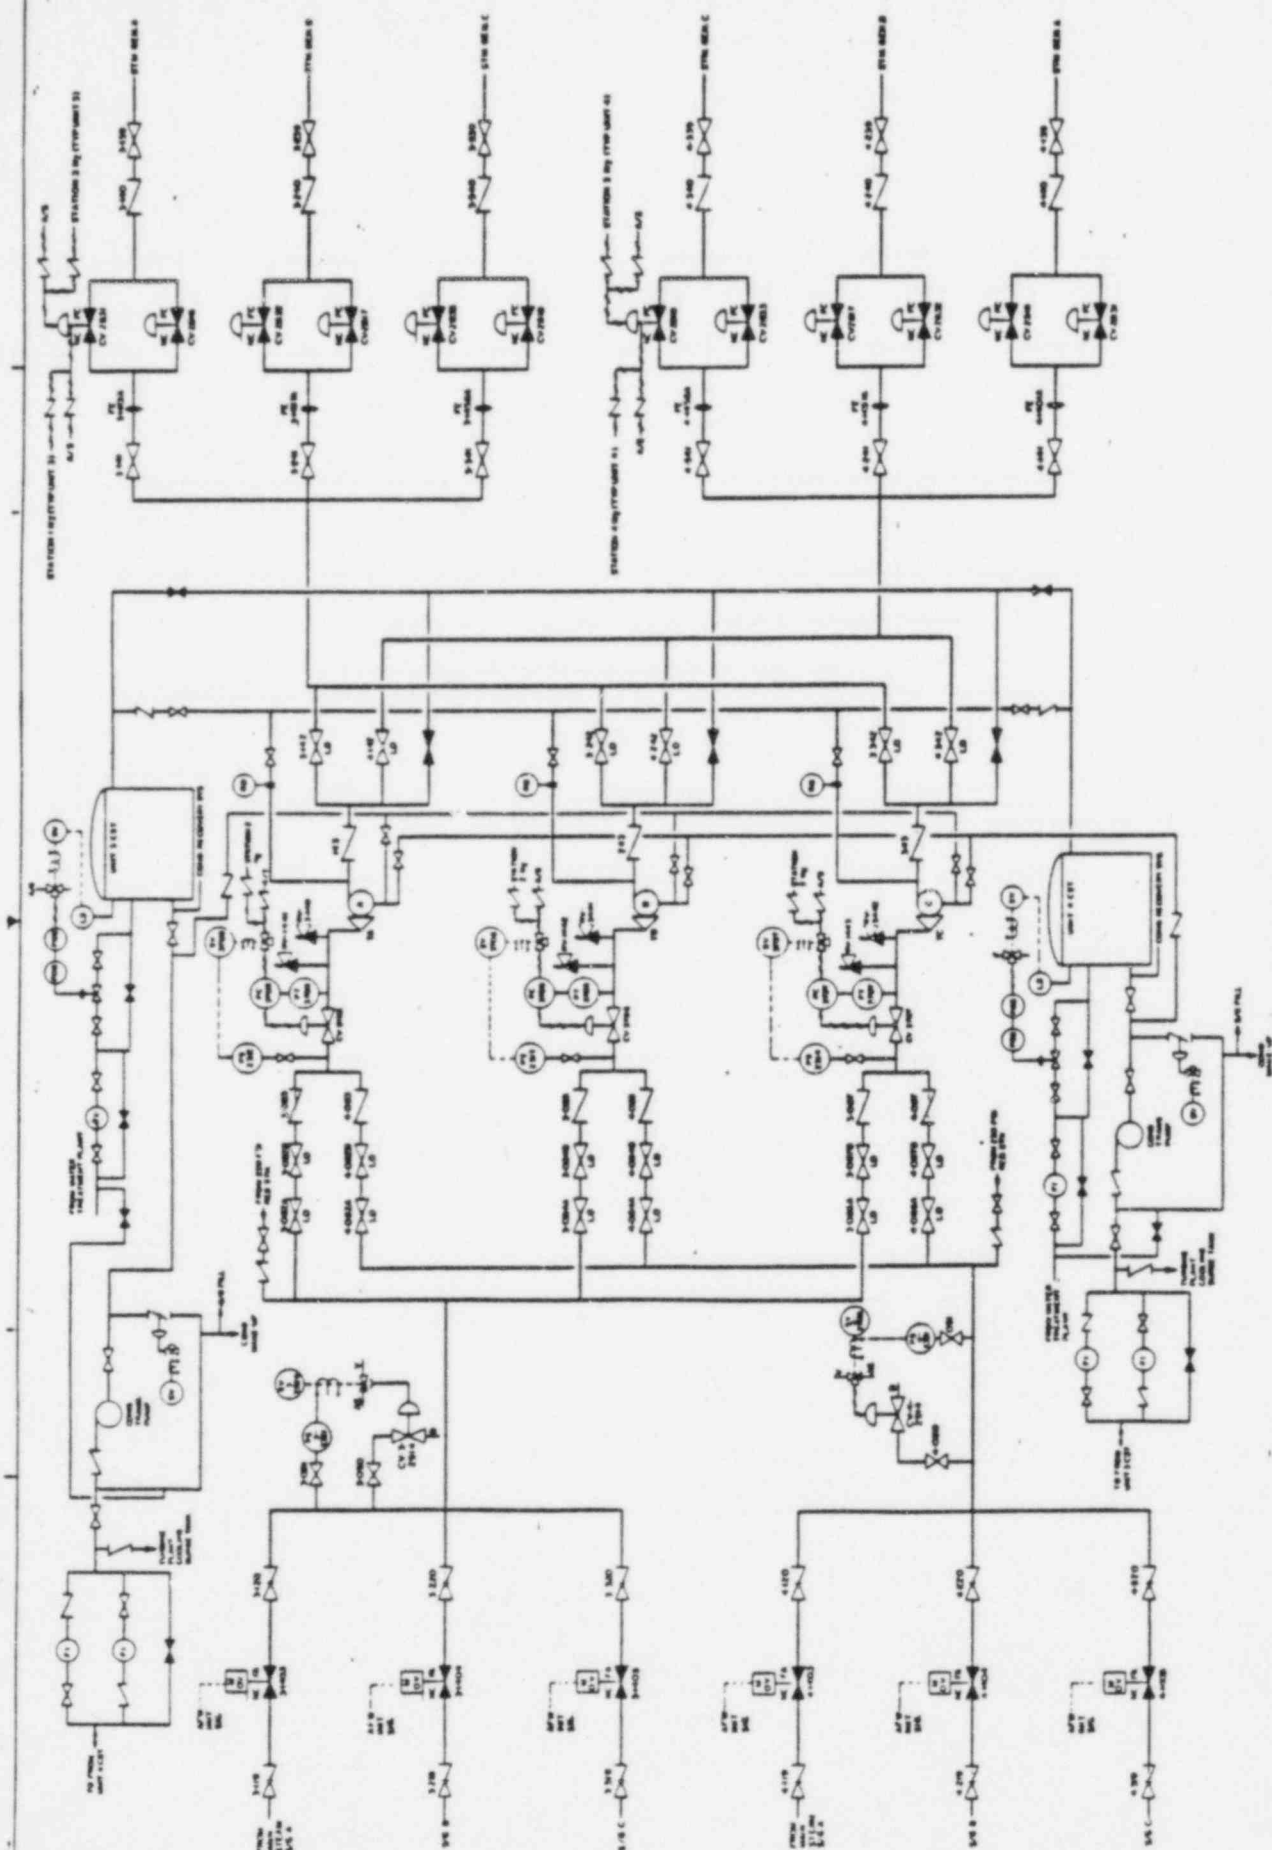
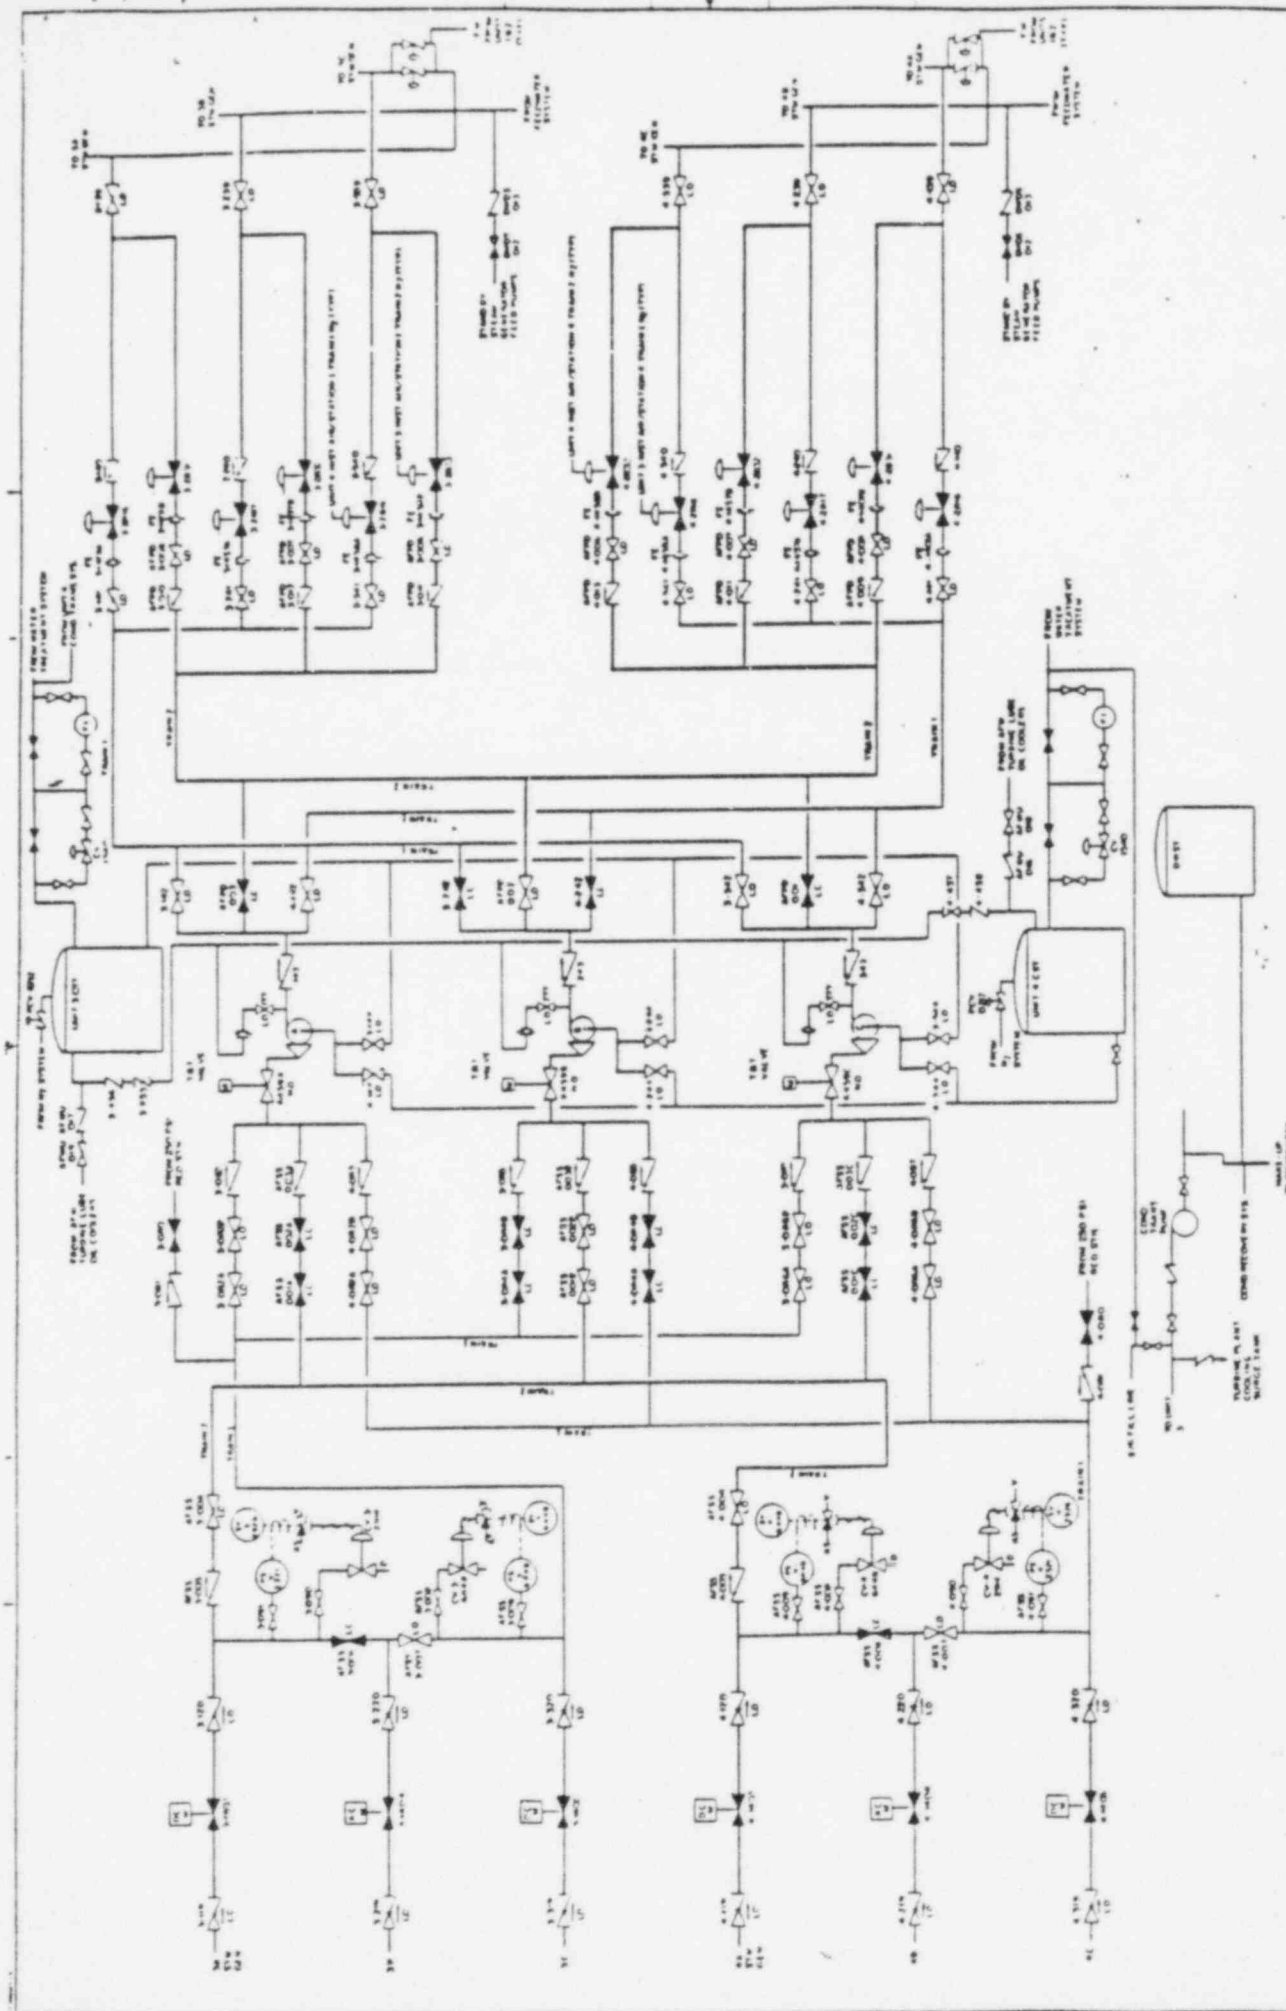
1. MINIMIZE AFW FLOW CONTROL OSCILLATION
2. AFW TECHNICAL SPECIFICATION REVISION
3. AFW GOVERNOR PERFORMANCE
4. UPGRADE OF AFW FLOW CONTROL VALVE NITROGEN SUPPLY LINES
5. AFW T&T VALVE SWITCHES AND LOCAL INDICATING LIGHTS
6. DESIGN BASIS DOCUMENT
7. AFW-NITROGEN BACKUP SYSTEM
8. AFW SYSTEM ACCESSIBILITY
9. AFW SYSTEM STEAM LEAKOFFS
10. AFW-AFP RPM MONITORING
11. AFW-ELECTRICAL CONDUIT REROUTE
12. AFW-REMOVAL OF OBSOLETE EQUIPMENT
13. SINGLE FAILURE ANALYSIS
14. MISALIGNMENT OF AFW
15. AFW-AUXILIARY OIL PUMP
16. AUXILIARY FEEDWATER SUPPLY FROM THE DWST
