LONG-TERM SURVEILLANCE PLAN FOR THE MEXICAN HAT DISPOSAL SITE MEXICAN HAT, UTAH

June 1997

Uranium Mill Tailings Remedial Action Project

Prepared by
Jacobs Engineering Group Inc.
Albuquerque, New Mexico

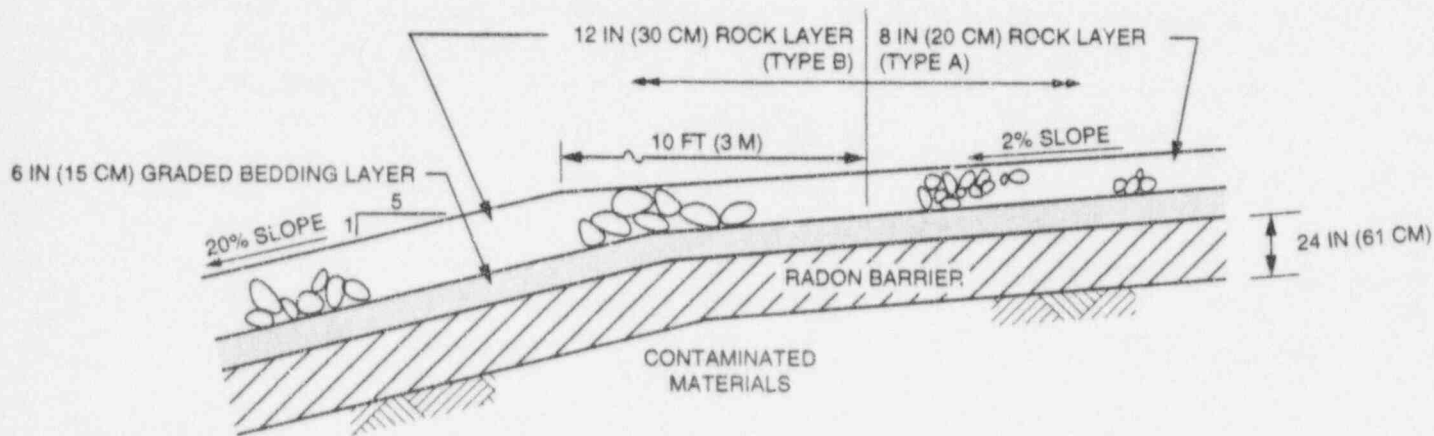
SCHEMATIC - NOT TO SCALE

FROM MK-F, 1995.

emanation and water infiltration. The radon barrier consists of 24 inches (61 cm) of compacted silty sand amended with 10 percent bentonite clay. The radon barrier is covered with a 6-inch (15-cm)-thick graded bedding layer of coarse sand and gravel. The graded bedding layer protects the fine-grained radon barrier during placement of the rock layers and functions as a drain that sheds water laterally off the disposal cell while protecting the radon barrier from erosion caused by interstitial flow. The graded bedding layer was covered with a layer of coarser-grained material to prevent erosion due to wind or rain. The erosion protection layer consists of an 8-inch (20-cm)-thick layer of 1.7-inch (4.3-cm) or larger mean diameter rock (riprap) on the top of the disposal cell and a 12-inch (30-cm)-thick layer of 4.4-inch (11-cm) or larger mean diameter rock on the sideslopes and aprons of the disposal cell.

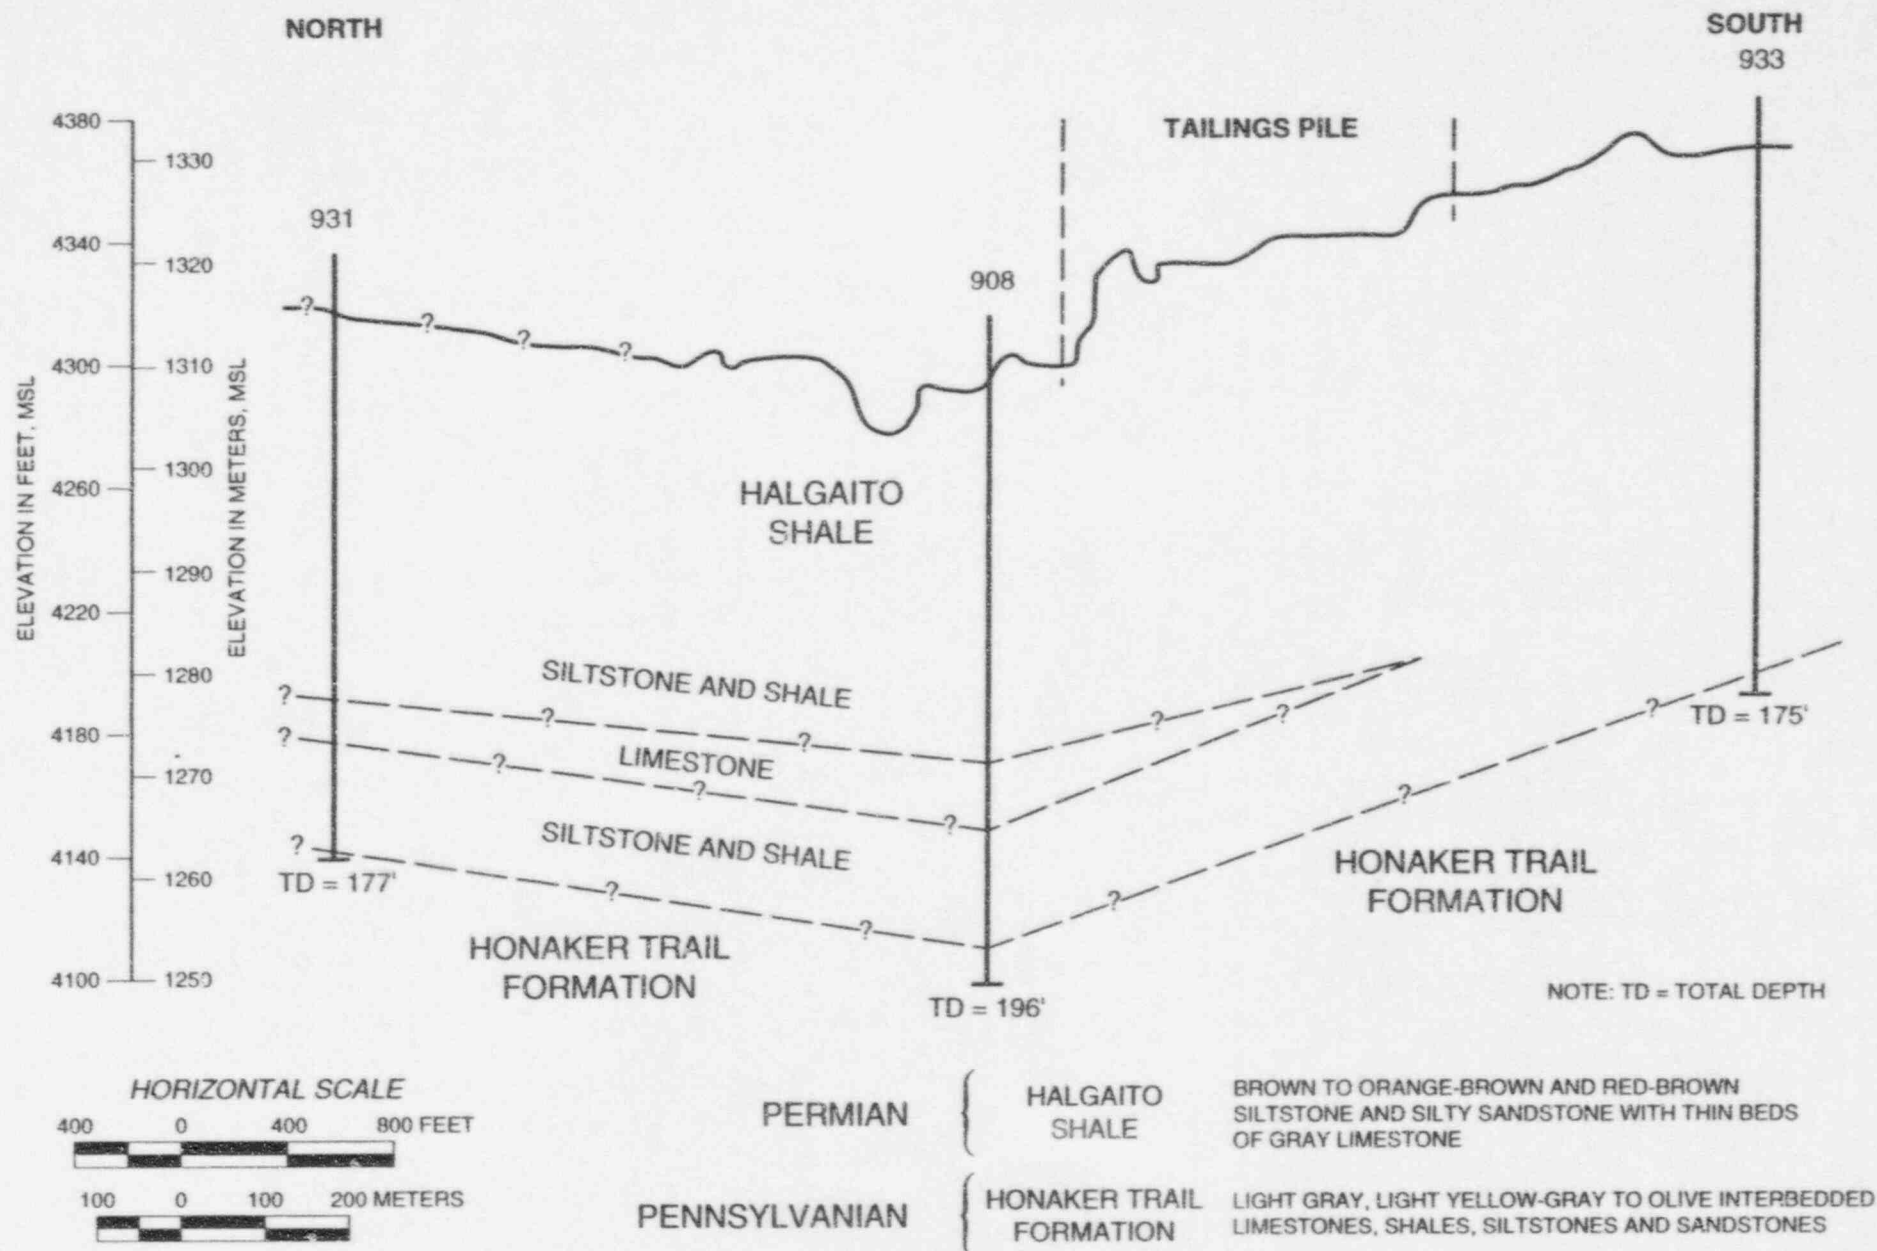
FIGURE 4.1
TYPICAL GEOLOGIC CROSS SECTION
MEXICAN HAT, UTAH, DISPOSAL SITE

FROM DOE, 1993a.

The Halgaito Shale, the lowermost unit of the Permian Cutler Group, is exposed at the ground surface of the site (Figure 4.1). This shale consists primarily of interbedded silty sandstone, siltstone, and shale. Calcareous, well cemented beds alternate with less-cemented beds, and there are some thin lenticular beds of limestone and conglomerate (siltstone and limestone pebbles in a silty matrix). The unit is 80 to 215 ft (24 to 66 m) thick in the site vicinity. Two sets of nearly vertical fractures trending east-west and northeast-southwest and fractures along bedding planes that dip toward the east are present in the upper portion of the Halgaito Shale at the site. The presence and size of the fractures decreases significantly with depth (DOE, 1995; 1993).

The Honaker Trail Formation is the uppermost unit of the Hermosa Group and lies beneath the Halgaito Shale (Figure 4.1). The Honaker Trail Formation consists of interbedded siltstone, limestone, shale, and sandstone. Chert and limestone nodules are found throughout the siltstone beds, and the limestone units are predominantly fine to very fine grained. The formation is more than 300 ft (90 m) thick (DOE, 1995; 1993).
