*PRELIMINARY SUBMITTAL*  
OYSTER CREEK NUCLEAR GENERATING STATION

TOPICAL REPORT 045

A COMPARISON BETWEEN RETRAN-02 MOD3 &  
RETRAN-02 MOD4 AND ITS IMPACT ON  
OYSTER CREEK RETRAN MODEL

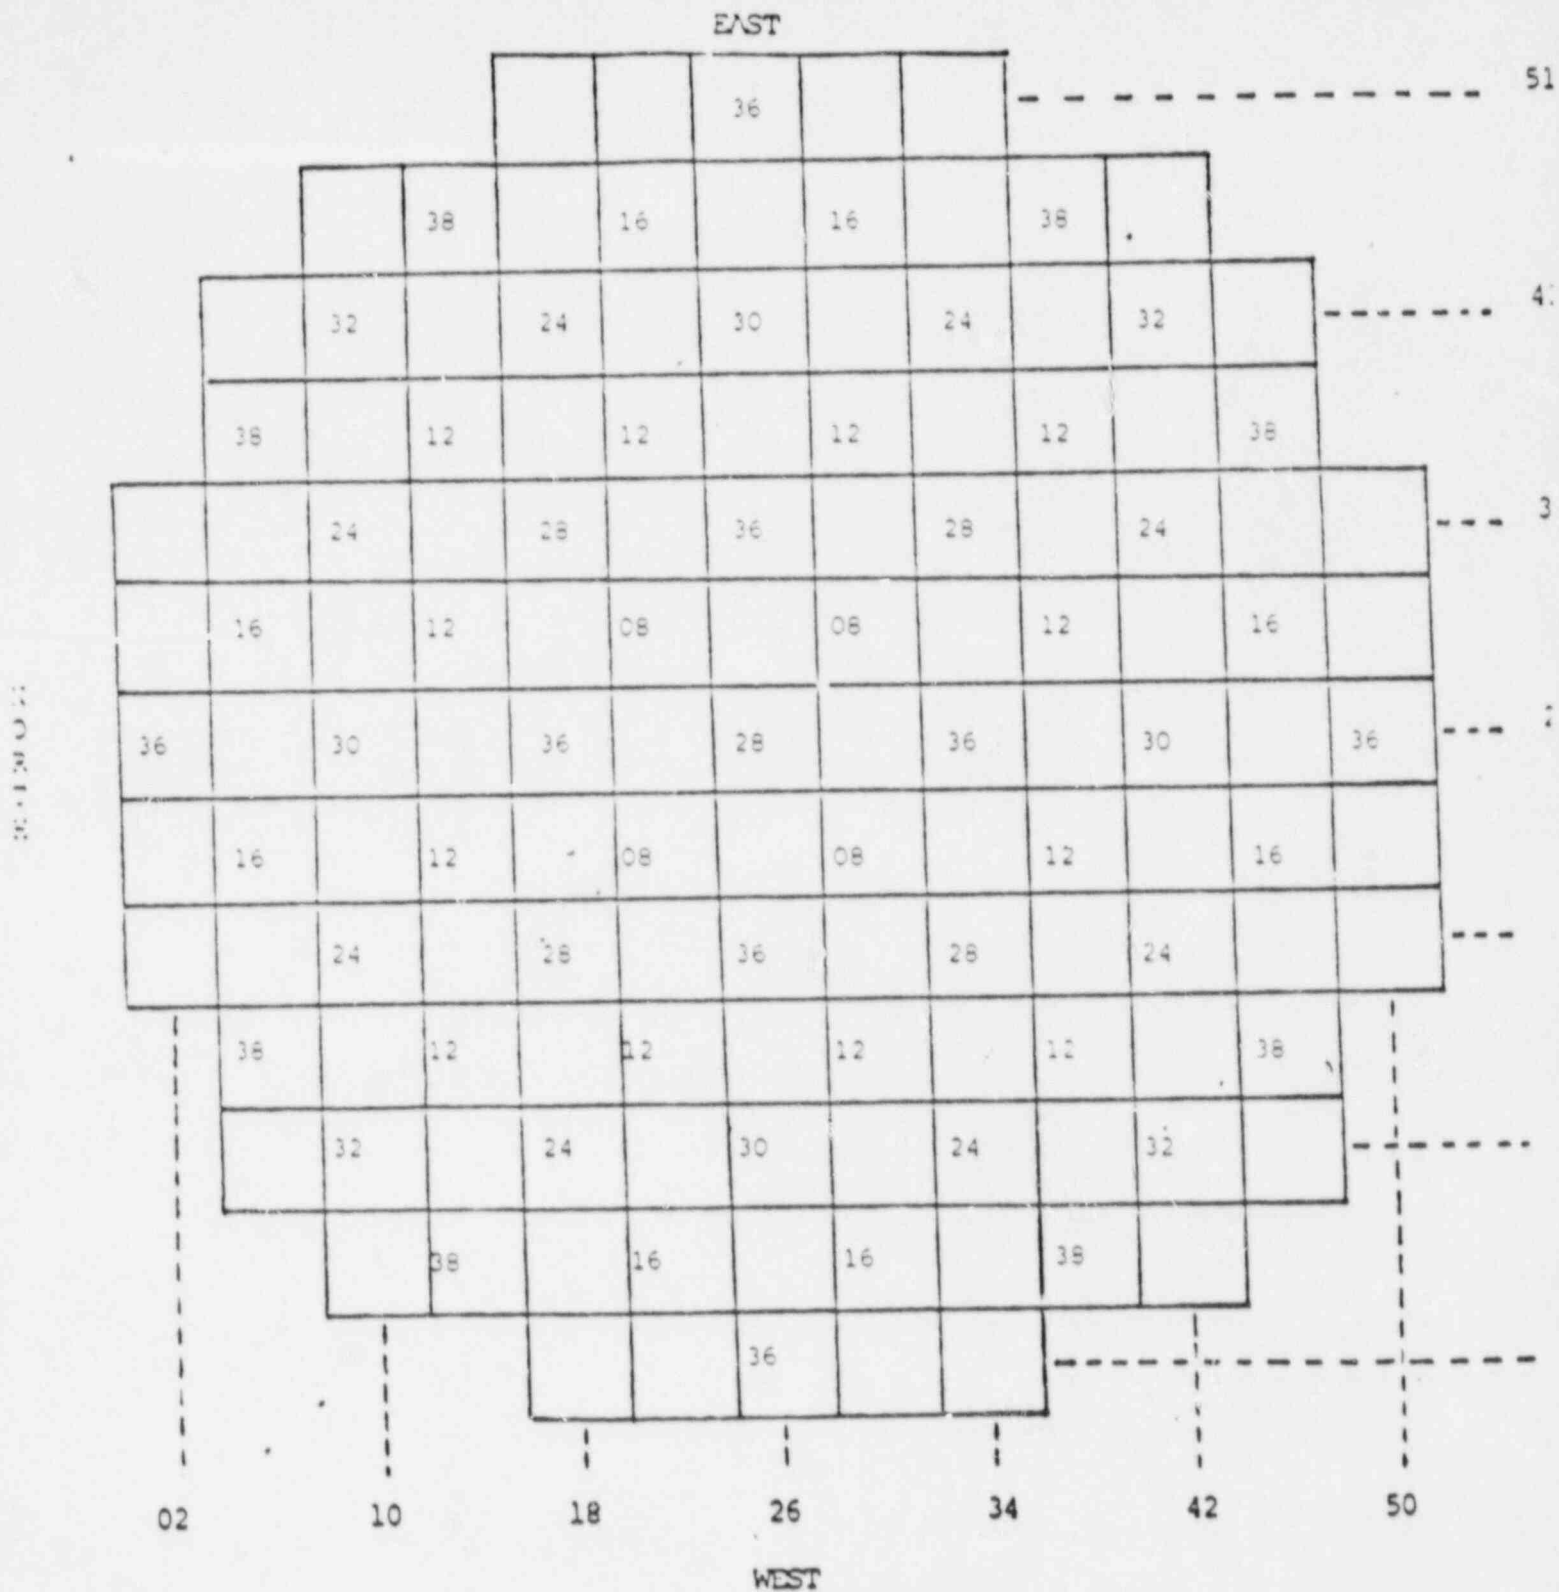
Figure 1: Control Rod Pattern for OC Turbine Trip

XX - notches inserted  
 00 - full in  
 48 - full out (blank space indicates full out)

CORE ARRANGEMENT  
 CONTROL CELLS  
 TOP VIEW

The testing was performed using data for a turbine trip performed during Oyster Creek (OC) startup testing. The control rod density at the time of the test was 22.1% (See Figure 1 for the control rod pattern). The high rod density makes this a good test for the new control rod model and highlights the deficiency in the current control rod model. Some of the basic data for the test is included in Table 1.

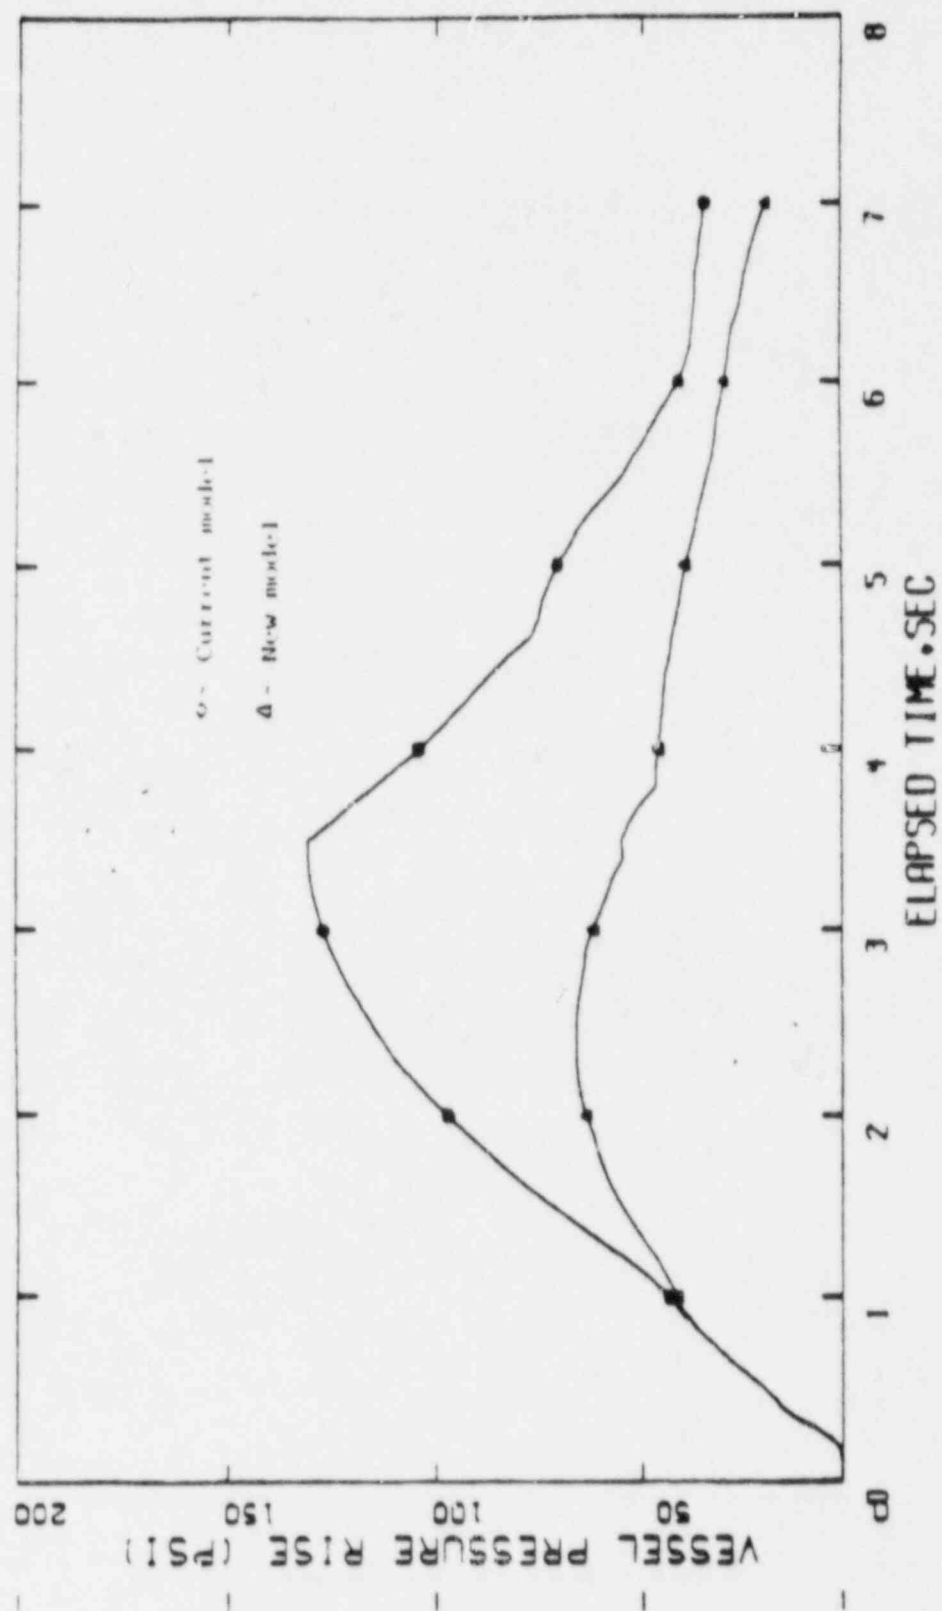
FIGURE 3

COMPARE CURRENT VS NEW CONTROL ROD MODEL IN RETRAN

The input to SIMTRAN and RETRAN was identical for the two models, except for input changes required for the modification. The results for this transient using the two RETRAN models are shown in Figures 2 and 3. Figure 2 shows

transient power response and Figure 3 pressure. Clearly, the new control rod model shows an improvement over the current model. The current model does not handle high control rod density very well. If it is at all possible, we would like to see the new control rod model in RETRAN02 MUD04.

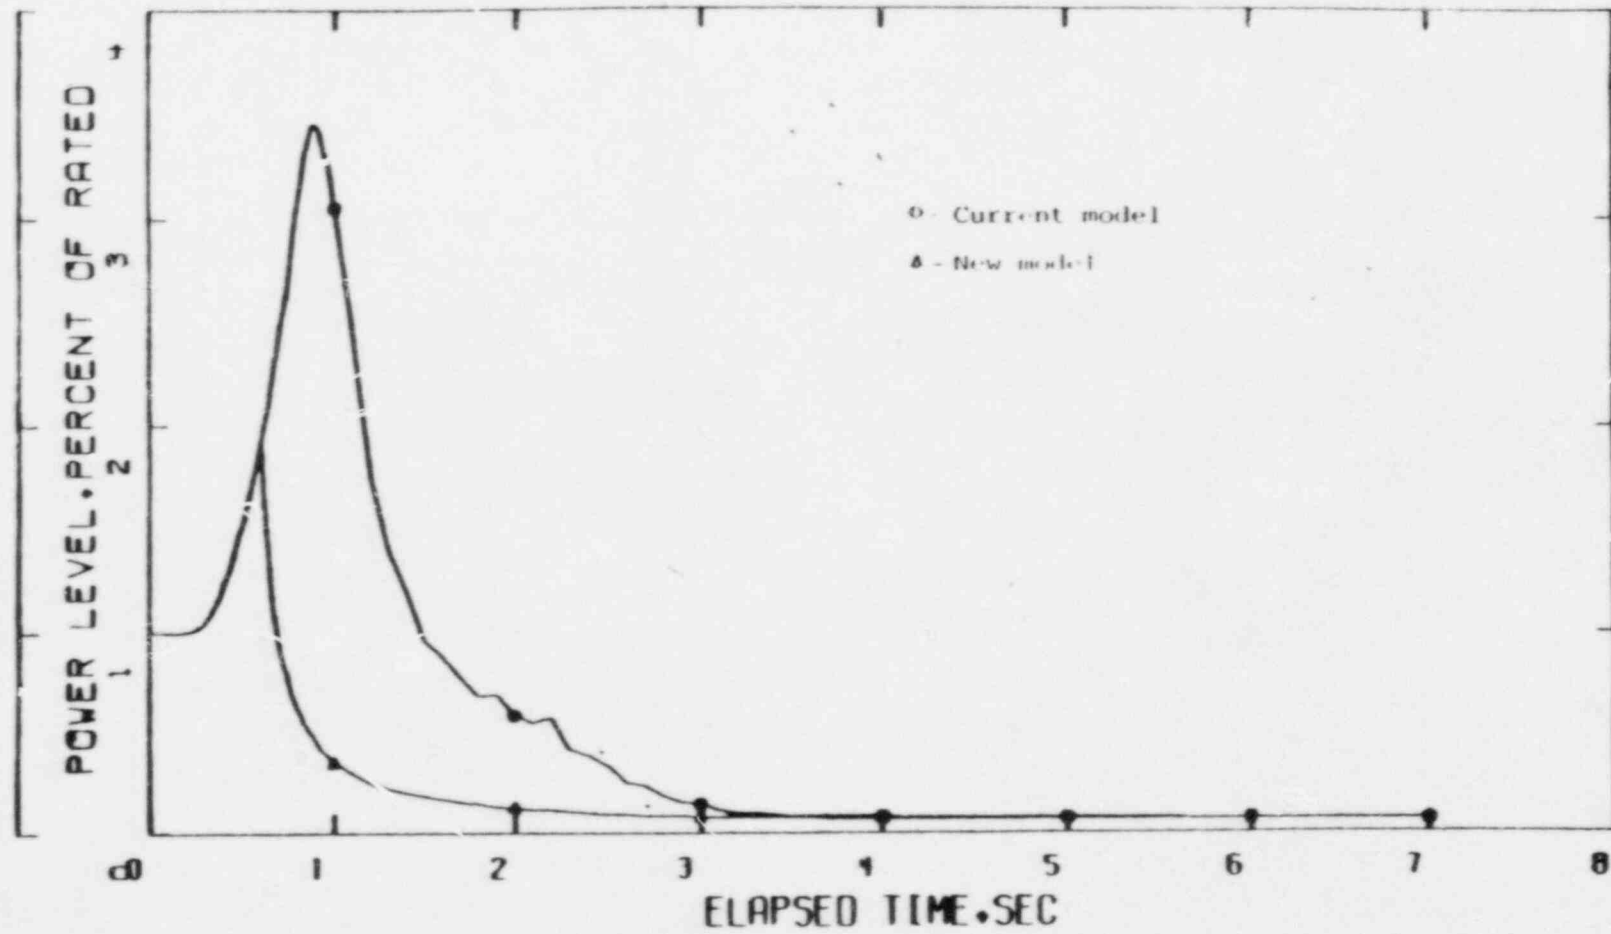
FIGURE 2

COMPARE CURRENT VS NEW CONTROL ROD MODEL IN RETRAN
