**INDEPENDENT SAFETY ASSESSMENT
OF
MAINE YANKEE ATOMIC POWER COMPANY**

Licensee: Maine Yankee Atomic Power Company
Facility: Maine Yankee Atomic Power Station
Location: Wiscasset, Maine
Docket No: 50-309
Onsite Evaluation Period: July 15-26, 1996, and
August 12-23, 1996
Team Manager: Edward L. Jordan
Team Leader: Ellis W. Merschoff
Administrative Assistant: Ola B. West
Team Members: Larry Bell
John R. Boardman
Russell L. Bywater, Jr.
Harold O. Christensen
George M. Hausman
John V. Kauffman
Kriss M. Kennedy
G. Norman Lauber
Ronald L. Lloyd
Alan L. Madison
Thomas O. Martin
Peter J. Prescott
Jack E. Rosenthal

EQUIPMENT PERFORMANCE FOR AUXILIARY FEEDWATER, EMERGENCY FEEDWATER, HIGH
PRESSURE SAFETY INJECTION, AND EMERGENCY DIESEL GENERATOR SYSTEMS FROM JANUARY
1, 1992 THROUGH JUNE 30, 1996

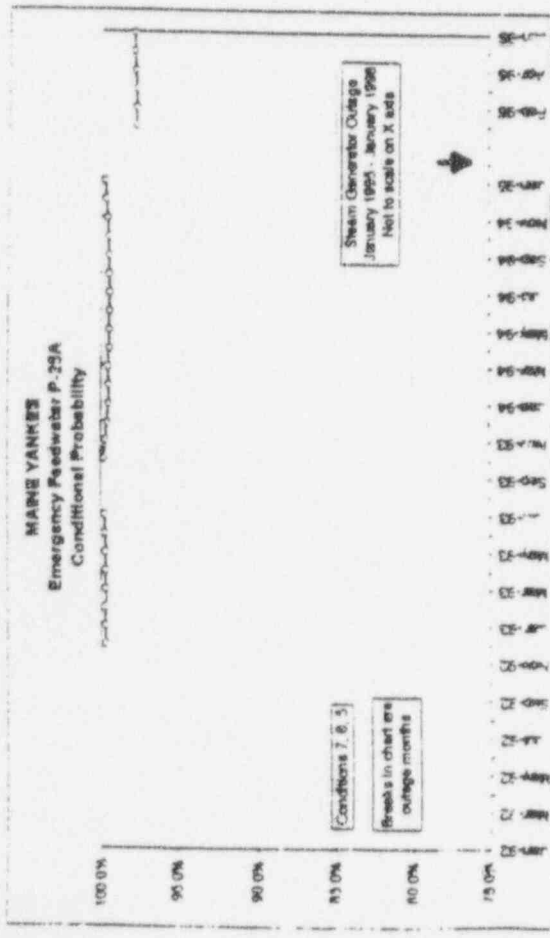
Figure 2

For these curves, high values are better than low values.

Total Starts	130
Successful Starts	130
Failures to Start	0
Total Run Hours	487
Run Failures	0
Planned Maintenance Hours	44.5
Unplanned Maintenance Hours	143.5
