SUBJECT: SUMMARY OF MEETING WITH WESTINGHOUSE TO DISCUSS FUEL  
PERFORMANCE ISSUES

In the non-proprietary portion of the meeting, Westinghouse summarized the fuel performance for the Vantage 5H fuel and for fuel using Zirlo. Due to confusion in the different types of Westinghouse fuel referenced by both licensees and Westinghouse, the staff requested Westinghouse provide a list of the different fuel types and the various names that may be referenced such that the staff is better able to understand the nomenclature.

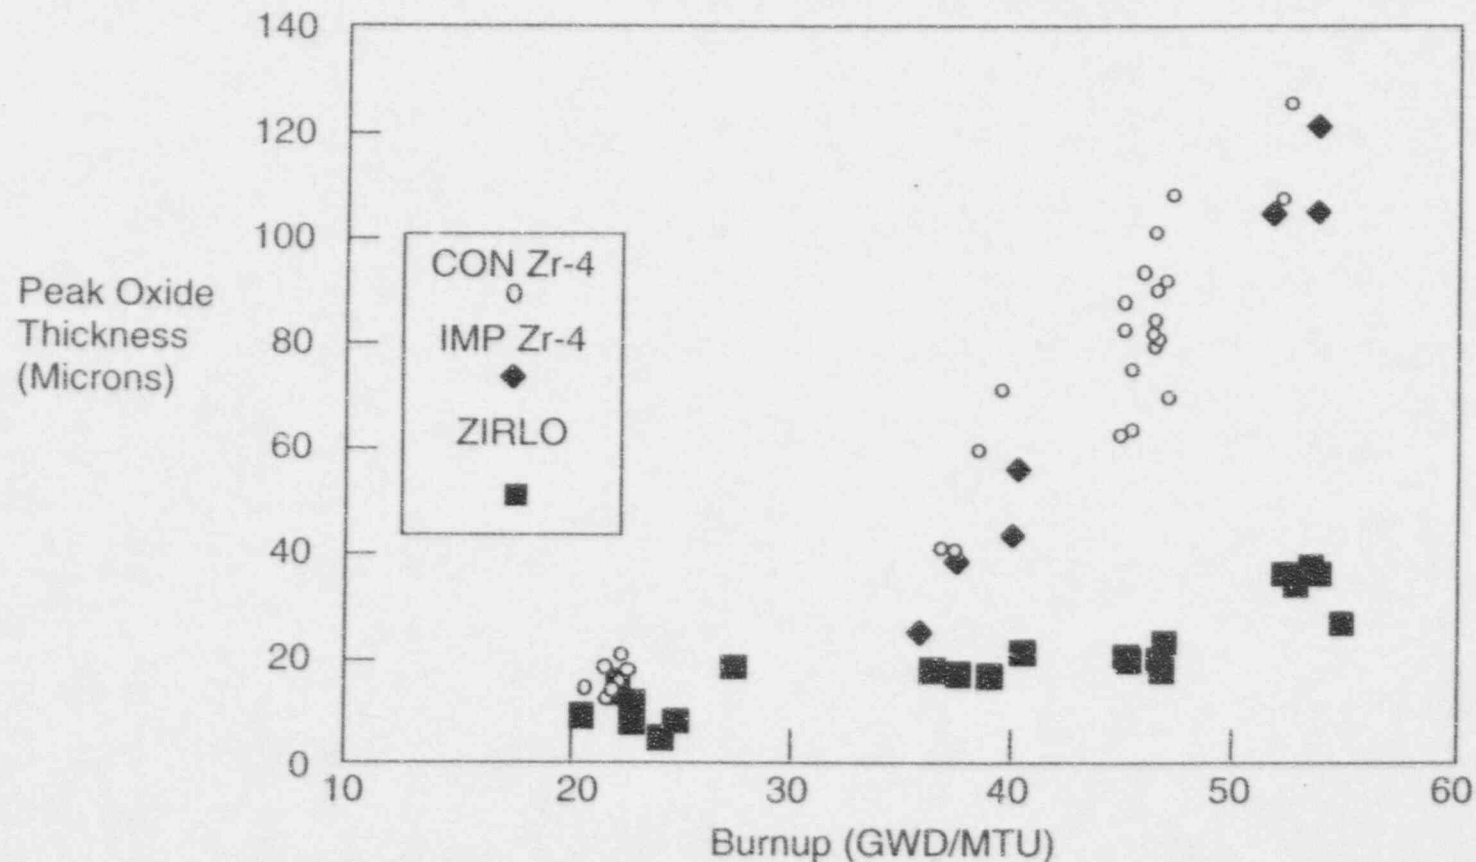
# ZIRLO™ Provides Increased Margin to Cladding Corrosion Limits

- Additional corrosion margin needed for high burnup
- Zirlo provides needed margin
