NRC Pre-Submittal Meeting

Byron Unit 2 LAR for One-Time Deferral of Steam Generator Inspections

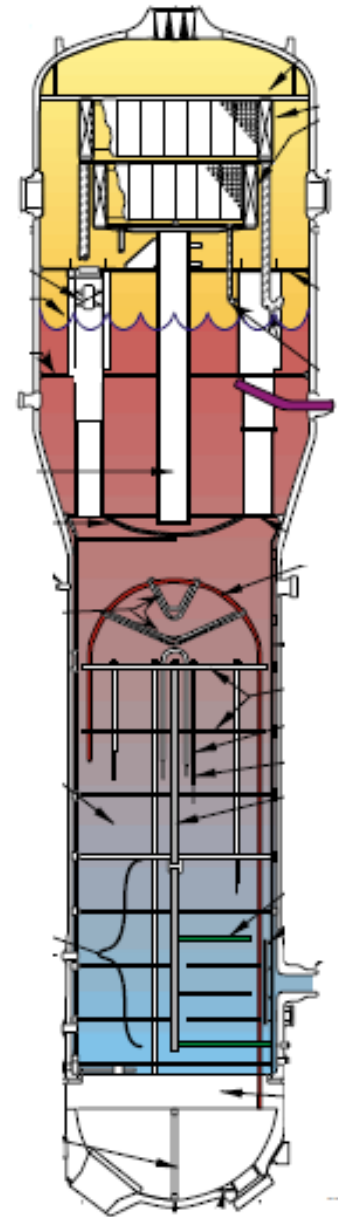
Normal Operating Parameters:

- NOP (Primary) = 2250 psia
- NOPD = 1385 psid
- $T_{\text{Hot}} = 611^{\circ}\text{F}$
- Operating Cycle Length = ~18 months
- SG EFPY at October 2020 Outage = 29.9
