DRAFT
Long-Term Surveillance Plan for
the Durita, Colorado,
UMTRCA Title II Disposal Site,
Montrose County, Colorado

November 2020

**Long-Term Surveillance Plan for the Durita, Colorado,
UMTRCA Title II Disposal Site, Montrose County, Colorado
Document History**

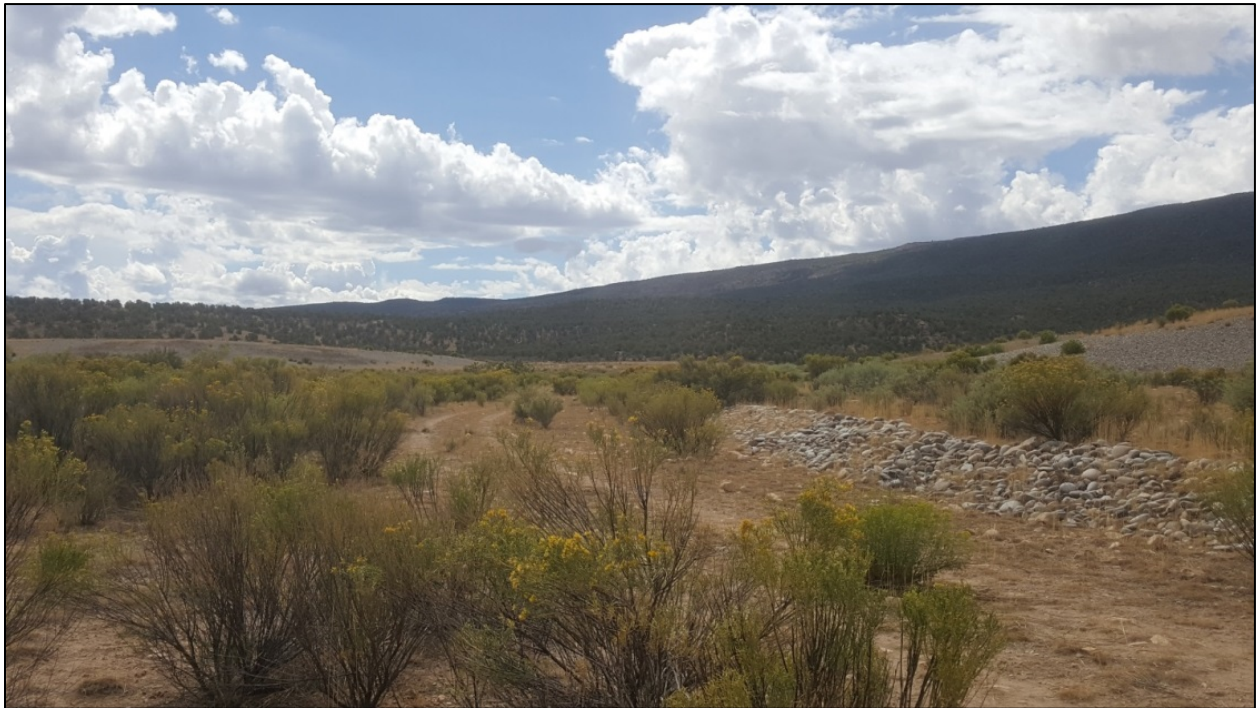
Figure 3. Reclaimed Surfaces in Central Area of Durita, Colorado, Disposal Site (September 2018)

The site includes three reclaimed heap leach tanks, surface water diversion structures, and a riprap-armored disposal cell containing the contaminated sludges and salts from six reclaimed evaporation ponds. Reclaimed surfaces are graded and protected from erosion with a combination of rock armoring, contouring, and revegetation to achieve the necessary surface water run-on and runoff control and erosion protection to satisfy the longevity design requirements (Figure 3). The revegetated surfaces have been reseeded with a mix of plants that has proven to be successful in reclaiming disturbed areas at the site and will help provide for soil stability.

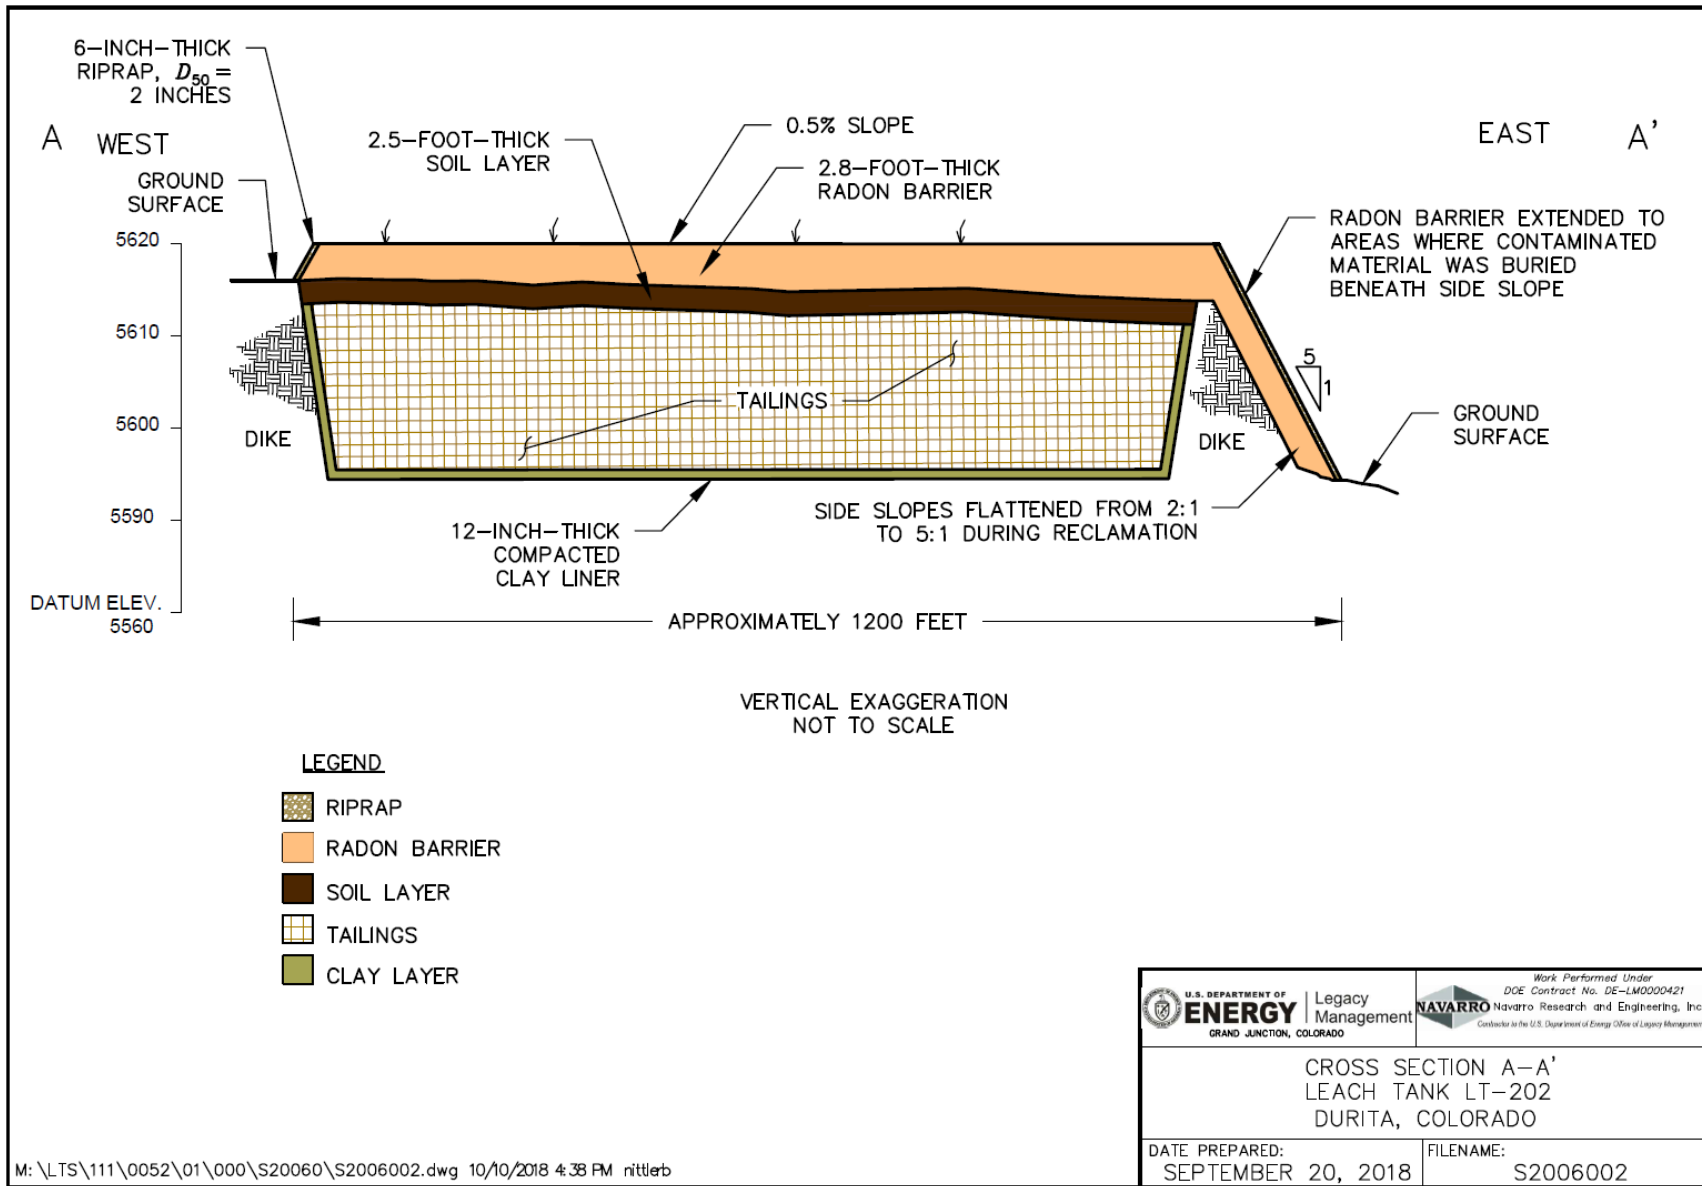
Figure 8. Cross Section, Leach Tank, Durita, Colorado, Disposal Site

The leach tank tailings materials consisted of sandy soils with some silt and clay. They were unsaturated and have been in place since 1980 (CDPHE 2016). The licensee stabilized the leach tanks after the leaching process was complete; stabilization involved contouring and covering the tanks with 2 to 2.5 feet of clean soil. Additional soil cover was placed on the leach tanks to reduce the radon emanations to below 20 picocuries per square meter per second, resulting in a final cover thickness of 5.28 feet (Dames & Moore 1978, CDPHE 2016) (Figure 8). The side slopes of the leach tanks were regraded to a slope of 5H:1V from a slope of 2H:1V. The side slopes are covered with a 6-inch-thick layer of riprap. Some of the material used in the regrading was cut from the crest of the existing tanks, and the remainder was obtained from approved borrow sources. Process plant debris including concrete foundations, pads, support structures, tanks, and other materials not decontaminated in accordance with release criteria was also placed on the out slopes of LT-201 and LT-203. The top slopes of the leach tanks were graded to slopes of 0.5% and vegetated for erosion protection, and rock was placed on the side slopes with rock size calculated to withstand the erosive forces of the probable maximum precipitation event of 8.4 inches per hour of rainfall (CDPHE 2016, Hecla 2000).
