SEABROOK STATION  
UPDATED FINAL SAFETY  
ANALYSIS REPORT

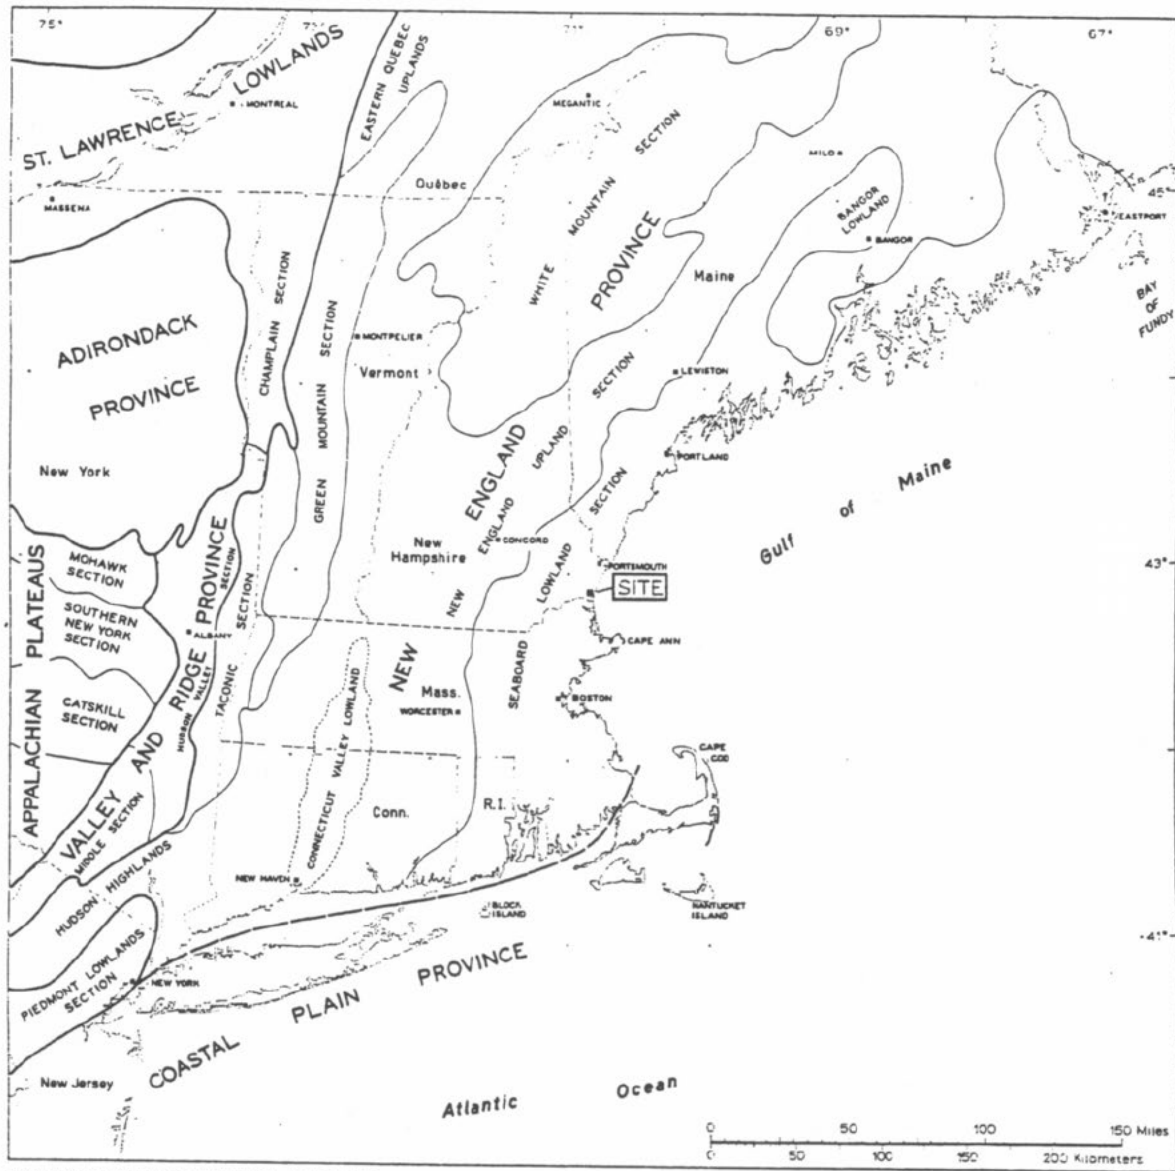
Figure 2.5 1

Regional Physiographic Map

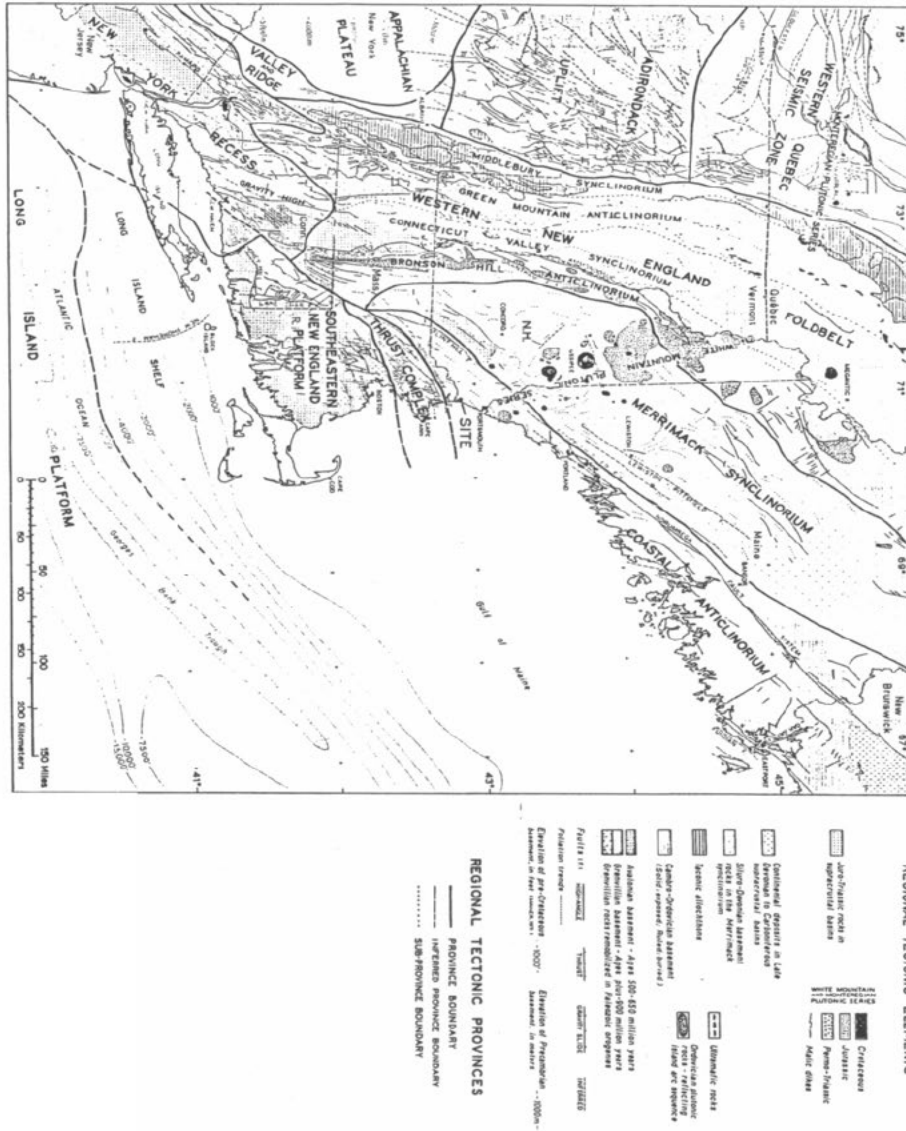
SEABROOK STATION UPDATED FINAL SAFETY ANALYSIS REPORT	Regional Tectonic Provinces	
		Figure 2.5-5

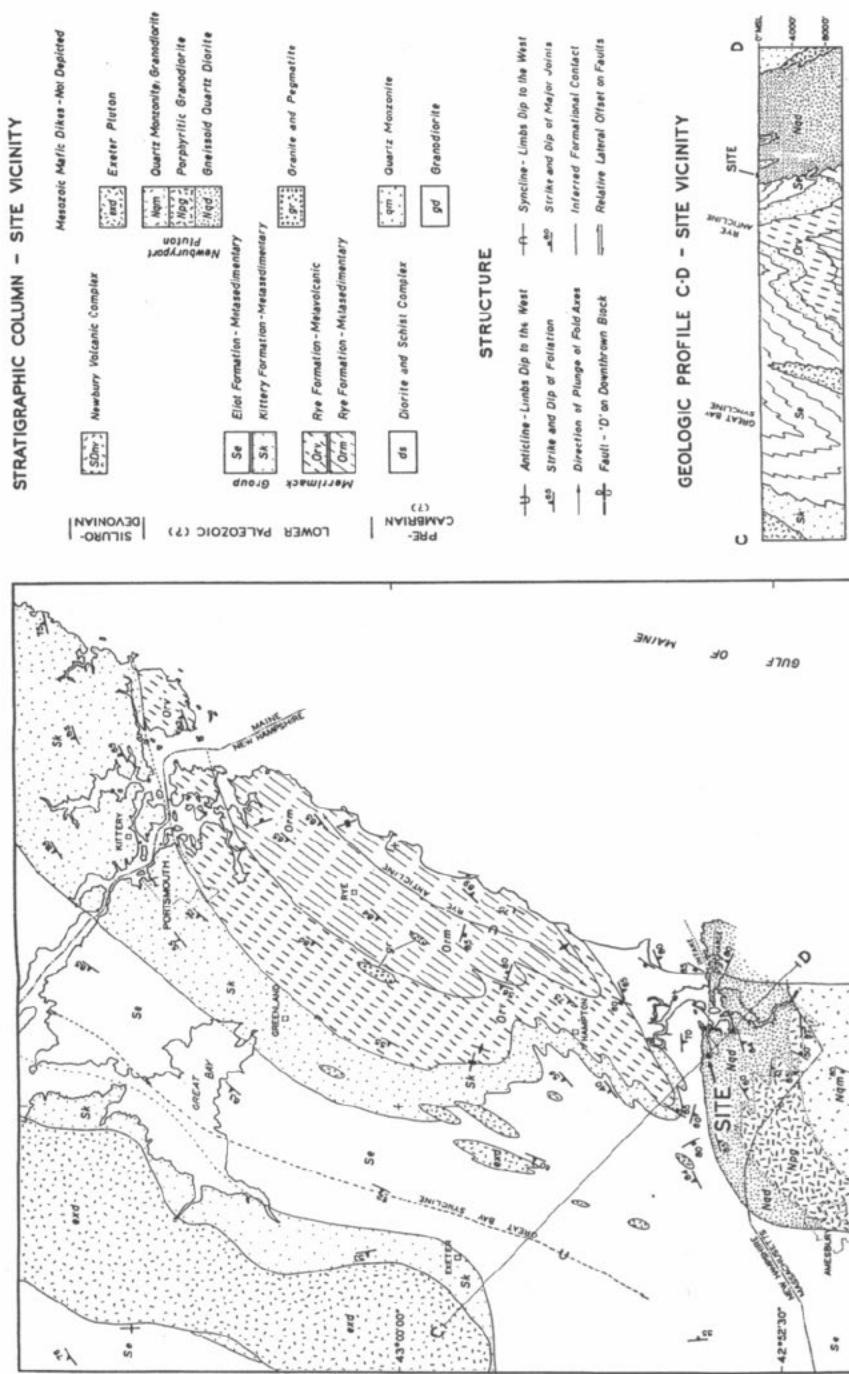
SEABROOK STATION UPDATED FINAL SAFETY ANALYSIS REPORT	Site Vicinity - Bedrock Geology	
		Figure 2.5-7

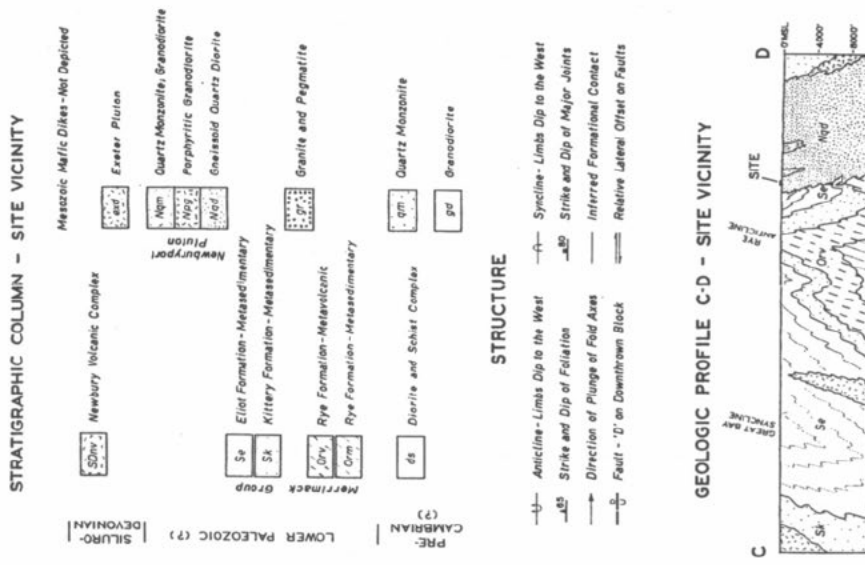
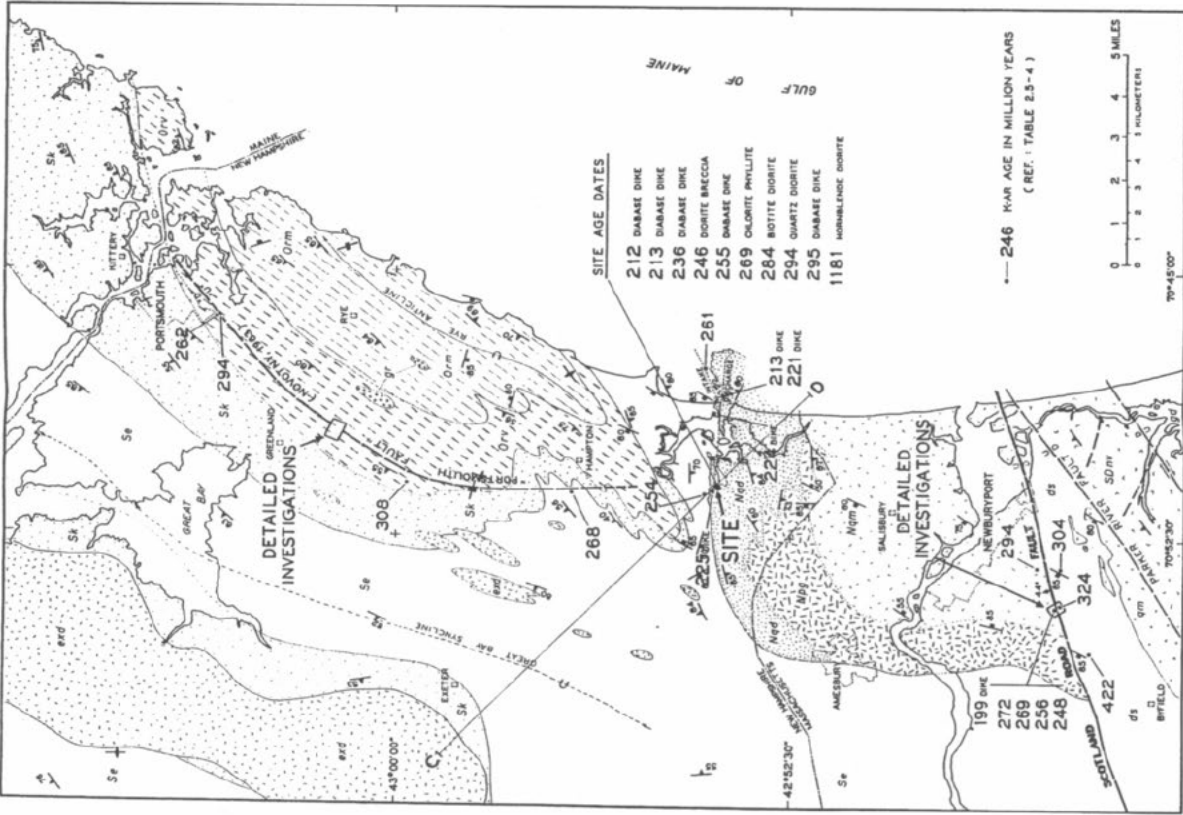
SEABROOK STATION UPDATED FINAL SAFETY ANALYSIS REPORT	Site Vicinity – Fault Investigations and Radiometric Dating	
	Figure	2.5-8

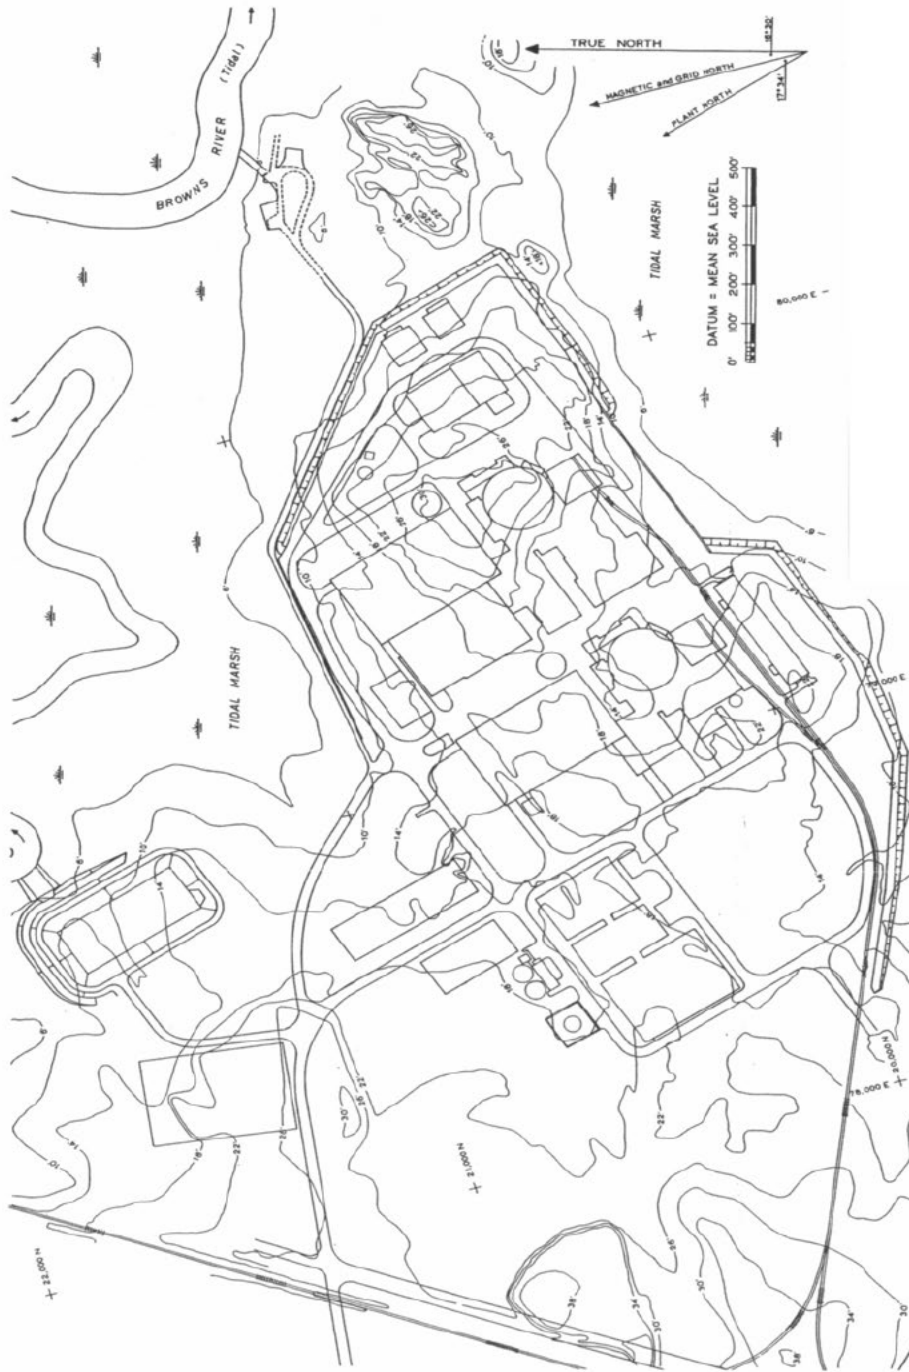
SEABROOK STATION UPDATED FINAL SAFETY ANALYSIS REPORT	ite Area – Plot Plan and Original Surface Topography	
		Figure 2.5-15

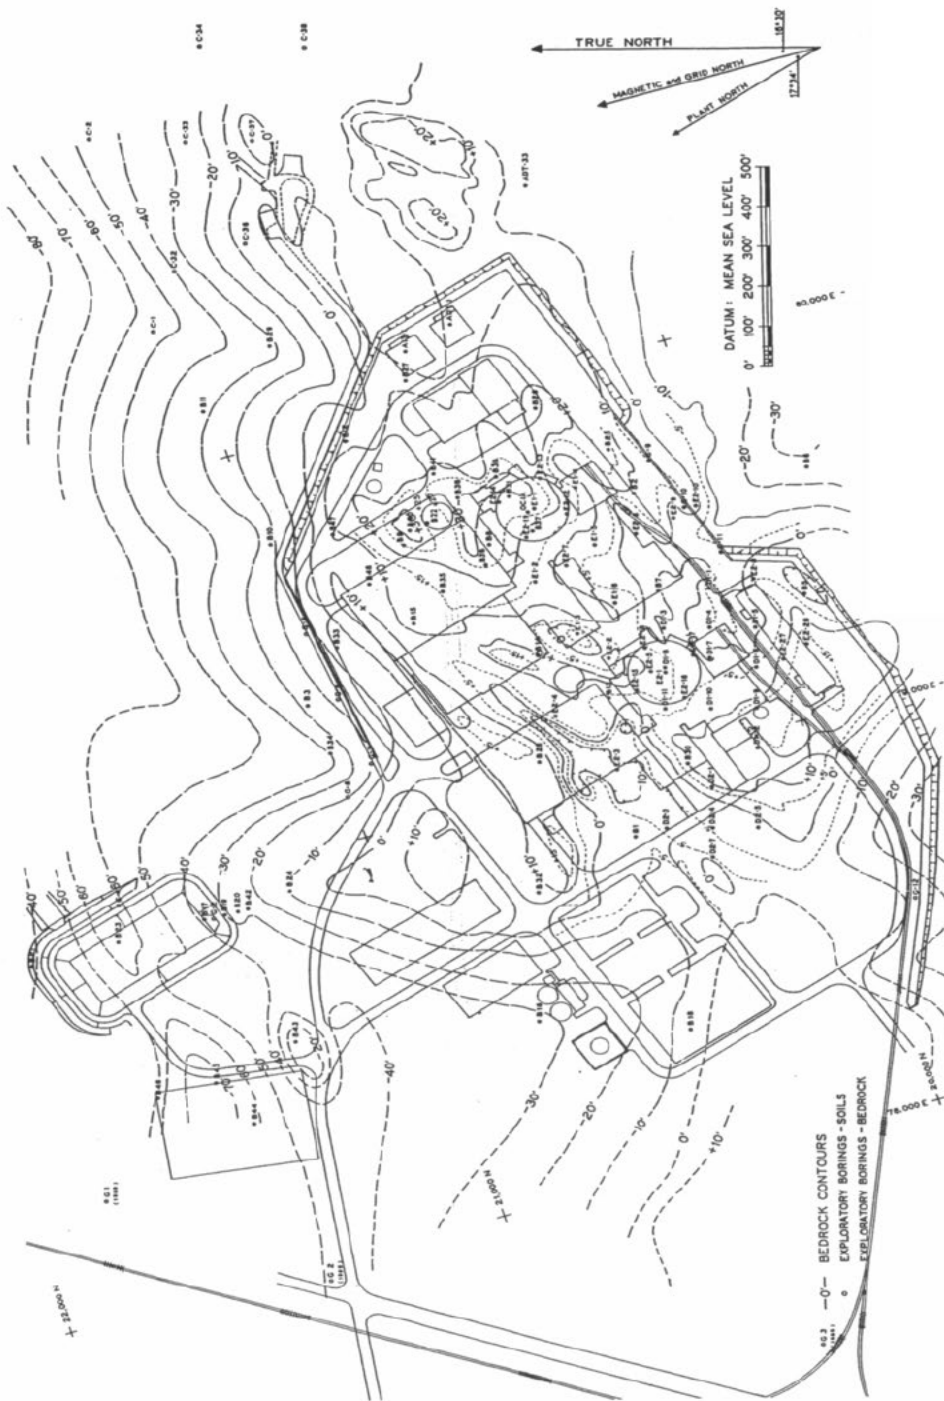
Figure 2.5-17

Site Area – Boring Locations and Estimated Bedrock  
Topography

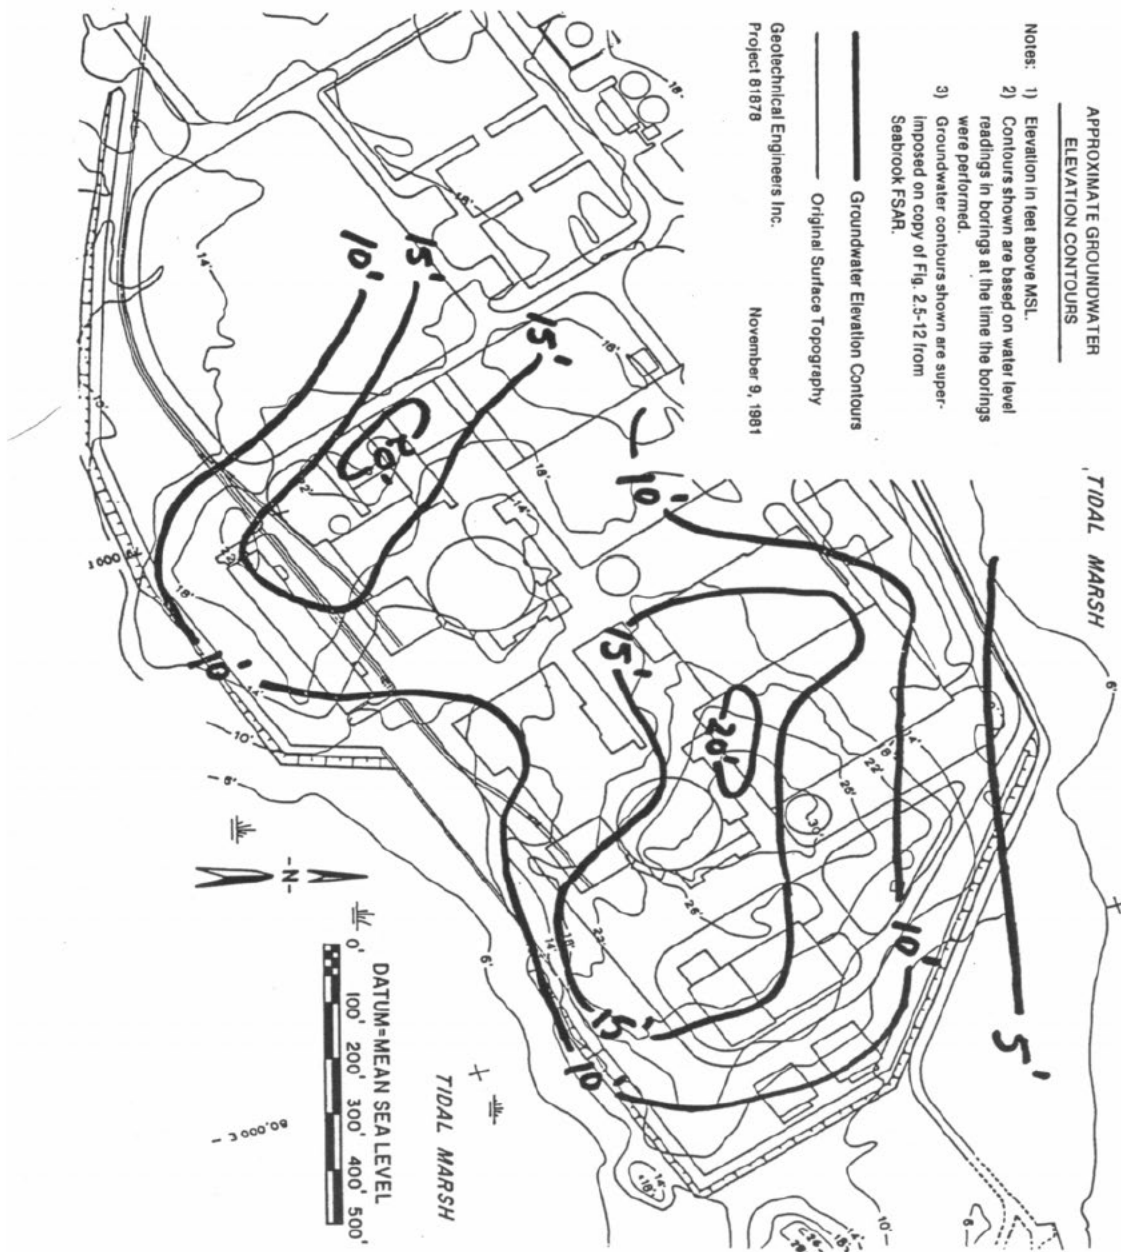
SEABROOK STATION UPDATED FINAL SAFETY ANALYSIS REPORT	Approximate Groundwater Elevation Contours	
		Figure 2.5-18

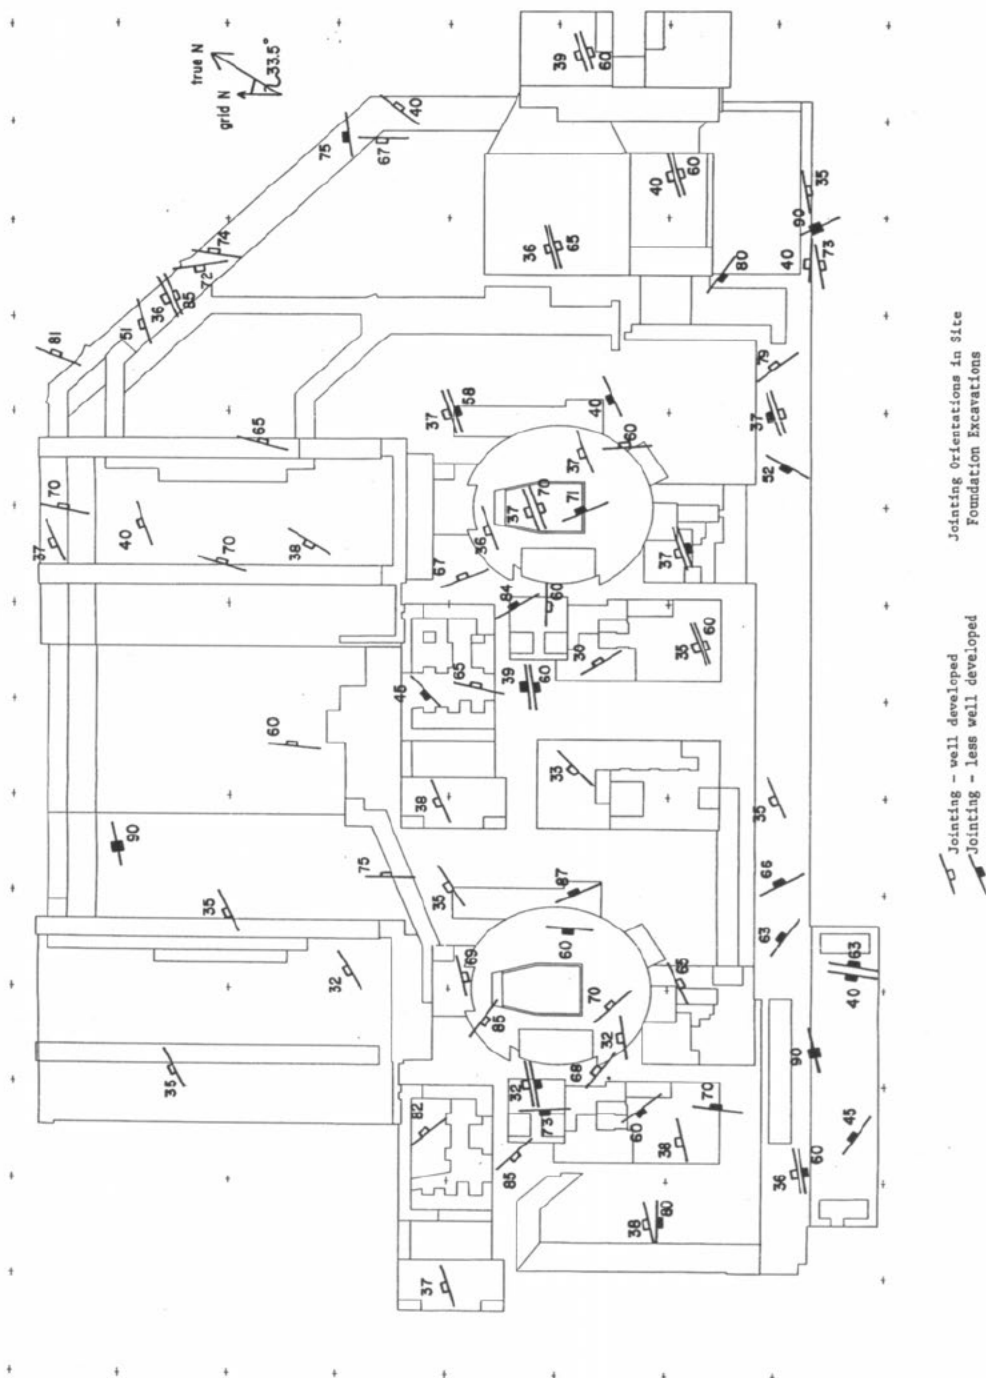
Figure 2.5-21

Jointing Orientations in Site Foundation Excavations

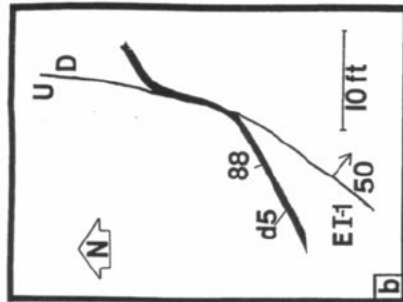
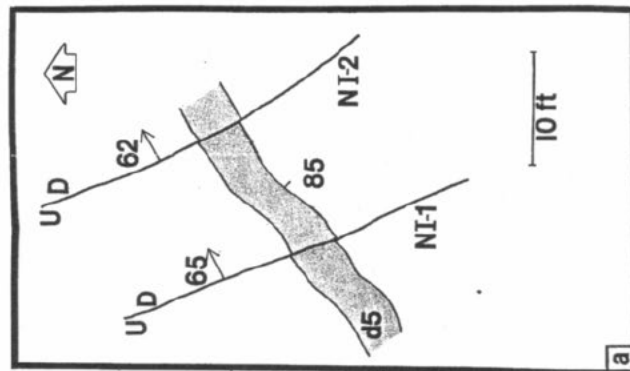
a. PLAN SKETCH FROM THE CBI. FAULTS NI-1 AND NI-2 CLEANLY OFFSET DIKE d5 AND THE HOST ROCK, NEWBURYPORT. b. PLAN SKETCH FROM DI. FAULT W-6 DEFLECTS AND OFFSETS DIKE d5 AND THE HOST ROCK, NEWBURYPORT. c. PLAN SKETCH FROM THE AREA BETWEEN THE CWI AND THE ESPFCI. DIKE d5 CROSS-CUTS FAULT EI-1.

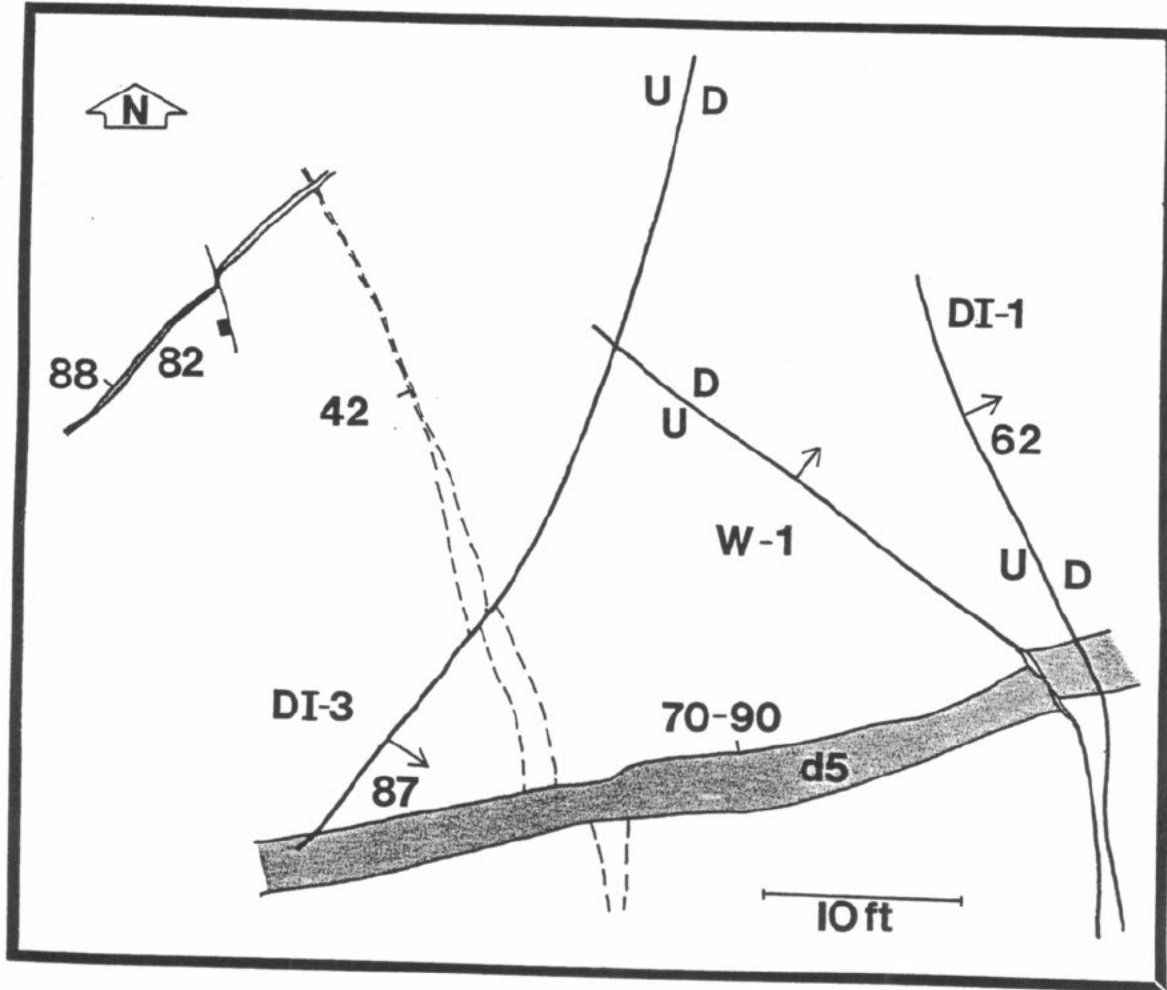
PLAN SKETCH FROM D1. FAULT DI-3 ENDS WITH DIKE d5. FAULT DI-1 APPARENTLY DISPLACES DIKE d5 ALTHOUGH THE FAULT NARROWS TO A SINGLE, NARROW, TIGHT FRACTURE BETWEEN TWO CALCITE PODS AT THE DIKE'S CENTER. FAULT DI-1 APPARENTLY DISPLACES d5 ALTHOUGH HEAVY CALCITE COATINGS PREVENT MEASUREMENT OF DIKE OFFSET. A DIKELET ASSOCIATED WITH d5 IS DEFLECTED ALONG A JOINT IN A MANNER WHICH MIMICS SOME APPARENT OFFSETS OF DIKES ALONG FAULTS OVER THE SITE. DILATION OPENING FOR d5 TOOK PLACE OTHER THAN AT RIGHT ANGLES TO DIKE CONTACTS. DIABASE DIKELET SHOWS PSEUDO-OFFSET ALONG JOINT. HOST ROCK IS NEWBURYPORT.

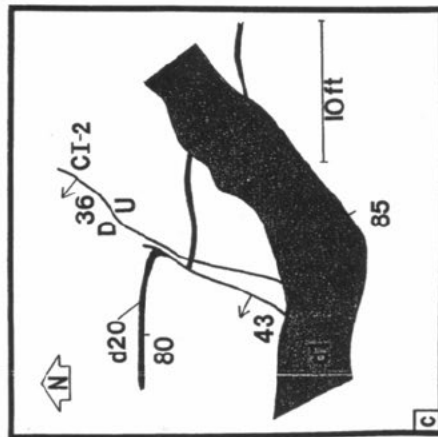
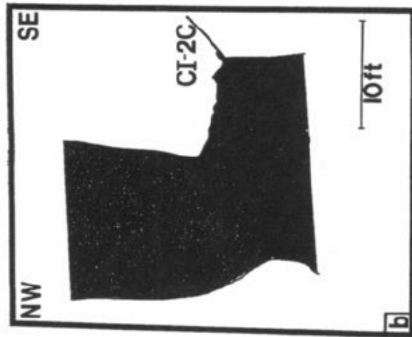
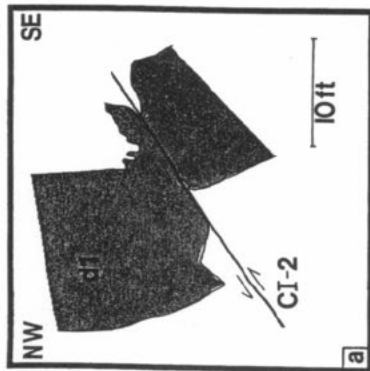
a. PROFILE SKETCH FROM THE NORTHEAST WALL OF E11. FAULT CI-2 DEFLECTS AND CROSS-CUTS BUT DOES NOT APPEAR TO DISPLACE DIKE d1. HOST ROCK IS THE NEWBURYPORT. b. PROFILE SKETCH FROM THE CWT'S EAST WALL ADJACENT TO THE CP. FAULT CI-20 DEFLECTS AND OFFSETS DIKE d1. APPARENT REVERSE MOTION SENSE RESULTS FROM DIKE FLOW DEFLECTION. HOST ROCK IS NEWBURYPORT. c. PLAN SKETCH FROM CWT SOUTH OF WPB. DIKE d1 CUTS DIKE d20. FAULT CI-2 OFFSETS AND DEFLECTS DIKE d20 AND ENDS AGAINST DIKE d1. HOST ROCK IS KITTEERY MIXED WITH SOME NEWBURYPORT.

SEABROOK STATION UPDATED FINAL SAFETY ANALYSIS REPORT	Sketches Detailing CI-2 and CI-2C	
		Figure 2.5-25

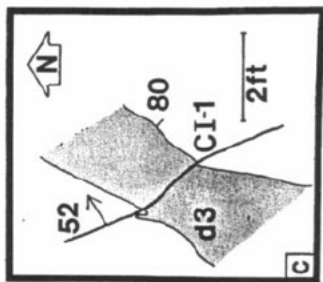
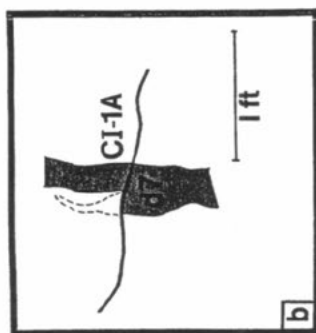
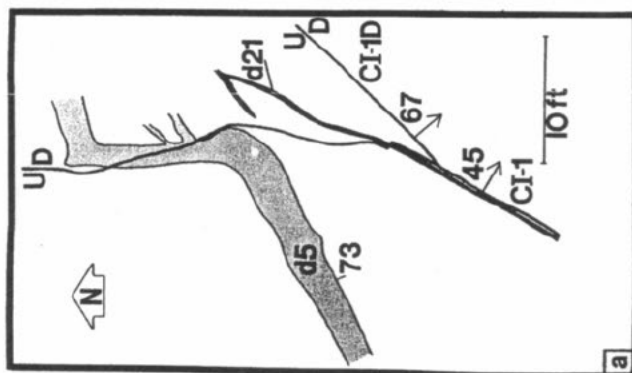
a. PLAN SKETCH FROM NORTHEAST QUADRANT OF CI AND ADJACENT EFFBI. DIKE d21 CROSS-CUTS FAULT CI-1. FAULT CI-1 DEFLECTS DIKE d5 AND TRENDS THROUGH THE DEFLECTED SEGMENT AS A TIGHT, NARROW FRACTURE, BUT DOES NOT OFFSET DIKE CONTACTS. FAULT CI-1D SPLAYS FROM CI-1. HOST ROCK IS NEWBURYPORT. b. FAULT CI-1A DEFLECTS DIKE d7 AND TRENDS THROUGH THAT DIKE AS A NARROW FRACTURE, BUT DOES NOT OFFSET DIKE CONTACTS. THE VUGGY CRACK ADJACENT TO THE d7 IS THE REMNANT OF THE ABANDONED DIKE PATH. HOST ROCK IS NEWBURYPORT. c. PLAN SKETCH FROM RI. FAULT CI-1 CUTS DIKE d3, OFFSETTING ONE DIKE CONTACT BUT APPARENTLY ONLY DEFLECTING AND NOT OFFSETTING THE OTHER CONTACT.

SEABROOK STATION UPDATED FINAL SAFETY ANALYSIS REPORT	Sketches Detailing CI-1, CI-1A and CI-1D	
		Figure 2.5-26

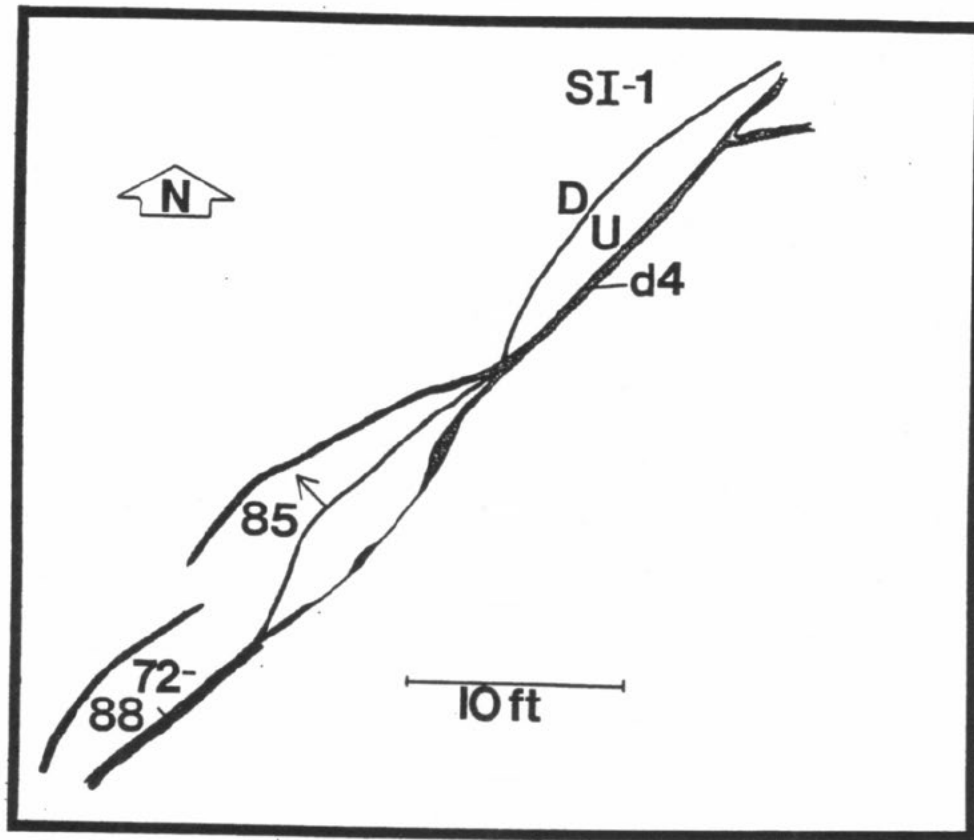
PLAN SKETCH FROM ESFPCI. DIKE d4 BOTH CROSS-CUTS AND WAS CHanneled ALONG FAULT SI-1. HOST ROCK IS NEWBURYPORT.

SEABROOK STATION UPDATED FINAL SAFETY ANALYSIS REPORT	Sketches Detailing SI-1	
		Figure 2.5-27

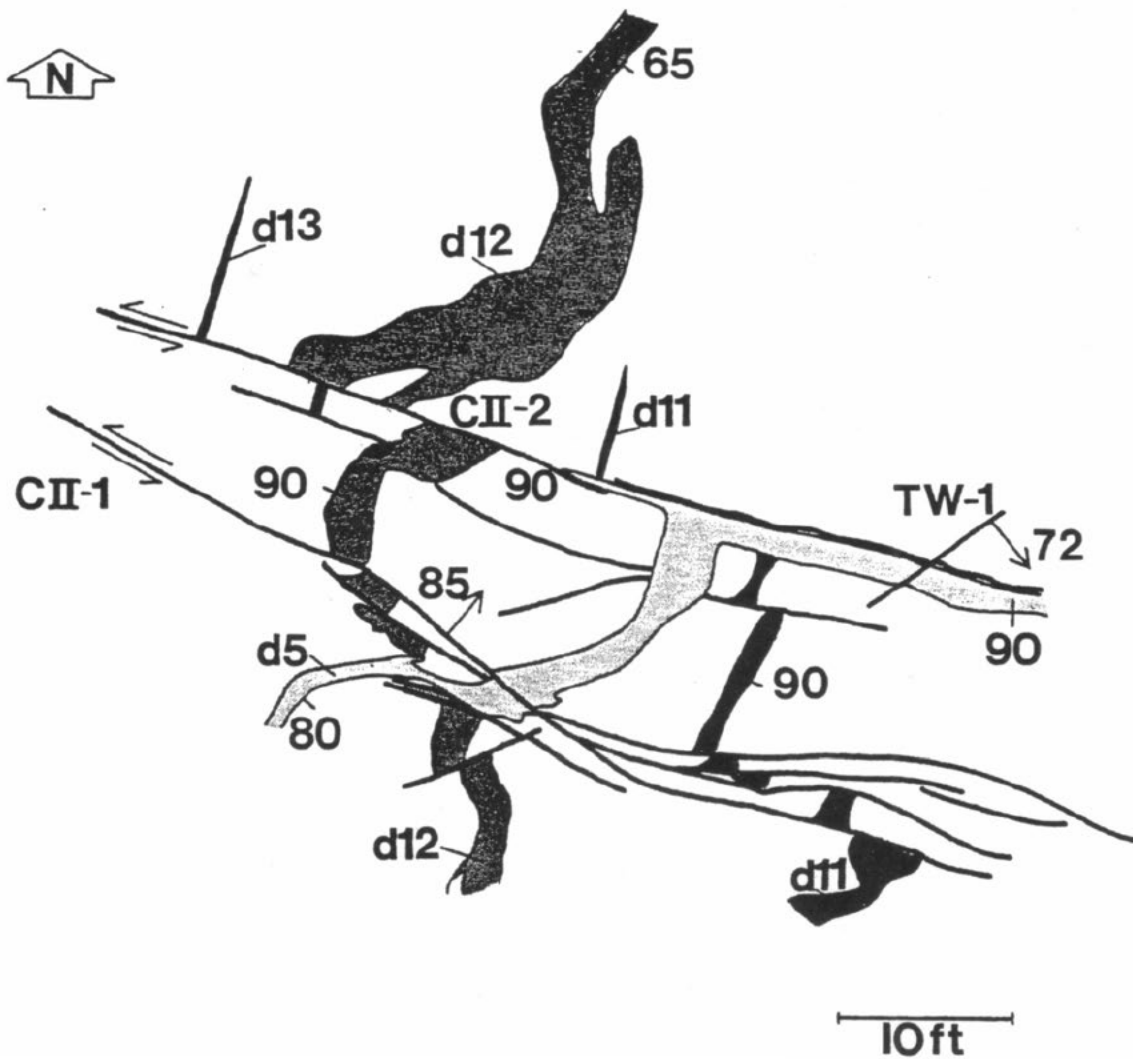
PLAN SKETCH FROM TWII. FAULT CII-1 OFFSETS DIKES d11, d12, d13, AND d5. FAULT CII-2 OFFSETS DIKES d11, d12, AND d13. FAULT TW-1 OFFSETS DIKE d5 AND FAULT CII-2. DIKE d5 CROSS-CUTS CII-2 AND PARTIALLY CROSS-CUTS CII-1. HOST ROCK IS KITTEERY WITH MINOR NEWBURYPORT.

SEABROOK STATION UPDATED FINAL SAFETY ANALYSIS REPORT	Sketches Detailing CII-1, CII-2 and TW-1	
		Figure 2.5-28

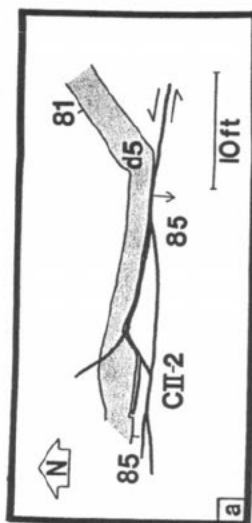
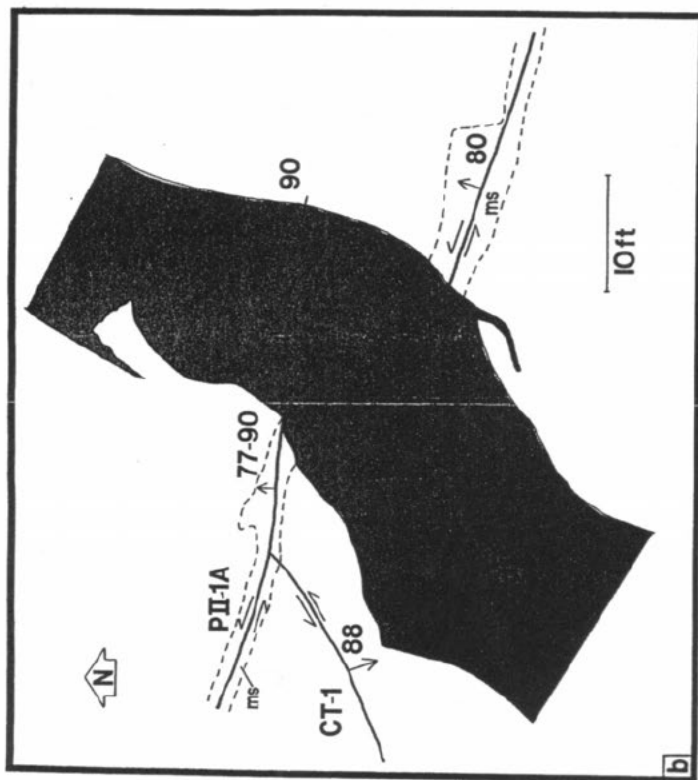
8. PLAN SKETCH FROM JUST WEST OF EFPBII. DIKE d5 TURNS AT AND IS CHANNELLED ALONG FAULT CII-2. HOST ROCK IS KITTEERY WITH SUBSTANTIAL NEWBURYPORT. b. PLAN SKETCH FROM SWT AT NORTH SIDE OF CT. DIKE d1 CROSS-CUTS FAULT PII-1A WITH VERY MINOR FRACTURING AT THE DIKE'S SOUTHEAST CONTACT. FAULT CT-2 ENDS AGAINST PII-1A. HOST ROCK IS MOSTLY NEWBURYPORT WITH KITTEERY (ms) AS SHOWN.

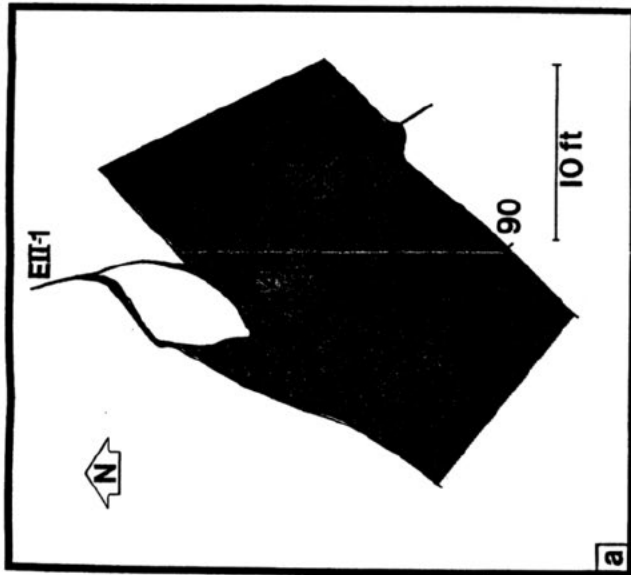
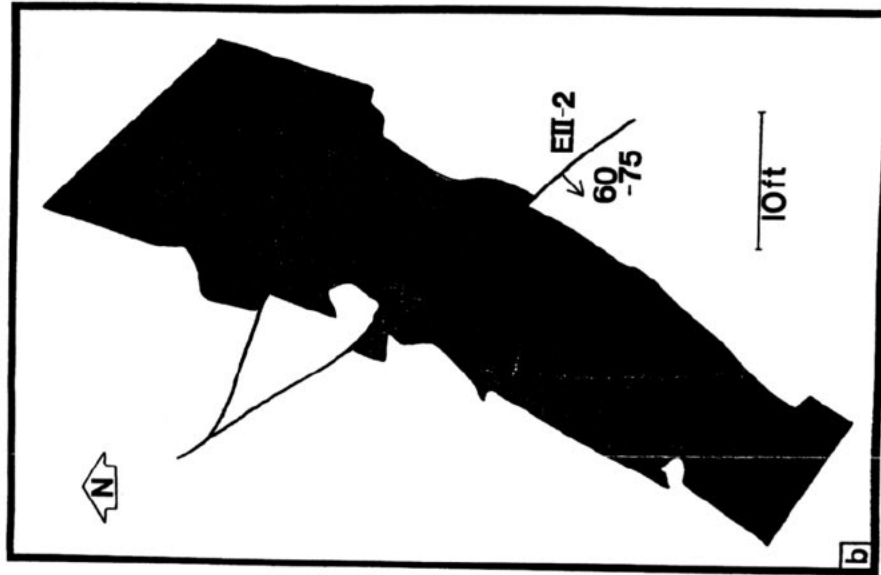
a. PLAN SKETCH FROM SWT NORTHEAST OF CT. FAULT EII-1 CROSS-CUTS DIKE d1. DEFLECTION OF DIKE CONTACTS PREVENTS PRECISE DEFINITION OF DISPLACEMENT. CONTRARY TO APPARENT MOTION OF EII-1 (NORMAL-RIGHT-LATERAL) ON OFFSET COOLING JOINT SUGGESTS REVERSE OR LEFT-LATERAL MOTION. HOST ROCK IS NEWBURYPORT.

b. PLAN SKETCH FROM SWT SOUTHEAST OF WPB. FAULT EII-2 OFFSETS DIKE d1.

SEABROOK STATION UPDATED FINAL SAFETY ANALYSIS REPORT	Sketches Detailing EII-1 and EII-2	
		Figure 2.5-30

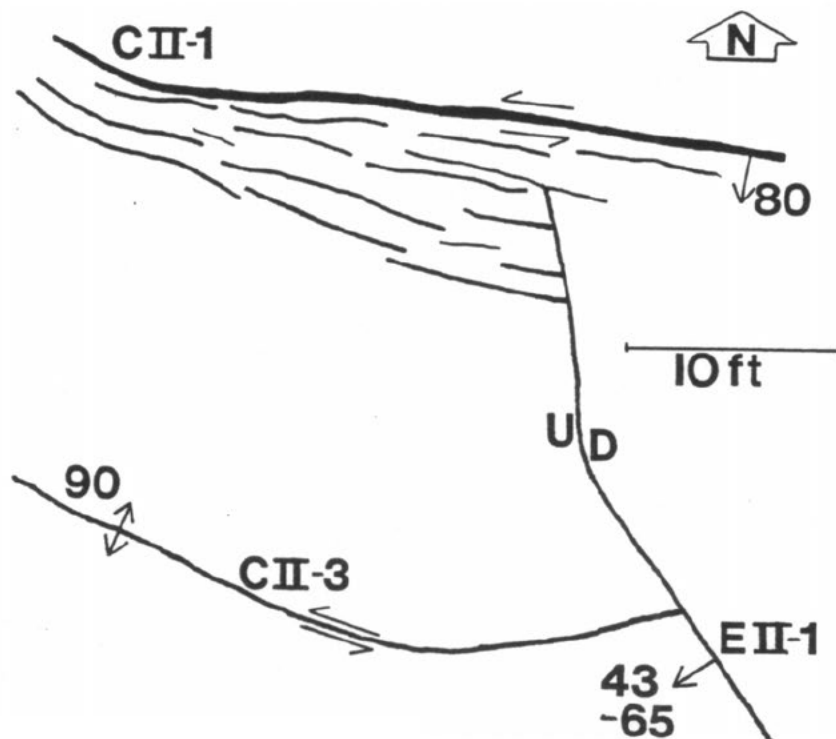
PLAN SKETCH FROM SOUTHEAST OF CII. FAULT CII-1 OFFSETS FAULT EII-1. THE CONTINUATION OF EII-1 EMERGES FROM CII-1 TO THE WEST; EII-1, HOWEVER, DOES PARTIALLY CROSS-CUT PART OF THE ZONE REPRESENTING THE MORE ANCIENT MOTION ON CII-1. CII-3 ENDS AGAINST EII-1. ROCK IS KITTERY WITH MINOR NEWBURYPORT.

SEABROOK STATION UPDATED FINAL SAFETY ANALYSIS REPORT	Sketch Detailing CII-1, CII-3 and EII-1	
		Figure 2.5-31

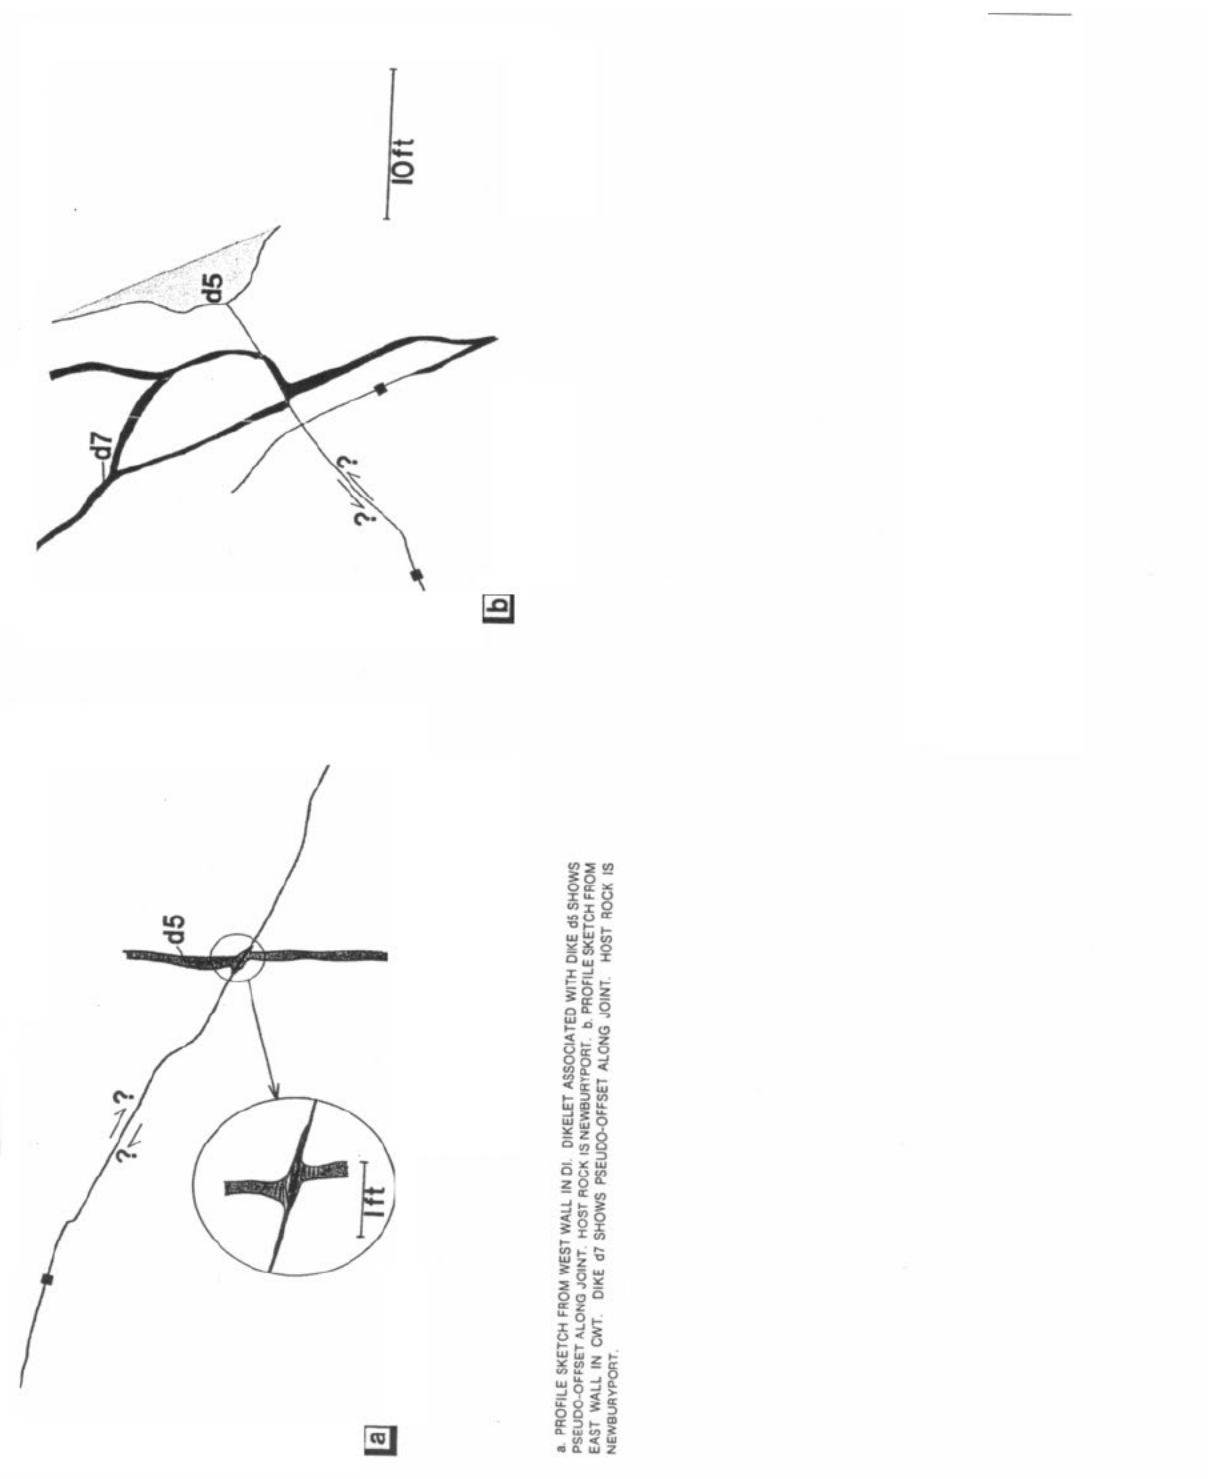
a. PROFILE SKETCH FROM WEST WALL IN DI. DIKELET ASSOCIATED WITH DIKE d5 SHOWS PSEUDO-OFFSET ALONG JOINT. HOST ROCK IS NEWBURYPORT. b. PROFILE SKETCH FROM EAST WALL IN CWT. DIKE d7 SHOWS PSEUDO-OFFSET ALONG JOINT. HOST ROCK IS NEWBURYPORT.

SEABROOK STATION UPDATED FINAL SAFETY ANALYSIS REPORT	Sketch Detailing Pseudo-Offset of Dikes	
		Figure 2.5-32

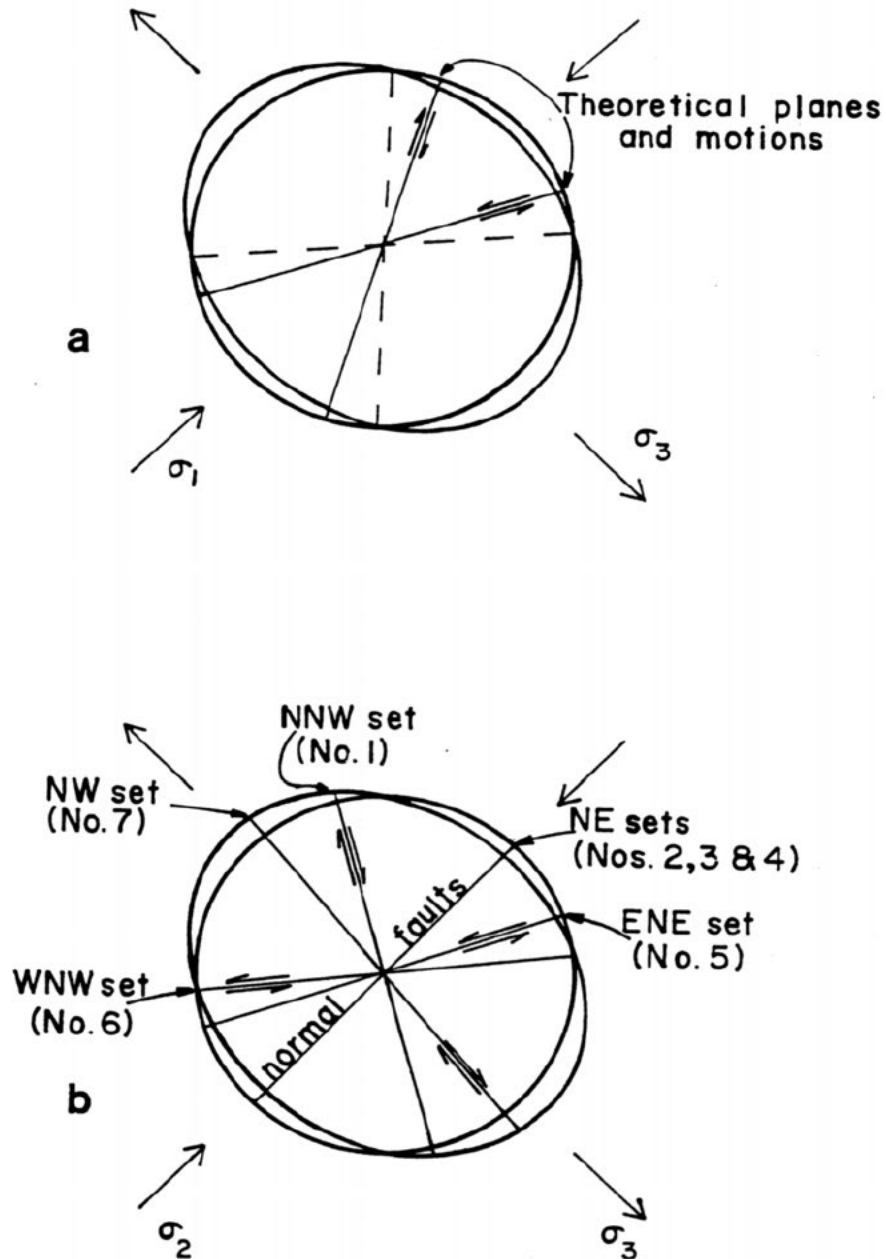
a. FAILURE PLANES AND MOTIONS AS PREDICTED BY "STRAIN THEORY" (BADGLEY, 1962) FOR NW-SE TENSIONAL STRESS FIELD. b. ACTUAL FAULT PLANES WITH LATERAL MOTION COMPONENTS OBSERVED IN SITE EXCAVATIONS. OBSERVED MOTIONS CONFORM TO PREDICTIONS IN a. FAULT MOTIONS AND INTRUSION OF NE-TRENDING DIKES ARE BOTH CONSISTENT WITH A NW-SE TENSIONAL STRESS.

SEABROOK STATION UPDATED FINAL SAFETY ANALYSIS REPORT	Strain Ellipsoid for NW-SE Tensional Stress	
		Figure 2.5-33

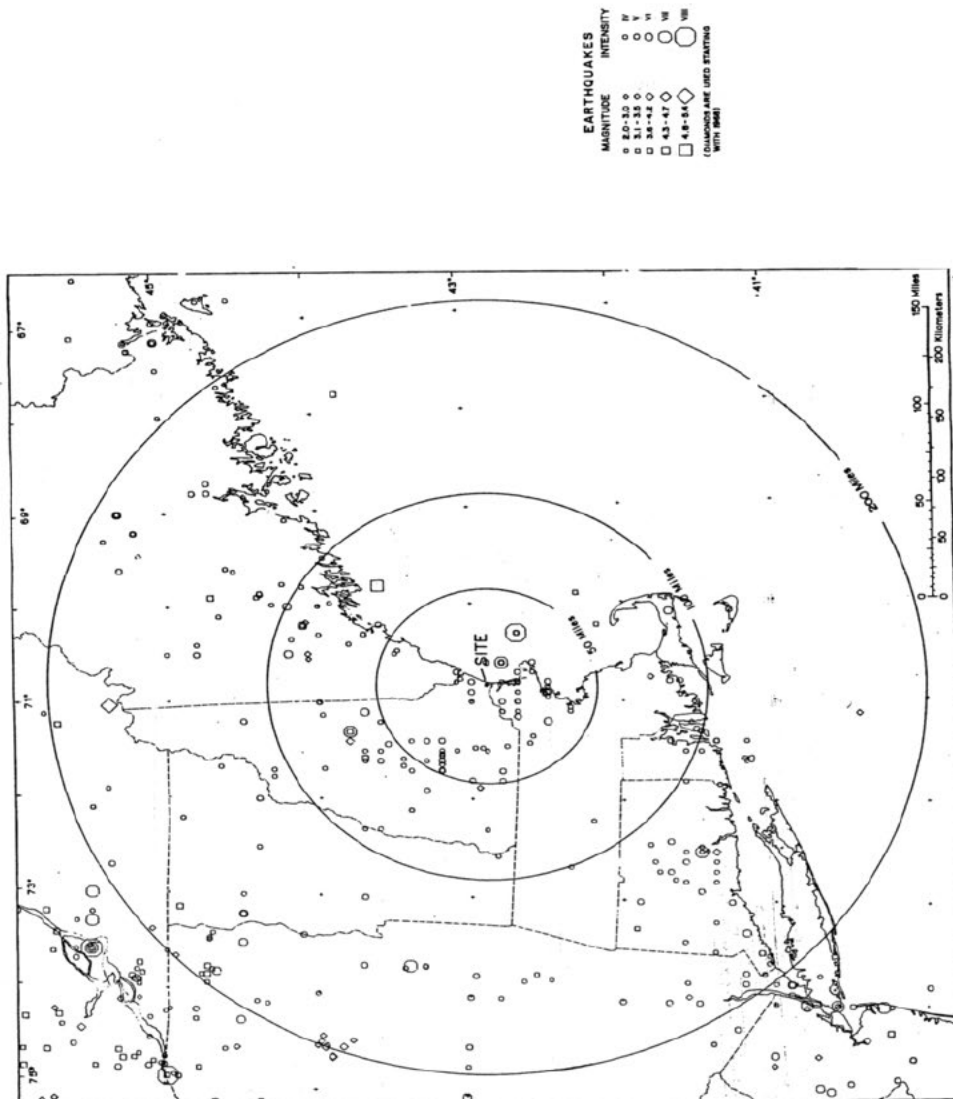
SEABROOK STATION UPDATED FINAL SAFETY ANALYSIS REPORT	Cumulative Seismicity Map	
		Figure 2.5-34
