SEABROOK STATION  
UPDATED FINAL SAFETY  
ANALYSIS REPORT

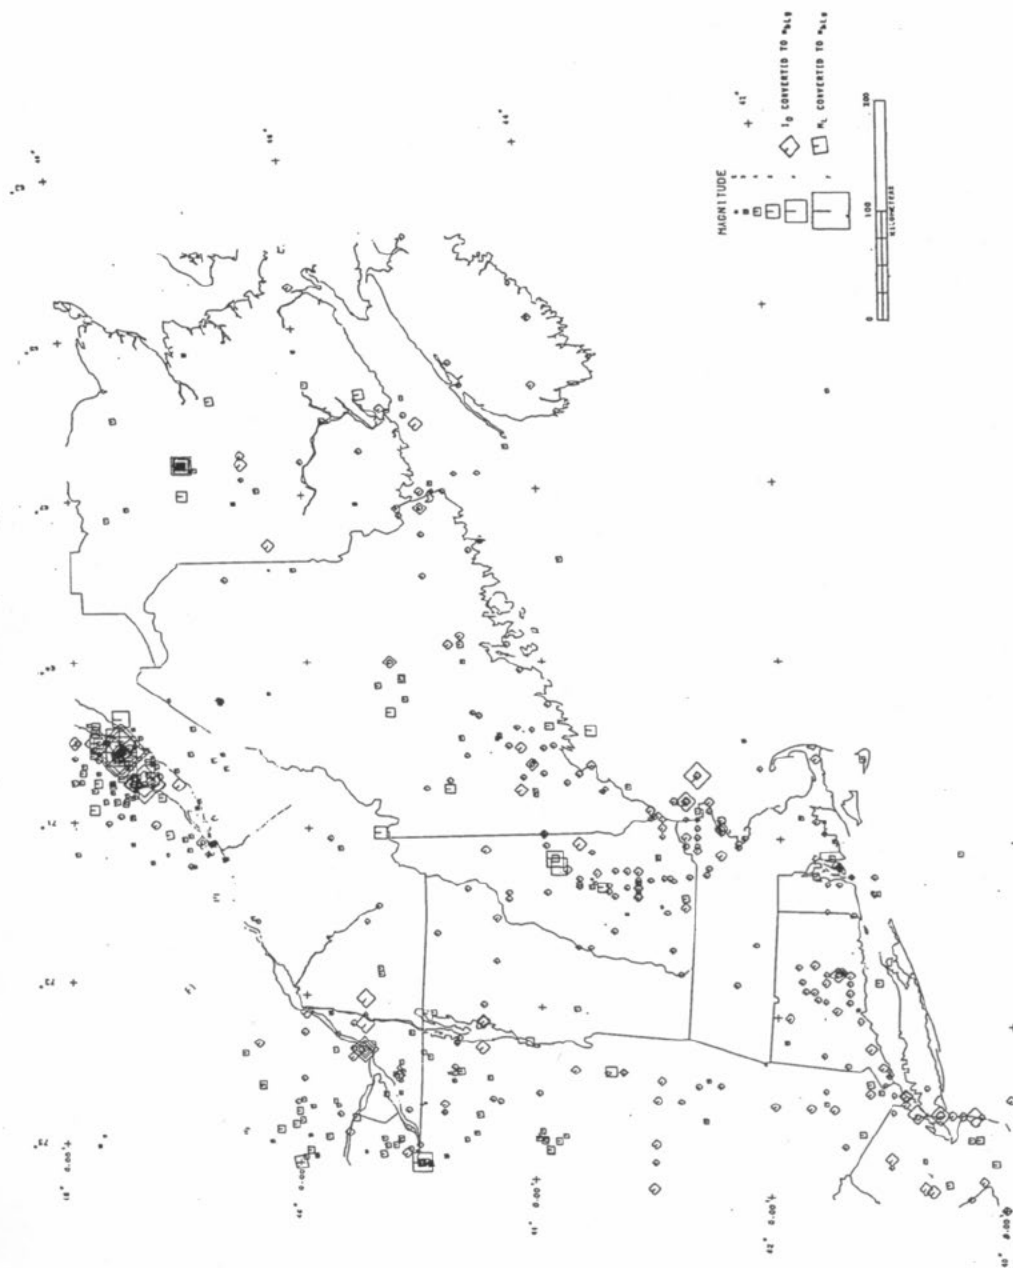
SEABROOK STATION UPDATED FINAL SAFETY ANALYSIS REPORT	Regional Seismicity Map	
		Figure 2.5-35

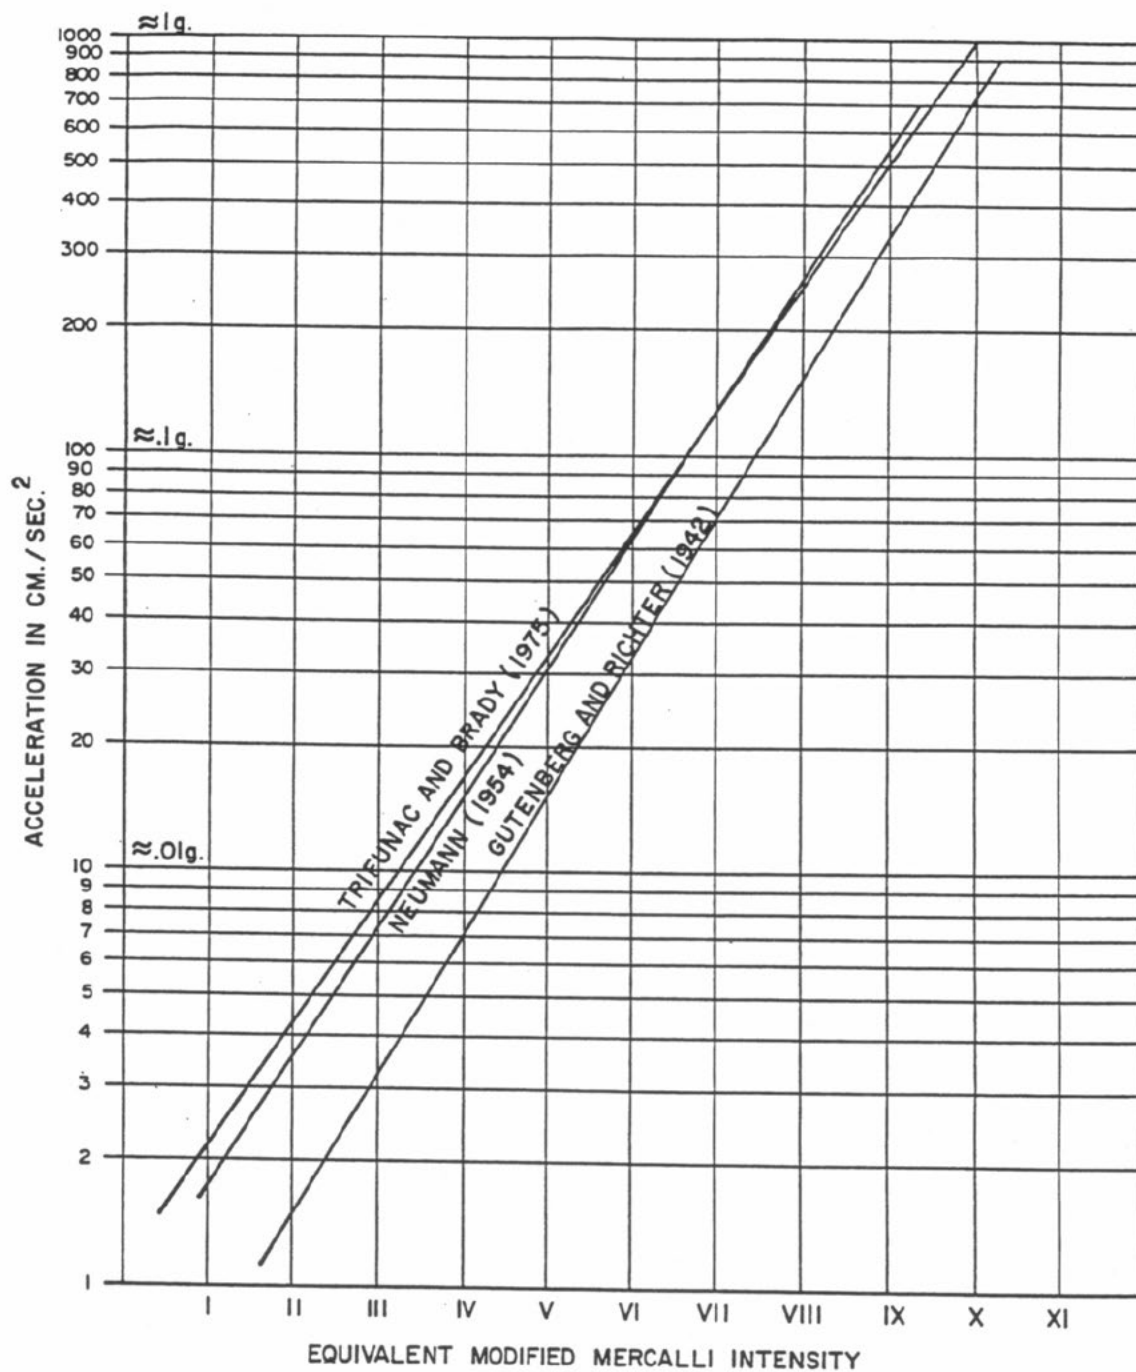
Figure 2.5-42

Intensity-Acceleration Relationship

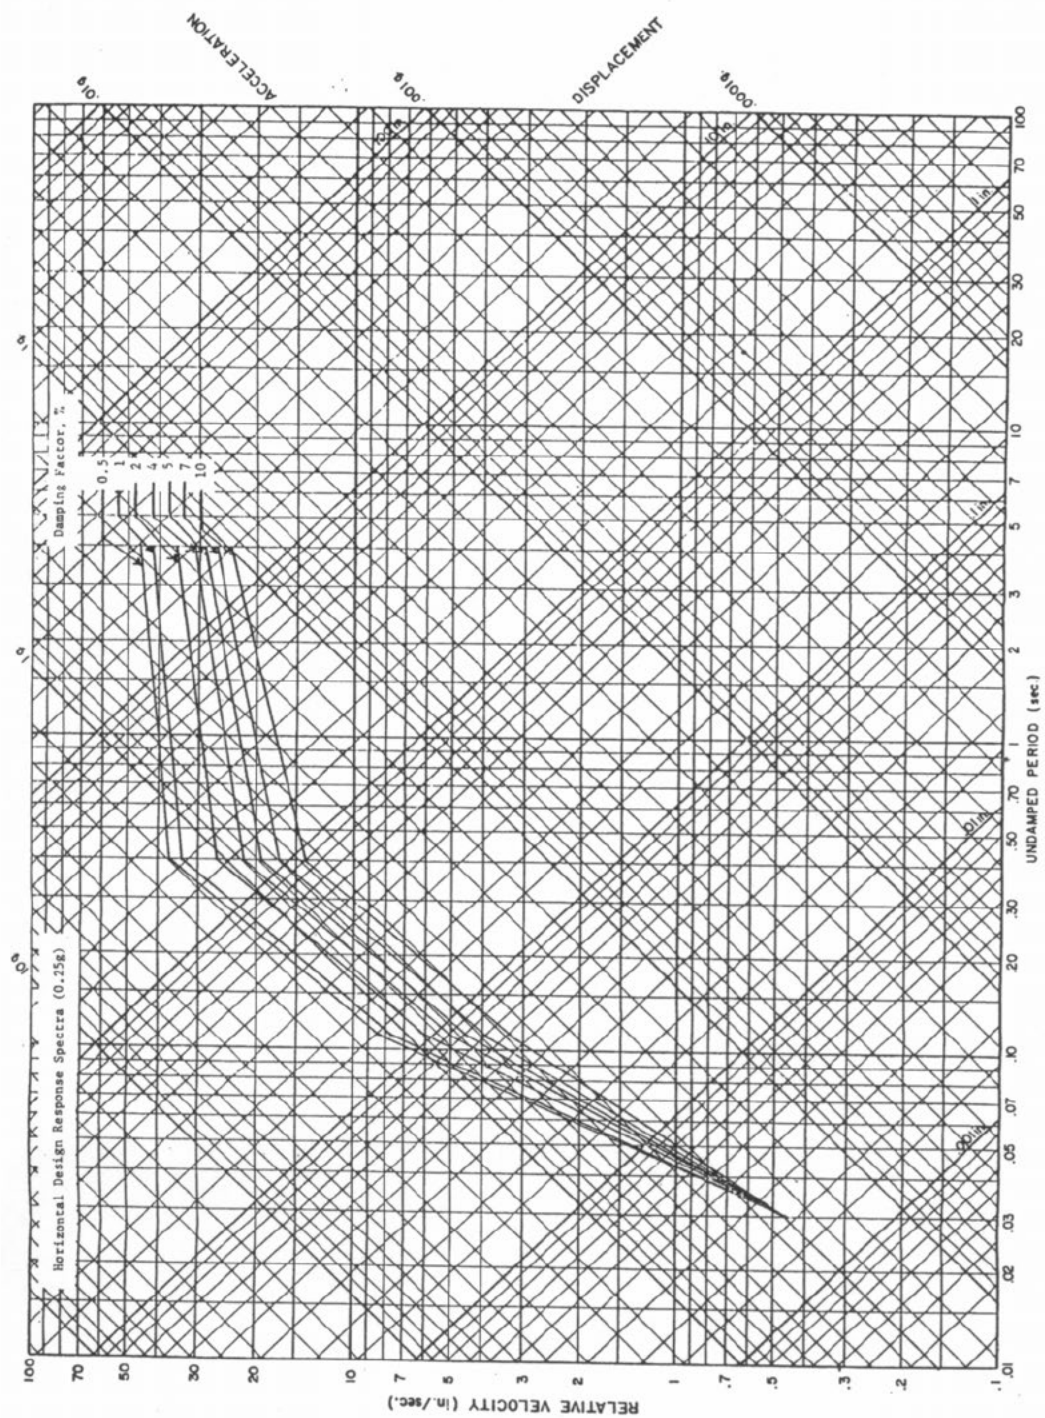
Figure 2.5-43

Safe Shutdown Earthquake Design Response Spectra,  
Horizontal Motion

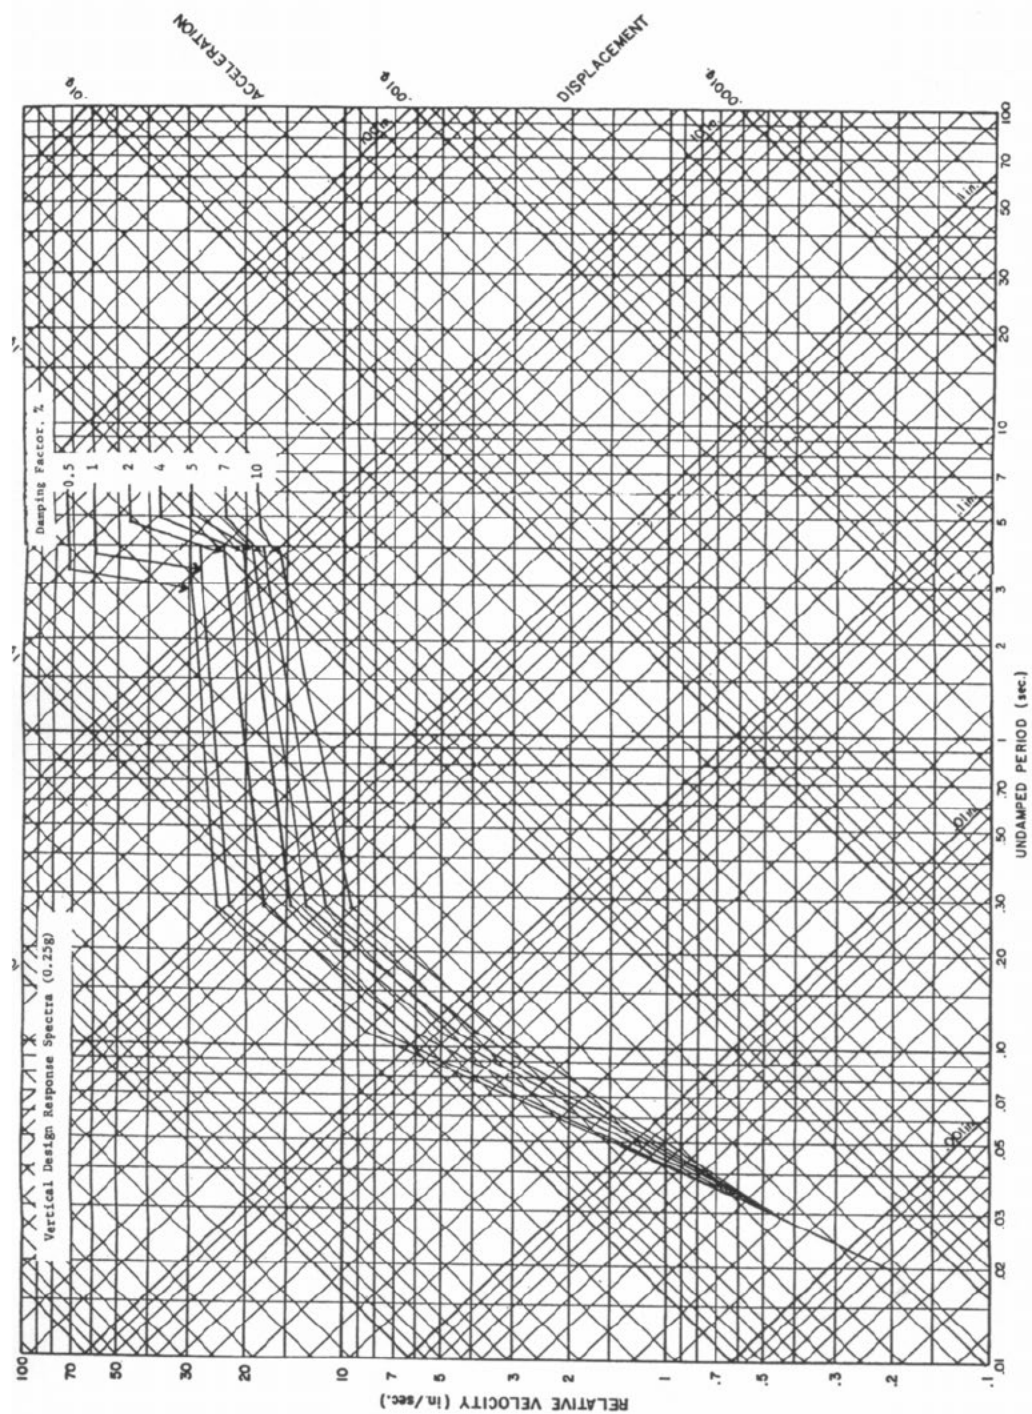
Safe Shutdown Earthquake Design Response Spectra,  
Vertical Motion

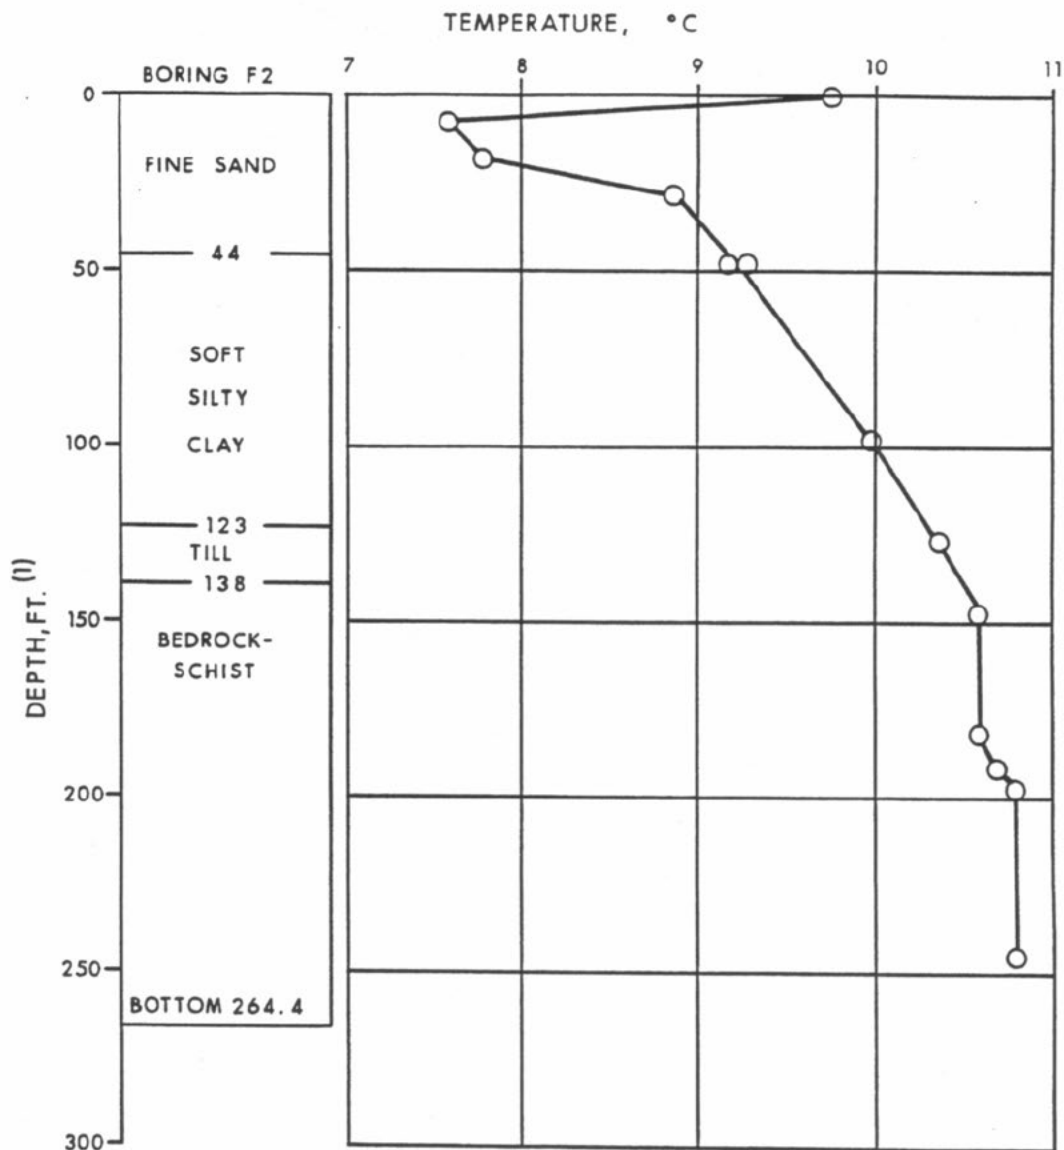
NOTE: DATA RECORDED MAY 16, 1973 ON DAY AFTER DRILLING OF BOREHOLE WAS COMPLETED.

(1) GROUND ELEVATION = -1.4 (MSL=0)

SEABROOK STATION  
UPDATED FINAL SAFETY  
ANALYSIS REPORT

In Situ Temperature vs. Depth, Boring F2

Figure 2.5-45

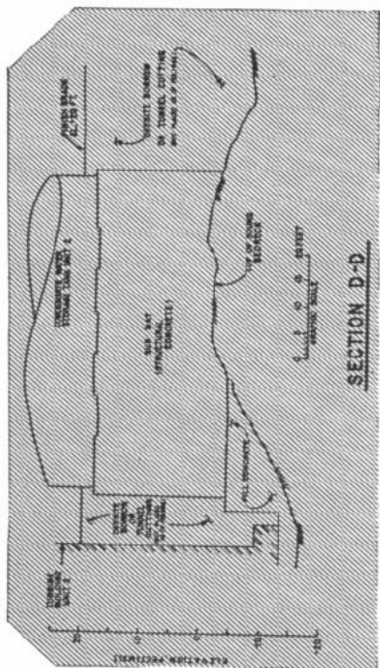
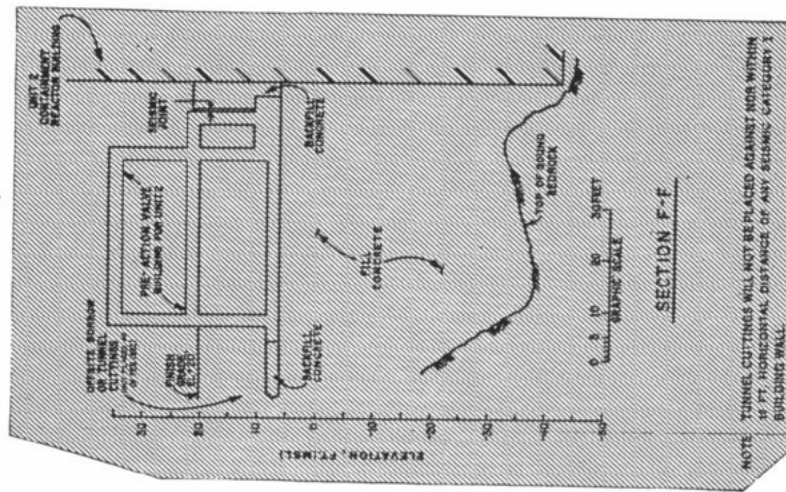
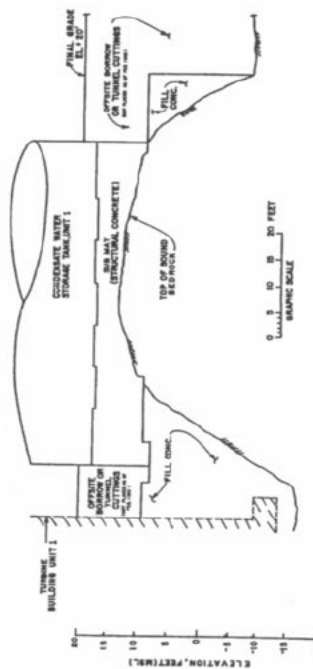
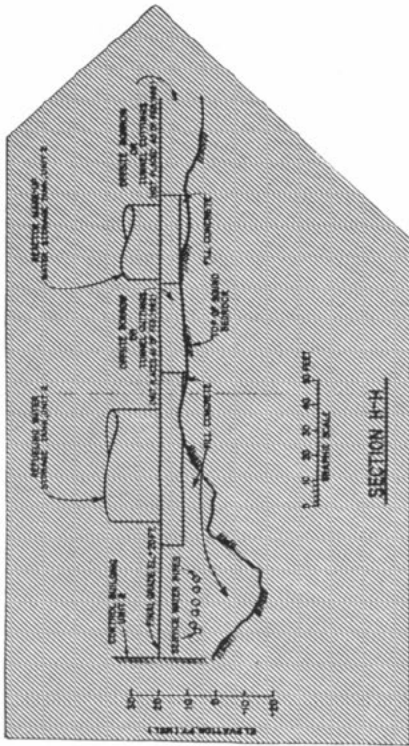
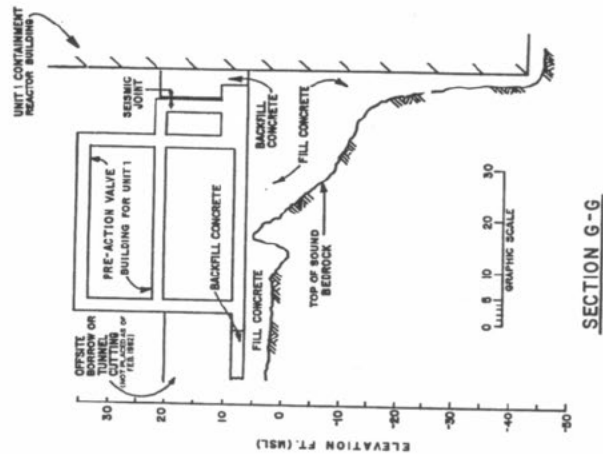
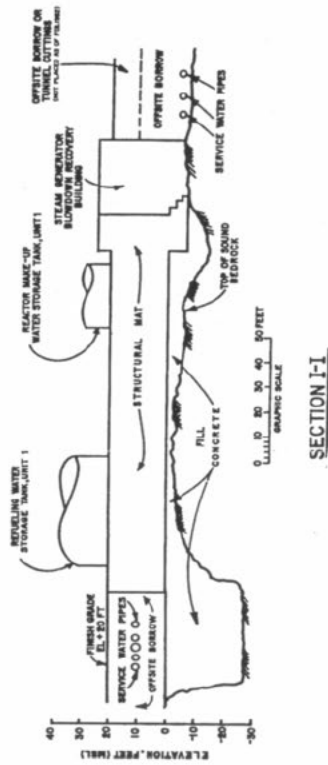
NOTE: TUNNEL CUTTINGS WILL NOT BE PLACED AGAINST NOR WITHIN 10 FT. HORIZONTAL DISTANCE OF ANY SEISMIC CATEGORY I BUILDING WALL.
