USBR HL-2019-01

EROSION TESTING OF ZONED ROCKFILL EMBANKMENTS

Date Published: September 2021

U.S. Department of the Interior
Bureau of Reclamation
Technical Service Center
Hydraulic Investigations and Laboratory Services Group
Denver Colorado

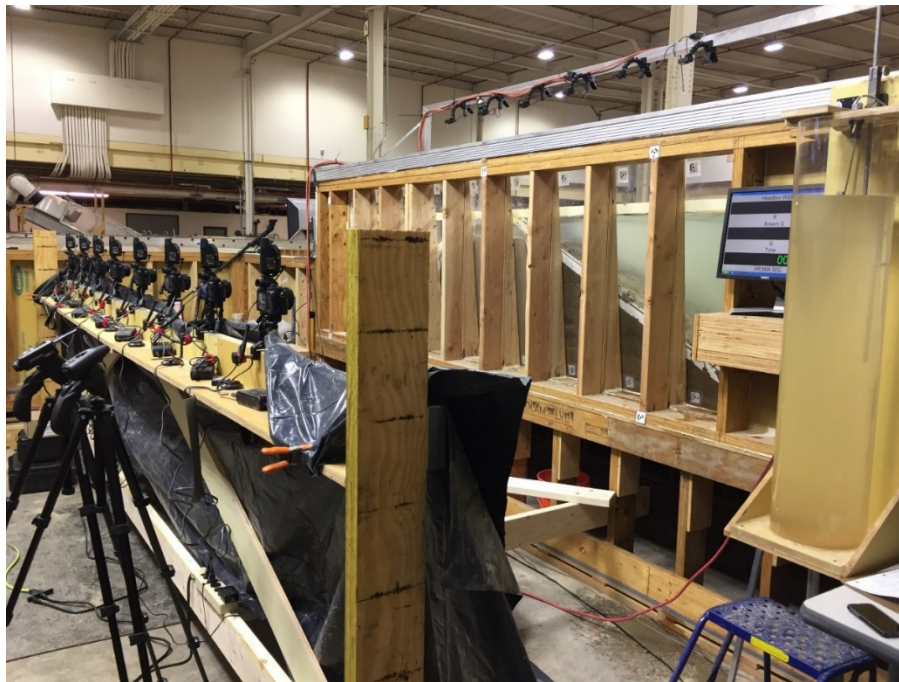
Figure 2-3 Camera equipment used during the test included six GoPro cameras deployed above the embankment and eight DSLR cameras viewing the left abutment through the acrylic wall.

Two arrays of still photo cameras were used to record images of the erosion taking place at the left abutment of the embankment test section and on the upstream and downstream surfaces of the embankments (Figure 2-3). Eight digital single lens reflex (DSLR) cameras were set up to take overlapping photos through the acrylic abutment wall, and 6 GoPro video/still cameras were positioned overhead to obtain overlapping photos of the surface of the left end of the embankment. Each camera's field of view included photogrammetry targets to enable subsequent image analysis. Picture rates were adjusted as needed during the various tests, with intervals varying from 10 seconds up to 5 minutes. Following the completion of the tests, images were processed to create time-lapse imagery and models of the erosion progress.

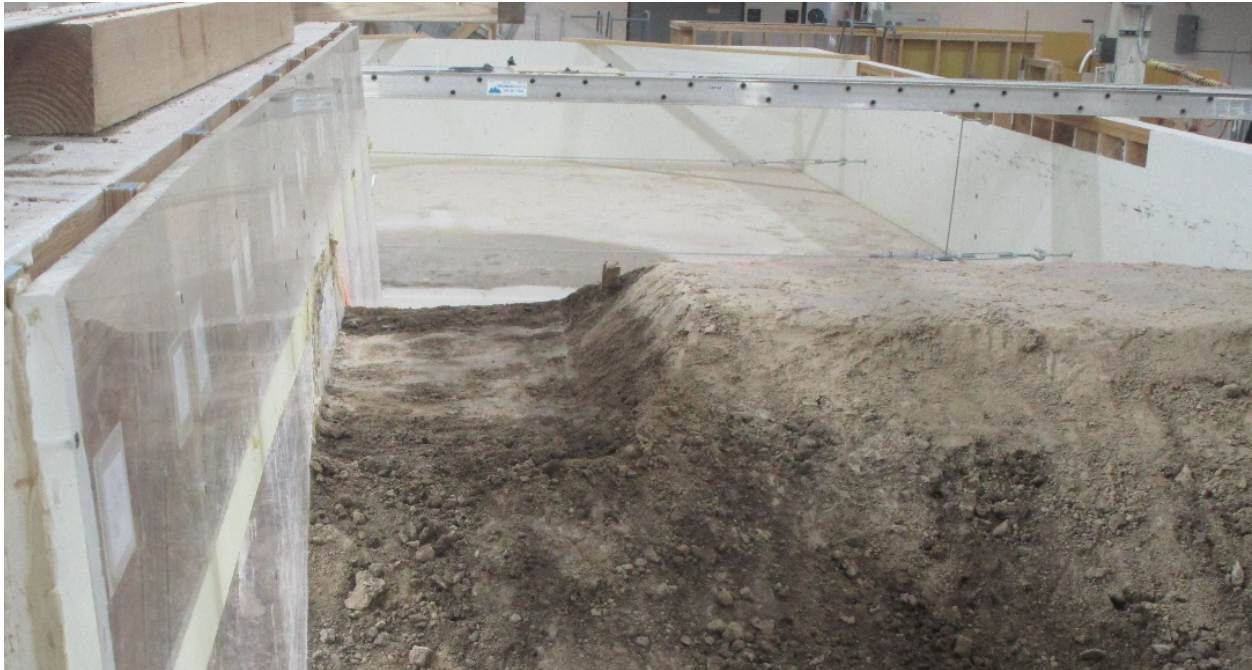
Figure 2-7 Pilot channel in zoned embankment prior to overtopping test.

For the overtopping test, a pilot channel was cut at the left abutment after the embankment was finished (Figure 2-7). The pilot channel was excavated to a depth of 5 inches (13 cm) and a base width of 15 inches (38 cm) with a 1:1 side slope on the embankment side. The invert of the pilot channel had segments of the core zone and the gravel zones exposed within it.

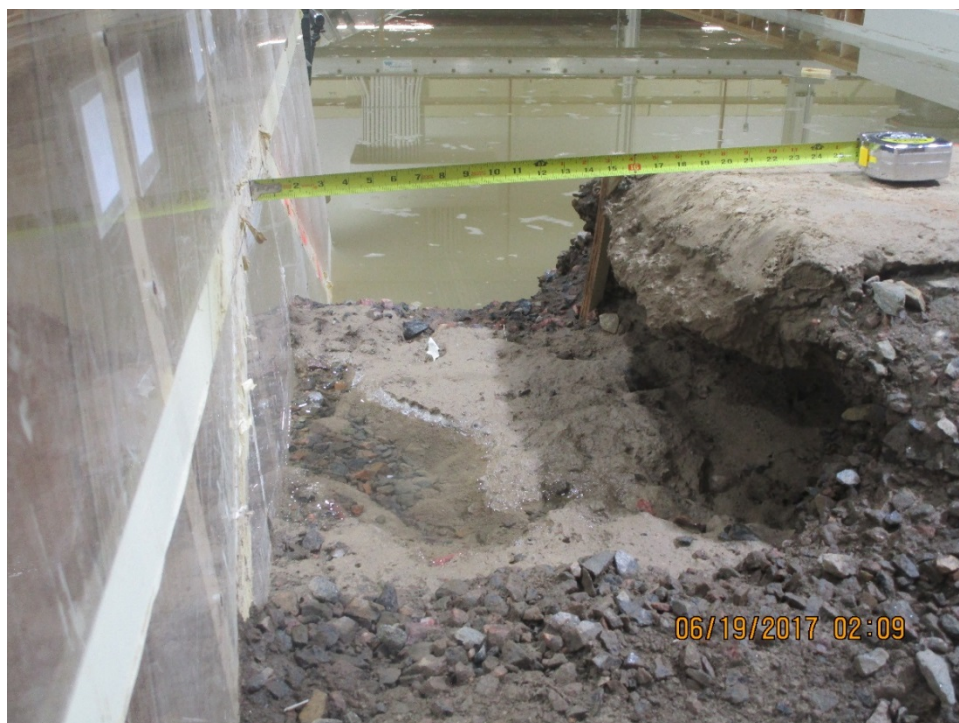
Figure 4-2 Breach pilot channel at the end of the first day of testing. Note the embedded wood stake that appeared to restrict lateral erosion.

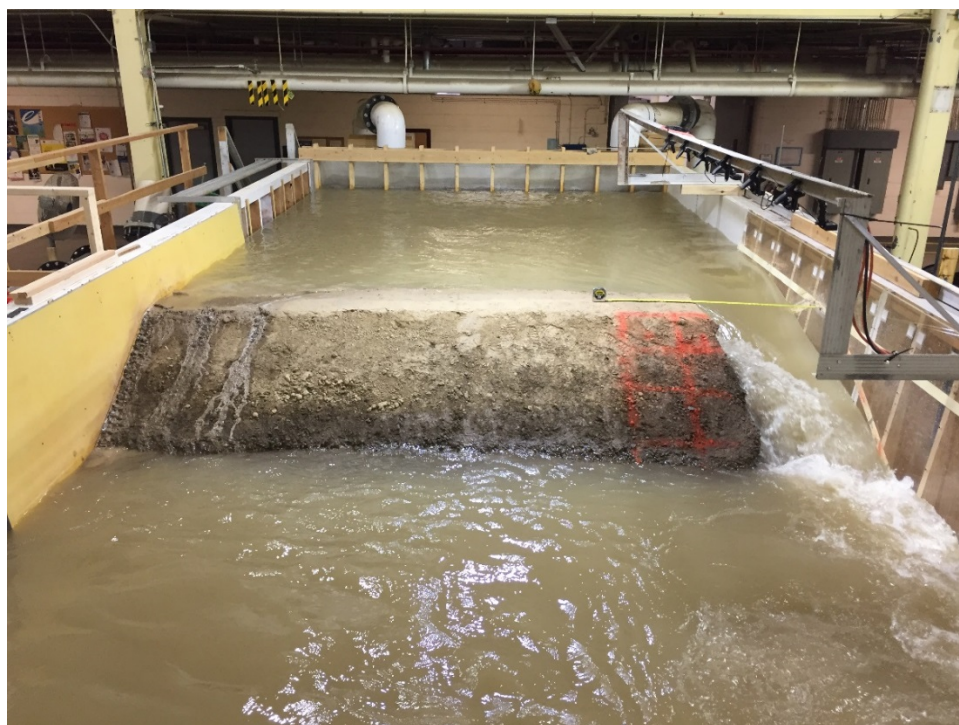
Figure 4-3 Flow conditions through the breach channel near the end of the zoned embankment overtopping test (t=2 hr 56 min).

The widening of the pilot channel appeared to some degree to be driven by flow contraction taking place at the entrance of the pilot channel and then the creation of horizontal recirculation zones immediately downstream from the pilot channel entrance. These horizontal eddies worked on the soil at the edges of the pilot channel, causing the pilot channel to widen, often at a rate that exceeded the deepening of the pilot channel. As the test progressed, an overhang began to form, with soil above the water surface hanging over areas that had eroded and widened. Eventually this overhanging soil broke off like a cantilevered beam and fell into the channel. Widening of the channel downstream from the crest was significant in the first 33 minutes of flow on the first day of testing, with the channel growing from about 15 to 24 inches wide (38 to 61 cm). Widening of the pilot channel during the first day was restricted somewhat by a wood stake that was embedded in the downstream edge of the embankment crest during construction (to hold a board separating zones as soil was initially placed) and accidentally left in place (Figure 4-2). This stake was removed before flow was resumed on the second day. As a result, the pilot channel width grew more rapidly for a short time during the second day of testing, but overall the width of the downstream channel grew slowly during the second day. Figure 4-3 shows the flow conditions just before the test was ended.

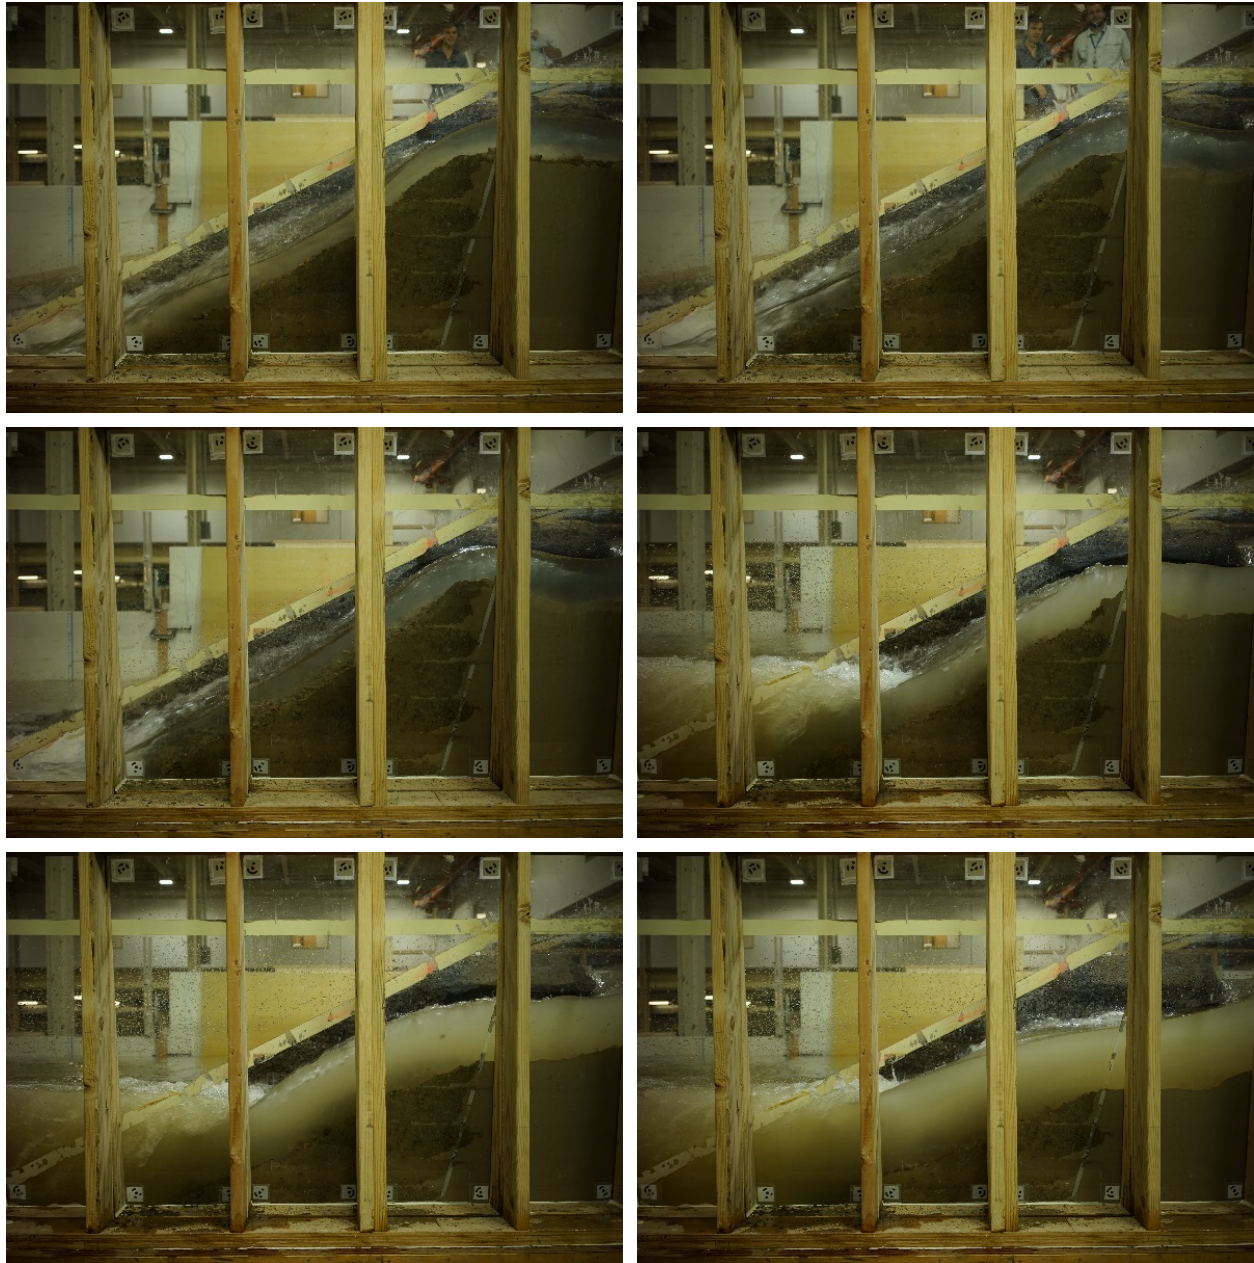
Figure 4-6 Photos of breach channel downward erosion progress on the second day of the zoned embankment overtopping test. Total elapsed times in minutes in the photos from left-to-right, top-to-bottom are: 34.5, 37, 47, 77, 120, 180.

Table 4-1 provides a summary of the data obtained from the photos shown in Figure 4-5 and Figure 4-6 from the first 3 hours of testing and the resulting k_d values. The k_d value at the end of each incremental time period was computed using the observed erosion during the preceding time interval and the average shear stress during that interval. Figure 4-7 shows the results graphically. The rate of erosion was rapid during the first 5 minutes of the test, but slowed dramatically thereafter. This was likely due to difficulty obtaining good compaction at the edge of the placement where there was no way to confine the soil. The highly erodible layer was about 6 inches (15 cm) thick. After the first few minutes, the flow depth was more difficult to determine from the photos due to turbulence, splashing, and aeration of the surface of the flow.

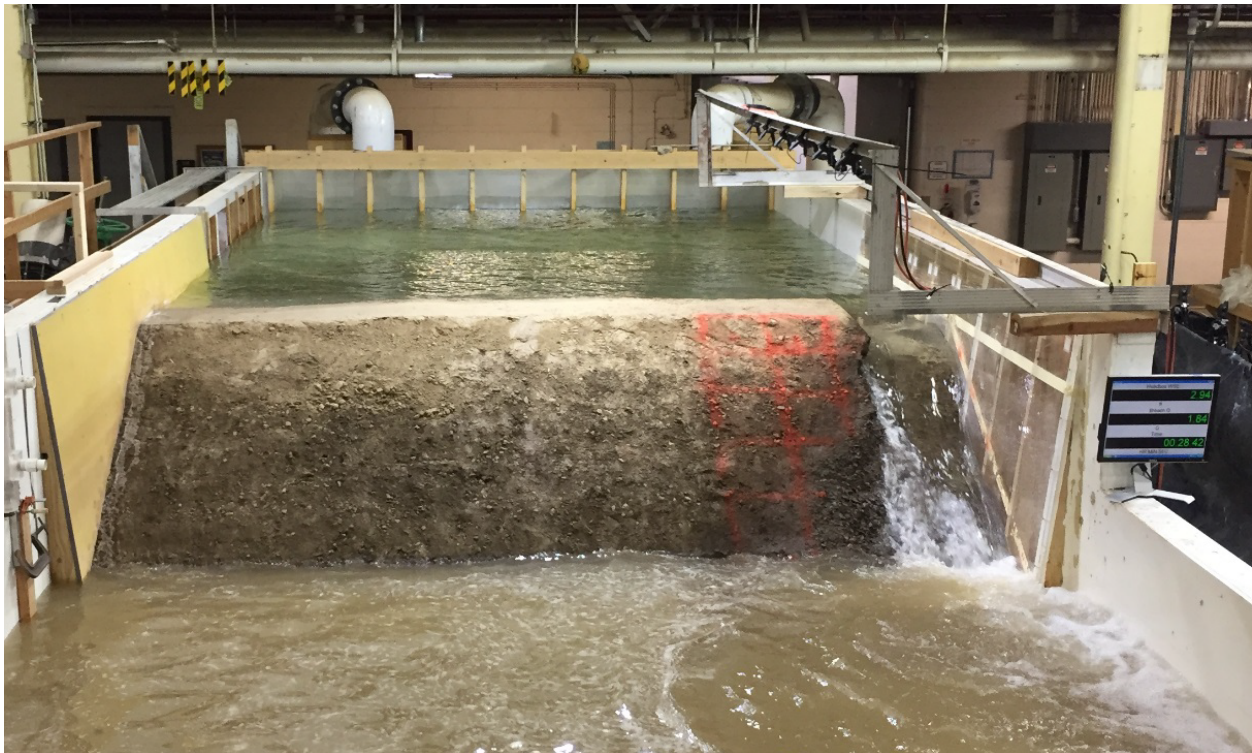
Figure 4-8 Downstream view of the breach channel 28 minutes after the start of overtopping flow. Vertical lines on the embankment face are at 1 ft (30.5 cm) intervals. Horizontal lines are at 0.5 ft (15.3 cm) elevation intervals.

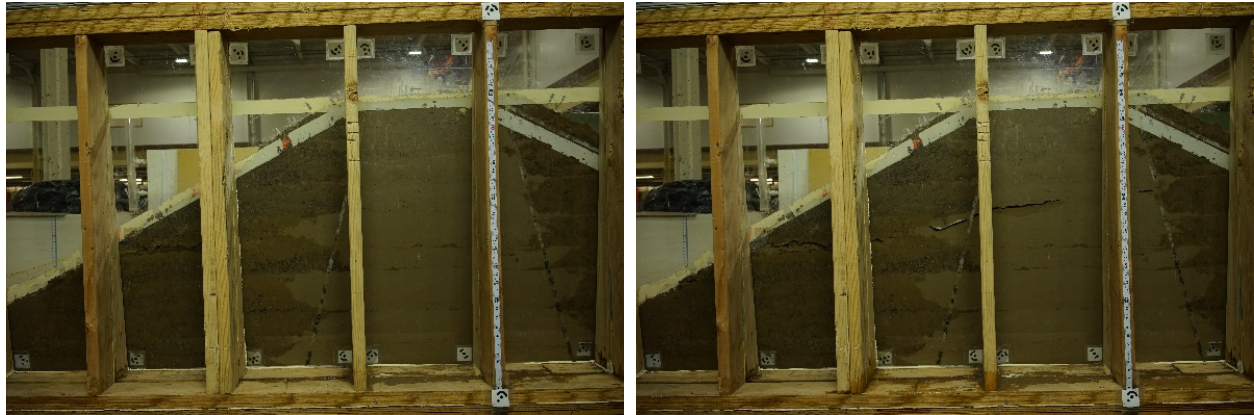
Figure 5-2 Pipe beginning to develop through embankment after removal of rebar on second day of testing. Elapsed times since the restart on the second day are 1 min (left) and 103 minutes (right). In the first photo the pipe is only visible in the downstream gravel zone. In the right hand photo, the color variation in the portion of the pipe within the core zone indicates redeposition of soil in the bottom of the pipe as erosion occurs from the roof.

removed. The initial process was consistent with what is typically described as concentrated leak erosion (USBR and USACE 2015). Figure 5-2 shows the upstream progress of erosion. The photos also show that there was not a perfect delineation of the zone boundaries as each lift was placed, but the straying of materials across the zone boundaries did not seem to affect the tests.

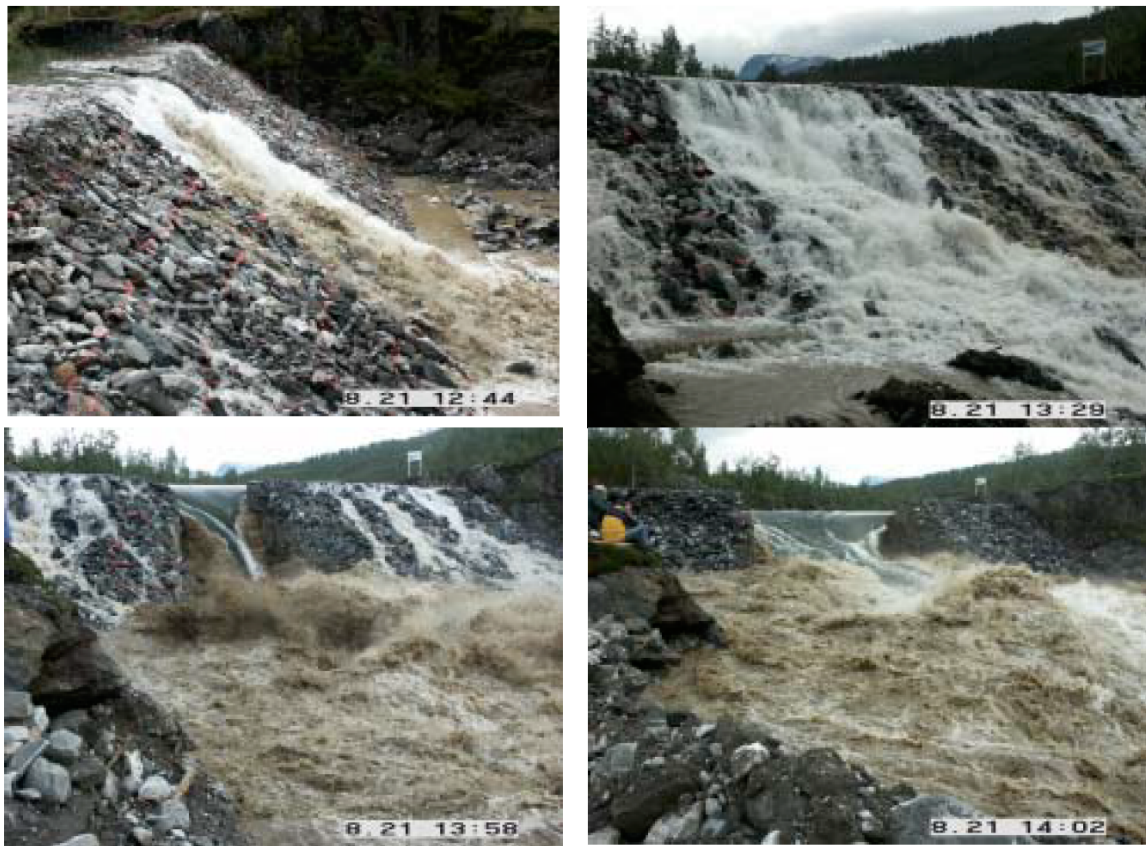
Figure 6-5 Headcut development during IMPACT test of zoned gravel dam, 1-2003 (from IMPACT WP2 Technical Report: Section 4).

Both of these tests demonstrated that broadly-graded rockfill materials can experience headcut erosion. The gravel zones of both embankments exhibited enough strength to stand at steep slopes and enough erosion resistance to avoid unraveling immediately under the initial surface flow. Although photos of the tests do not show a deep tailwater pool downstream of these embankments, it is likely that local tailwater developed quickly as materials eroded from the embankments were dropped a short distance downstream, creating a tailwater pool that could have enabled scour of the toe and creation of a vertical drop. In the test performed for the present study, the free overfall immediately downstream from the embankment did not support this kind of flow in the tailwater zone, which may partially explain why headcutting was not observed.
