## **Finding of No Significant Hazard**

In a license amendment request dated December 23, 2021, the NIST Center for Neutron Research (NCNR) requested an amendment to the facility license Technical Specifications (TS). As required by 10 CFR 50.91(a), the following analysis is presented to show the proposed amendment does not create a significant hazard using the criteria of 10 CFR 50.92(c).

### 3.9.2 Fuel Handling

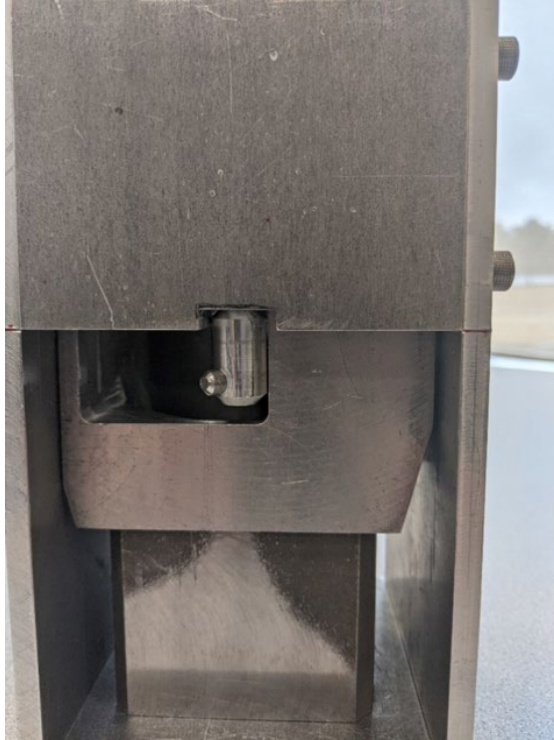
**Figure 1.** Fuel element head latched into a mockup of the upper grid plate.

Upon movement of a fuel element to its intended position in the core grid, the final mechanical manipulation is to push down on the fuel element head via the pickup tool and compress the spring on the head to move the latch to below the bottom of the upper grid. The tool is then rotated counterclockwise about 45° to its full stop position thus moving the latch underneath the notch in the upper grid. The tool is then raised slightly to release the spring, thus setting the latch into the notch. See Figure 1.

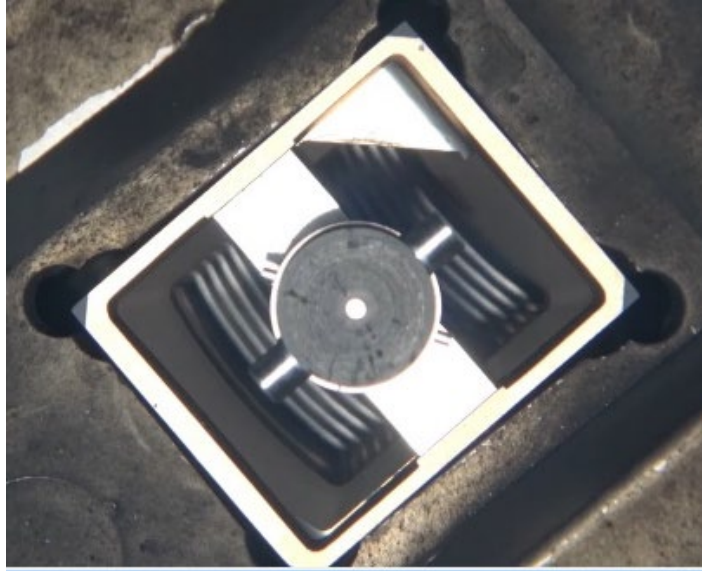
**Figure 4.** Video capture of element in latched position (core position I-6)

Photos of the video results of a test with a fully latched element in core position I-6 is shown in Figure 4. A photo of the H-7 element rotated about 6° off of full counterclockwise (the same as in Figure 3) is shown in Figure 5. The difference between the two can be easily seen, as the “ears” of the rotated element are clearly off perpendicular and would be rejected. Further rotation clockwise would also have the latch bar coming into view. As in the rotation check, evaluations are being made to clearly define acceptable visual check angle deviations.

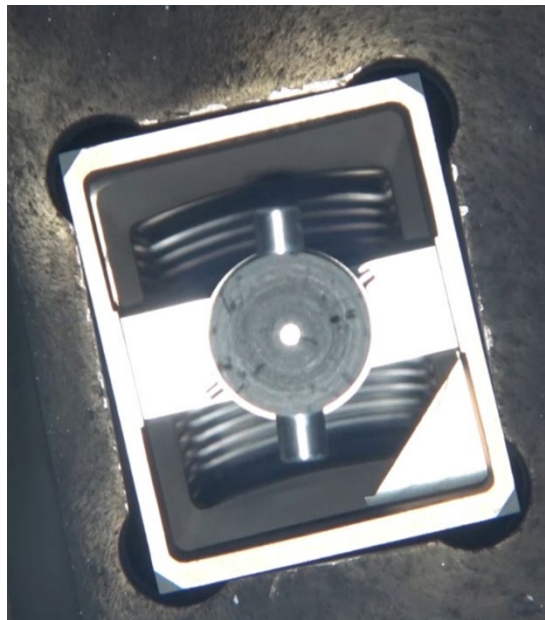
**Figure 5.** Video capture of element with latch rotated clockwise within the notch (core position H-7)
