Calvert Cliffs Nuclear Power Plant, Units 1 and 2
Renewed Facility Operating License Nos. DPR-53 and DPR-69
NRC Docket Nos. 50-317 and 50-318

Subject: Proposed Relief Request for Mitigation of Buried Saltwater Piping Degradation

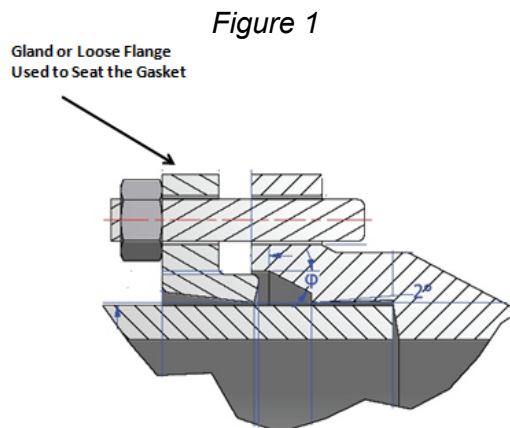
There are no approved methods or new technologies that provide an adequate method to weld ductile cast iron piping without adversely affecting the integrity of the base metal. The ductile cast iron Saltwater System underground piping contains bell and spigot pipe with fittings that connect to compress the joint gasket. This consists of a loose flange or gland that is slid over the spigot section of the pipe prior to insertion into the bell. Once inserted into the joint, bolting is installed between the gland and the integrally cast flange on the bell section of piping. The bolting is then tightened to seat the "V" wedge type gasket and thus provide a leak tight joint. Figure 1 below provides the general configuration of an ANSI/AWWA A21.10/C110 style joint.

Repairs and modifications to ductile cast iron pipe must use similar methods of mechanical compression for connectivity. In some cases, threaded joints may also be utilized.
