Steam Generator Task Force/NRC Meeting

March 3, 2022

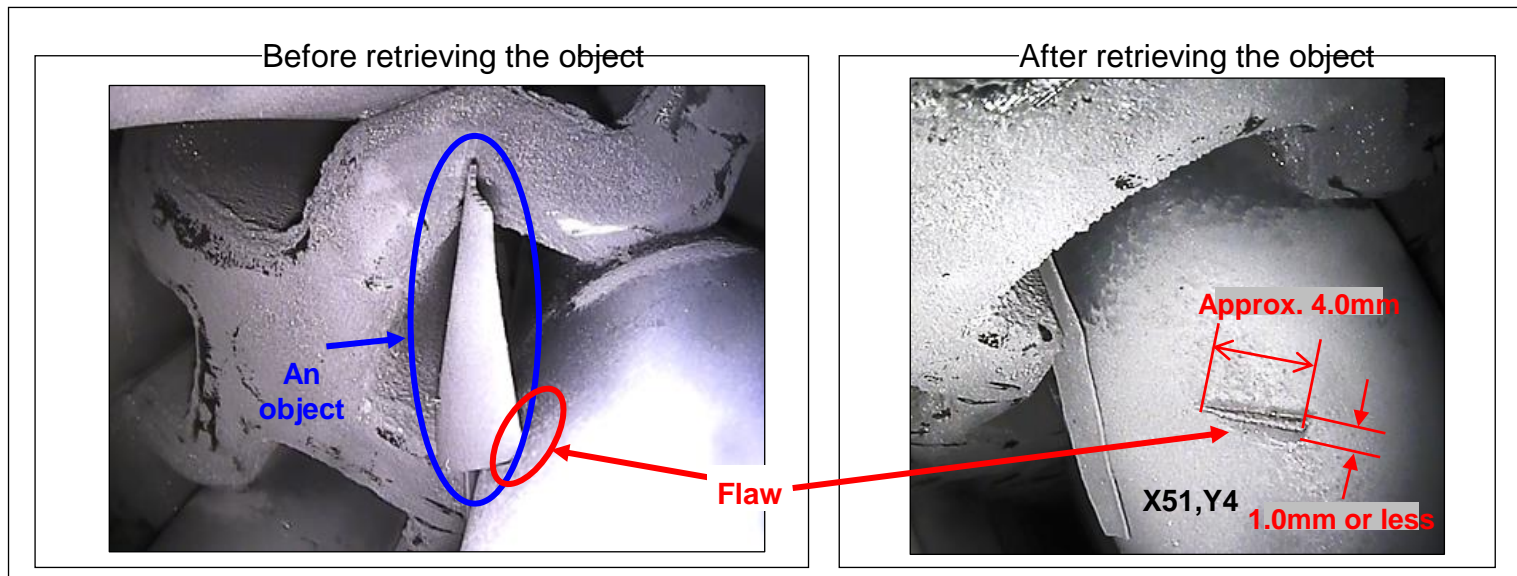
- One international PWR identified hard, dense scale that had spalled off the SG tubes at one unit and assumed by the utility to be the result of tube wear on 4 tubes in 2 SGs
- The utility provided EPRI with information on their OE
- EPRI communicated the details of the OE with SGMP member utilities and with the NRC at the 10/7/2021 SGTF meeting
- The SGMP has begun work to improve our knowledge of the wear mechanism and its relevance to the industry

- One international PWR identified hard, dense scale that apparently resulted in tube wear
- The SGMP has begun work to improve our knowledge of the wear mechanism and its relevance to the industry
 - One project is expected to obtain information on industry tube scale that can be used to gain a better understanding of the deposit flaking mechanism that could lead to tube wear
 - Another project is intended to develop a set of tube samples with synthetic OD tube deposits to evaluate and improve the ability of NDE to accurately assess 1) secondary side deposits and 2) flaws in the presence of tube deposits

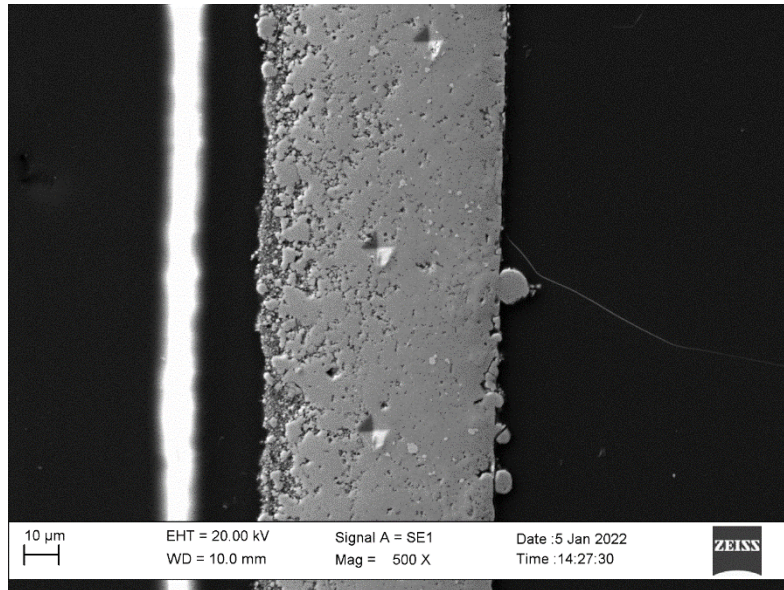
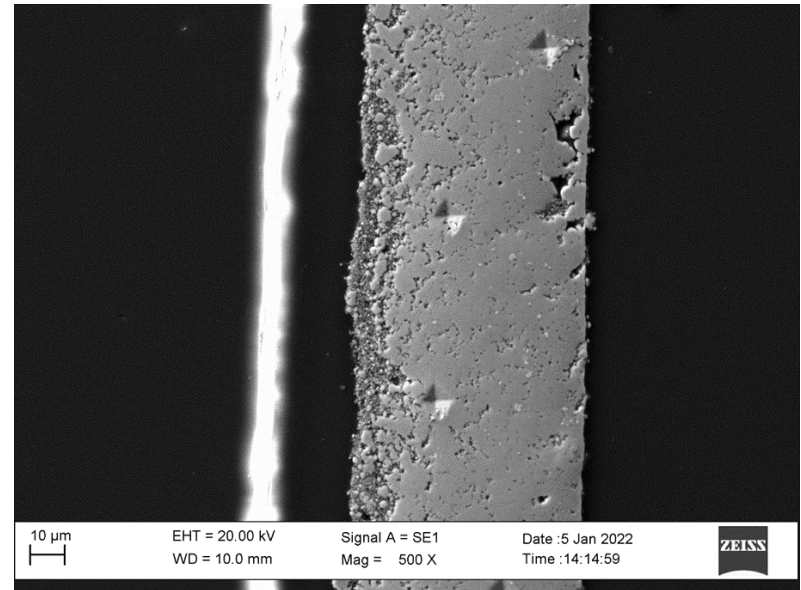
SG Tube Scale Deposit Characterization

- To date, deposit data from 10 of the 20 units has been collected
- Following data collection, data assessment will be performed

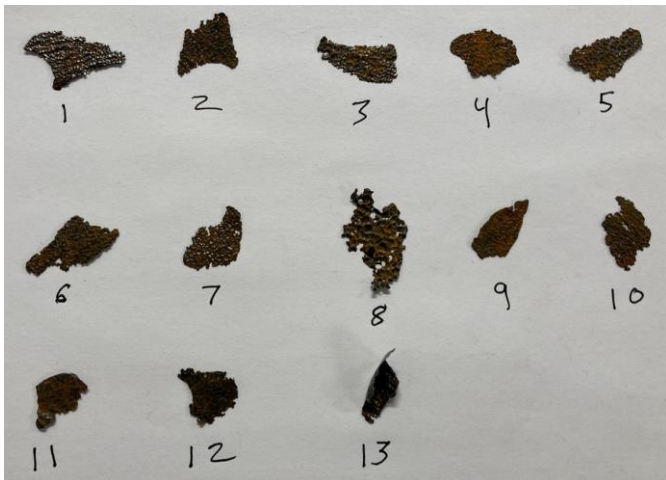
Objects removed from a SG in 2021

Thickness:
0.010" (0.25mm)

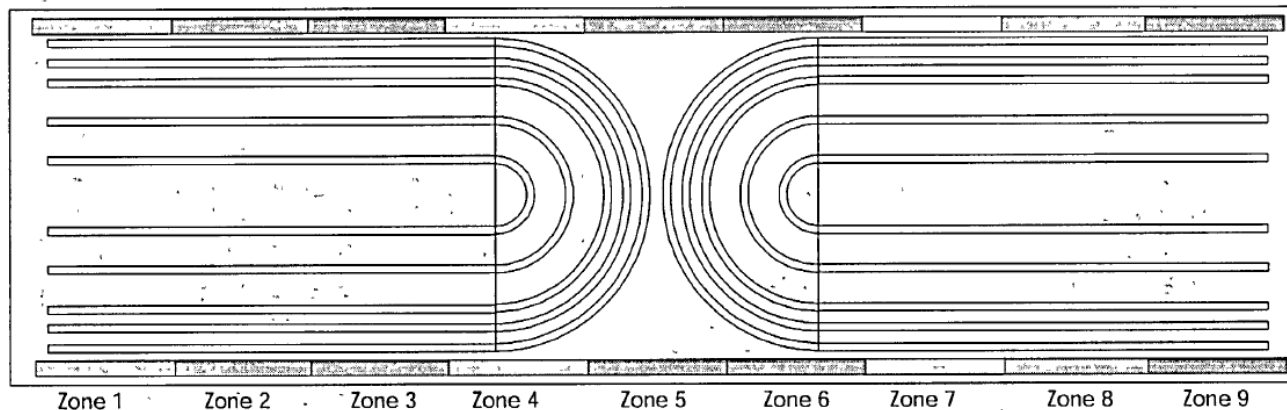
- During Fall 2021 SG inspections, axial SCC was reported on a Row 1 tube in the U-bend at two plants with Alloy 600TT tubing
- The low row tube U-bend and some length (about 40 to 60 inches) of vertical straight section are stress relieved after bending so what drives the crack?

Zones 1 through 9 are heating zones in the furnace. Only zones 4, 5 and 6 were activated for stress relief of the u-bends.

Note: Figure not to scale

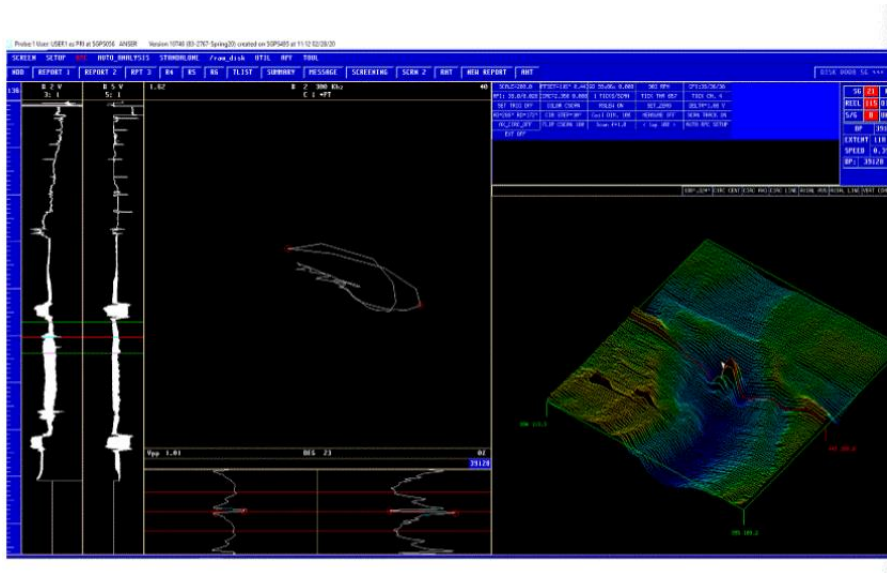
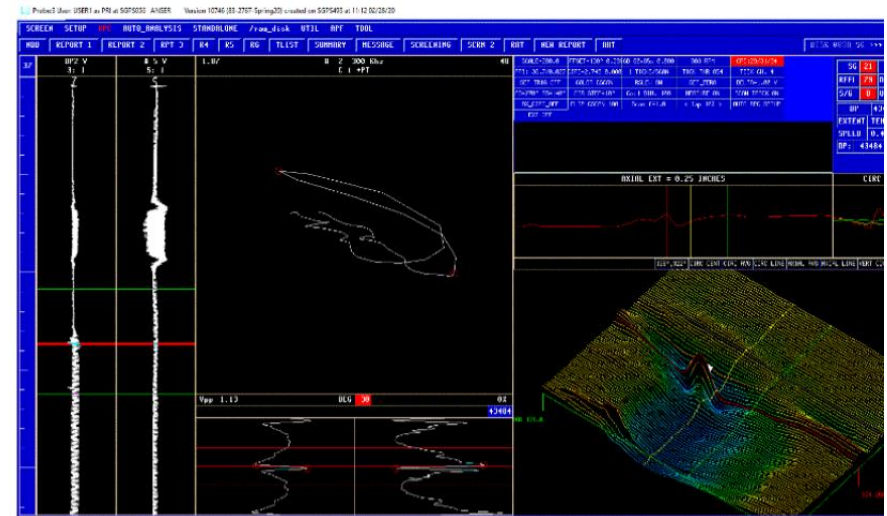
Data Union Comparison

- 2012 NDD data was used as host data
- Injected flaw parameters: phase angle consistent with 60%TW ODSCC, amplitude consistent with pulled tube ODSCC data
- Data Union combination on left, Plant data on right

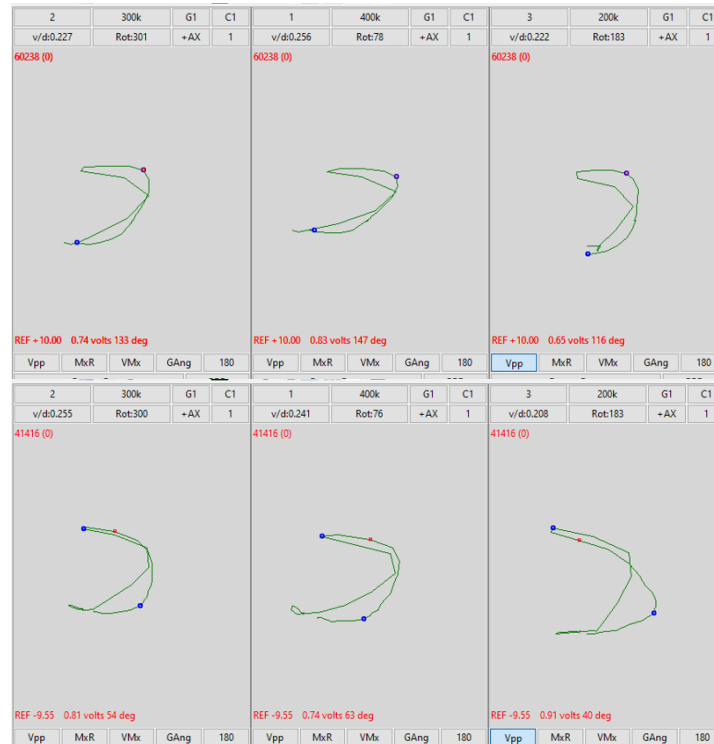
2017 (top) vs 2021
+Pt Signal Response

- SGMP did not perform a Data Union study for this flaw
- Array probe inspection confirms the indication
- As with the Model D5 experience, a very low growth rate is apparent

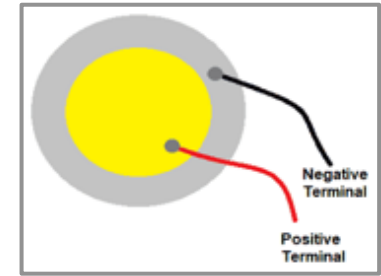
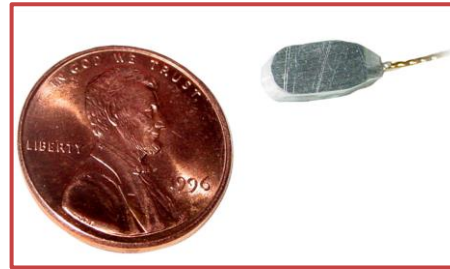
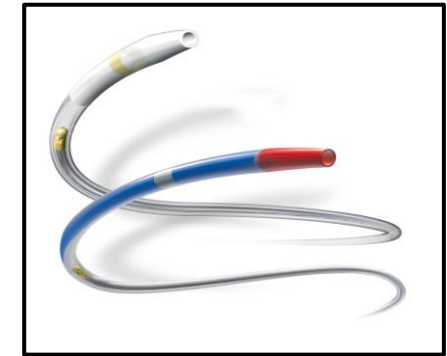
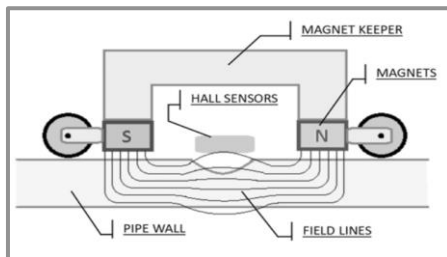
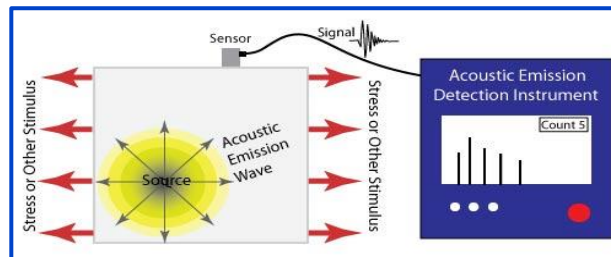
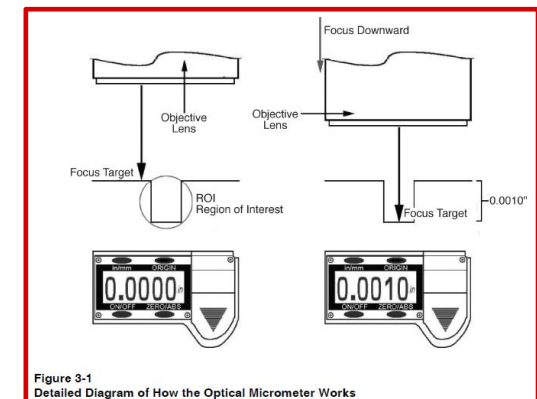
Other Technologies Researched

- Various methods of characterizing wear scars from the steam generator's secondary side were studied to determine the best technique for further development:
 - Ultrasonic guided waves
 - Polymer molding
 - Optical micrometer
 - Lasers
 - Piezoelectric Sensors
 - Acoustic Emission Testing
 - Pulsed Magnetic Field Leakage

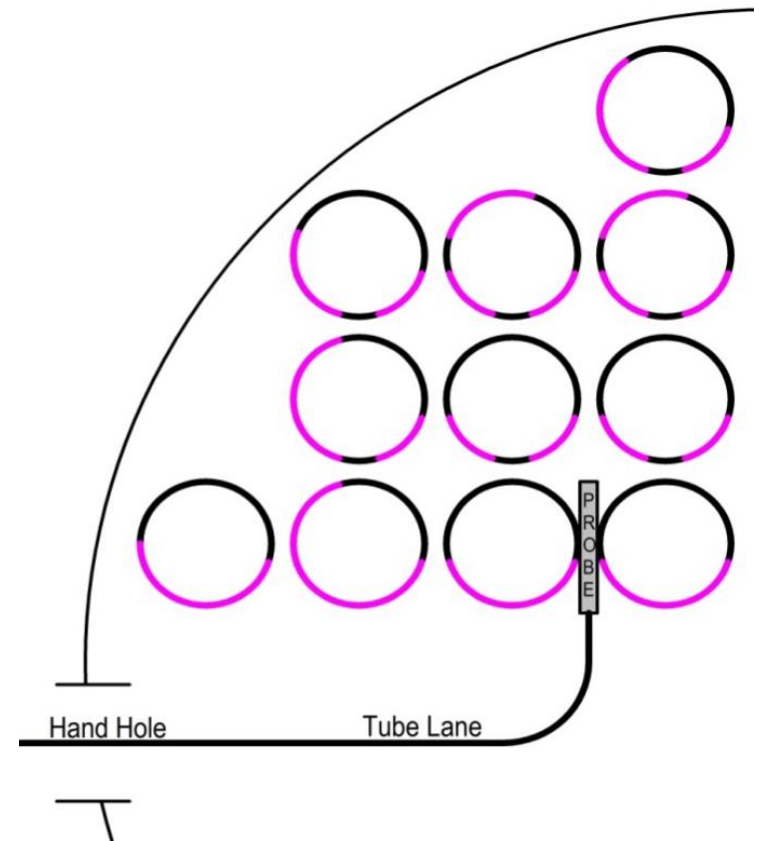
SG Tube Access Issues

- Obstacles to Overcome
 - Equipment size limitations due to small tube-to-tube gaps
 - Visual inspection blind spots
 - Robotic delivery system

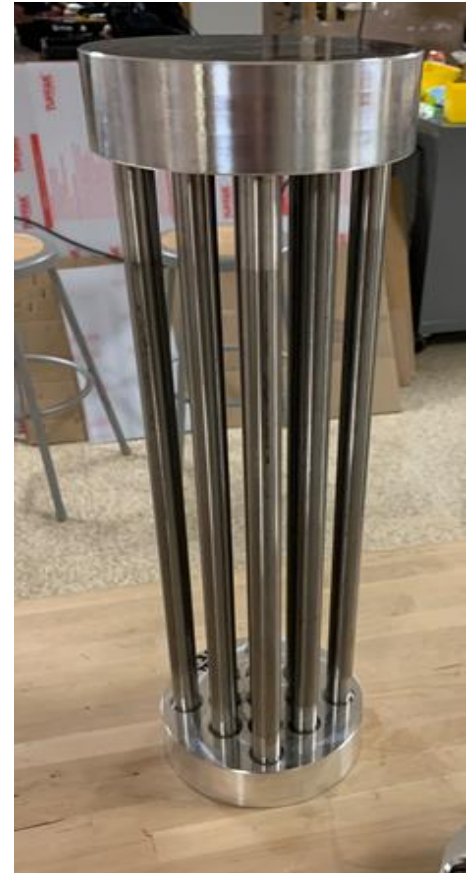
SG Tube Bundle Mockups Fabricated

- The mockups match tube bundle configurations for many operating SGs
 - Square Pitch
 - Triangular pitch
- Having tube bundle mockups available will allow EPRI to test the capability of NDE systems to:
 - Pass through tight gaps between SG tubes
 - Maneuver around tubes to measure wear scars that extend around the tube circumference

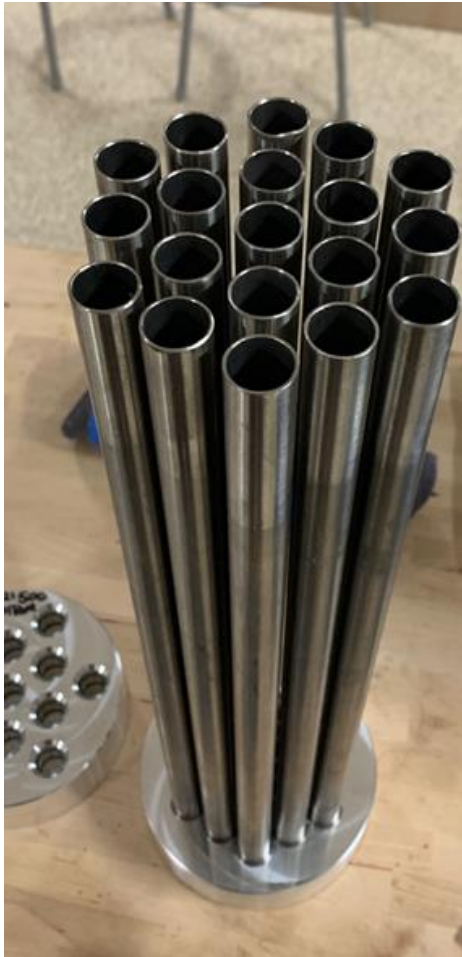
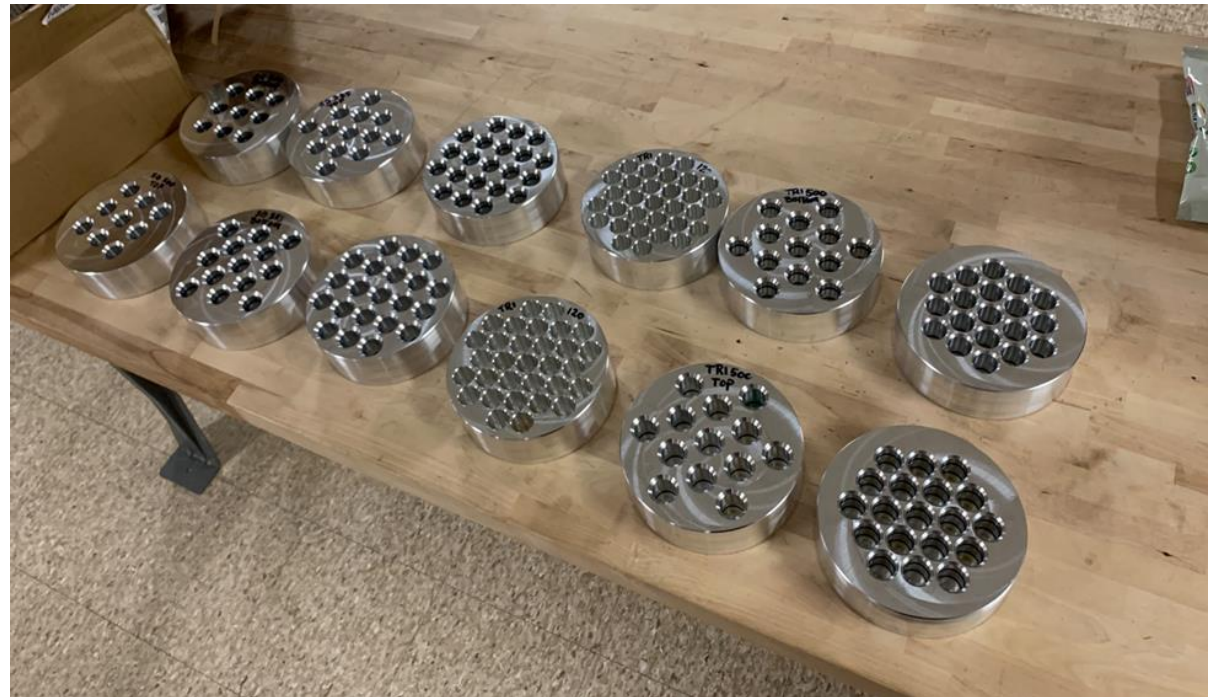
Six Different SG Tube Bundle Mockups were Manufactured

Top and Bottom of Tubesheet Mockups

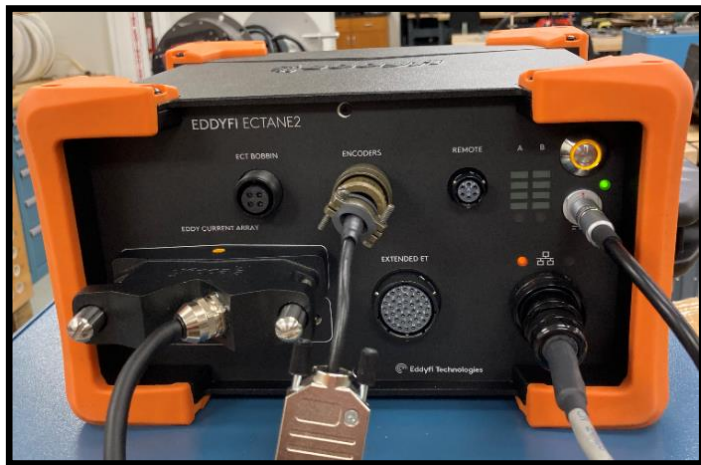
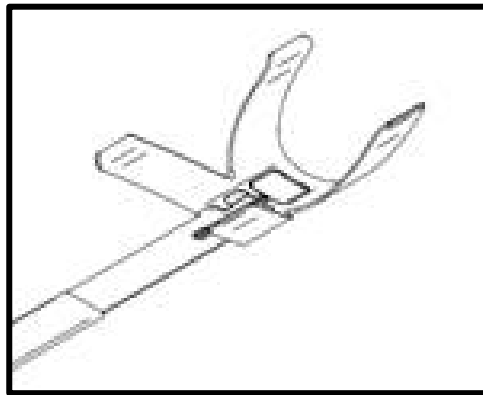
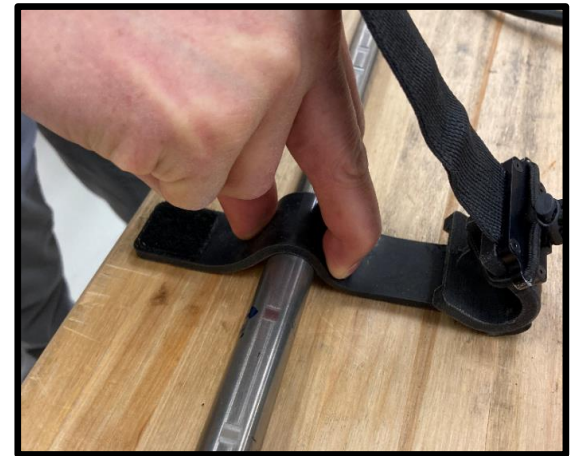
- Eddyfi Tester and Tape Array Probe
 - Most promising approach, current technology used to inspect Fuel Bundle Assembly

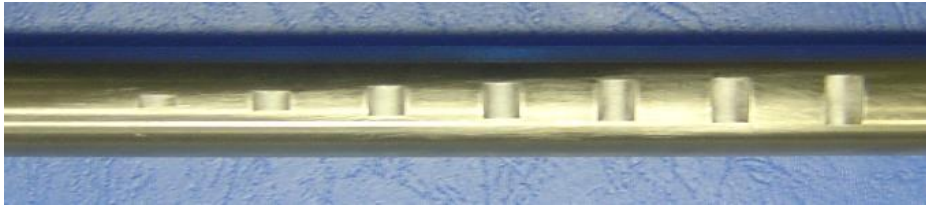
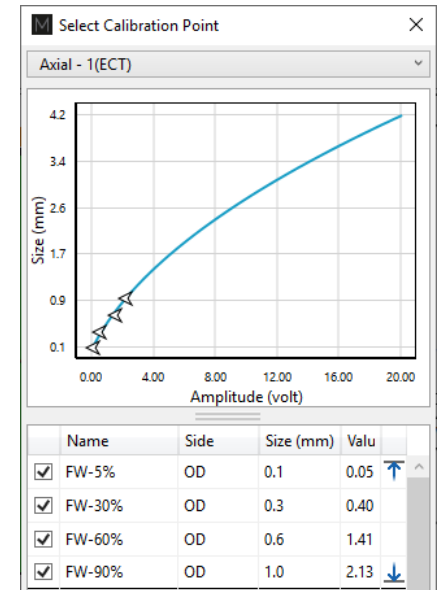
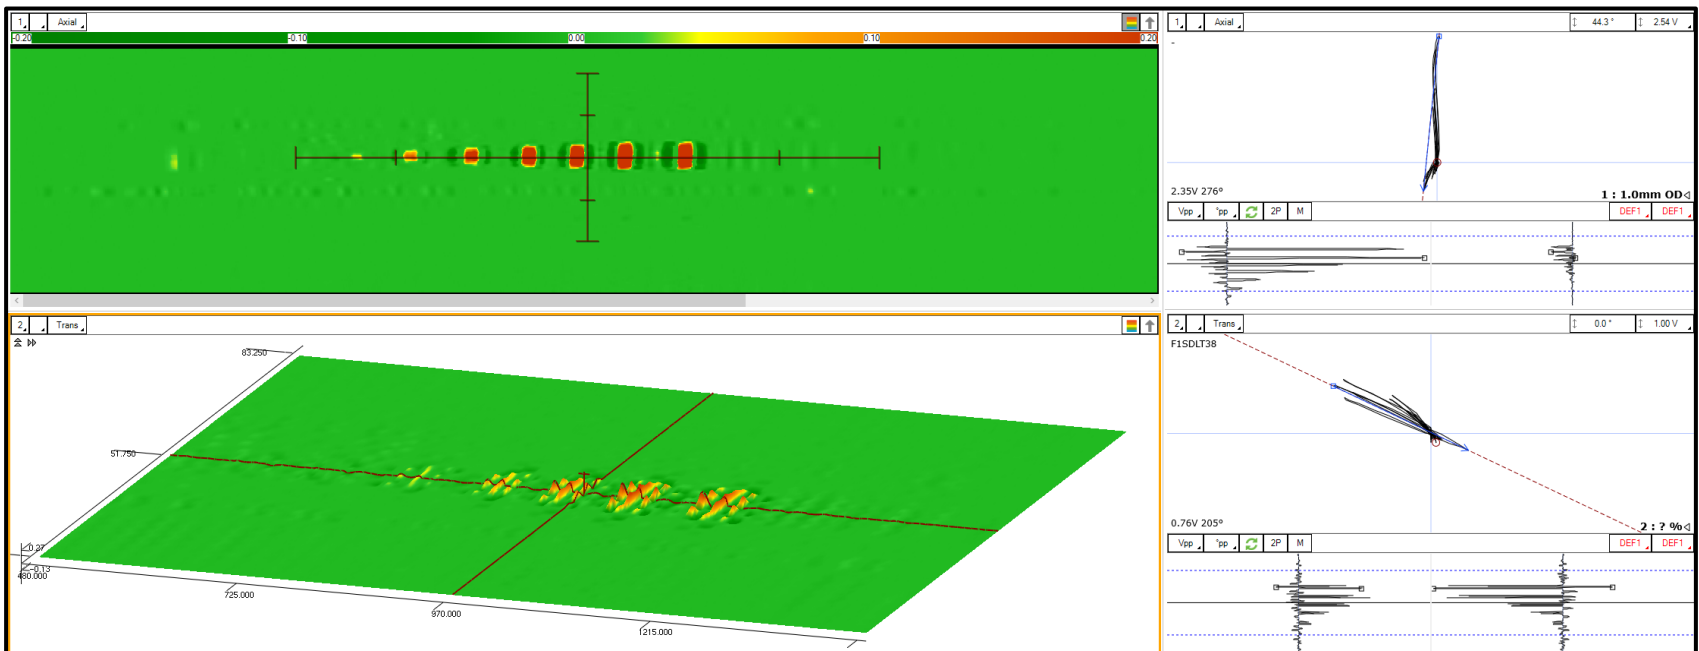
Results from Tape Array Probe on Flat Wear - Bench Top Tested at EPRI

- Wear depths between 5% - 90% TW
- All wear scars on the sample were detected

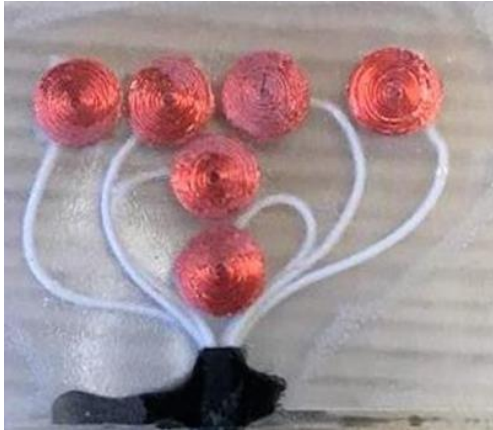
Single Element Prototype

- A single element prototype was investigated to better assess the effect of the frequency on sizing accuracy
- Coil dimensions were selected to give the highest accuracy without being excessively affected by noise
- For this specific application, defect depth can be sized as lift-off
- The most accurate results are achieved when wear width is at least twice the coil diameter
- Depth sizing of smaller defects will be addressed with another ECA prototype

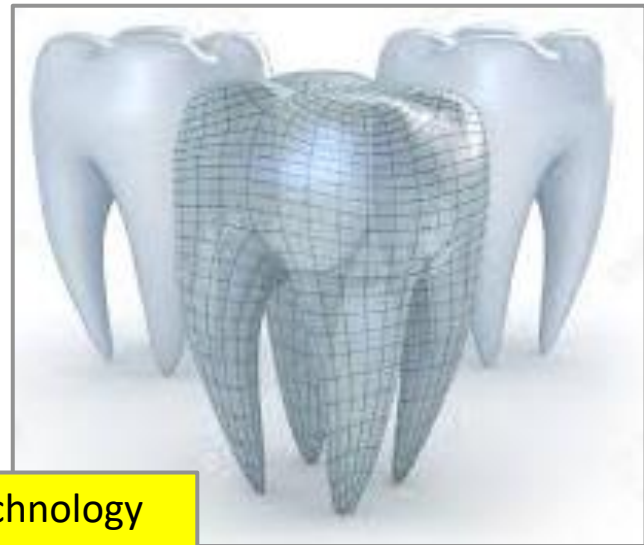
Engineering Evaluation on Other Technology

- Investigating other technologies
 - 3D Mapping
 - Uses photos and/or video from existing equipment
 - Technology appears promising

Similar technology
to dental imaging

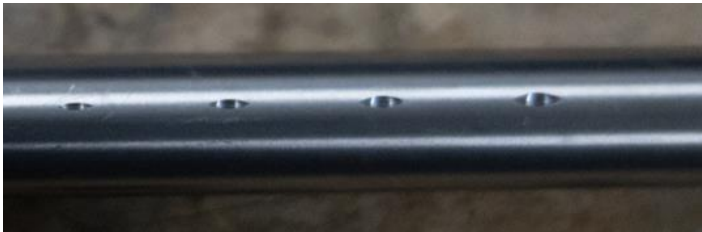
Wear Scar Sample

Visual Inspection
