SGTF / NRC Technical Meeting

February 22, 2024

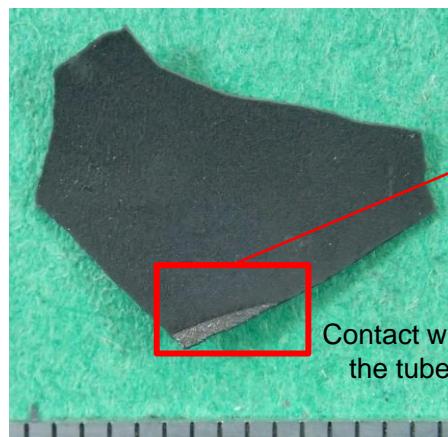
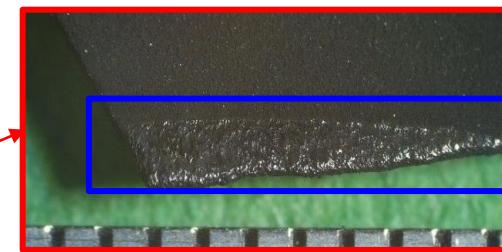
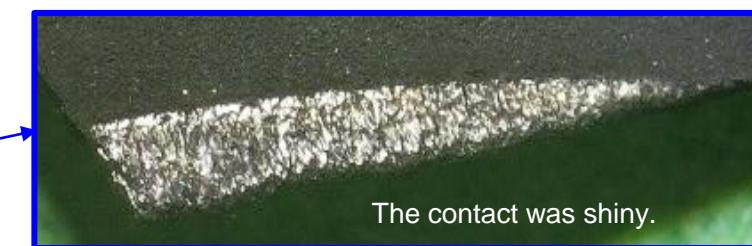
Analytical Results of the Retrieved Object

- The retrieved object from the tube wear location in SG-A exhibited a shiny area at the object-to-tube contact location
- Radius measurement of the object revealed that the object had a curved shape closely matching the curvature of the tube OD.
- All four cases of SG tube wear are suspected to have been caused by OD deposit tube scale that spalled off the tube

Size: approx. 15mm×9mm
Thickness: approx. 0.2~0.3mm
Weight: approx. 0.1g

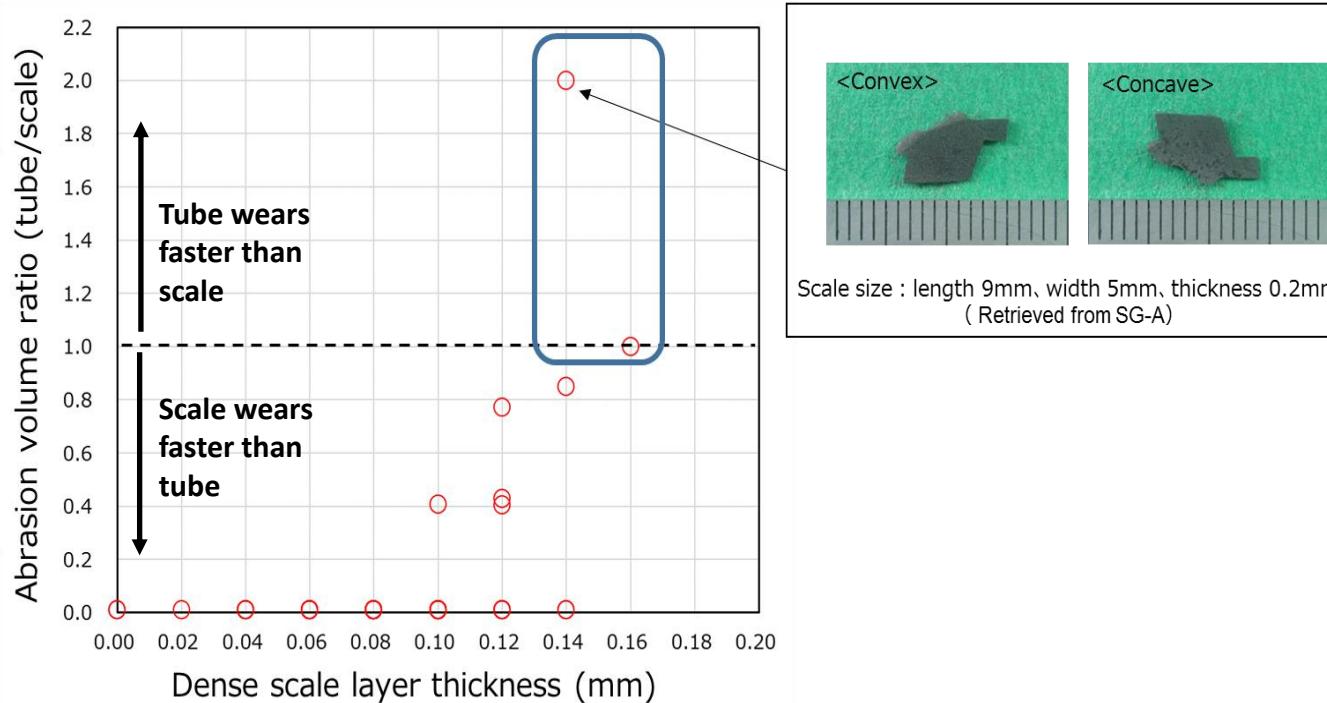
- Since no foreign objects were found, it was assumed that the scale caused the wear.
- Samples of scale were retrieved from inside the SGs to confirm its capacity to wear the tubes.
- Microscopic observations and wear tests confirmed that scale with high wear capacity [dense scale (i.e., 5% porosity) layer and thickness >0.1mm, abrasion volume ratio (tube/scale): 1.0] was present in both units.

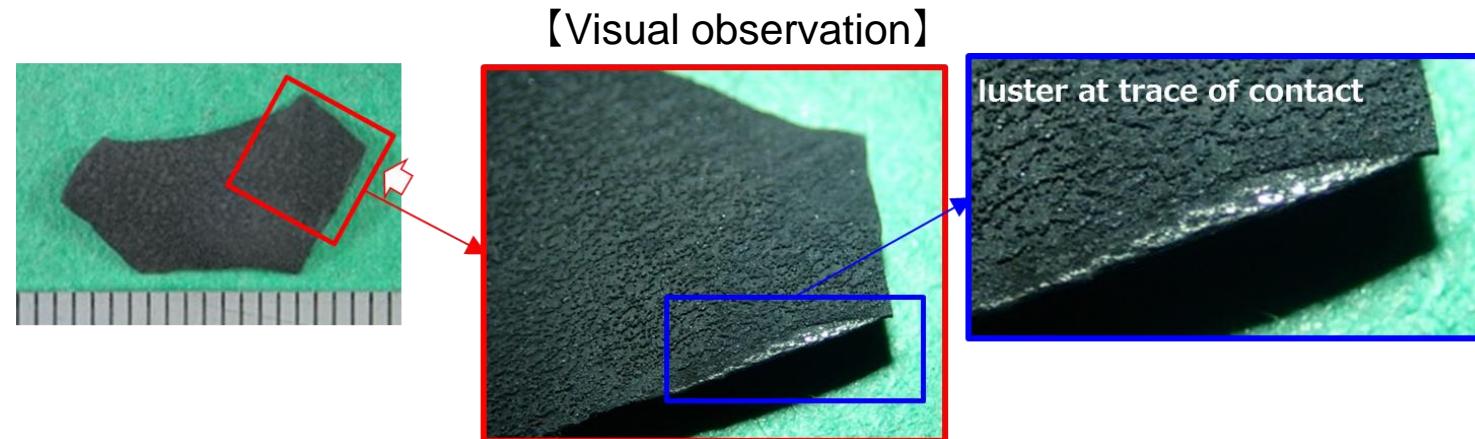
- Scale, presumed to have caused wear, has been identified. Figure shows a retrieved piece of scale.
 - Trace of contact on the tube
 - Components constitute the tube material (Nickel and Chromium)

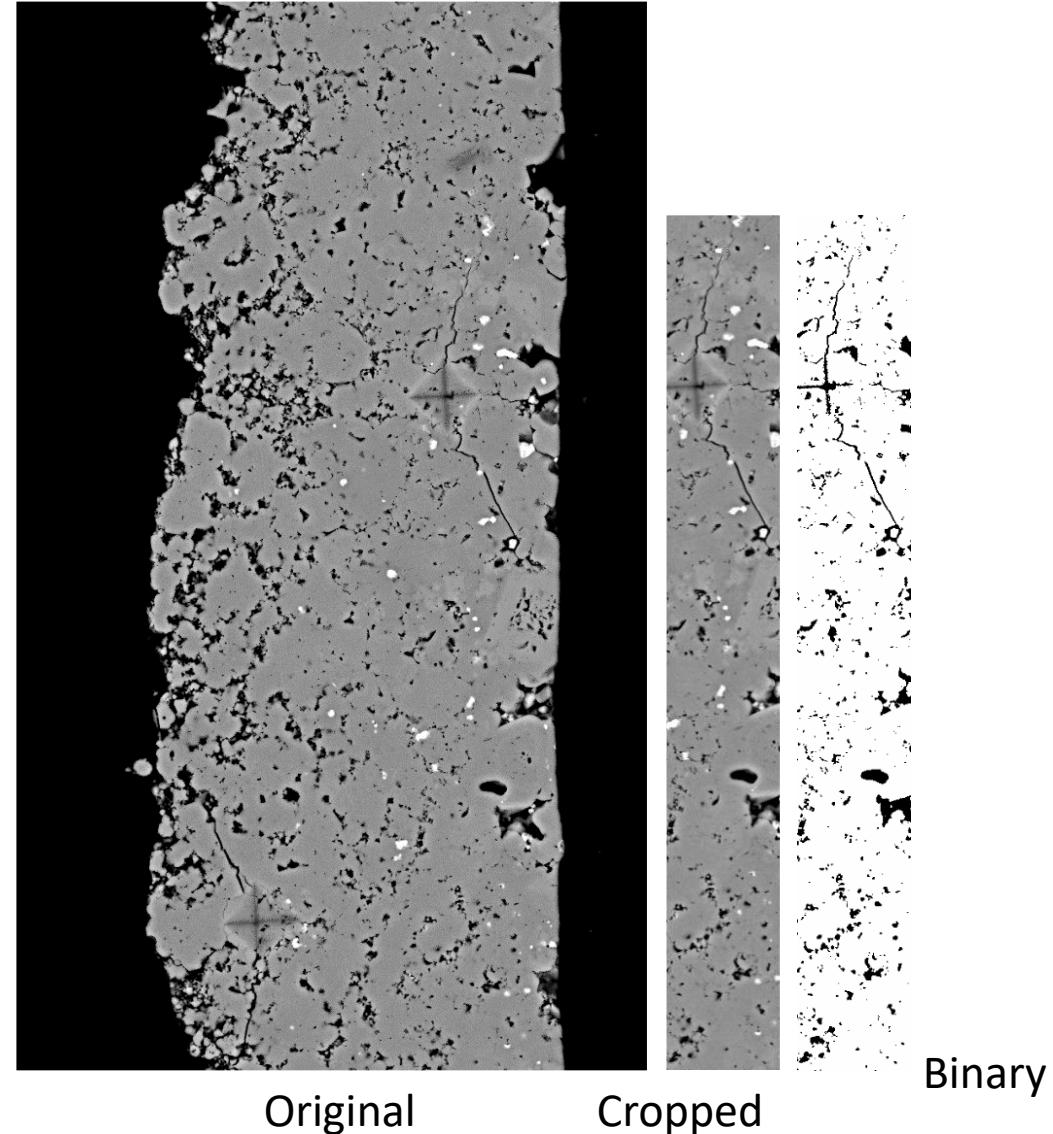
Example Porosity Analysis

In this study, three areas were selected for analysis in each flake:

1. a region near the tube side,
2. a region near the water side,
3. a region spanning the tube side to the water side

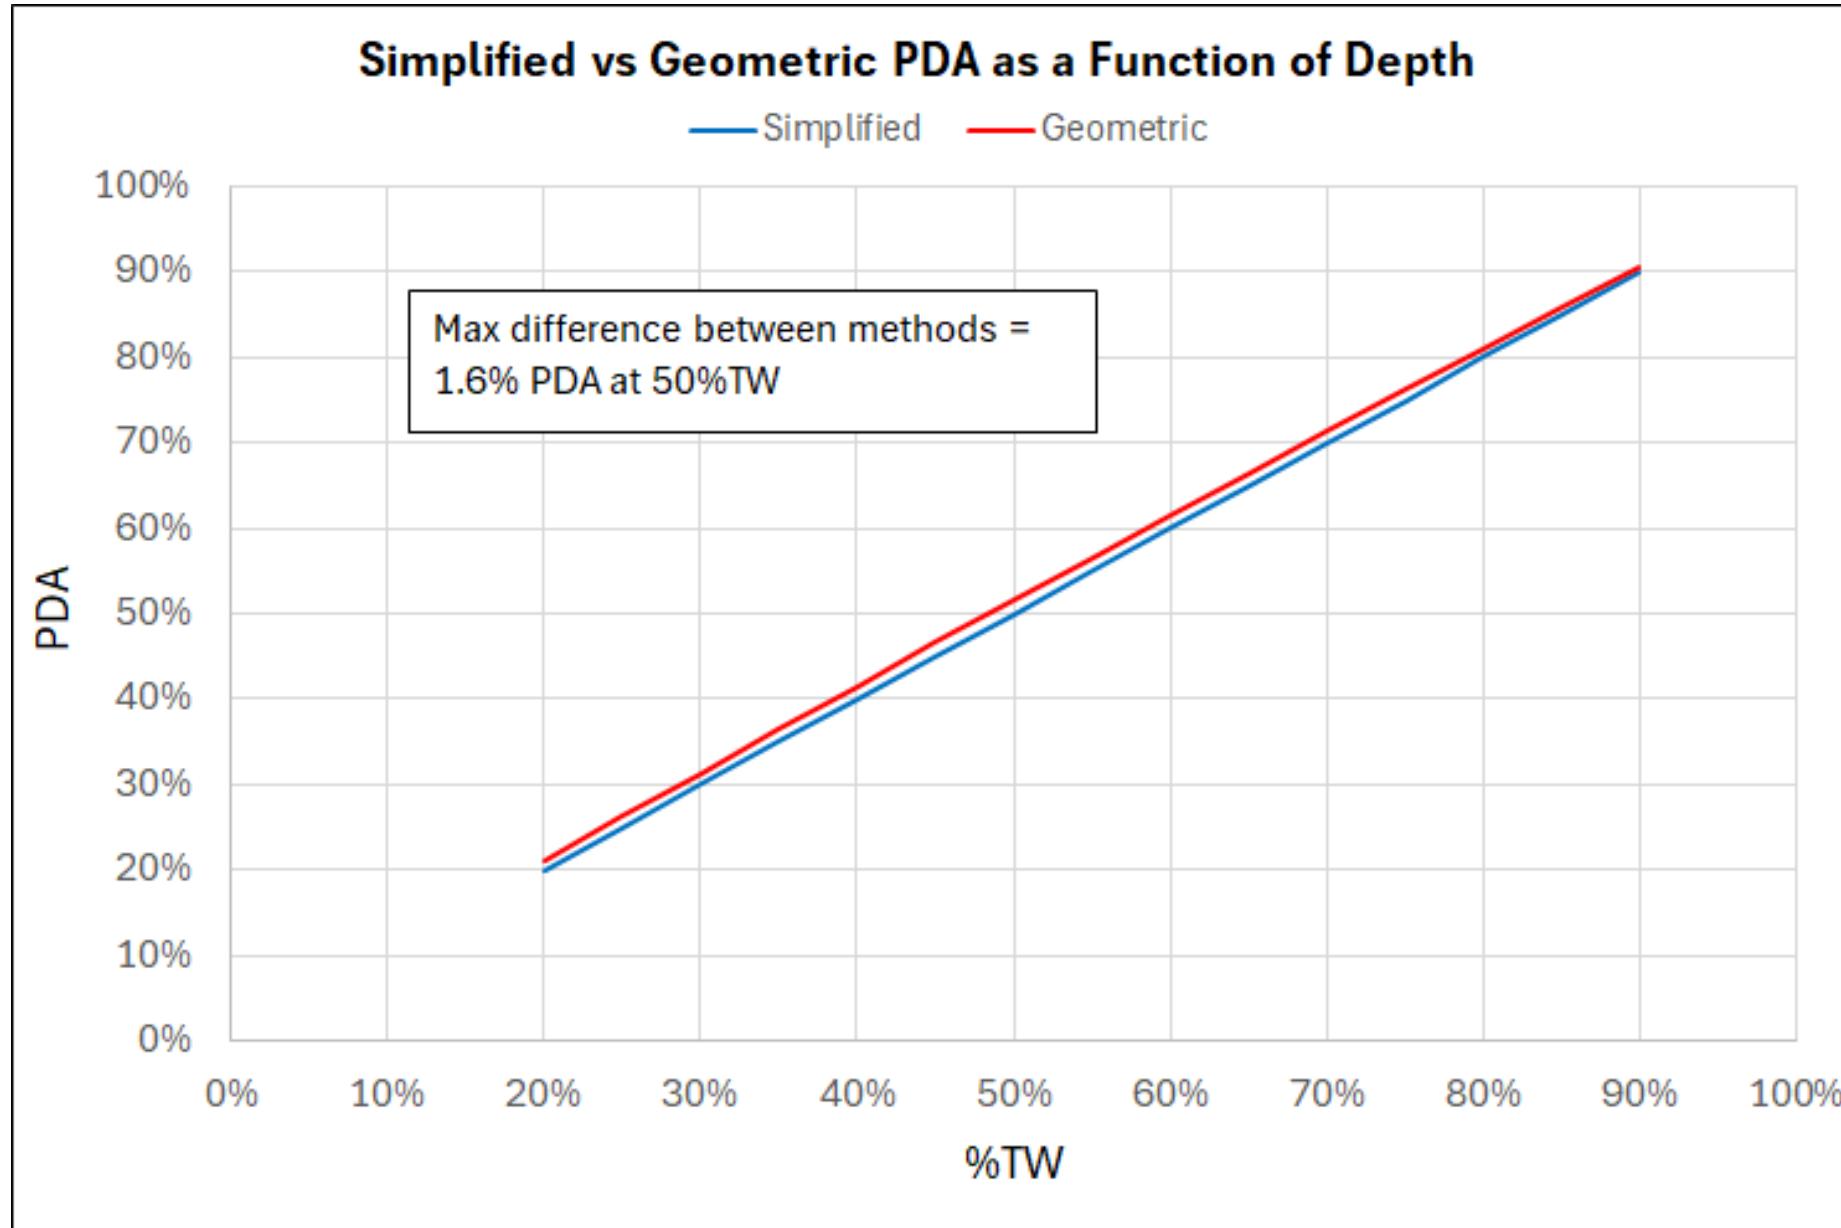
Industry's Comparison of Different Ways to Calculate

- Simplified method
 - $PDA = (\text{Depth} * \text{Length})/360$
- Geometric formula
 - $PDA = \frac{\pi \times (\text{Rout}^2 - \text{Rin}^2) - \pi \times (\text{Rout}^2 - \text{Rmid}^2)}{[\pi \times (\text{Rout}^2 - \text{Rin}^2)]}$
- EPRI guidelines do not prescribe how to calculate cross-sectional area of circ degradation
- The Flaw Handbook Calculator doesn't calculate PDA; it is an input
- The underlying spreadsheet used by the FHC were validated by manual calculation to be correct

75% TW crack 360 degrees			
Shortcut PDA Calculation Method			
$(75)(360)/(360) =$		75.0	PDA
Actual Surface Area Calculation			
$\text{Pi}^*(\text{Rod}^{\text{A2}}-\text{Rid}^{\text{A2}})$	0.070	sq. inches	Cross sectional area of entire tube
$\text{Pi}^*(\text{Rod}^{\text{A2}}-\text{Rmid}^{\text{A2}})$	0.053	sq. inches	Cross sectional area of 75% through-wall crack
$\text{Pi}^*(\text{Rod}^{\text{A2}}-\text{Rid}^{\text{A2}})-\text{Pi}^*(\text{Rod}^{\text{A2}}-\text{Rmid}^{\text{A2}})$	0.017	sq. inches	Cross sectional area of remaining 25% tube wall
$0.053/0.070 =$	76.2	PDA	
Radius			
Tube OD	0.625	0.3125	
Tube ID	0.549	0.2745	
Wall Thickness	0.038		
75%	0.75		
75% of wall	0.0285		
OD - 75% of wall	0.284		
180 deg	180

- If burst pressure is calculated as a function of PDA when determining CM, **there is no impact**
- If burst pressure is calculated as a function of PDA when performing an OA, **there is no impact**
- If you are comparing the calculated PDA for a detected flaw against the CM limit curve (deterministic), then there could be a small difference
- When burst is controlled by tensile failure mode, the difference in PDA between the geometric and approximate methods is a maximum of 1.6% PDA
