# NDE of Non-metallic Repairs

# Non-Metallic Components and Repairs

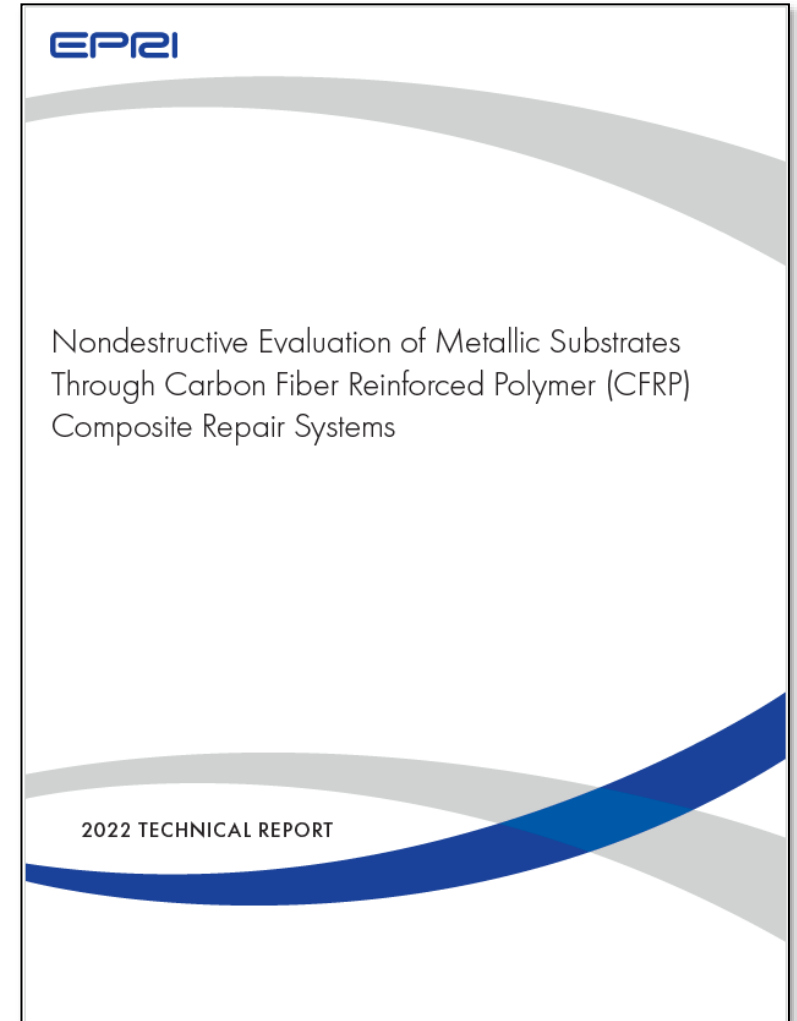
**EPRI Report 3002020823 Published March 2022: Free-to-Public**

- Identified two successful techniques:
  - **Dynamic Response Spectroscopy**
  - **Pulsed Eddy Current**
- Other electromagnetic techniques may also be applicable, depending on lift-off distance capabilities between sensors and substrate
- Report documents the sample configurations and examination results of each technique against baseline ultrasonic data

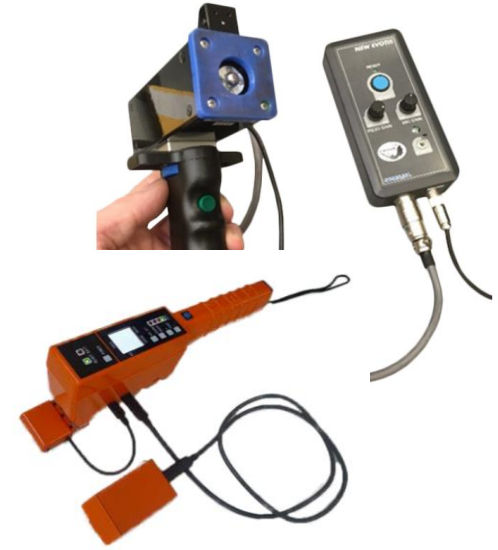
# Mockup Observations

- Edge and corner effects are substantial
  - Placing mockups in soil/sand to test may reduce edge effects
  - Round mockups, pipes, thin plates may be different
  - Excessive pitting on substrate might affect audio signatures?
- Large flaws are easily detectable
- Bulges offer visual cues for bubble flaws but are less apparent for small flaws under many CF layers
- Bubbles may constitute most readily detectable flaw type
- Mockups may be sectioned to confirm as-built characteristics
- Phased array and acoustic tap testing are promising based on first set of mockups, but resolution for small and deeper flaws is more challenging
