NDE of CFRP Repairs

Muthu Elen, Nicholas Conway
Pacific Northwest National Laboratory

2025 Annual NRC-Industry NDE TIE Meeting
NRC Headquarters, Rockville, MD

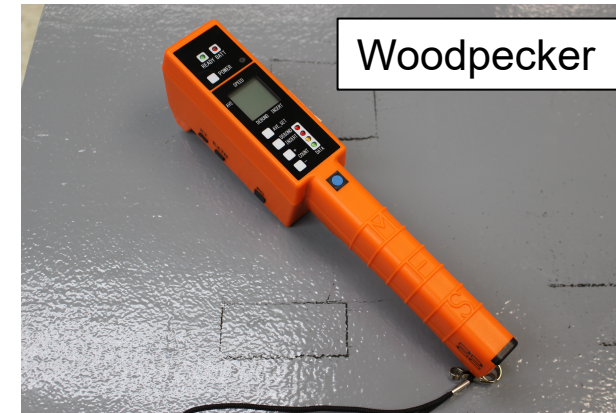
Data Collection: NDE

- Manual tap testing (MTT)
 - Aerospace tap hammer
 - Low-cost
 - Easily deployable
 - Requires trained inspector to interpret audible responses for flaw identification
- Automated tap testing (ATT)
 - Woodpecker WP-632AM-R
 - Uses a ratio of the response to a reference “good” location the operator collects to identify flawed regions
 - ✓ Not dependent on an individual’s hearing abilities
 - Records measurements (but not position)
- Encoded/Automated pulse-echo ultrasonic testing (PE-UT) method
 - Zetec DYNARAY w/ ZMC² (UV3, 2.5-mm scan/step increment)
 - Olympus V101 (0.5 MHz, 1.0-in. diameter) and Krautkramer 389-057-070 BMC (1 MHz, 0.5-in. diameter w/ 1-in. Rexolite delay line)
 - Frequencies are chosen based on preliminary testing
 - Normal beam (i.e., 0-degree incident angle)
 - Contact probe
 - Pulse-echo
 - Volumetric inspection
 - Widely accepted
 - Couplant: Ultragel

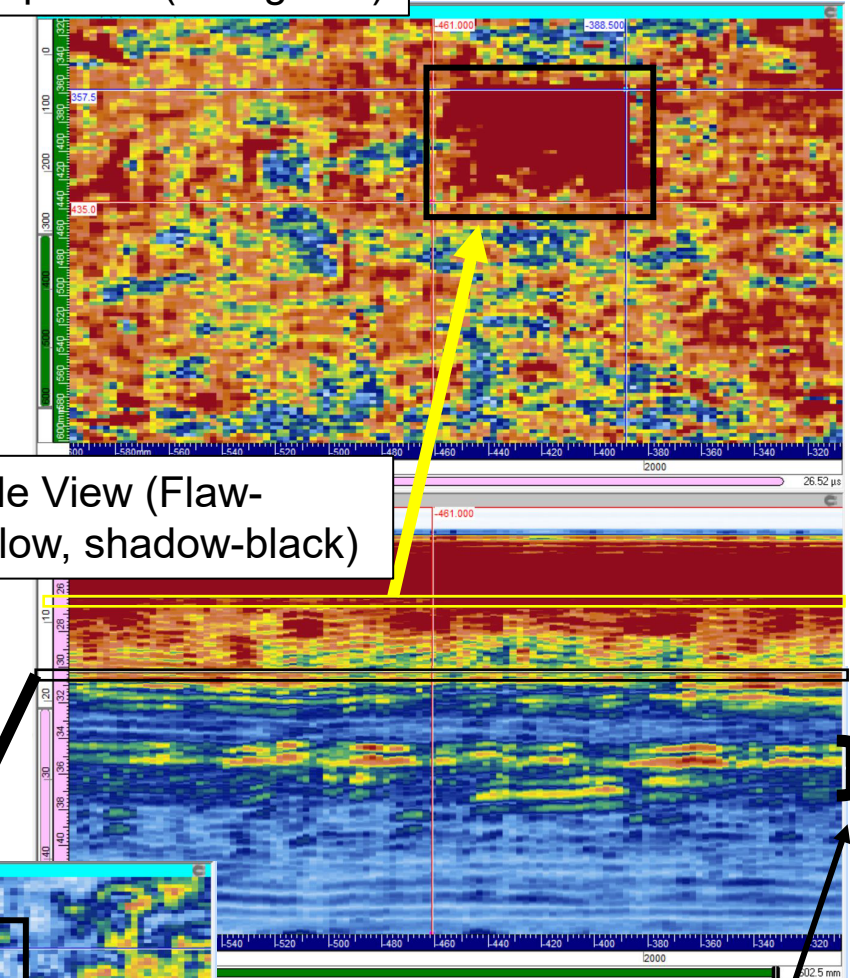
UT Observations

- To capture the interface response (CFRP to base plate), the gain was increased substantially
 - Surface saturation drowns out some of the shallow layers
- Images show a dry spot two layers below the surface
 - Top image is gated based on the layer location (yellow lines)
 - Response from the defect is at a higher amplitude than the surrounding signal
 - Lower image is based on gating on a deeper layer (black lines)
 - Lack of signal penetration due to dry spot
 - Shadow under the defect
- The lower image shows the potential for gating under shallow flaws for detection via the flaw shadow (blocked UT signal)

Top View (flaw gated)

Side View (Flaw-yellow, shadow-black)

Interface Response

Low amplitude due to blocked UT in layer above (shadow)
