Steam Generator Task Force Meeting

September 4, 2025

Update on Status of Secondary Sizing Technique

Secondary Side Depth Sizing

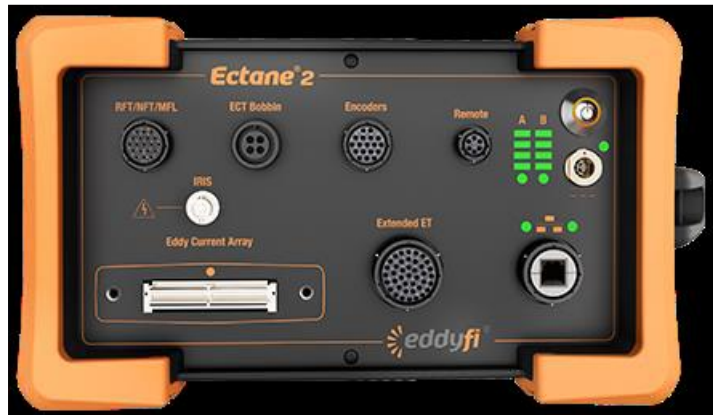
Eddyfi Ectane 2 Tester

- Eddyfi was contracted for probe development
- A single element prototype was investigated to better assess the effect of EC test frequency on sizing accuracy
- Coil sets and dimensions were researched to give the highest accuracy without being excessively affected by EC noise

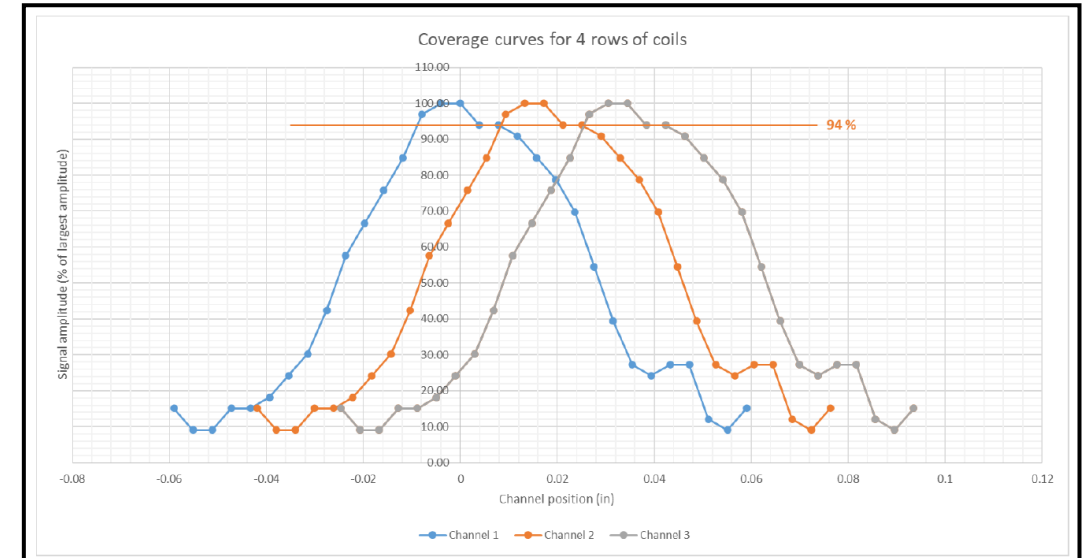
Four rows of coils produced a minimum signal amplitude of 94%

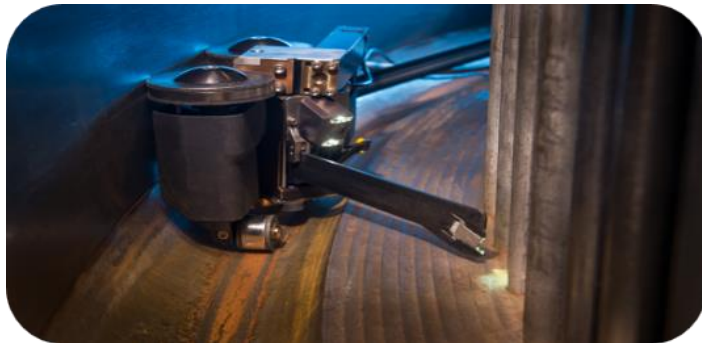
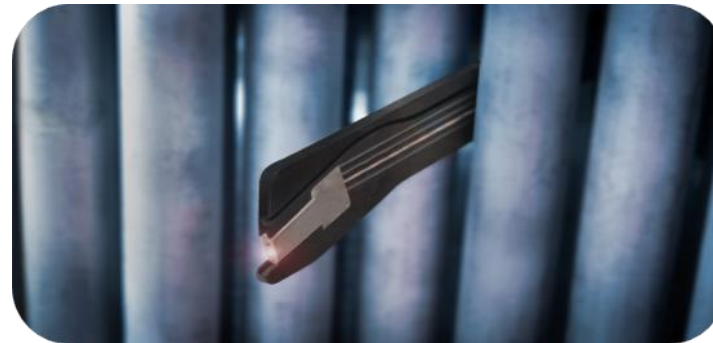
Additional Considerations When Developing Delivery System for a Secondary Side Probe Exam

- Considering Framatome currently has no apparatus (e.g., arm coming off existing FOSAR equipment)
 - Design considerations
 - Probe delivery – At a minimum, the probe should be able to reach the above tubesheet region near the periphery of the SG tube bundle
 - Probe positioning – Positioned such that the maximum depth of the wear scar can be measured, even if multiple static data acquisitions on a single wear scar are needed
 - FOSAR tool - Semi rigid blade that can translate forward, change pitch and yaw
 - ECA probe - would be mounted or built into (TBD) the front of blade for inspection
 - Watertight, could be up to 0.5” of standing water in the area
