SNC Proposed Alternatives for Containment Unbonded Post-Tensioning System Inservice Inspection Requirements

Public Meeting Discussion

Farley CTMT Post-Tensioning System

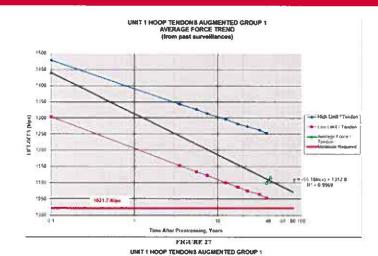
Present tendon force trends for the replaced/re-tensioned tendons during 2012 and 2017 events
