BWRVIP Inspection Committee Report Out

Chris McKean, Constellation
BWRVIP Inspection Committee Chair

NRC / Industry NDE Technical Information Exchange Meeting
Bethesda, MD
January 21, 2026

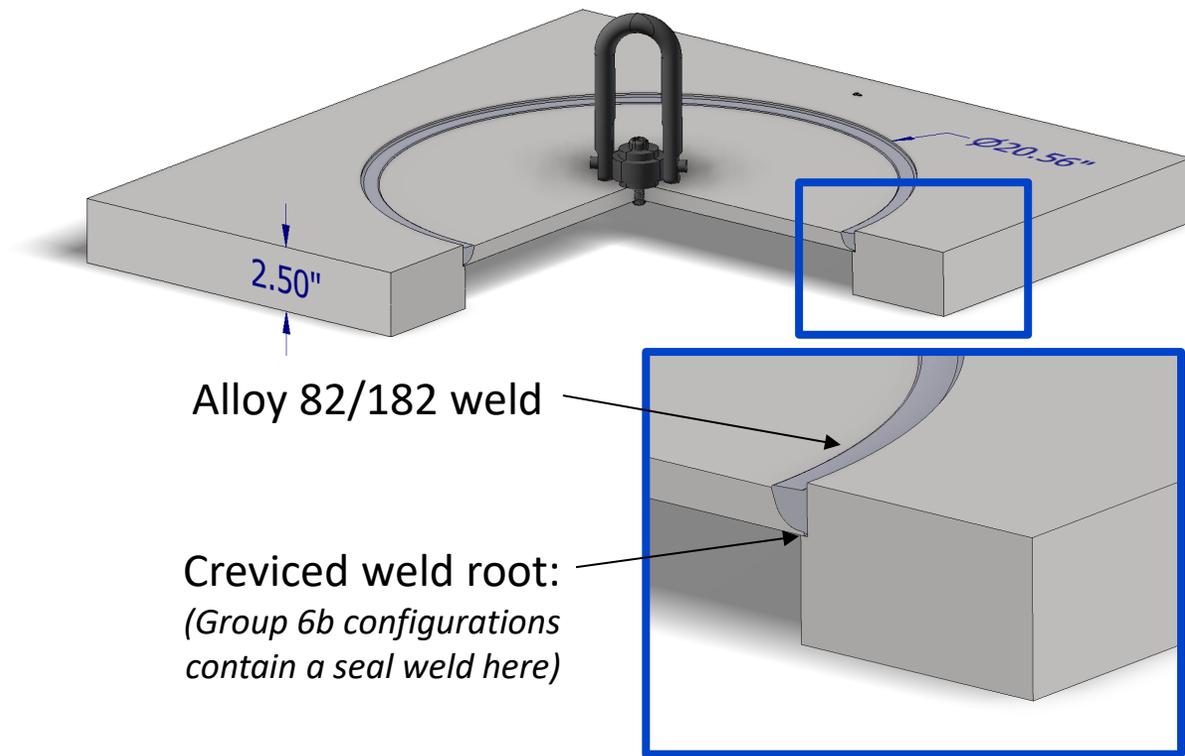
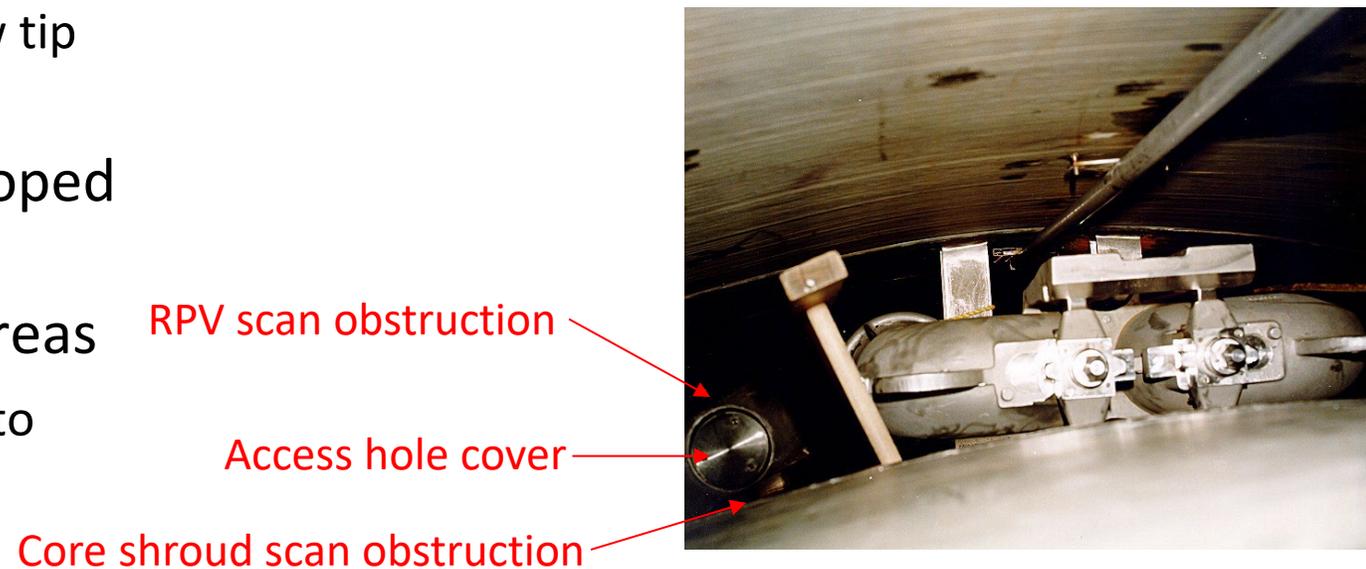
- Contact phased array technique to improve cover plate side scans
 - Applicable to Group 1 (*creviced*) and Group 6b (*seal welded crevice*) configurations
 - Shroud support plate side “looking in” immersion phased array UT scans work well, but are partially obstructed by RPV and core shroud
 - Cover plate side “looking out” immersion UT scans have struggled to detect reliable flaw tip responses
- Contact phased array technique developed to improve detection and flaw sizing reliability within partially obstructed areas
 - Attempted to adapt EPRI DMW technique to access hole cover configurations

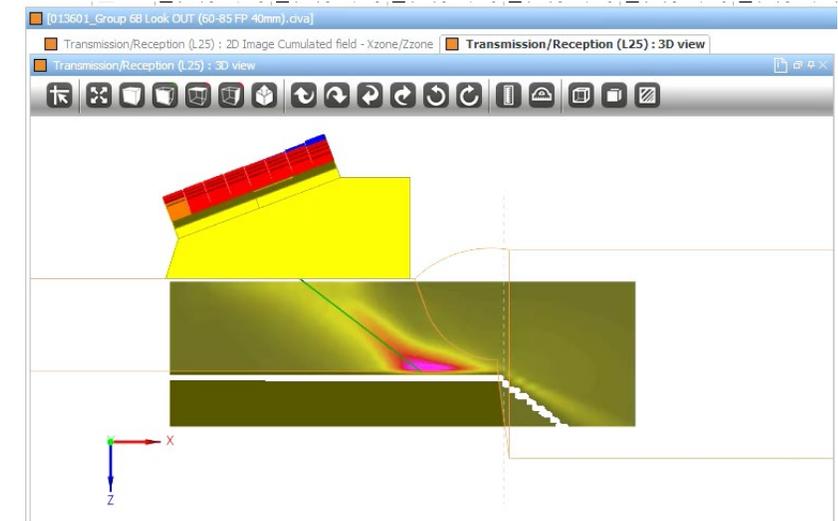
“Looking Out” Longitudinal Wave Probe

- J-groove weld configuration and typical flaw tilt create significant challenges when using refracted longitudinal waves
 - Weld root is on far side of joint, flaws have originated from root and tilted back towards probe
 - Unfavorable flaw tilt for cover plate side scans
- CIVA beam simulations revealed this inspection challenge; scans performed on flawed mockups confirmed the assessment made using CIVA
 - Increasing size of RL probe keeps moving exit point farther back
- A larger matrix array was then used to generate full-vee path shear wave focal laws
 - 2nd leg UT beams are oriented perpendicular to flaws

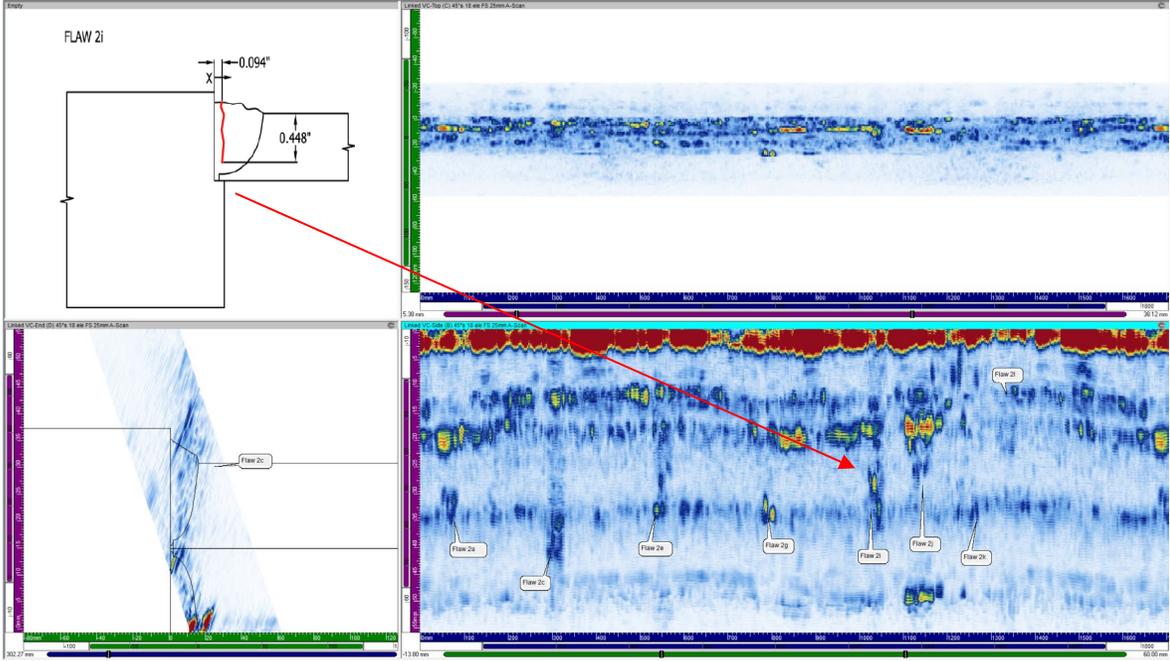
Cover plate side “looking out” immersion UT

BWRVIP-AHC2 Mockup Immersion Versus Contact UT Comparison

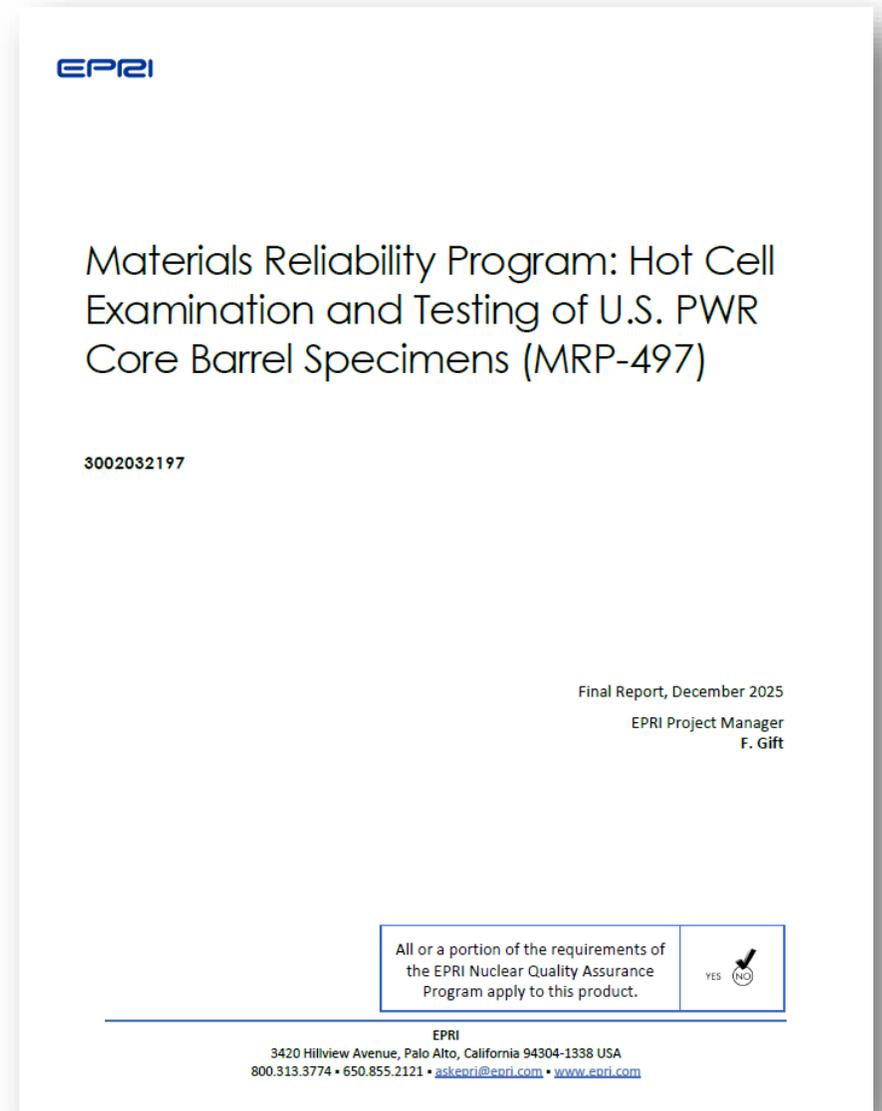
- BWRVIP-Demonstrated core shroud UT technique used to examine the core barrel prior to DE specimen removals during the fall 2024 refueling outage at a Westinghouse 3-loop PWR in the U.S.
 - Two full-thickness DE specimens were removed from the core barrel
 - One specimen fully contained flaw #3
 - One specimen contained the clockwise end point of flaw #4
- A hot cell metallurgical evaluation of the removed flaw specimens have now been documented in a December 2025 MRP report
- **This report provided an excellent opportunity to benchmark the pre-removal UT to the DE results**

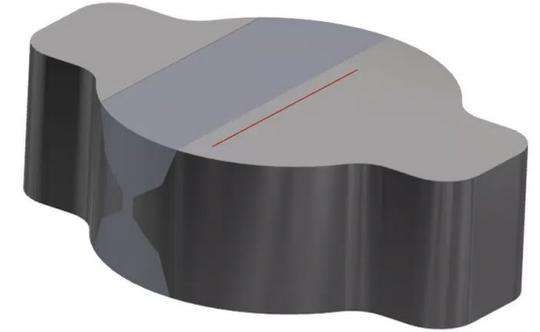
- *Inspection vendor's reported length of flaw #3 during 2024 RFO: 25 mm [1.0"]
- *Hot cell length sizing confirmation of flaw #3: 26 mm [1.0"] – Inspection vendor UT undersized by ~1 mm
- *Inspection vendor's reported depth of flaw #3 during 2024 RFO: 12 mm [0.46"]
- *MRP DE depth sizing confirmation of flaw #3: 10 mm [0.41"] – Inspection vendor UT oversized by ~2 mm
- **There was excellent correlation between 2024 remote VT, the inspection vendor's 2024 automated phased array UT measurements, and the December 2025 DE report**

EPRI created CAD model created during 2024 RFO showing removed flaw #3:

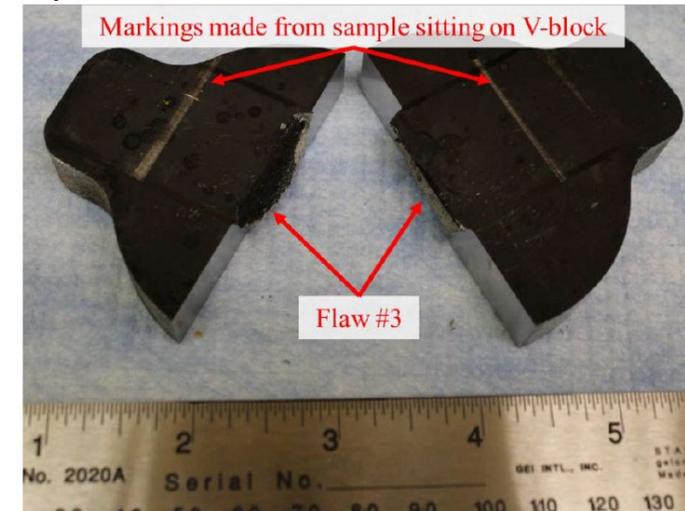
**Flaw #3 removed specimen after fracture faces were separated:*

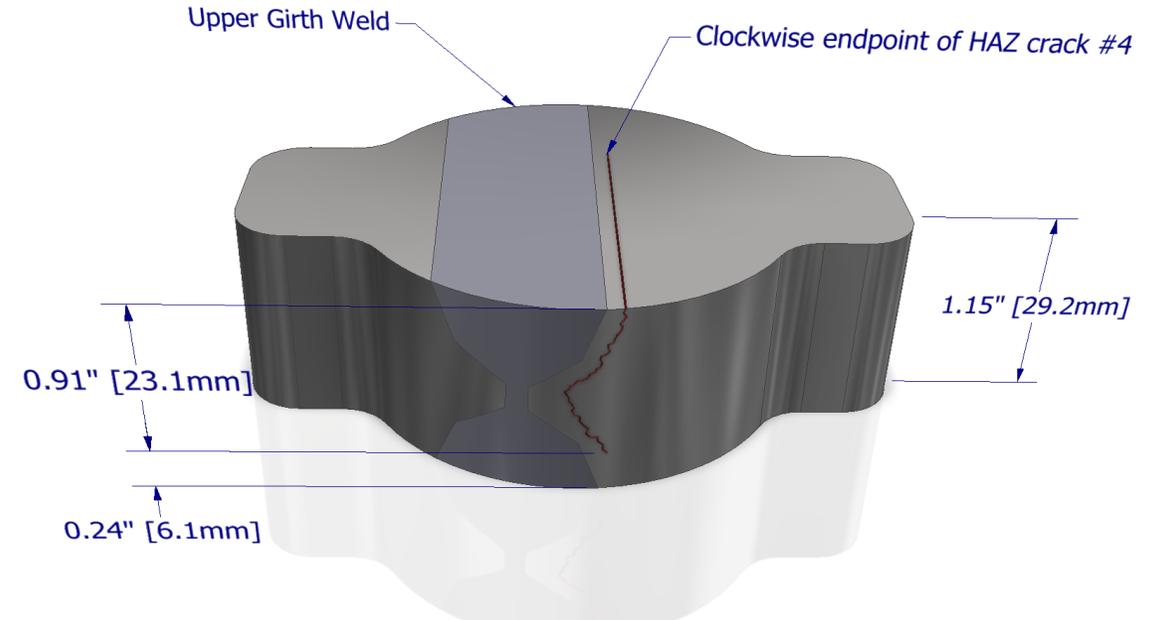
- EPRI performed an independent evaluation of the UT data and created a 3D CAD model of the removed specimens, with the UT measured flaw profiles shown within the CAD model
 - Flaw #4 was measured to have a depth of 23.1 mm within the removed specimen
 - Flaw was shown to propagate along the weld bevel configuration
- DE reported a maximum depth of flaw #4 within the specimen as 21 mm
 - UT oversized by 2.1 mm [0.08"]
- Removed specimen also confirmed the flaws path along the weld bevel to be correct

EPRI created CAD model created during 2024 RFO showing removed flaw #4:

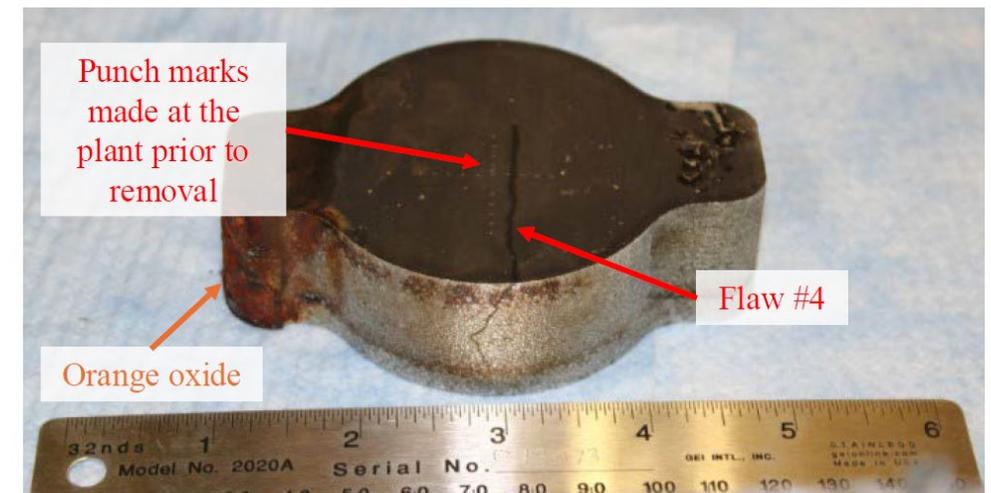
Removed specimen containing clockwise end point of Flaw #4:
