NDE of Carbon Fiber Reinforced Polymer Composite (CFRP) Repairs

PNNL

NDE TIE Meeting, January 2026

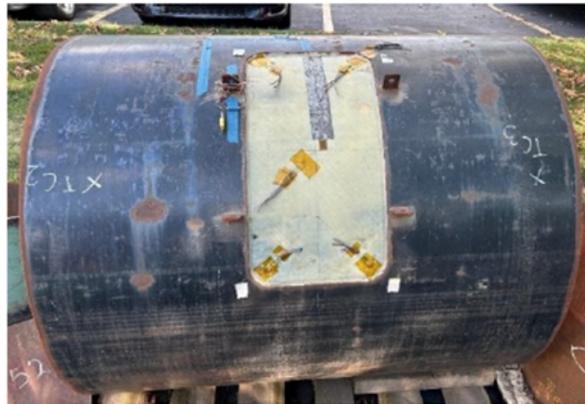
Photo showing cutout region

- DRS inspection was also performed on a CFRP repair on an NRC-owned pipe with a cutout
- The pipe was subjected to hydrostatic blast testing, and stored outdoors for ~2 years exposed to environmental conditions
- The hydrostatic blast testing produced a river-like matrix crack in the missing steel region
- The DRS results showed that the CFRP is well bonded to the steel pipe
- Some areas of the epoxy surface were rough enough to prevent good contact with the DRS scanning head, which resulted in some white pixels in the map that were not flagged as indications
- Two large indications, labeled 1 and 2, were identified as defects, 1 corresponding to the cutout and 2 to a disbond
