# Guideline for the Management of Adverse Localized Equipment Environments

**TR-109619**

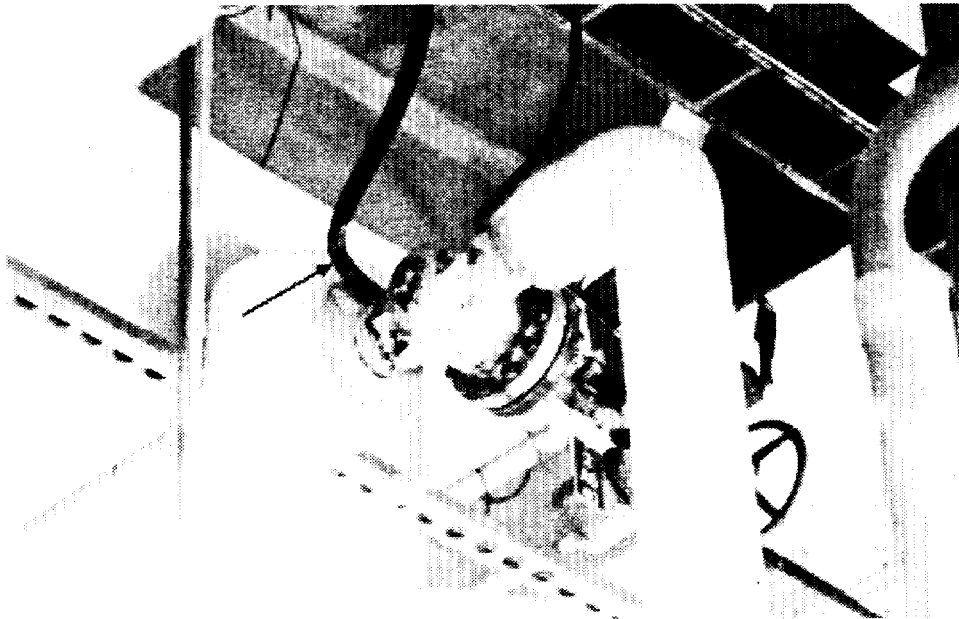
**Figure 3-2**  
**Example of an Installation That Could Create an Adverse Localized Equipment Environment—A Cable Installed near an Uninsulated Valve on a High Temperature Process Line**
