**GOLDEN GATE SWITCHBOARD CO.**  
1125 GOLDEN GATE DRIVE  
P.O. BOX 389  
NAPA, CALIFORNIA 94558

Pursuant to the requirement of Title 10, Chapter 1, Code of Federal Regulations-Energy-Part 21, we wish to report the following:

During the course of tests being run in a switchgear qualification program we have had two component failures indicative of defects which we feel might have implications affecting the safety of nuclear power plants.

The failures occurred during endurance tests of a General Electric Co. AM4.16-350-1200 air circuit breaker, serial no. 269A8794-223. Similar breakers are in use in nuclear power plants throughout the United States of America. These tests are being conducted in connection with a contract to supply switchgear for the Maanshan Nuclear Power Station in Taiwan, Republic of China.

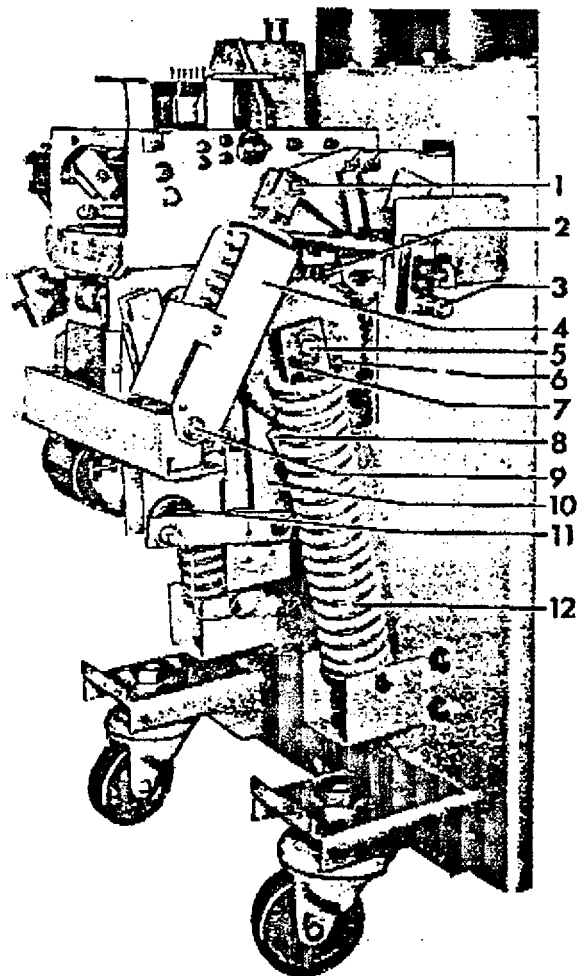
Figure 4. (8040405) Right Side View ML-13 Operating Mechanism

After 1,927 closures (at the rate of approximately 90 per hour), the shaft that mounts the ratchet driving pawl, (Part 8, Figure 4, ref. (1)), broke at the weld allowing the charging mechanism to run continuously without charging the springs.

After a total of 2,282 closures, one of the cotter pins which secure the latching pawl shaft, (Part 2, Fig. 4), broke and the shaft dropped out allowing the charging mechanism to run continuously without charging the springs. The cotter pins were replaced and the test was resumed. After approximately 560 additional operations, one of the replacement cotter pins failed.

1. Upper Spring Pin
2. Latching Pawls
3. Positive Interlock Roller
4. Opening Spring
5. Cam Shaft
6. Ratchet Wheel
7. Bearing Block
8. Driving Pawl
9. Lower Spring Pin
10. Driving Pawl Lever
11. Eccentric
12. Closing Spring

The driving pawl lever, (Part 10, Fig. 4), was replaced and tests were continued.

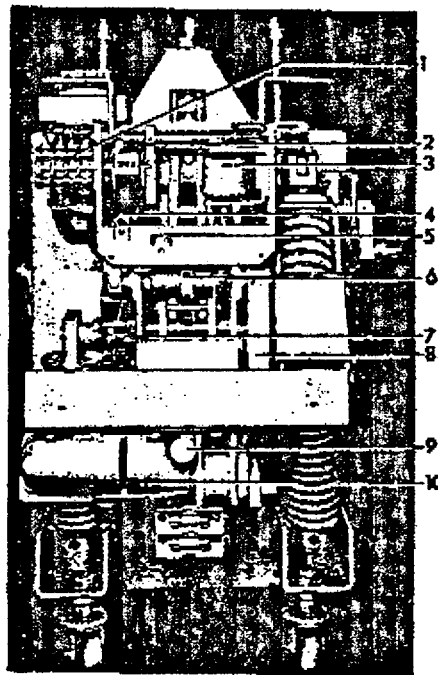
Figure 5. (8034471) Front View ML-13 Operating Mechanism

1. Auxiliary Switch
2. Open - Close Indicator
3. Trip Coil
4. Prop Spring
5. Operation Counter
6. Trip Latch
7. Charge - Discharge Indicator
8. Manual Trip Lever
9. Manual Close Lever
10. Motor

any reason the closing springs should be discharged against the positive interlock the mechanism will be jammed and be inoperable. The mechanism can be released and returned to the reset position by pushing in on the trip lever (8) Figure 5. It may require more than normal force to release the interlock.
