HYDROGEOLOGICAL AND GEOCHEMICAL SITE CHARACTERIZATION REPORT

**Sequoyah Fuels Corporation
I-40 & Highway 10
Gore, Oklahoma 74435**

SUPPLEMENTAL DATA COLLECTION TRIP REPORT

April 2002

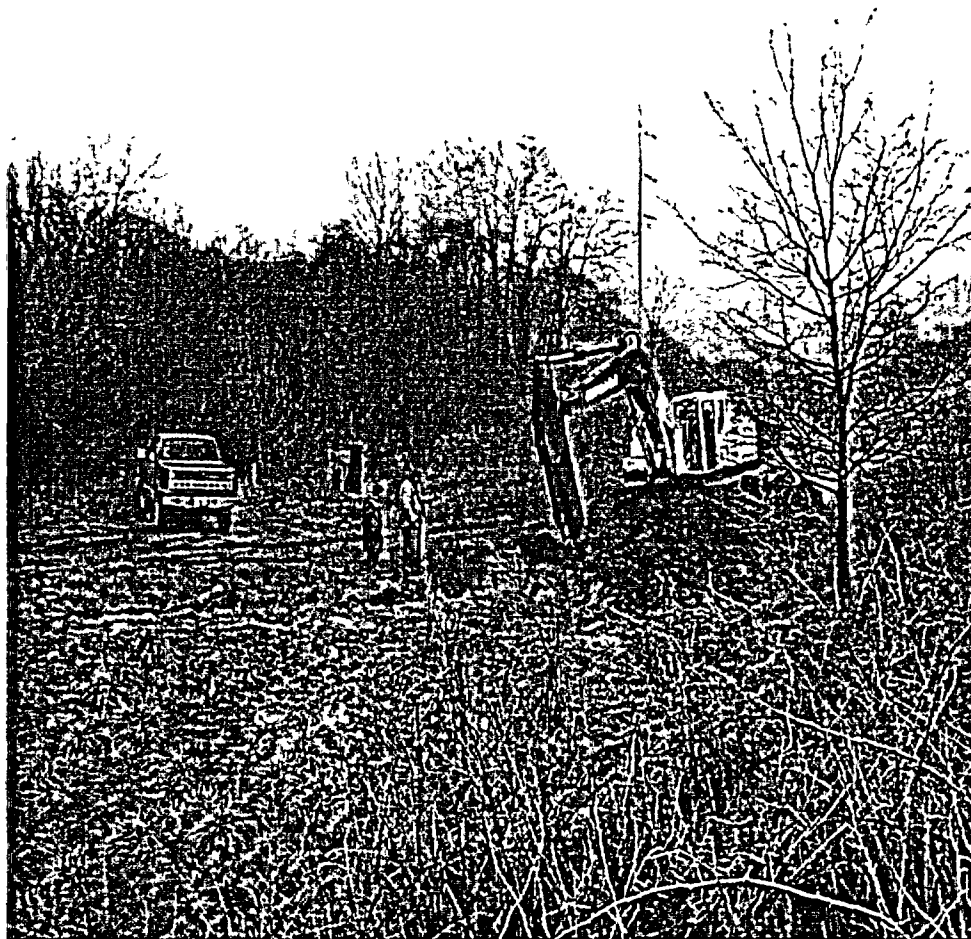
Photo 1

A track hoe was used to excavate down to competent bedrock (Photo 1). The excavation stratigraphy was documented and visually logged by a professional geologist from the top of the trench wall, and digital photographs were taken of the excavation. The end points of the trench

Excavation of 005 Drainage Trench 1 at Head of Drainage

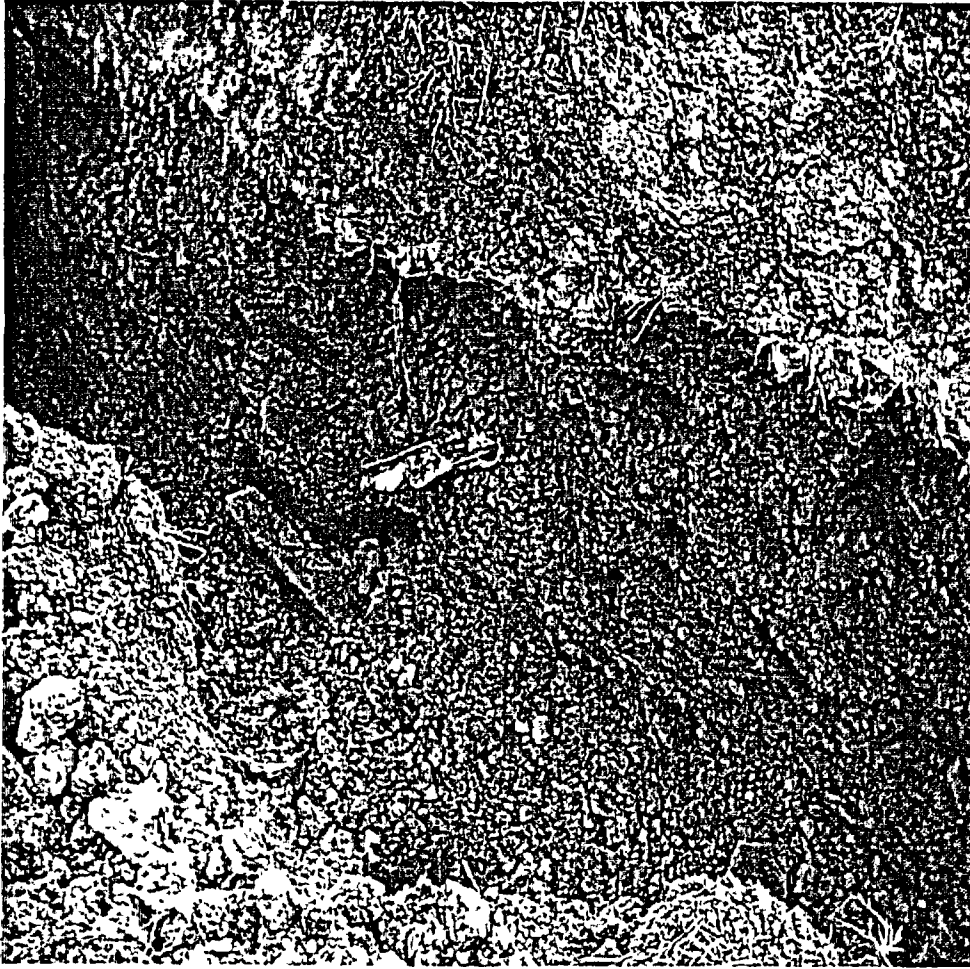
Photo 2

The clayey gravel unit was covered with roughly five to six feet of fill material consisting of clay with gravel and sand (Photo 2). The fill material is believed to be re-worked terrace deposits cut from higher portions of the site during facility construction. A layer of 10-mil black plastic was observed below the upper one to two feet of fill. This liner was apparently placed to reduce infiltration into the fill. The one to two feet of fill above the plastic liner was observed to be reddish brown clay that contained a trace of gravel.

Photograph of 005 Drainage Trench 1 Features, South End
