Subject: Biological Assessment for Crystal River Unit 3 (TAC No. MA1706)

# **Biological Assessment of Impact to Sea Turtles at Florida Power Corporation's Crystal River Energy Complex**

**Prepared by  
Florida Power Corporation**

**October 1, 1998**

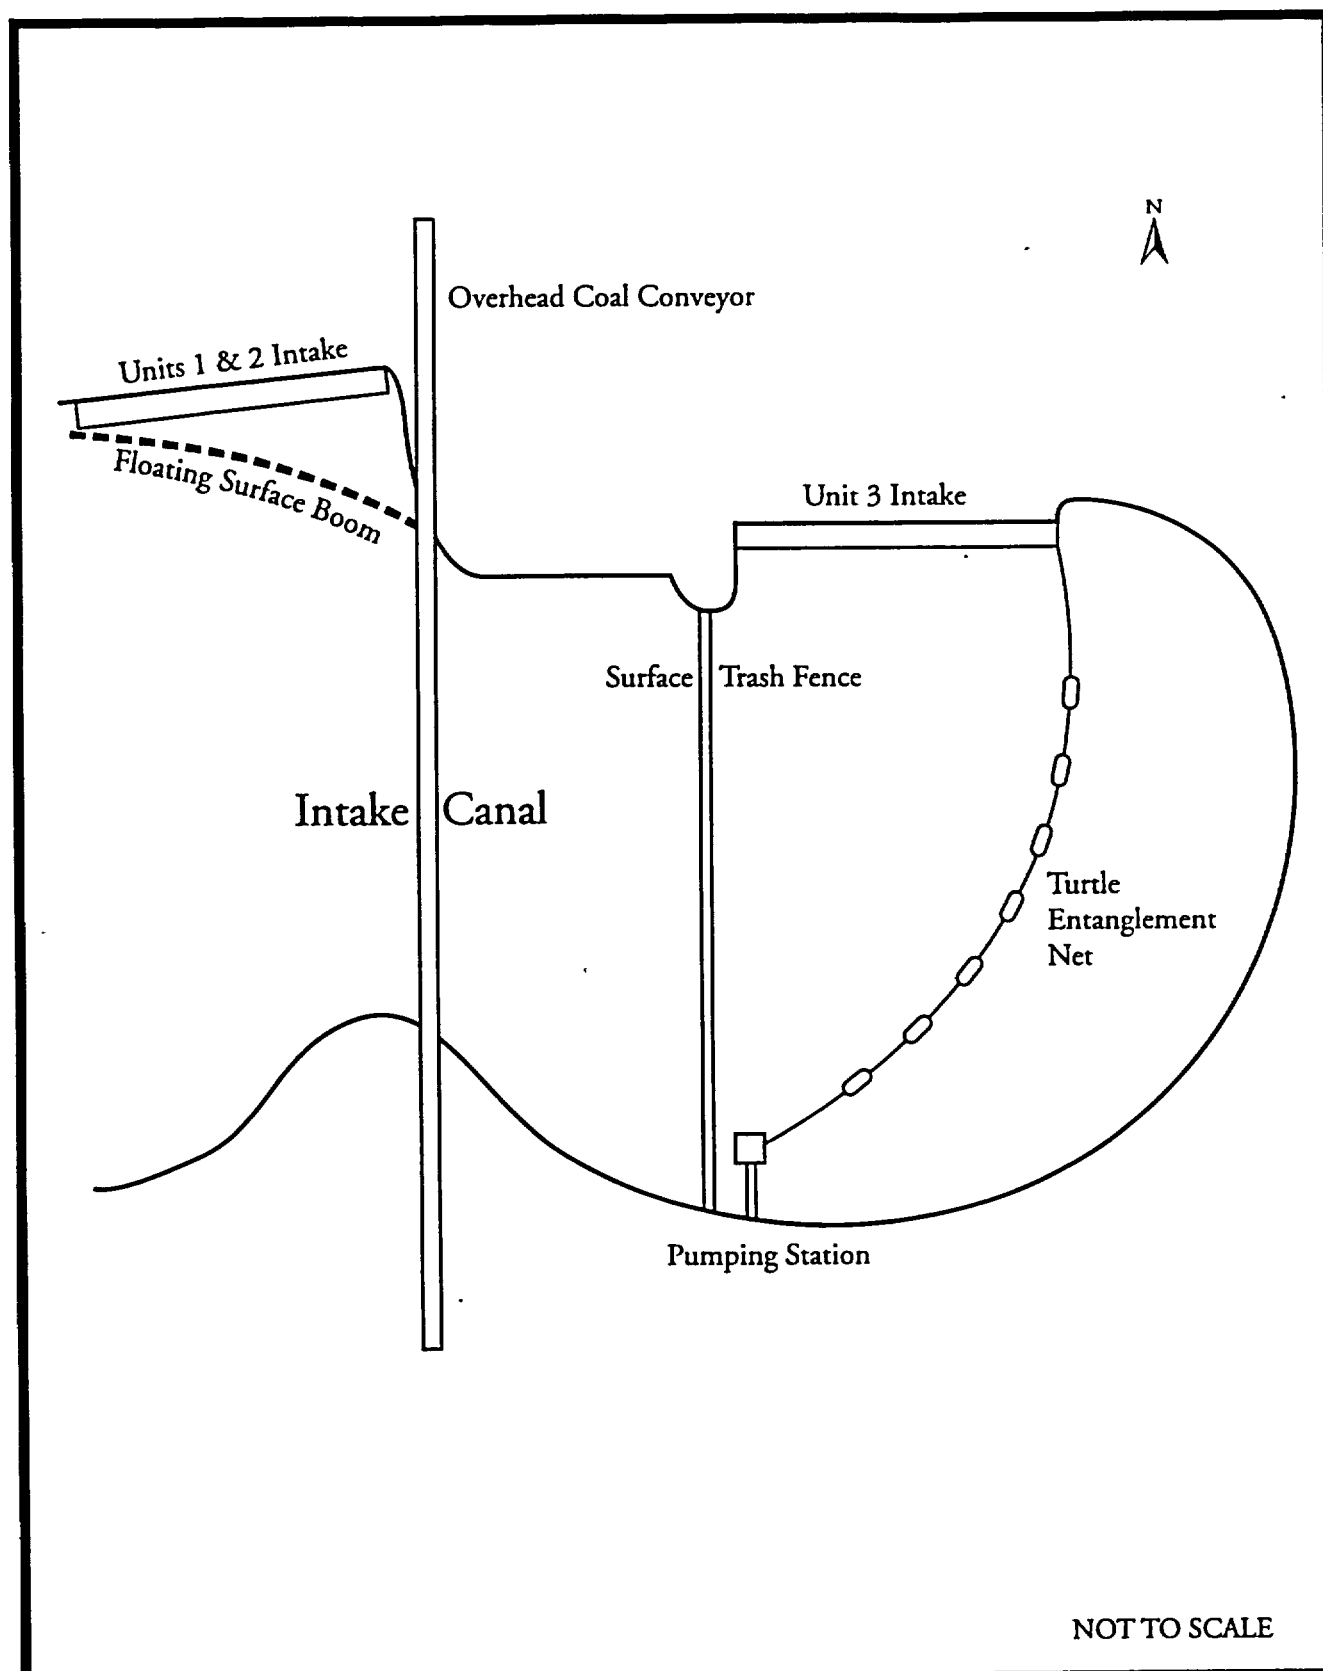
**FIGURE 3**

*Orientation of turtle entanglement net deployed in the intake canal.*

The consultant deployed a 45 m long, 6 m deep net in front of the Unit 3 intake structure (Figure 3). The net was deployed during daylight hours and fished for a total of 16 hours over three days. The net was constantly monitored from a johnboat while being fished. No turtles were captured during the netting effort, although turtles were observed in the intake canal. FPC has pursued improved netting techniques to increase the likelihood of turtle capture success should subsequent netting attempts be considered.
