Figure 8-105. PCCV Liner Seam Rat-Hole Study, Horizontal Strain Contour, Case 10, LST Strain Gage Data Superimposed at 2.8 Pd

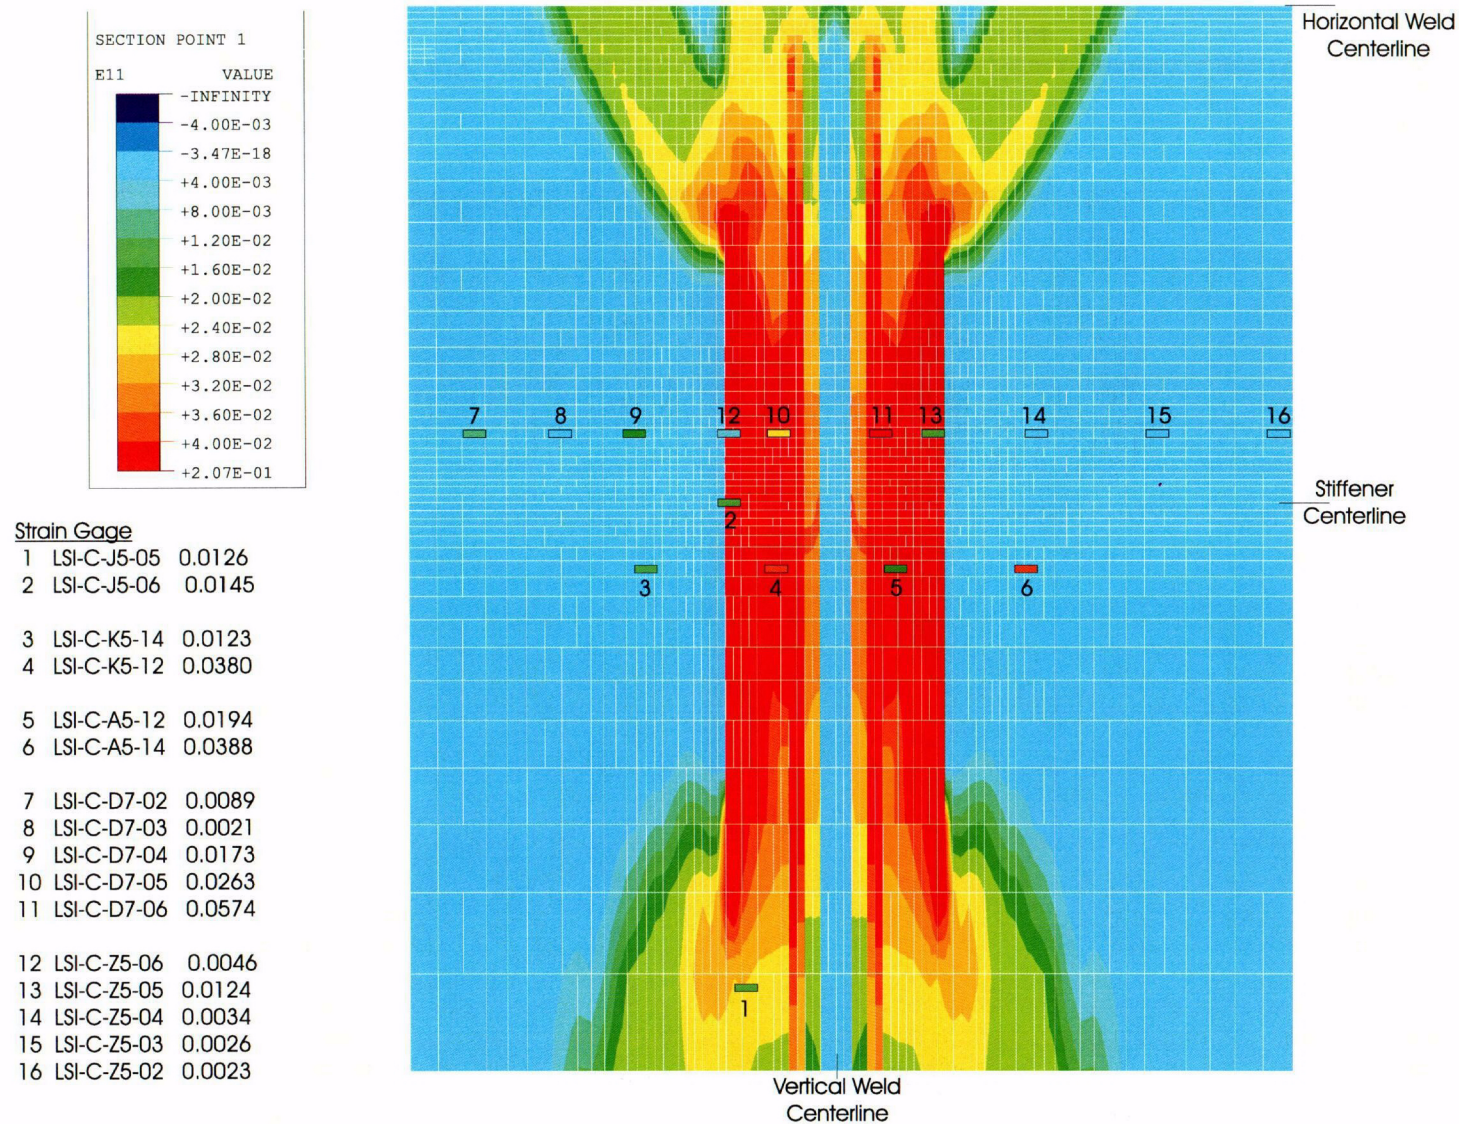
Figure 8-106. PCCV Liner Seam Rat-Hole Study, Horizontal Strain Contour, Case 10, LST Strain Gage Data Superimposed at 3.3 Pd

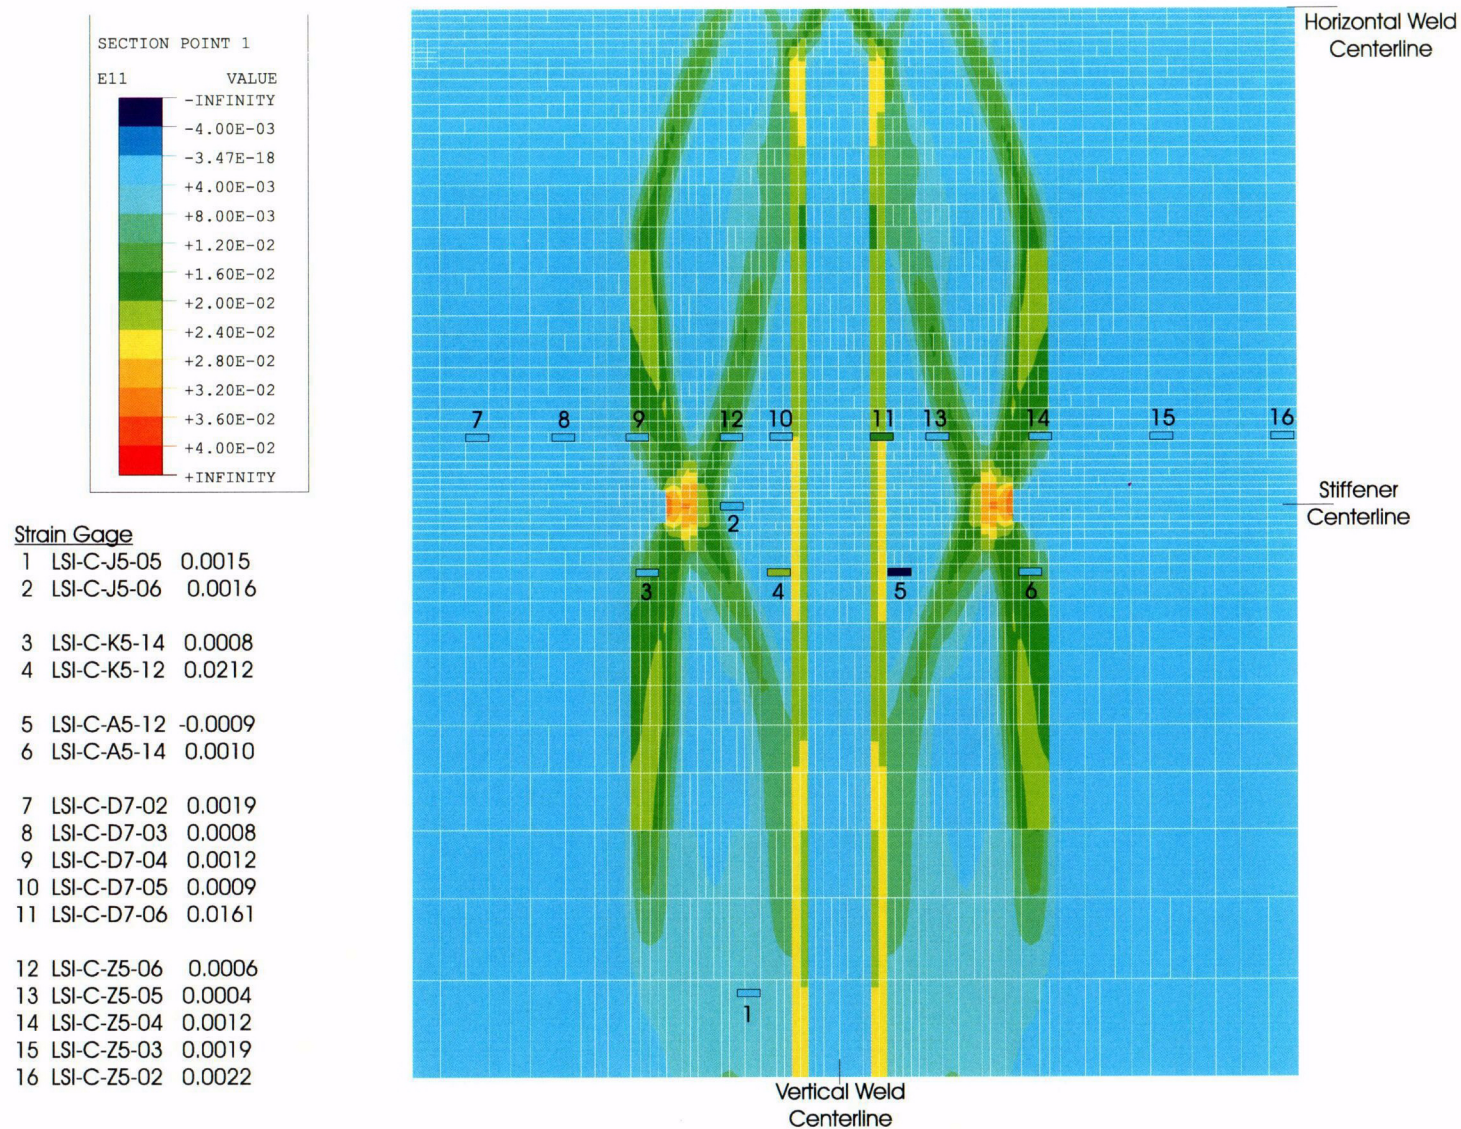
Figure 8-107. PCCV Liner Seam Rat-Hole Study, Horizontal Strain Contour, Case 11, LST Strain Gage Data Superimposed at 2.8 Pd

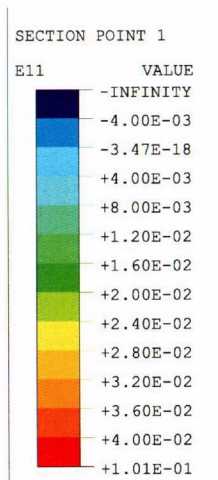
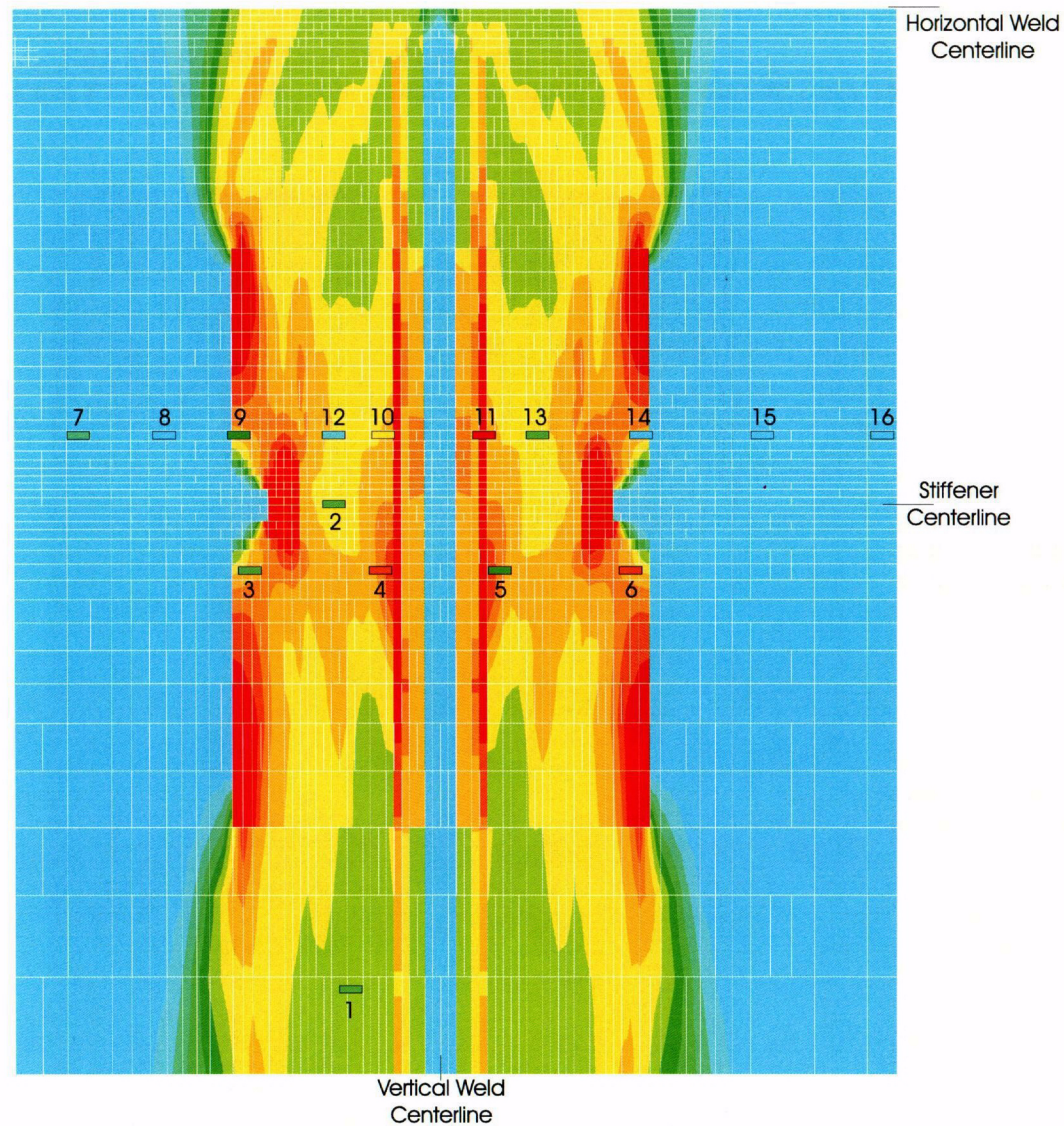
1	LSI-C-J5-05	0.0126
2	LSI-C-J5-06	0.0145
3	LSI-C-K5-14	0.0123
4	LSI-C-K5-12	0.0380
5	LSI-C-A5-12	0.0194
6	LSI-C-A5-14	0.0388
7	LSI-C-D7-02	0.0089
8	LSI-C-D7-03	0.0021
9	LSI-C-D7-04	0.0173
10	LSI-C-D7-05	0.0263
11	LSI-C-D7-06	0.0574
12	LSI-C-Z5-06	0.0046
13	LSI-C-Z5-05	0.0124
14	LSI-C-Z5-04	0.0034
15	LSI-C-Z5-03	0.0026
16	LSI-C-Z5-02	0.0023

Figure 8-108. PCCV Liner Seam Rat-Hole Study, Horizontal Strain Contour, Case 11, LST Strain Gage Data Superimposed at 3.3 Pd

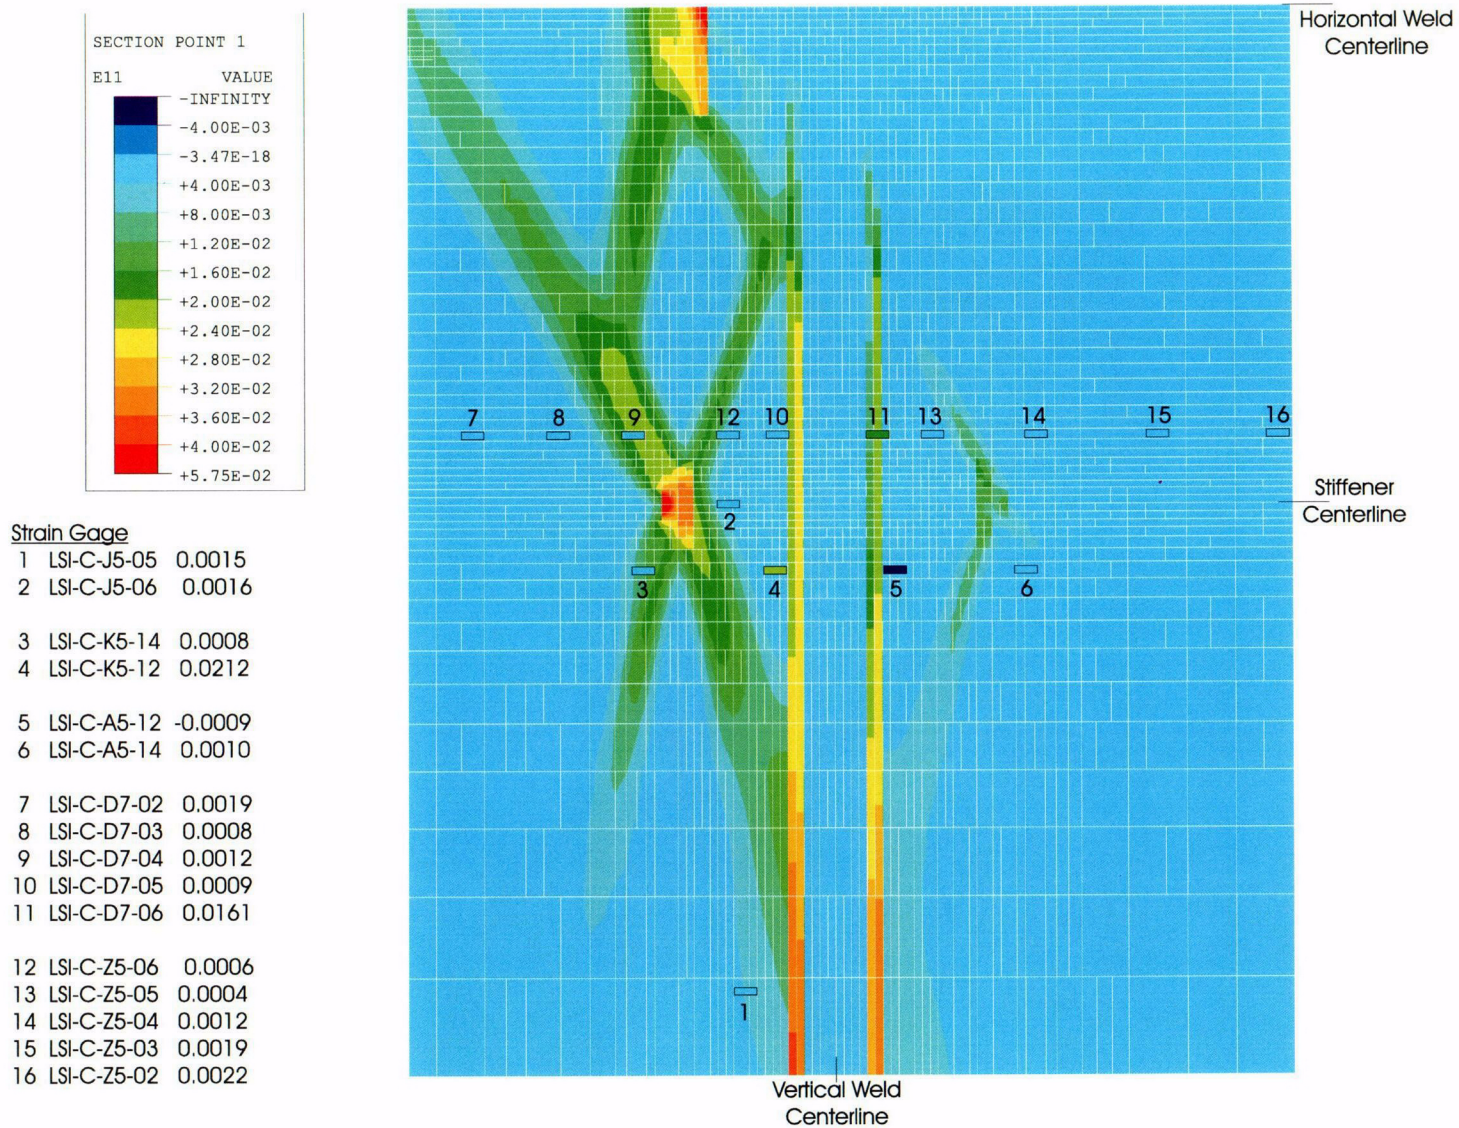
Figure 8-109. PCCV Liner Seam Rat-Hole Study, Horizontal Strain Contour, Case C4, □
LST Strain Gage Data Superimposed at 2.8 Pd

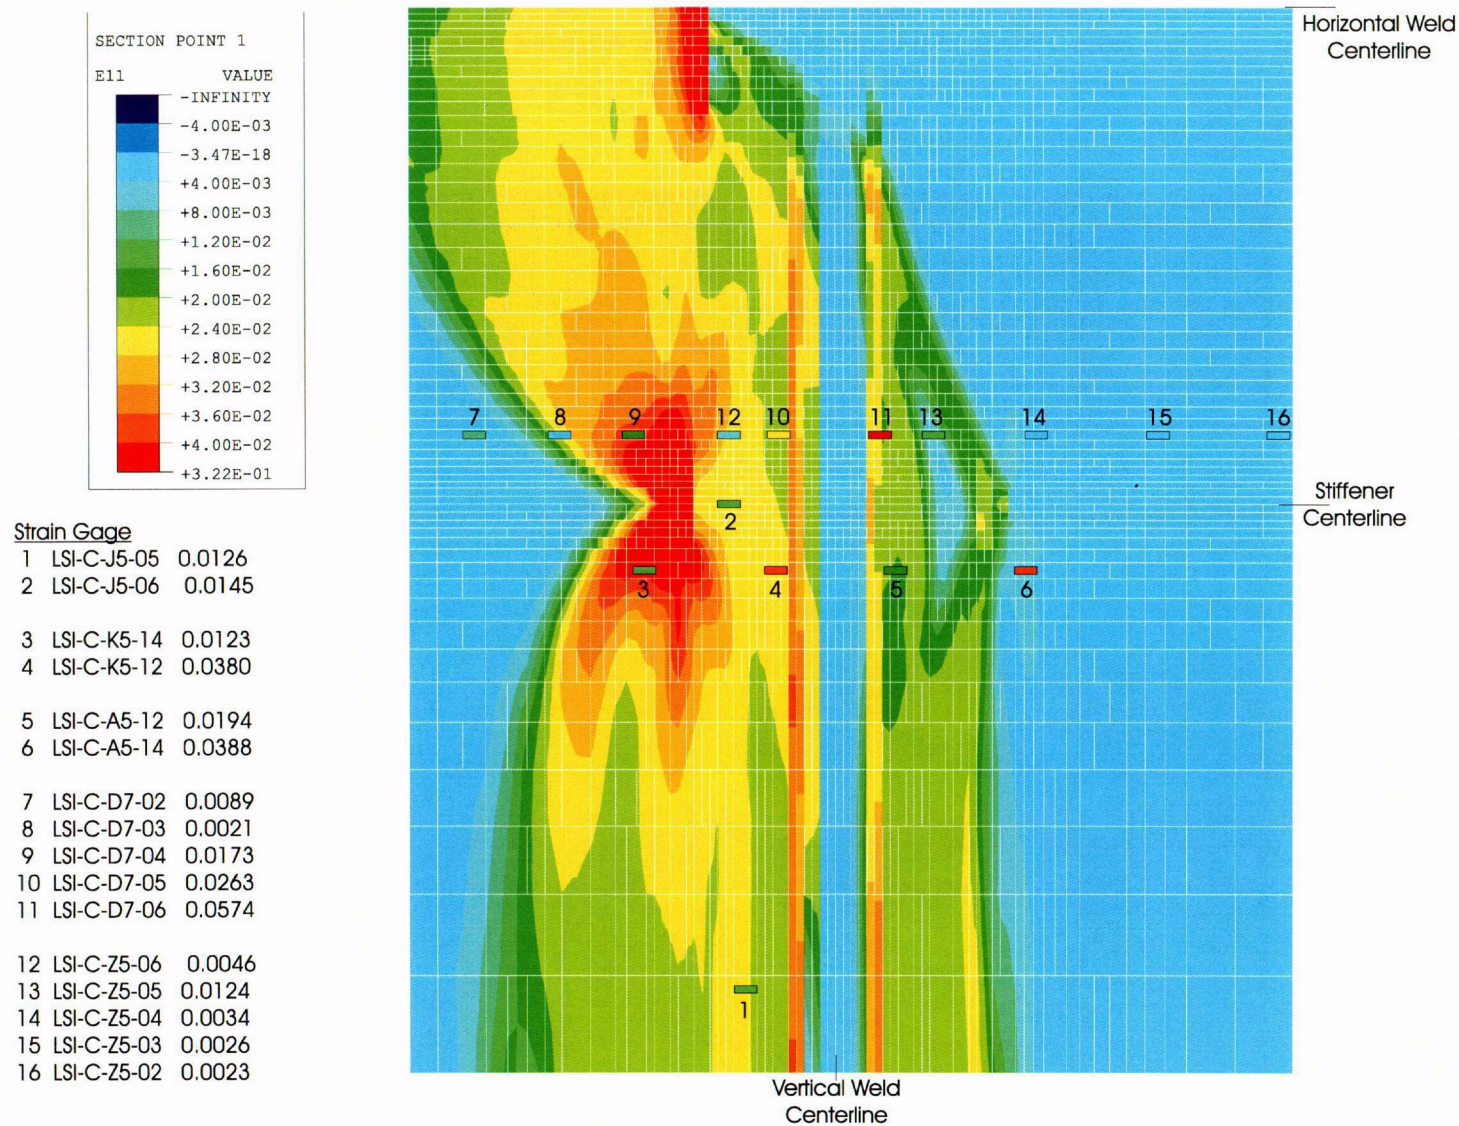
Figure 8-110. PCCV Liner Seam Rat-Hole Study, Horizontal Strain Contour, Case C4, □
LST Strain Gage Data Superimposed at 3.3 Pd

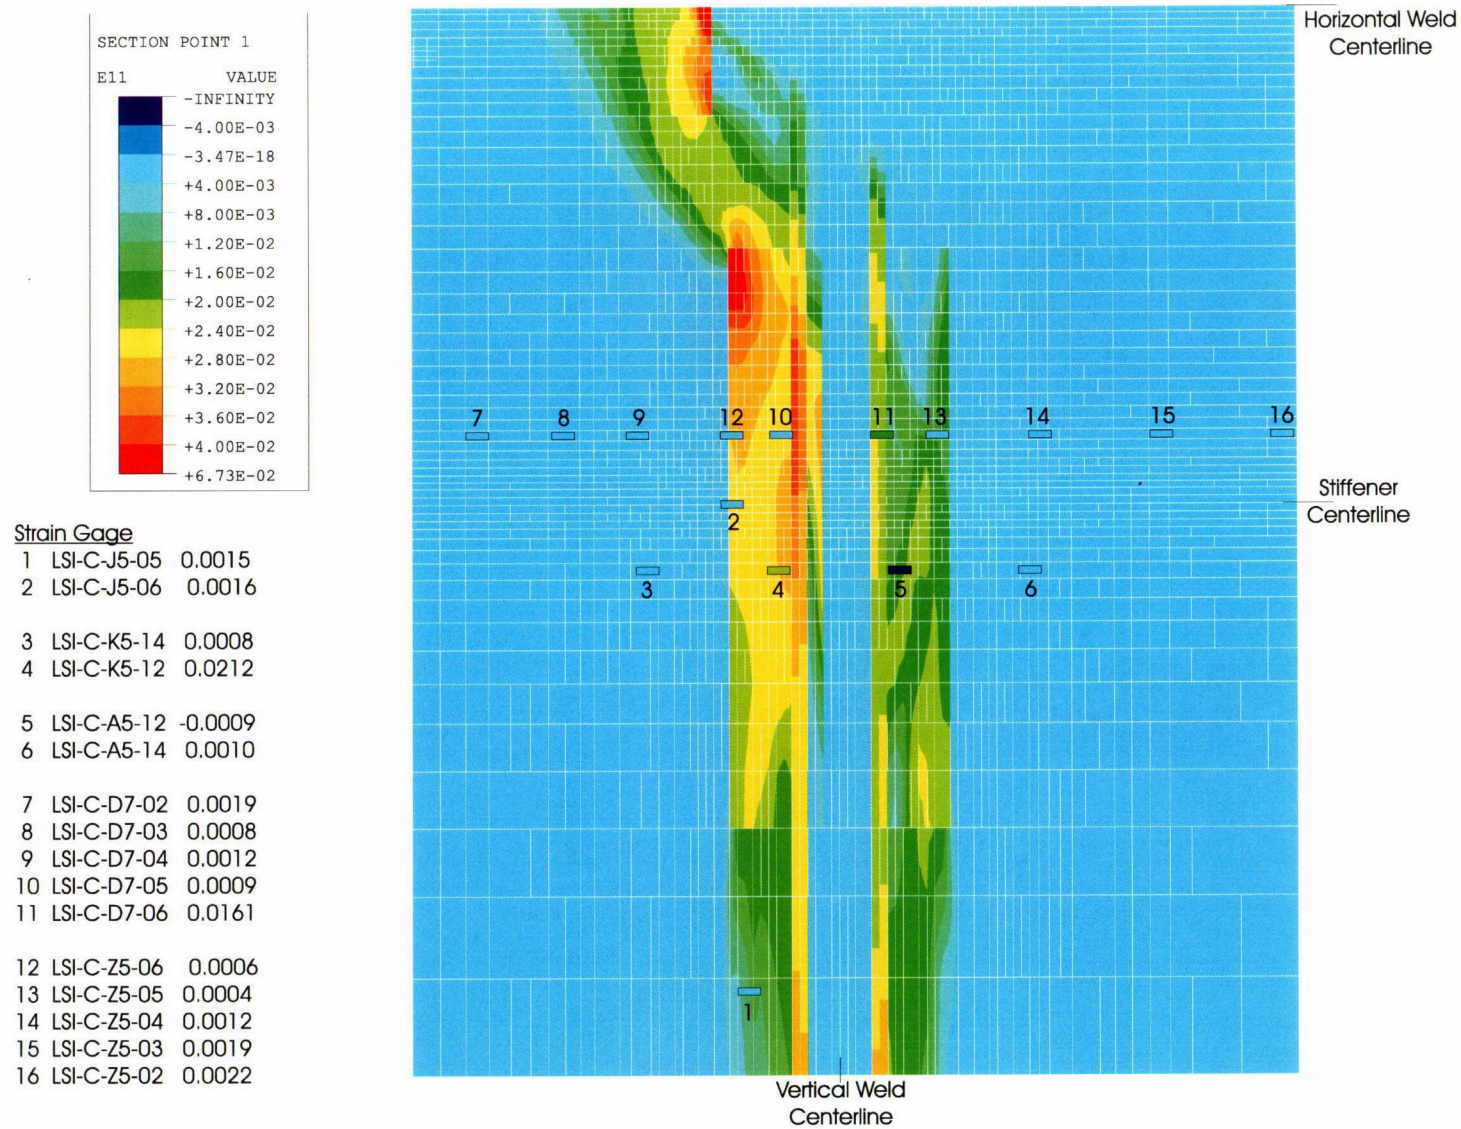
Figure 8-111. PCCV Liner Seam Rat-Hole Study, Horizontal Strain Contour, Case C5, ☐
LST Strain Gage Data Superimposed at 2.8 Pd

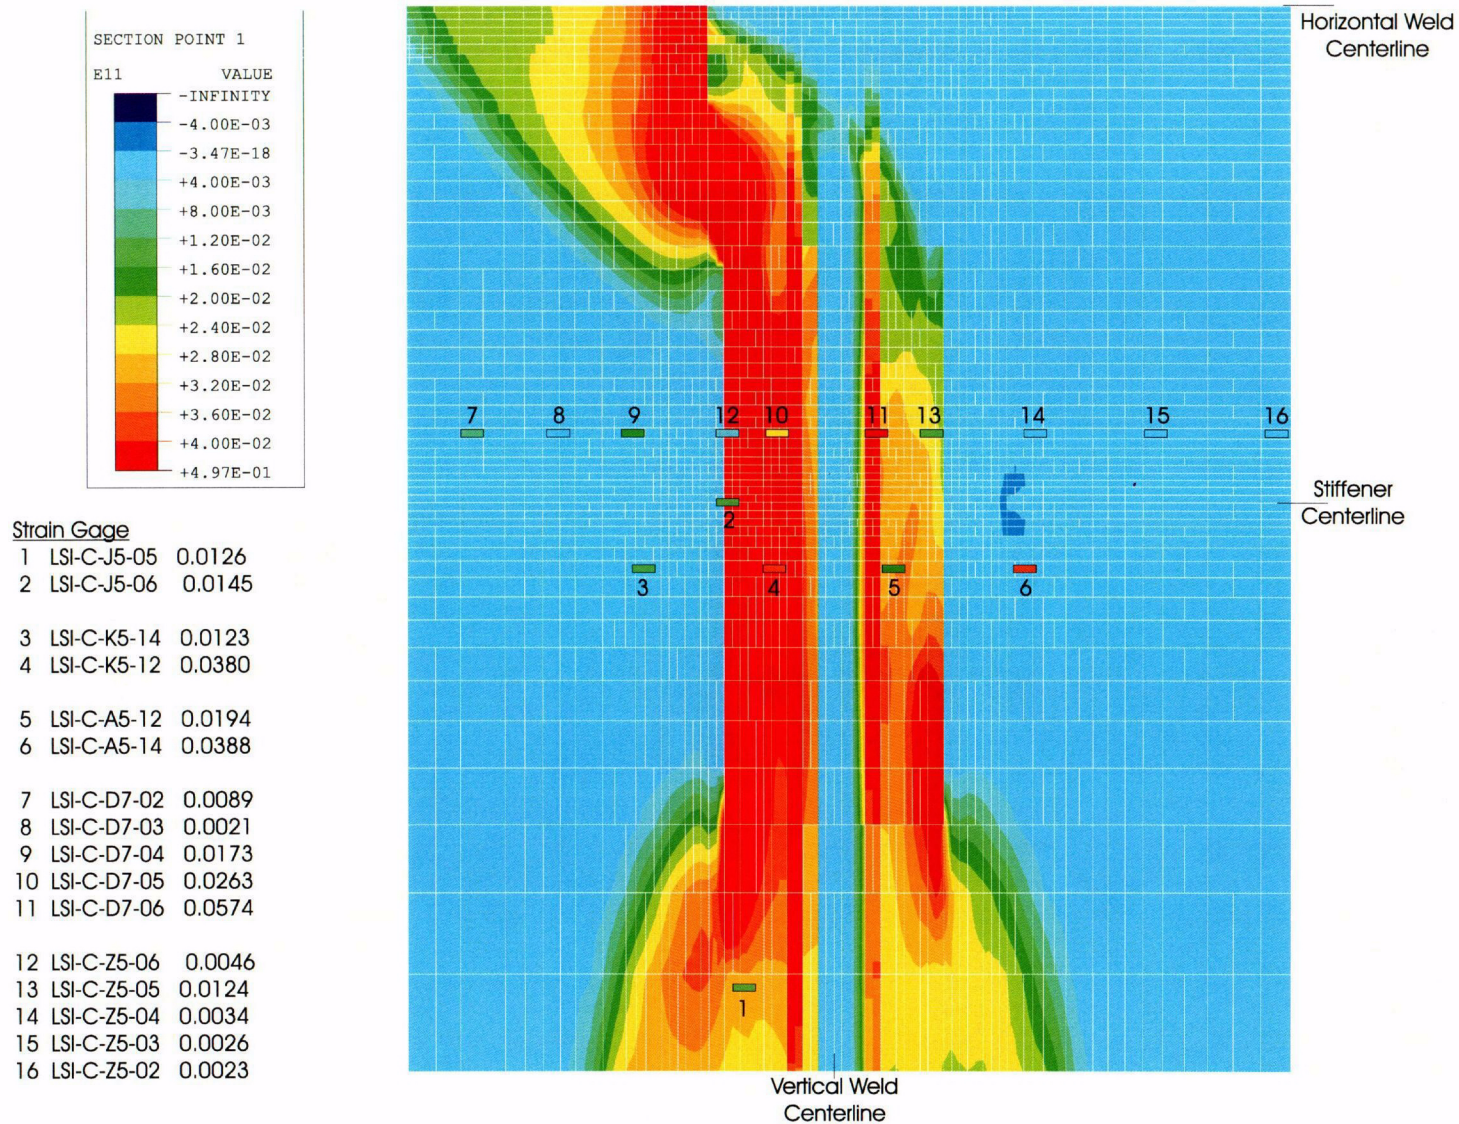
Figure 8-112. PCCV Liner Seam Rat-Hole Study, Horizontal Strain Contour, Case C5, \square
LST Strain Gage Data Superimposed at 3.3 Pd

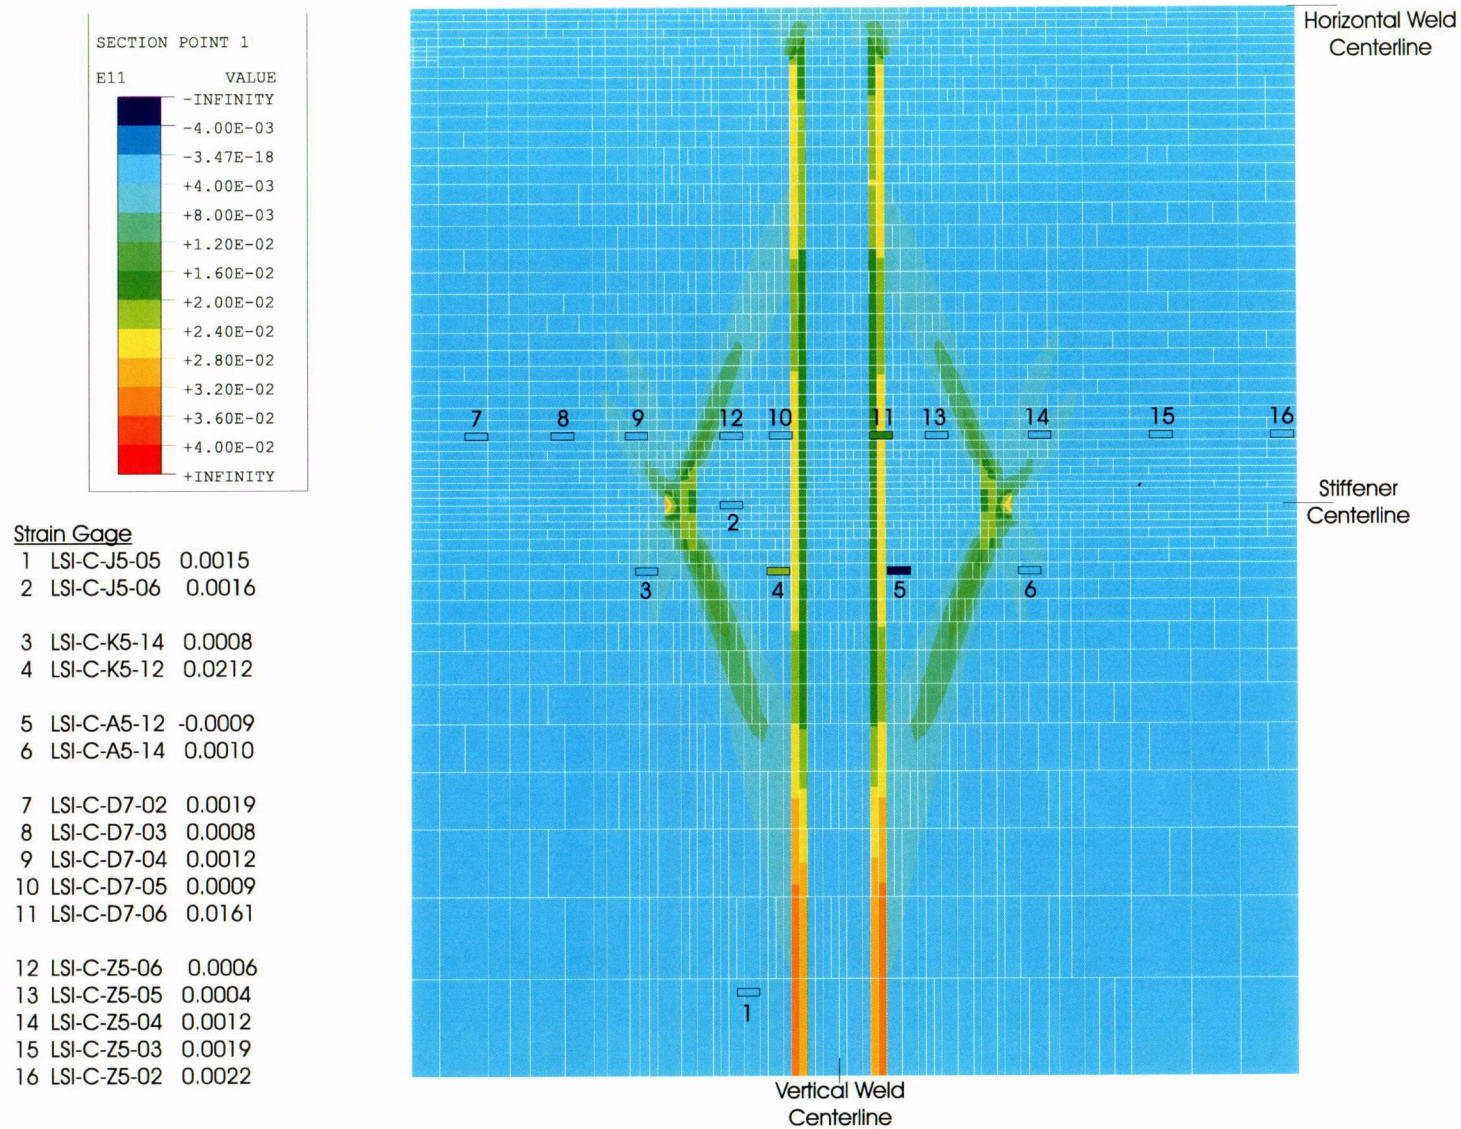
Figure 8-113. PCCV Liner Seam Rat-Hole Study, Horizontal Strain Contour, Case C6, ☐
LST Strain Gage Data Superimposed at 2.8 Pd

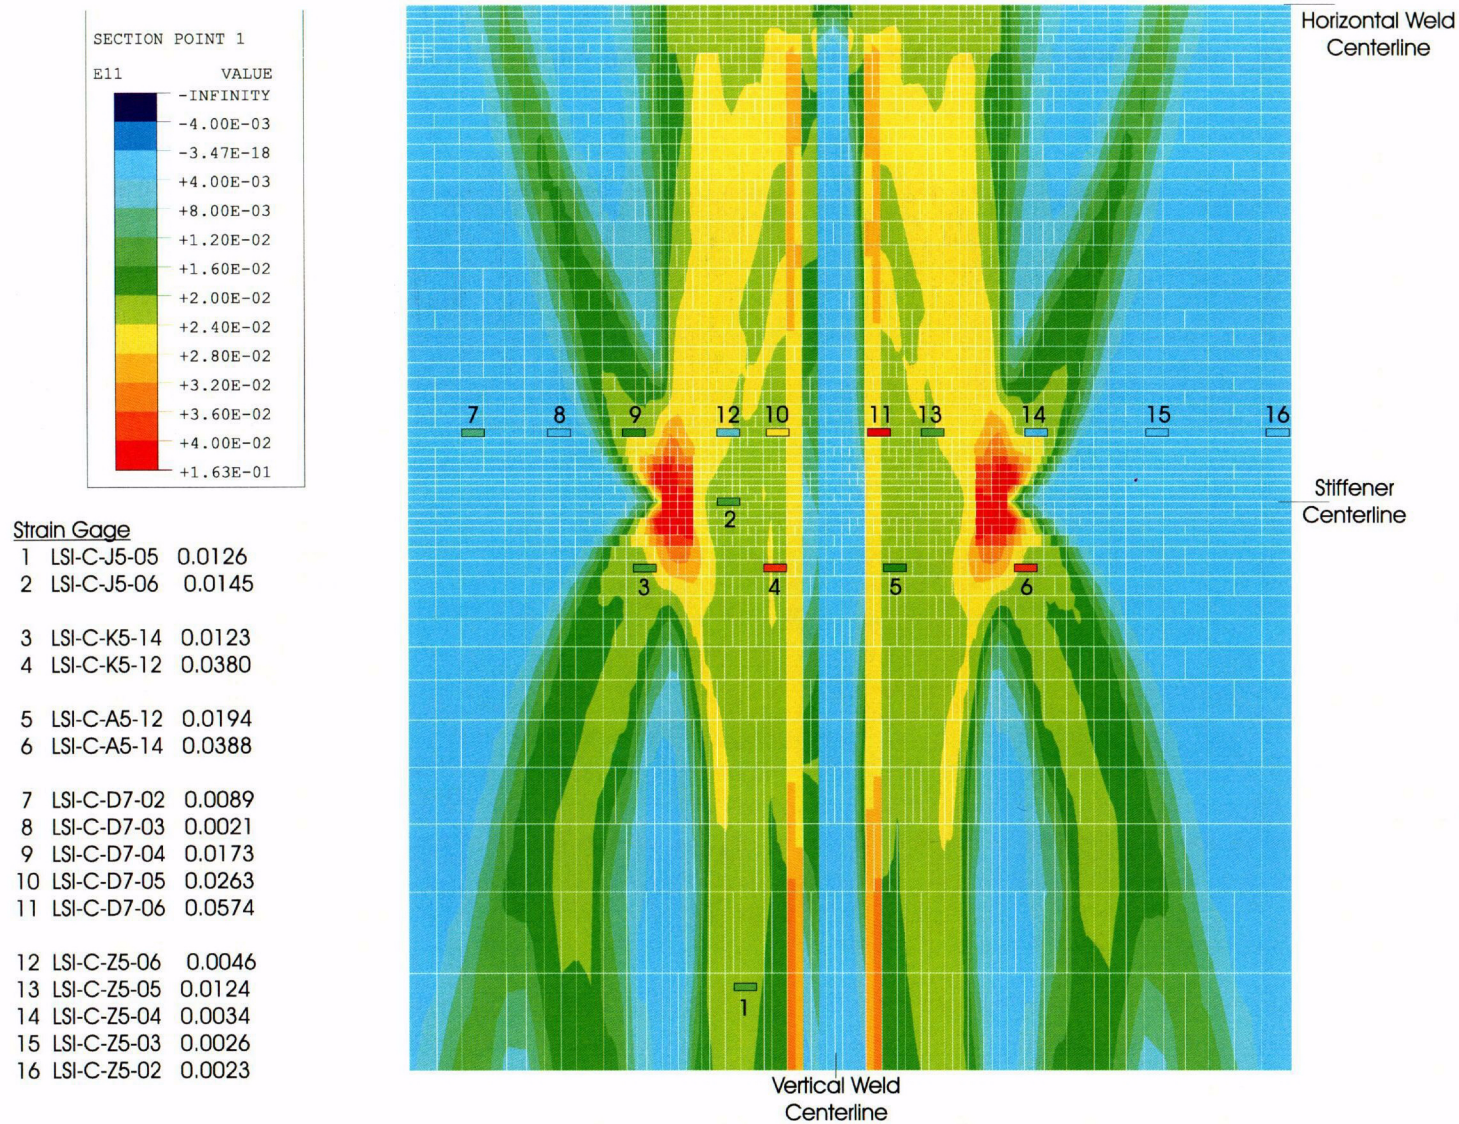
Figure 8-114. PCCV Liner Seam Rat-Hole Study, Horizontal Strain Contour, Case C6, □
LST Strain Gage Data Superimposed at 3.3 Pd
