Recent results from LOCA study at JAERI

Fumihisa Nagase
Japan Atomic Energy Research Institute

ANL Review Meeting
July 16 – 17, 2003

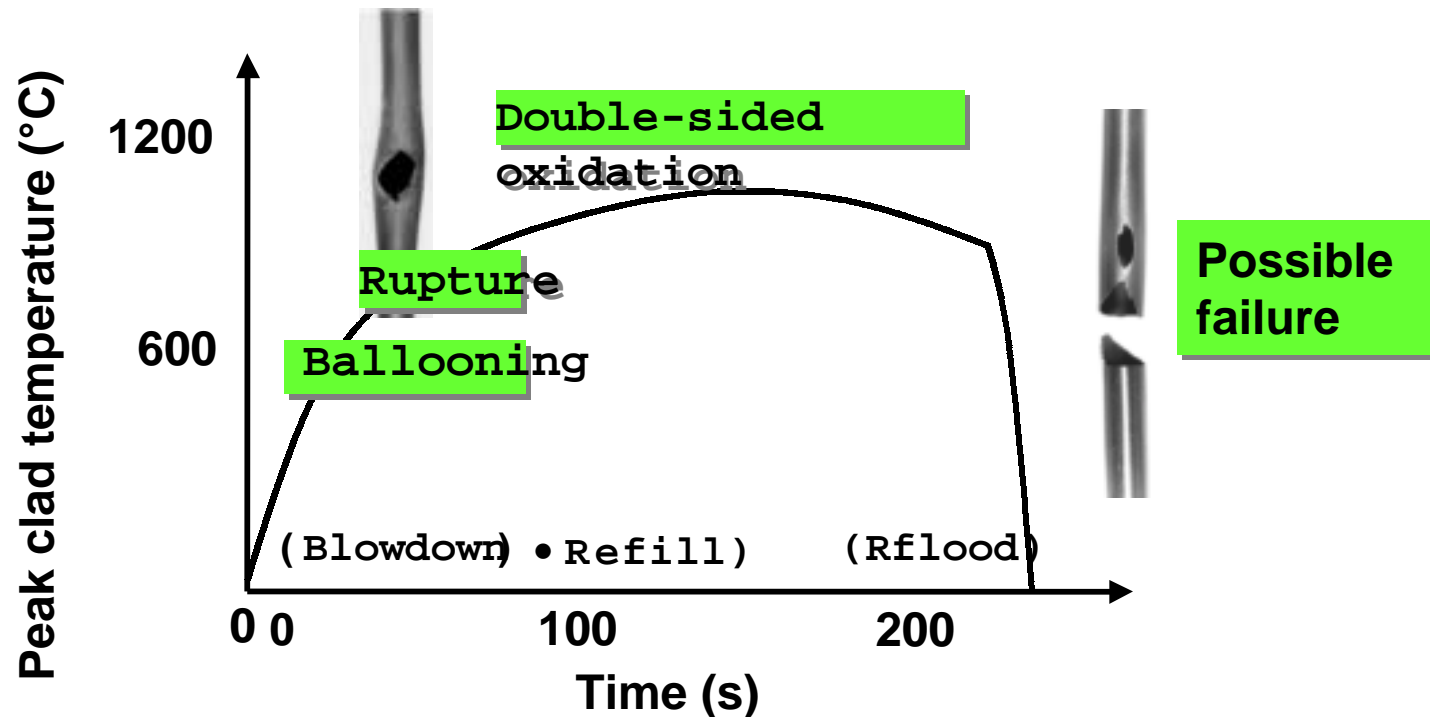
Behavior under LOCA conditions

Ballooning (Wall thinning), Rupture, Double-sided oxidation, Secondary hydriding induced by inner surface oxidation

- Embrittlement of cladding
- Possible spilt failure or fragmentation on quenching when severely embrittled

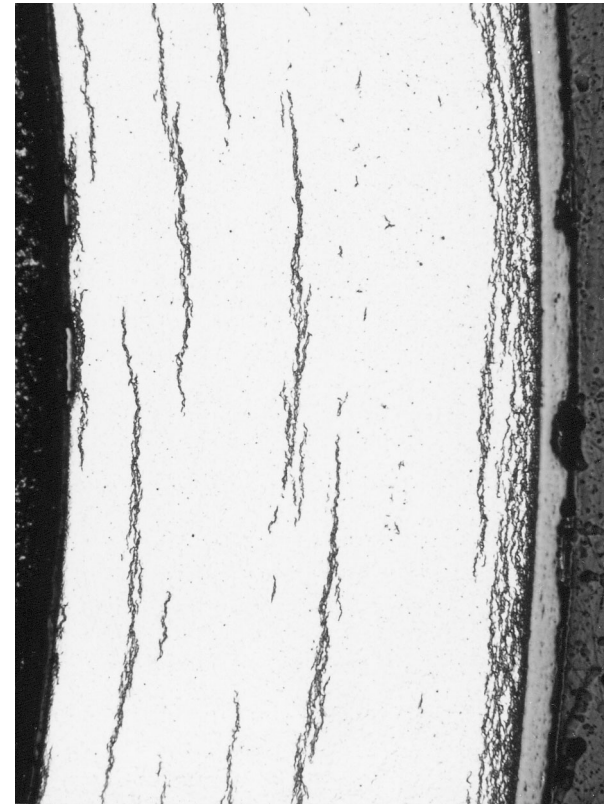
Hydrides

Oxide layer

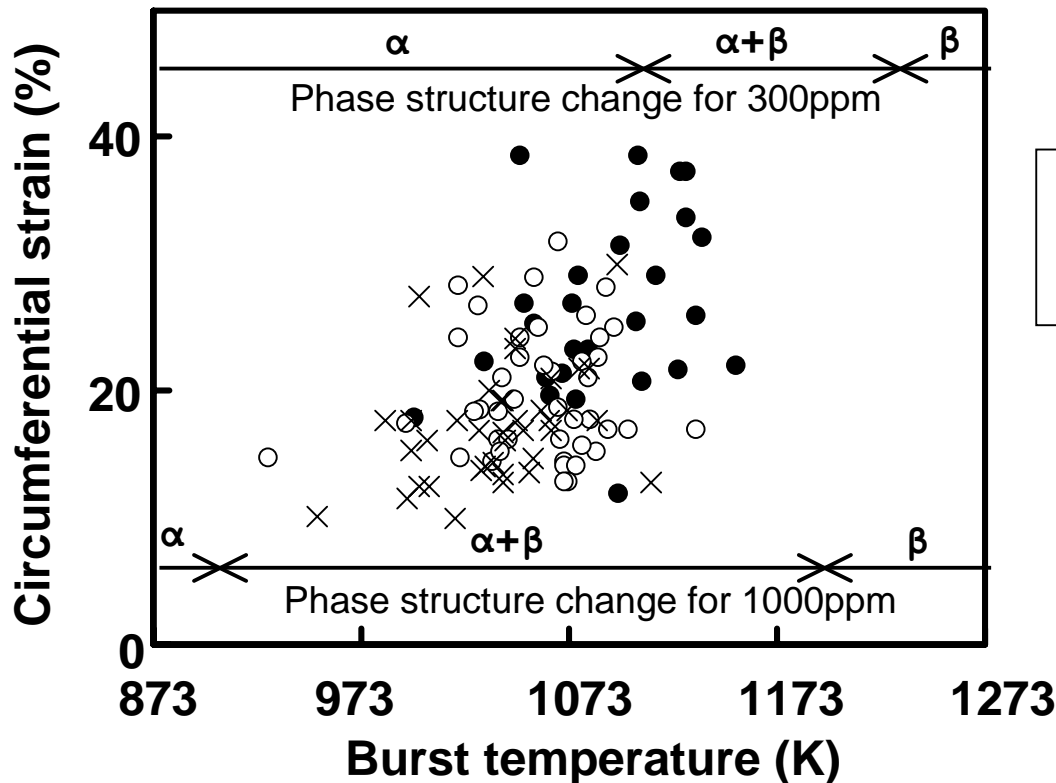
Hydrogen effect on burst strain

Conditions

- PWR 600mm rod
- Heated length 450mm
- 8mmOD Al_2O_3 pellet
- Initial pressure 5MPa
- Filled with Ar

Increase of hydrogen concentration causes

- Decrease of burst temperature
- Shift of phase structure boundaries
- Consequent decrease of burst strain

Increase of hydrogen concentration causes decrease of rupture temperature and shift of phase structure boundaries, resulting in decrease of burst strain.

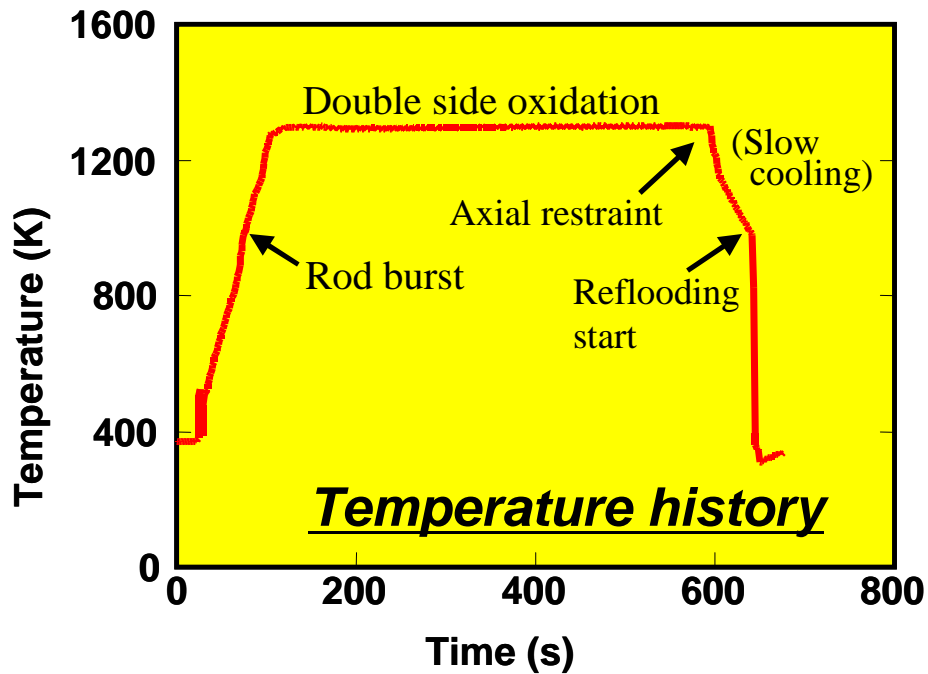
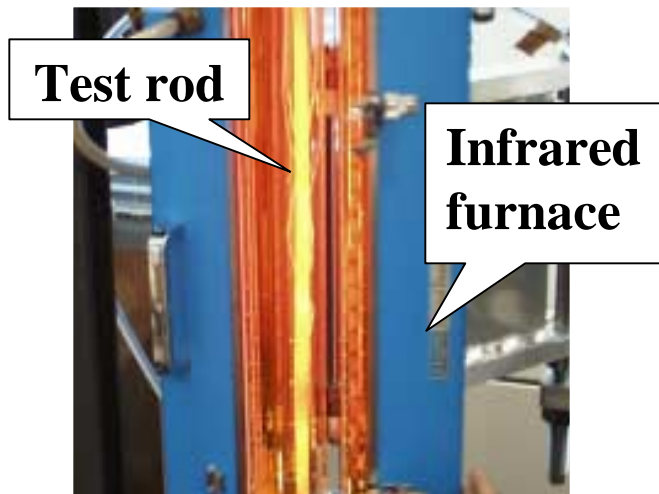
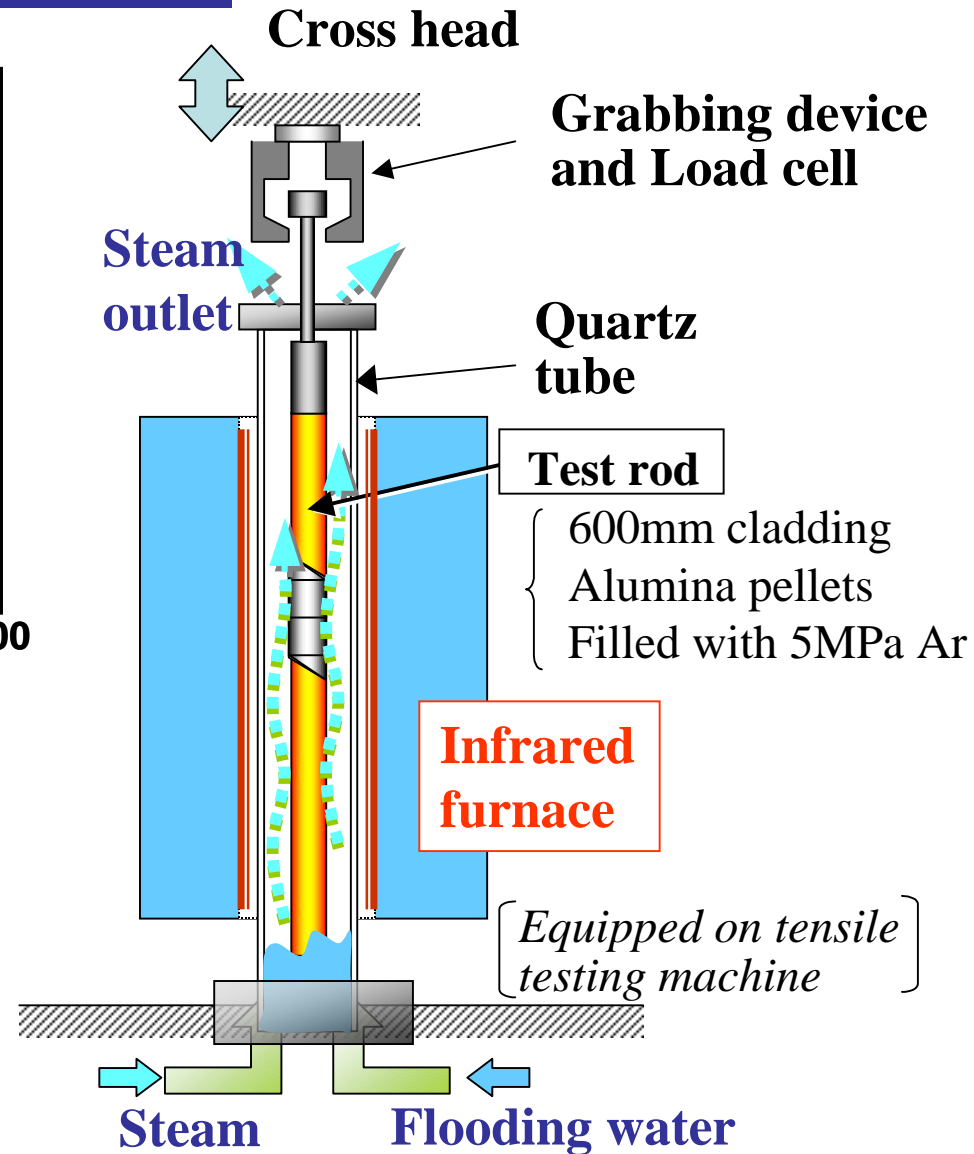
Schematic drawing of test apparatus

Integral thermal shock test

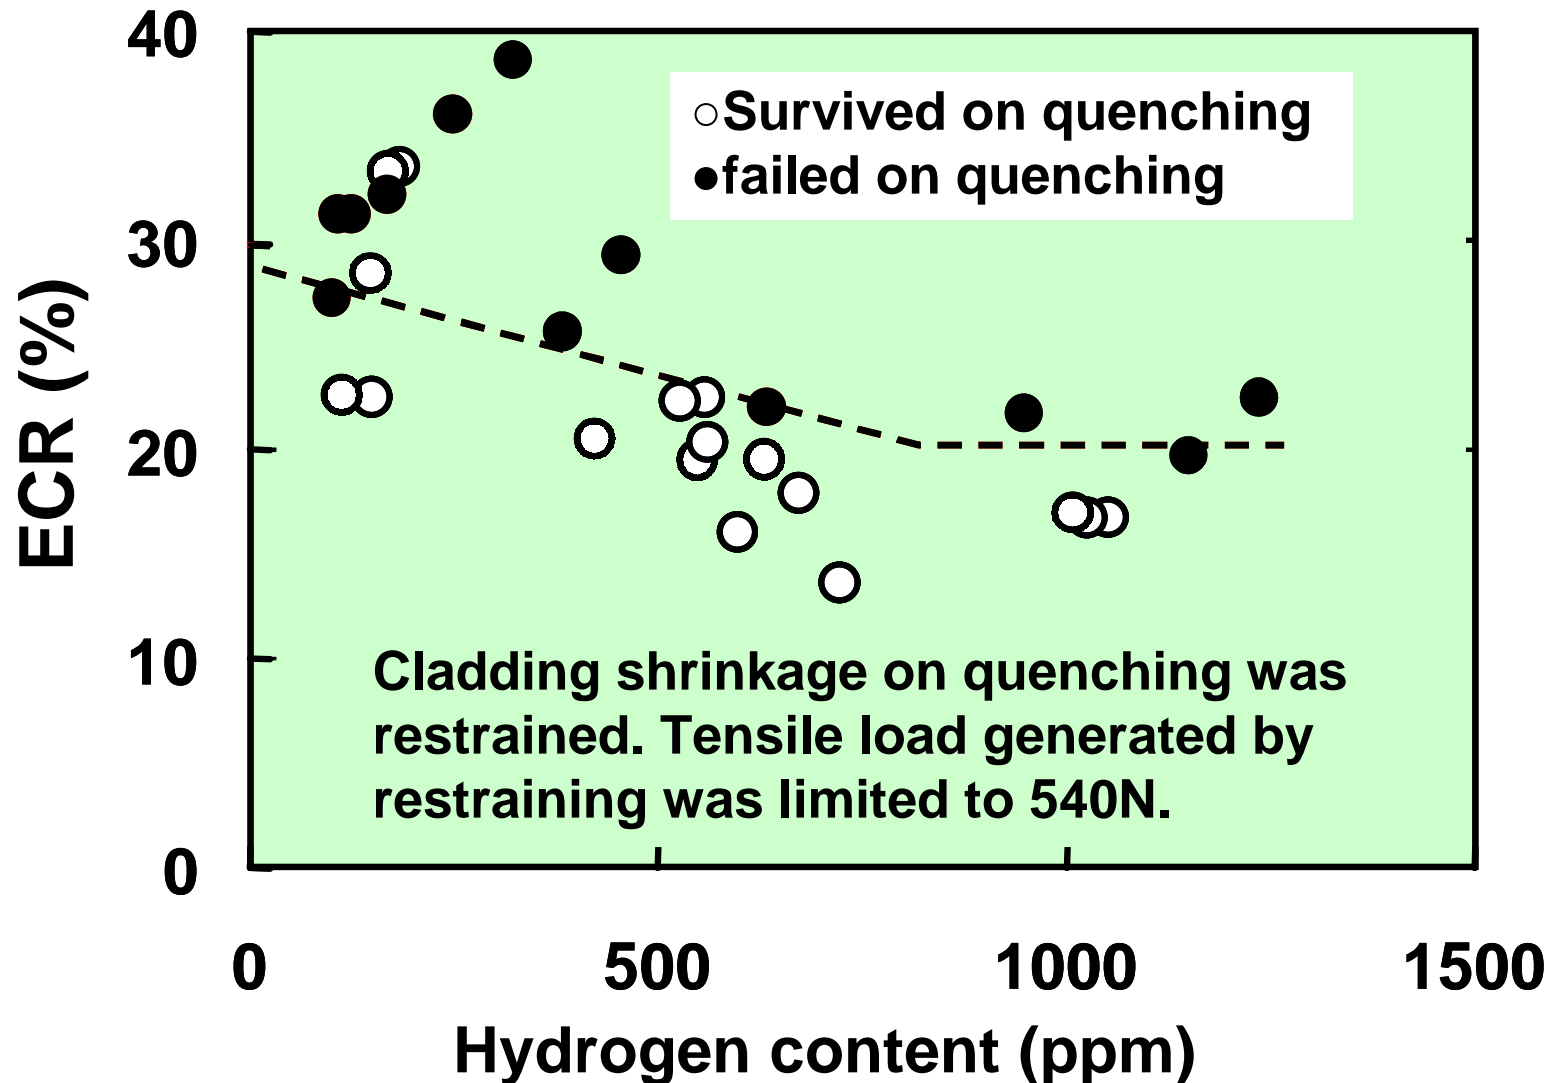
Hydride effect on failure boundary

Results from the tests under restraint condition
for artificially hydrided (unirradiated) Zircaloy-4 cladding

The influence of pre-hydriding was obviously seen on the failure threshold value under restraint conditions, while it was not seen under non-restraint condition.

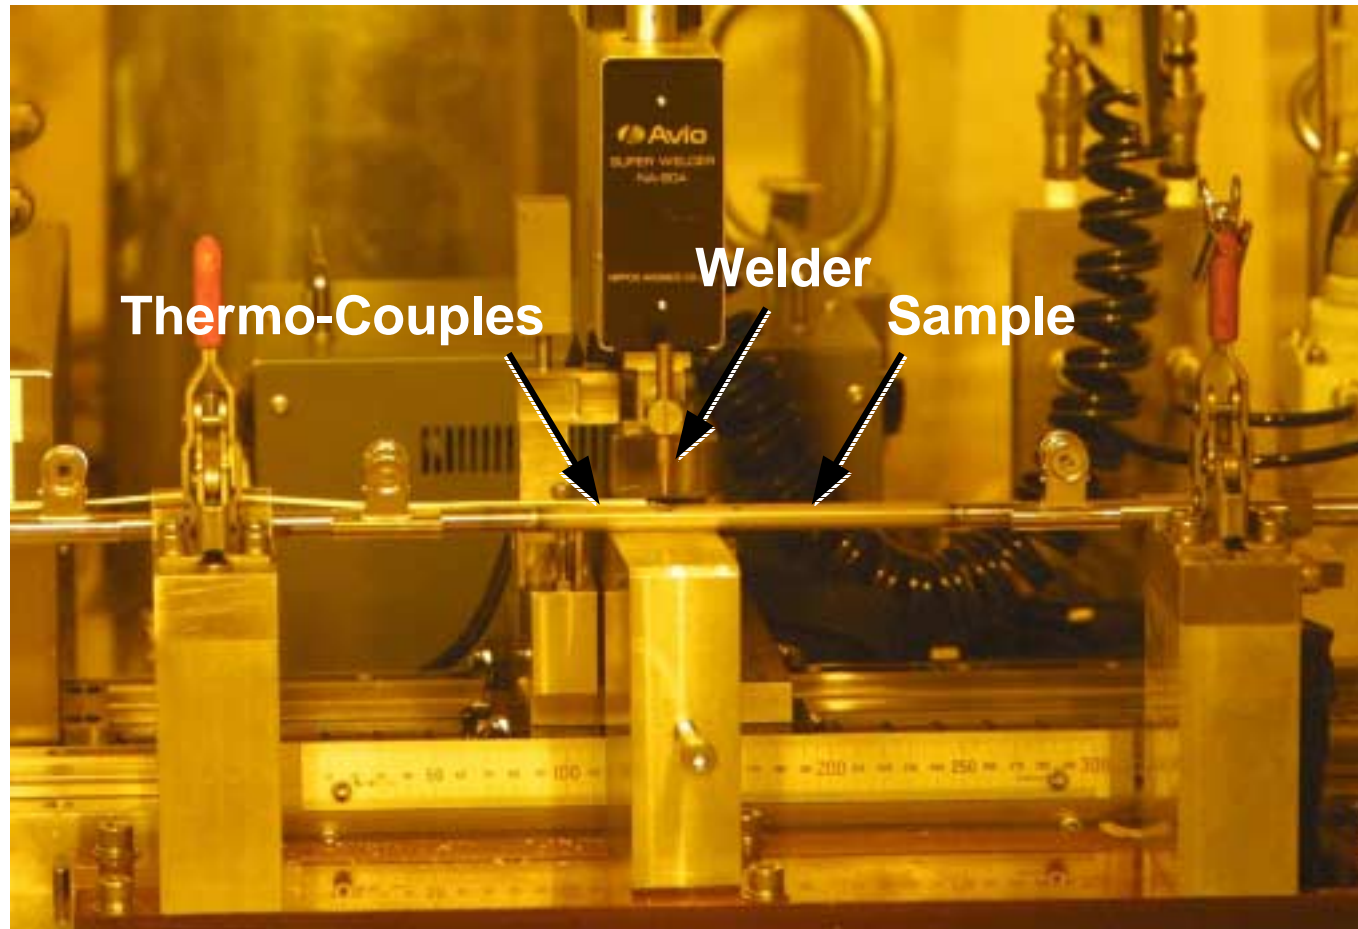
Thermo-Couples Spot-welding Apparatus

Four TCs are welded at different axial and circumferential positions.

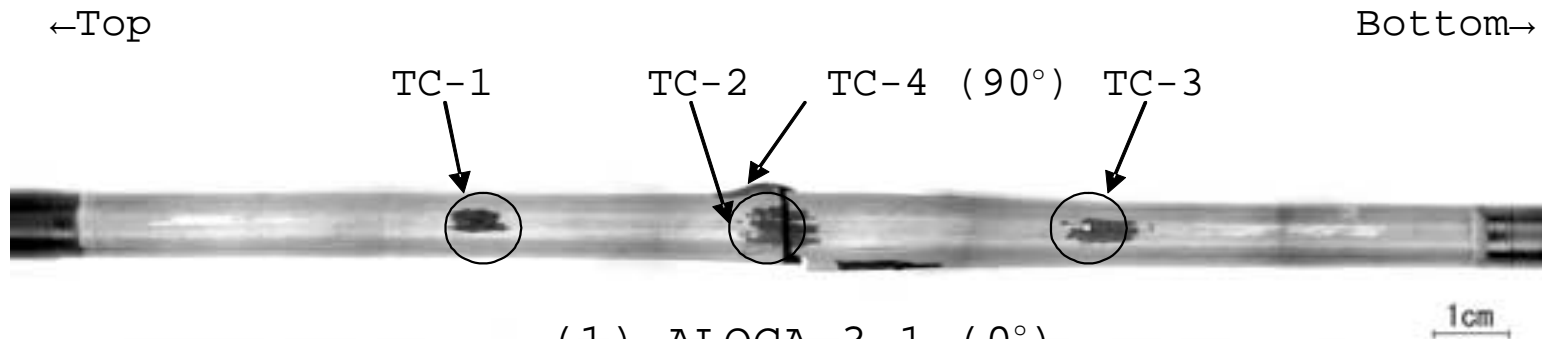
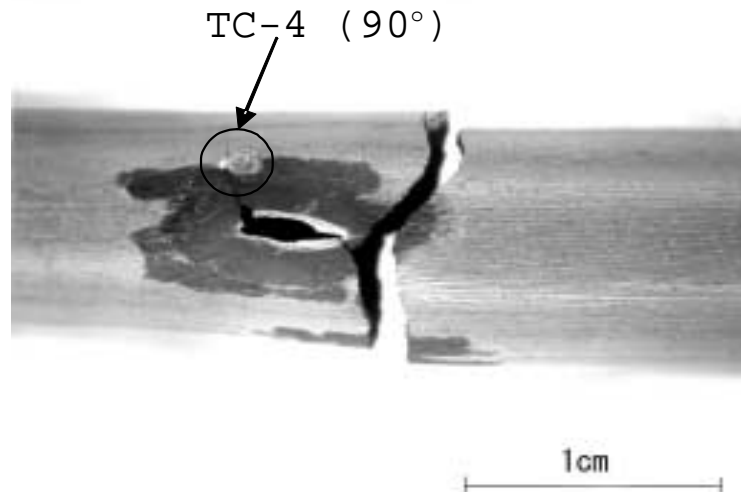
LOCA Quench Test Results

(2) Burst and failure position of ALOCA 3-1 (90°)

Test No.	1	2	3
Sample No.	ALOCA 3-1	ALOCA 1-2	BLOCA L-3
Initial Internal Pressure (MPa abs)	5.0		
Hearing Rate (K/sec)	10		
Burst Temperature (K) [(°C)]	1053 [780]	1053 [780]	1083 [810]
Burst Strain (%)	14.1	27.7	24.3
Oxidation Temperature (K) [(°C)]	1453 [1180]	1465 [1192]	1430 [1157]
Exposure Time during High Temperature (sec)	486	120	200
Equivalent Cladding Reacted (%ECR)	30.0*	17.9*	16.4*
Failed / Intact	Failed	Intact	Intact
Load at Failure (N) [(kgf)]	498 [50.8]	---	---

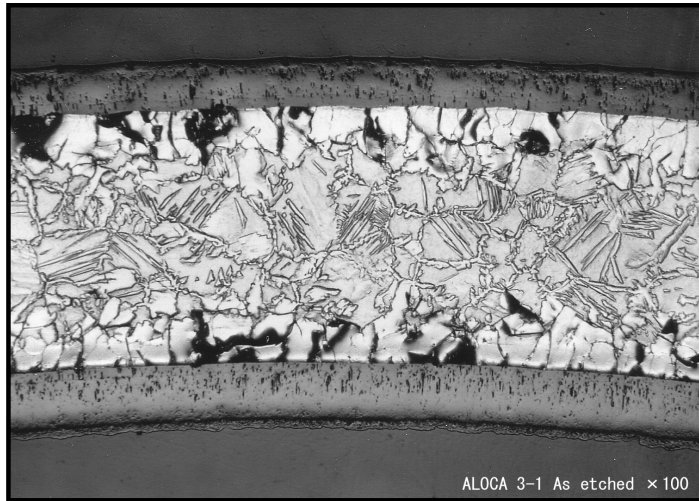
48GWd/t PWR cladding

1453K, 486sec, 30.0%ECR

Microstructure of fuel cladding after integral thermal shock test

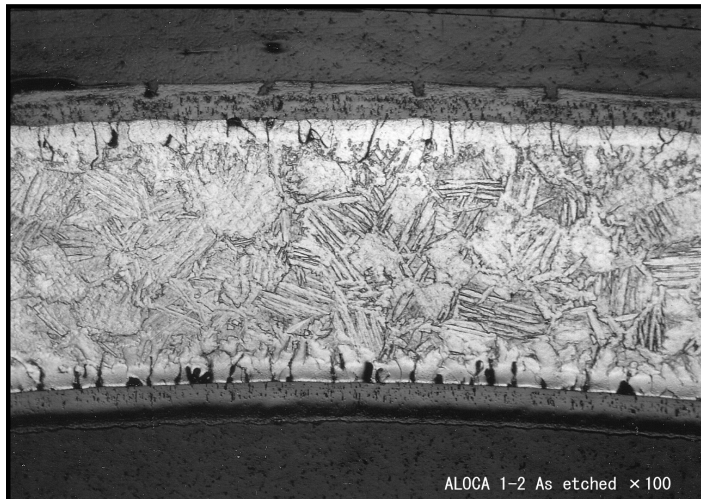
1465K, 120sec, 17.9%ECR

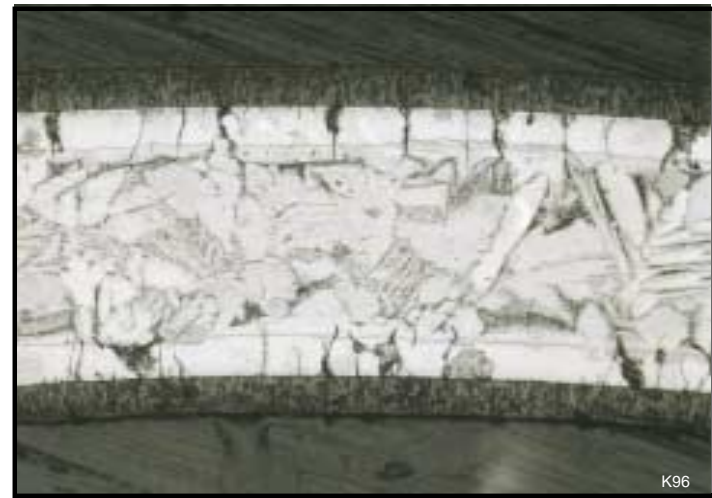
Pre-hydrided unirradiated cladding

1428K, 425sec, 28.7%ECR, 148ppmH

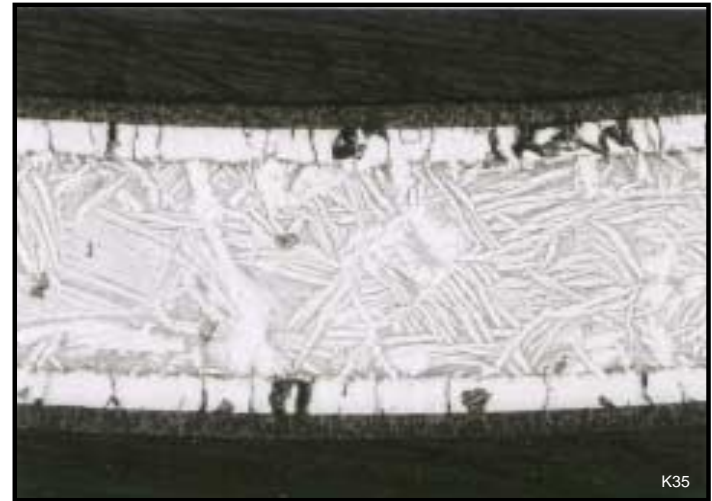
1463K, 134sec, 20.4%ECR, 311ppmH

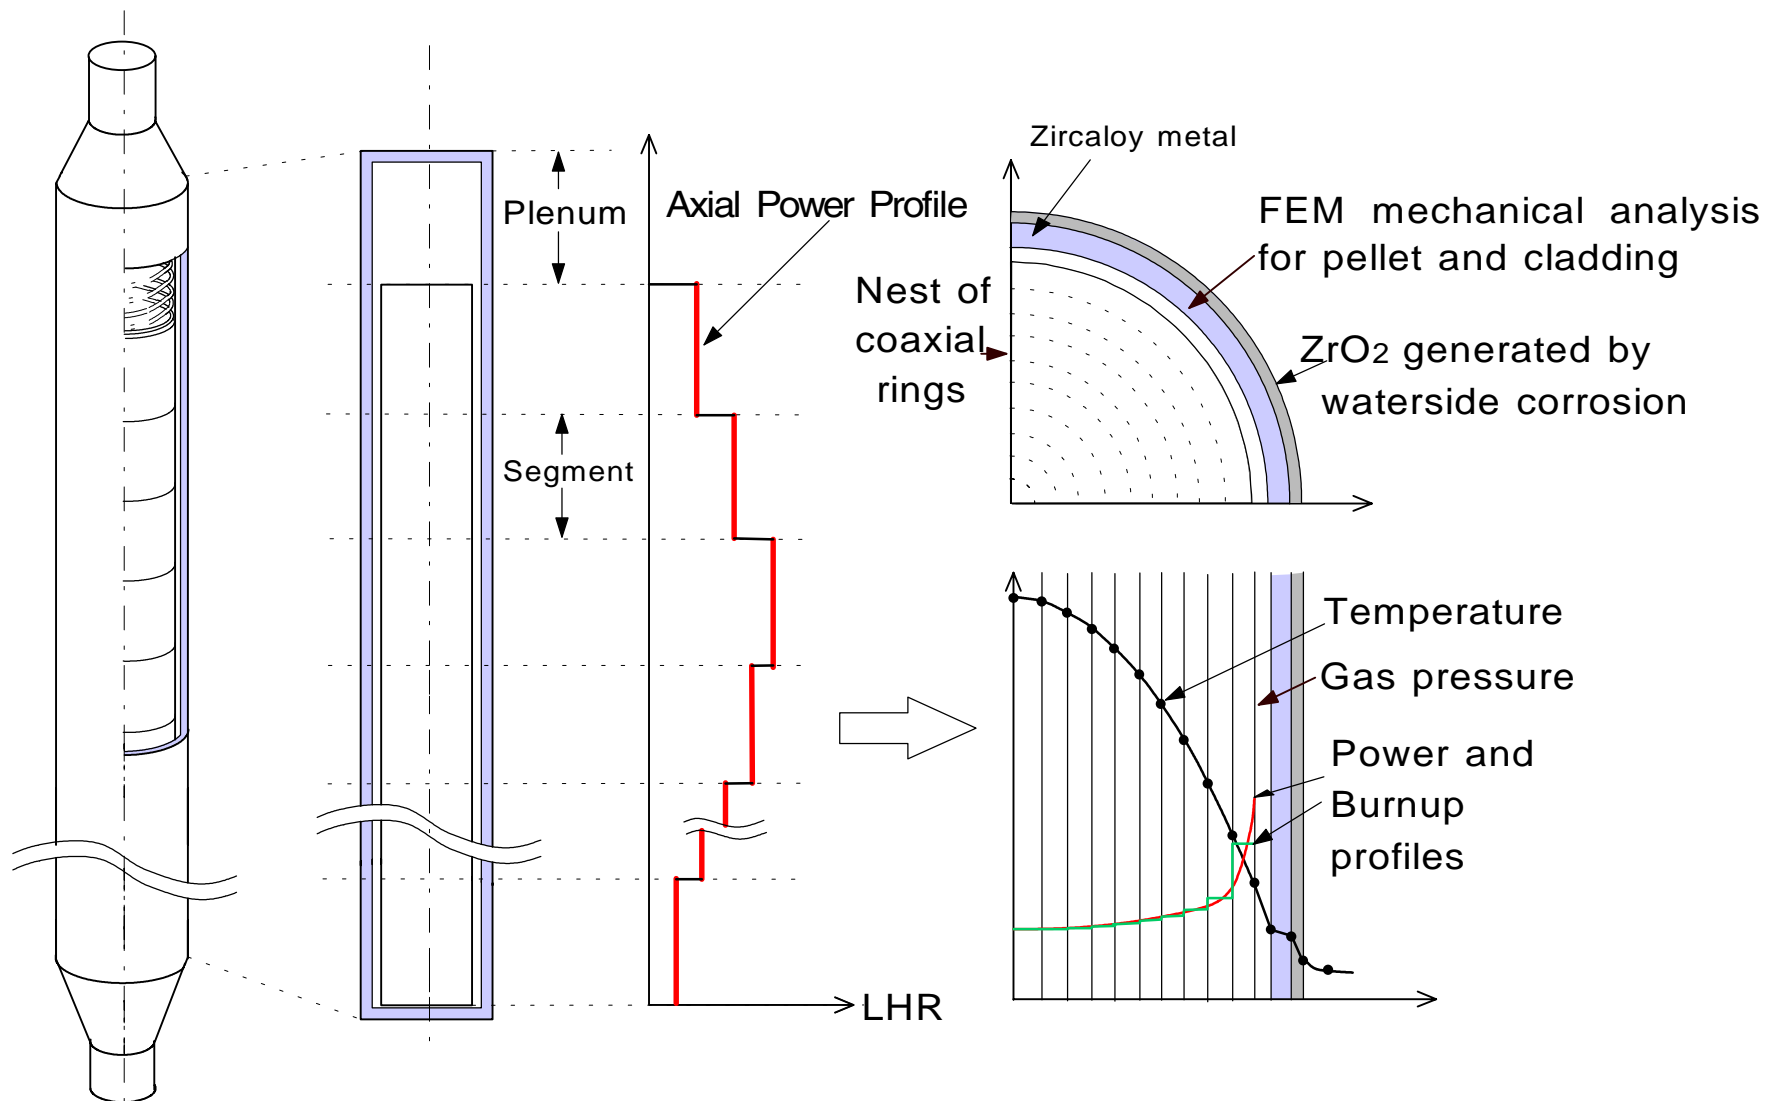
Analytical System taken over from FEMAXI-6 for FURBEL

- 1. Prediction of stress in cladding generated on quenching (under non-restraint and restraint conditions).**
- 2. Basic structure has taken over that of the fuel performance code FEMAXI-6.
Cladding consists of 8-layer finite element in the radial direction.**
- 3. Experimental analysis and evaluation is in progress.**

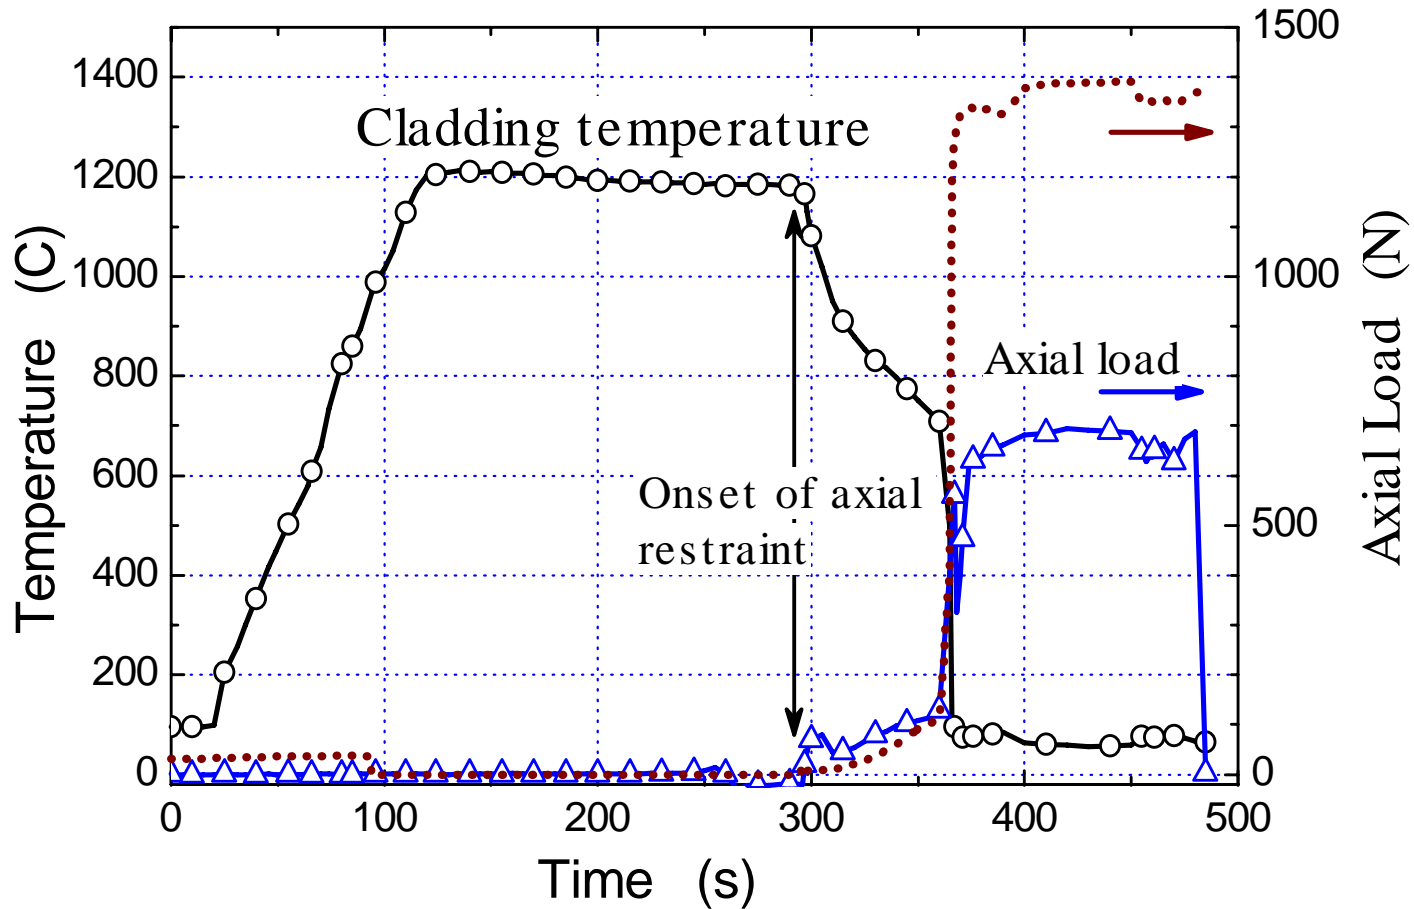
A Preliminary Result of Experimental Analysis by FURBEL

Cladding temperature measured in Quench-after-Oxidation test as input data for FURBEL analysis and comparison of axial load between measured (blue) and calculated (brown dots) values.

The difference of axial loads suggests that the evaluation of cross section area of cladding generating the axial force is to be improved.
