South Texas Project  
Unit 2  
Docket No. STN 50-499  
Supplement 1 to Proposed Emergency Change to Technical Specification 3.8.1.1 Note 12

This letter responds to a request for additional information regarding the Non-Destructive Examination (NDE) technique, Manual Phased Array Examination, used on both Unit 1 and Unit 2 SDGs connecting rod assemblies. Attachment 1 provides close-up photos of the calibration standard used for this NDE process.

### **Manual Phased Array Examination Photos**

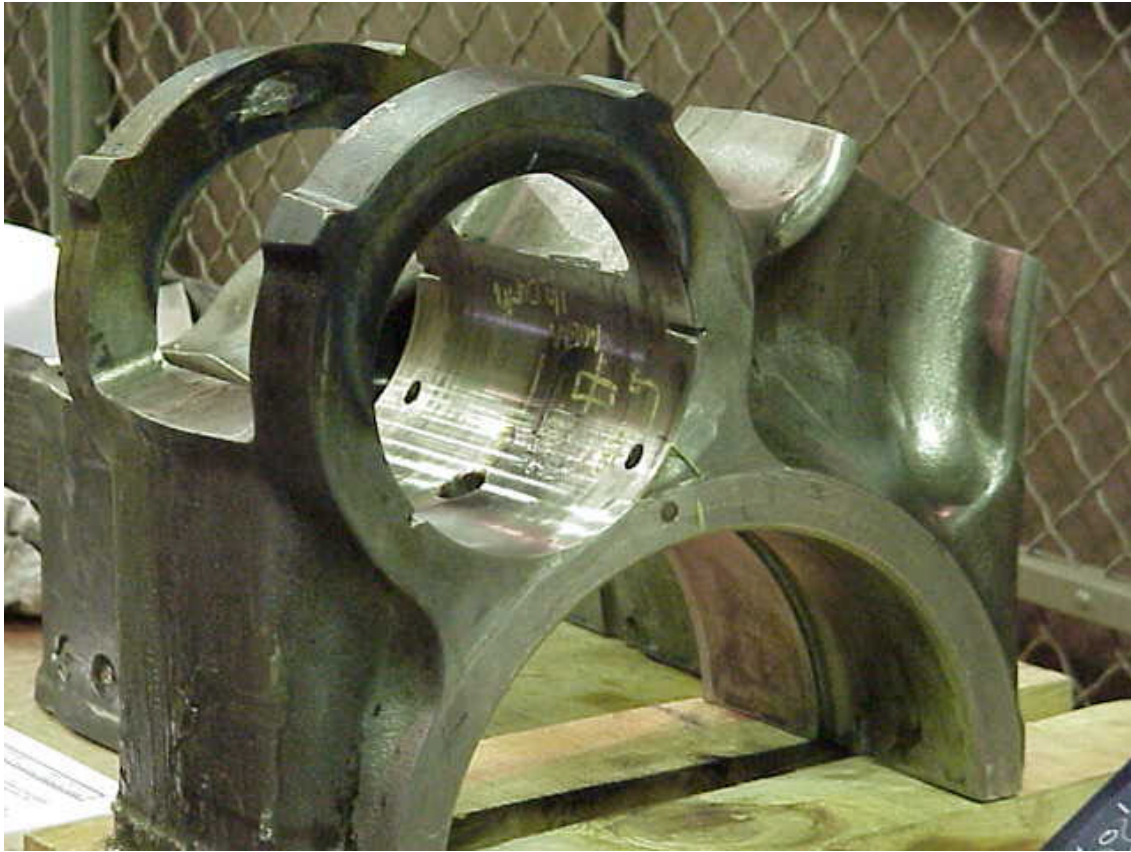
Fig 1. Overview of calibration standard cut from #8

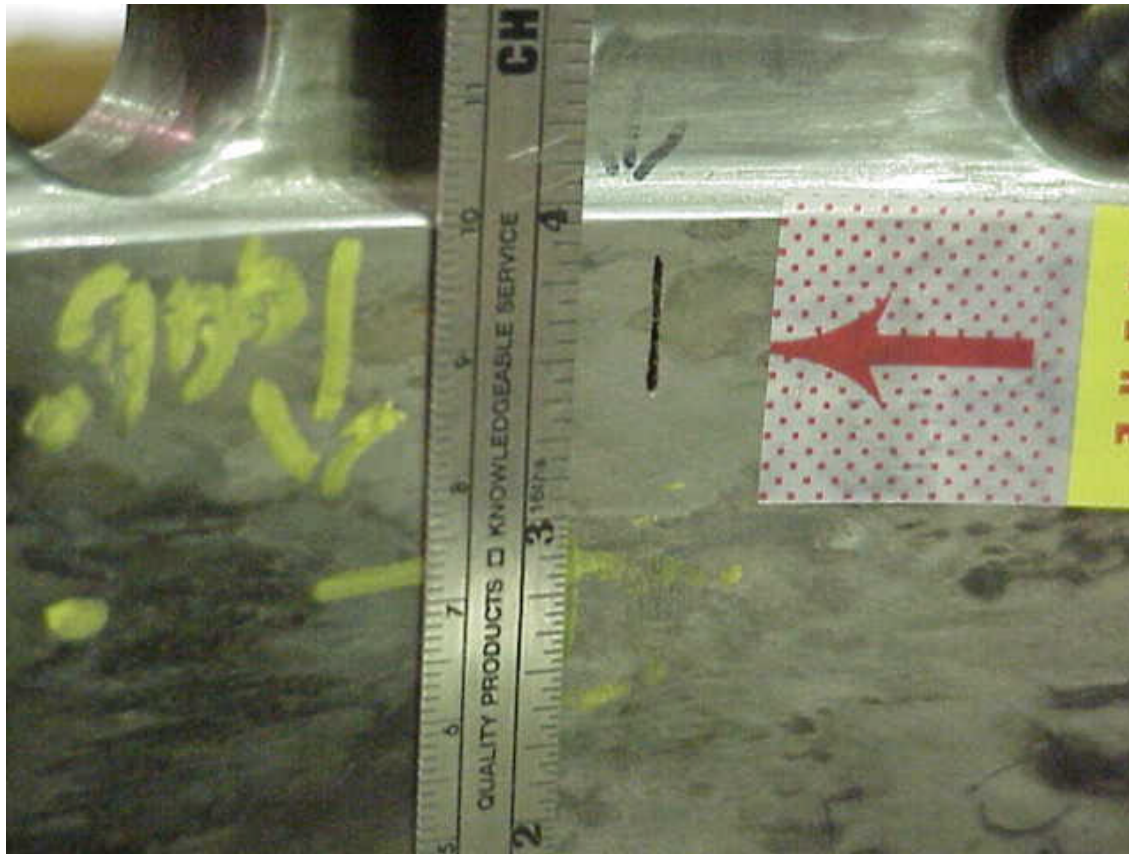
Fig 2. Close-up of calibration standard EDM notch

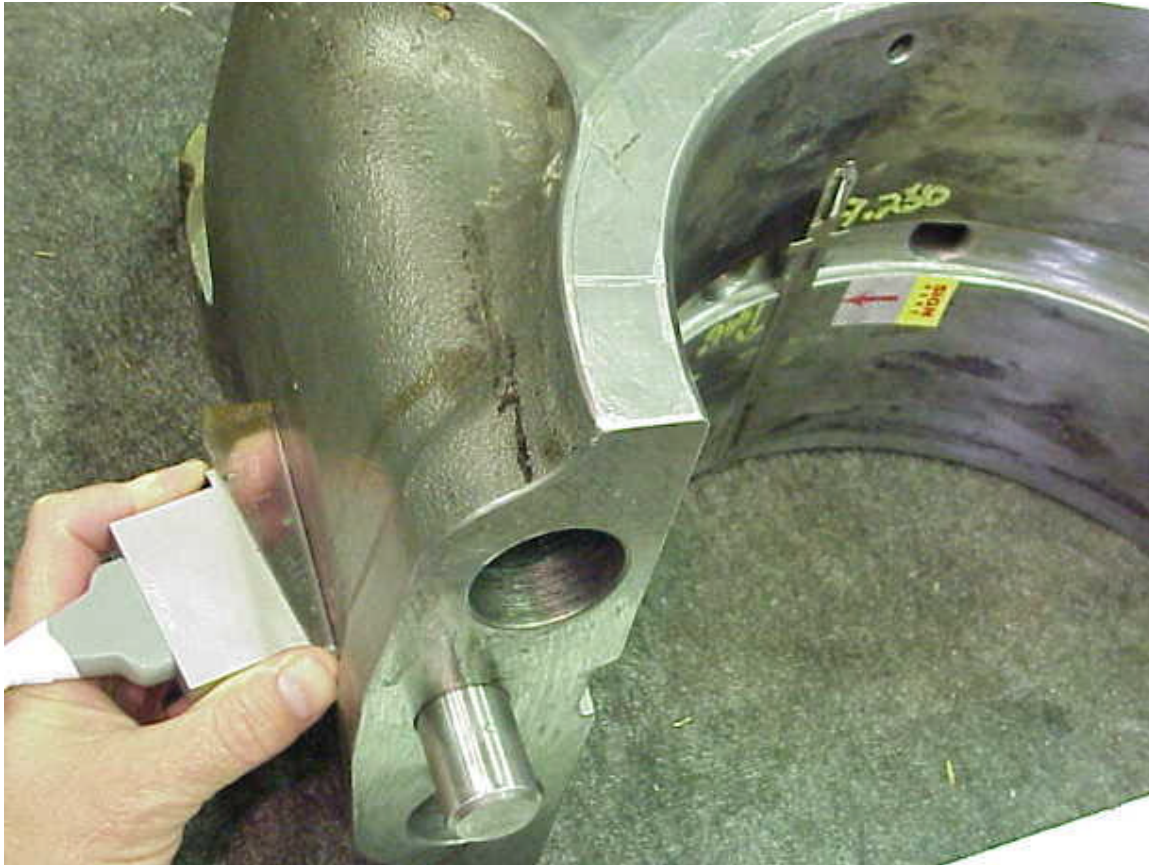
Fig 3. Calibration standard showing scanning surface of transducer

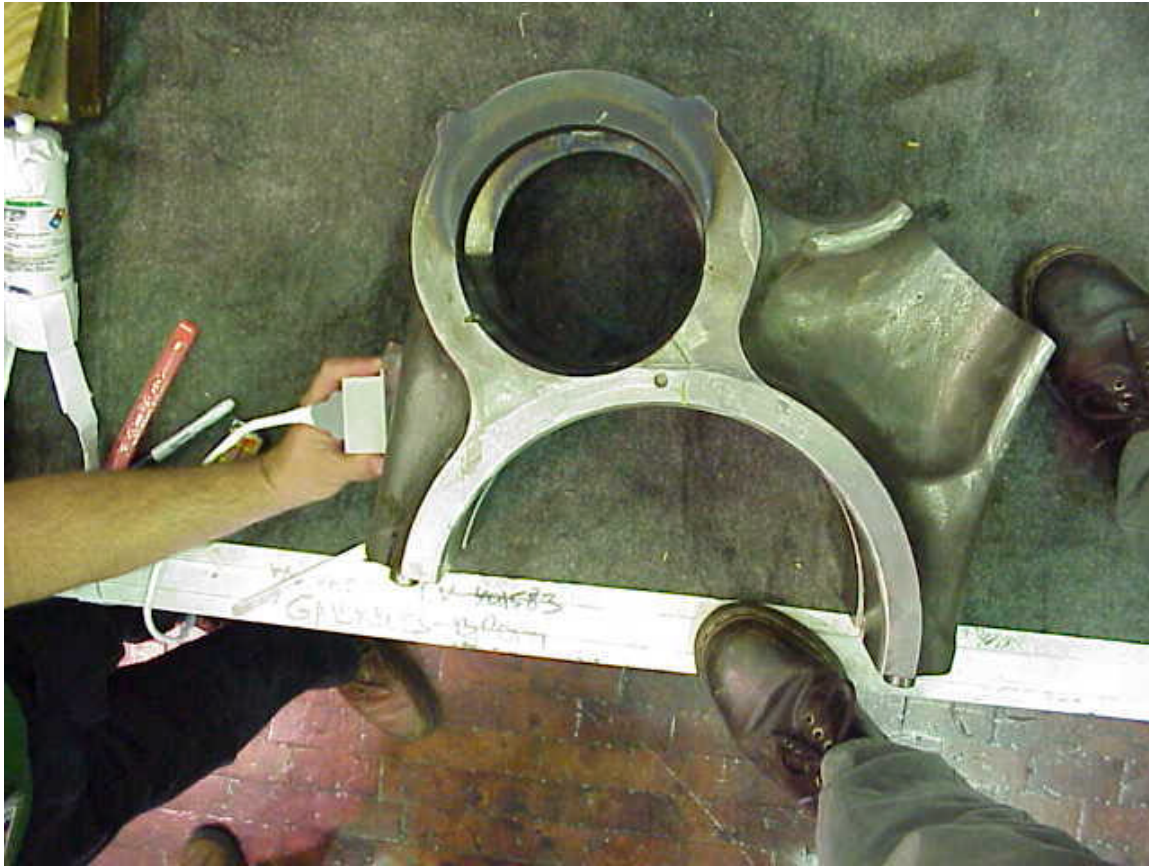
Fig 4. Side-view of calibration standard showing transducer

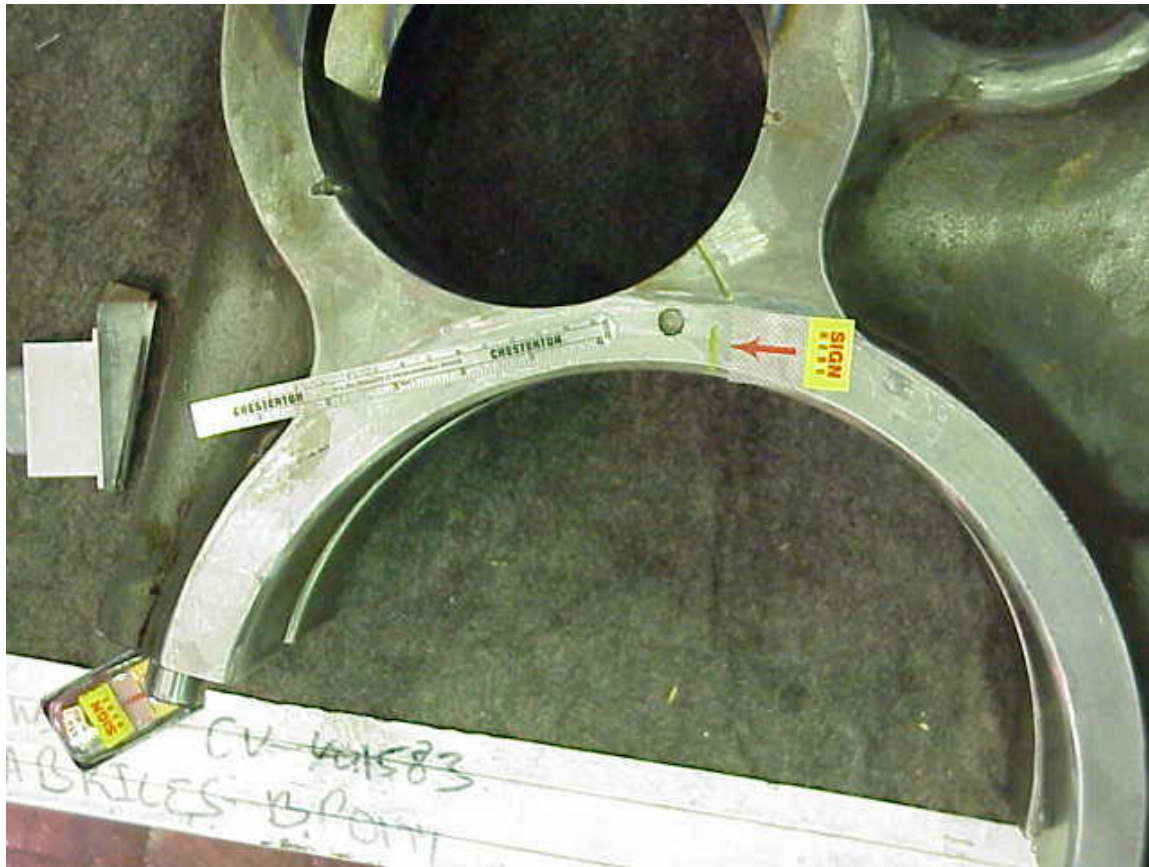
Fig 5. Side-view showing location of EDM notch

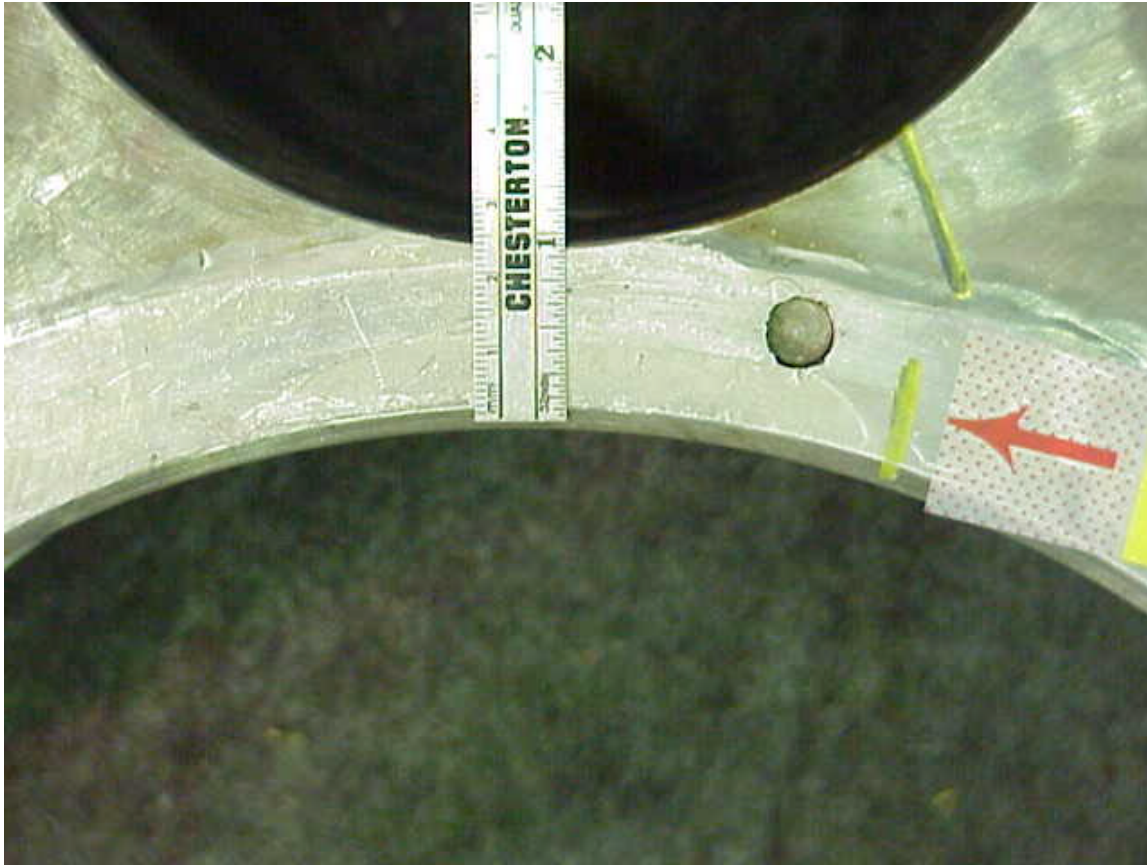
Fig 6. Close-up of side-view showing minimum master rod ligament and location of EDM notch  
(yellow line is just to show orientation and not depth)

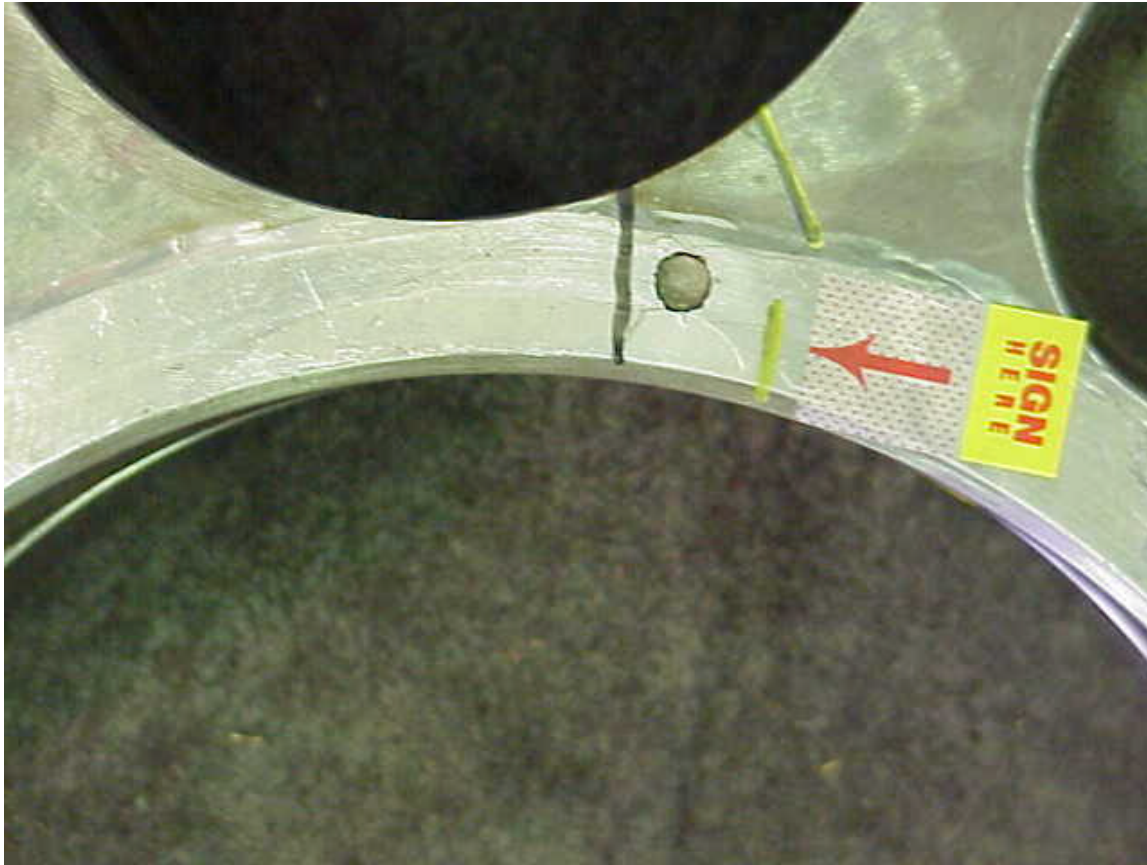
Fig 7. Close-up of side-view showing approximate location of crack on #9 (black line) and location of EDM notch (yellow line)
