Westinghouse Electric Company
Hematite Facility
3300 State Road P
Festus, MO 63028

Subject: Request for Amendment to Chapter 1 of SNM-33

Environmental Report for Building Demolition at the Hematite Facility

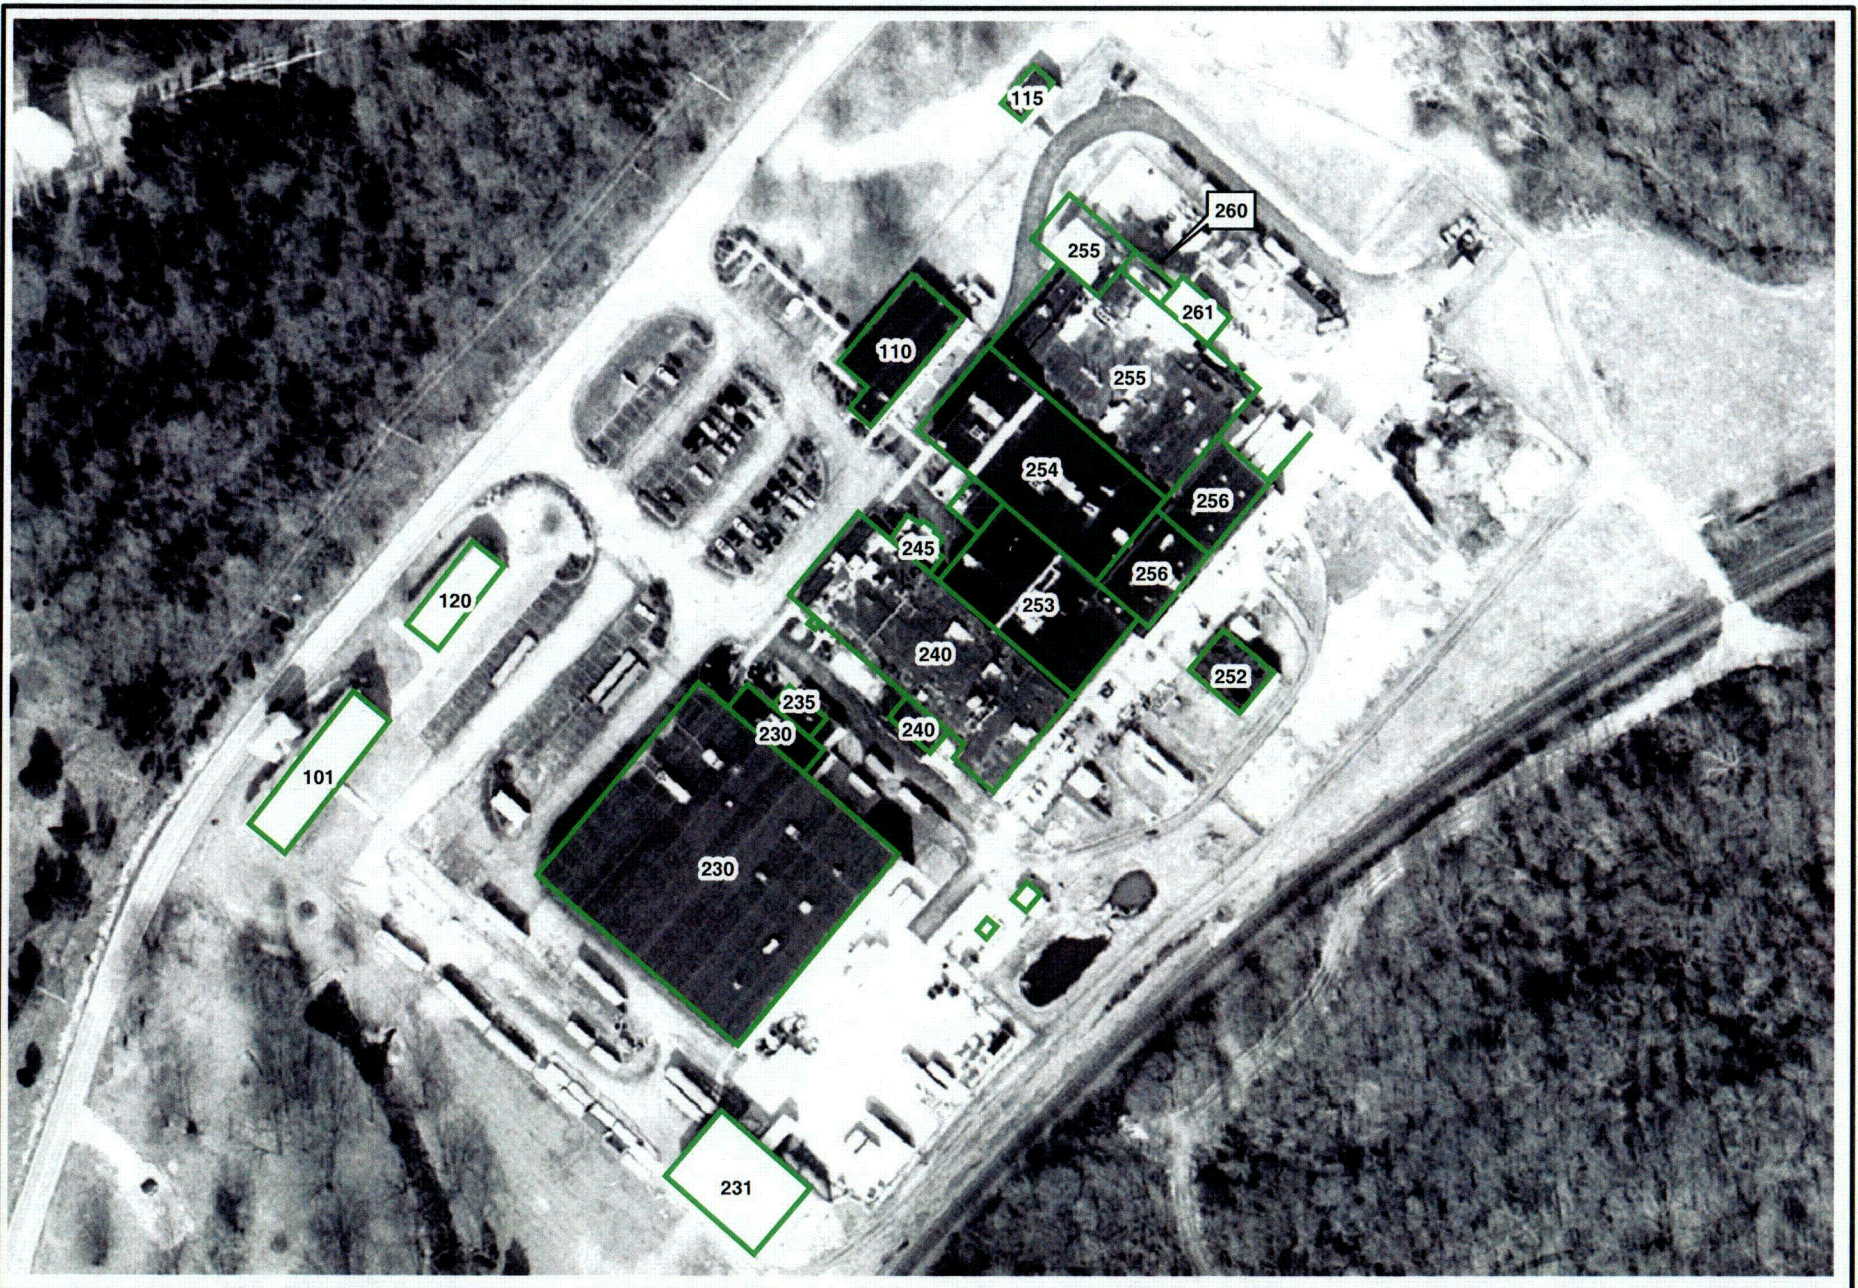
FIGURE
2

Site Buildings
Westinghouse Facility
Hematite, MO

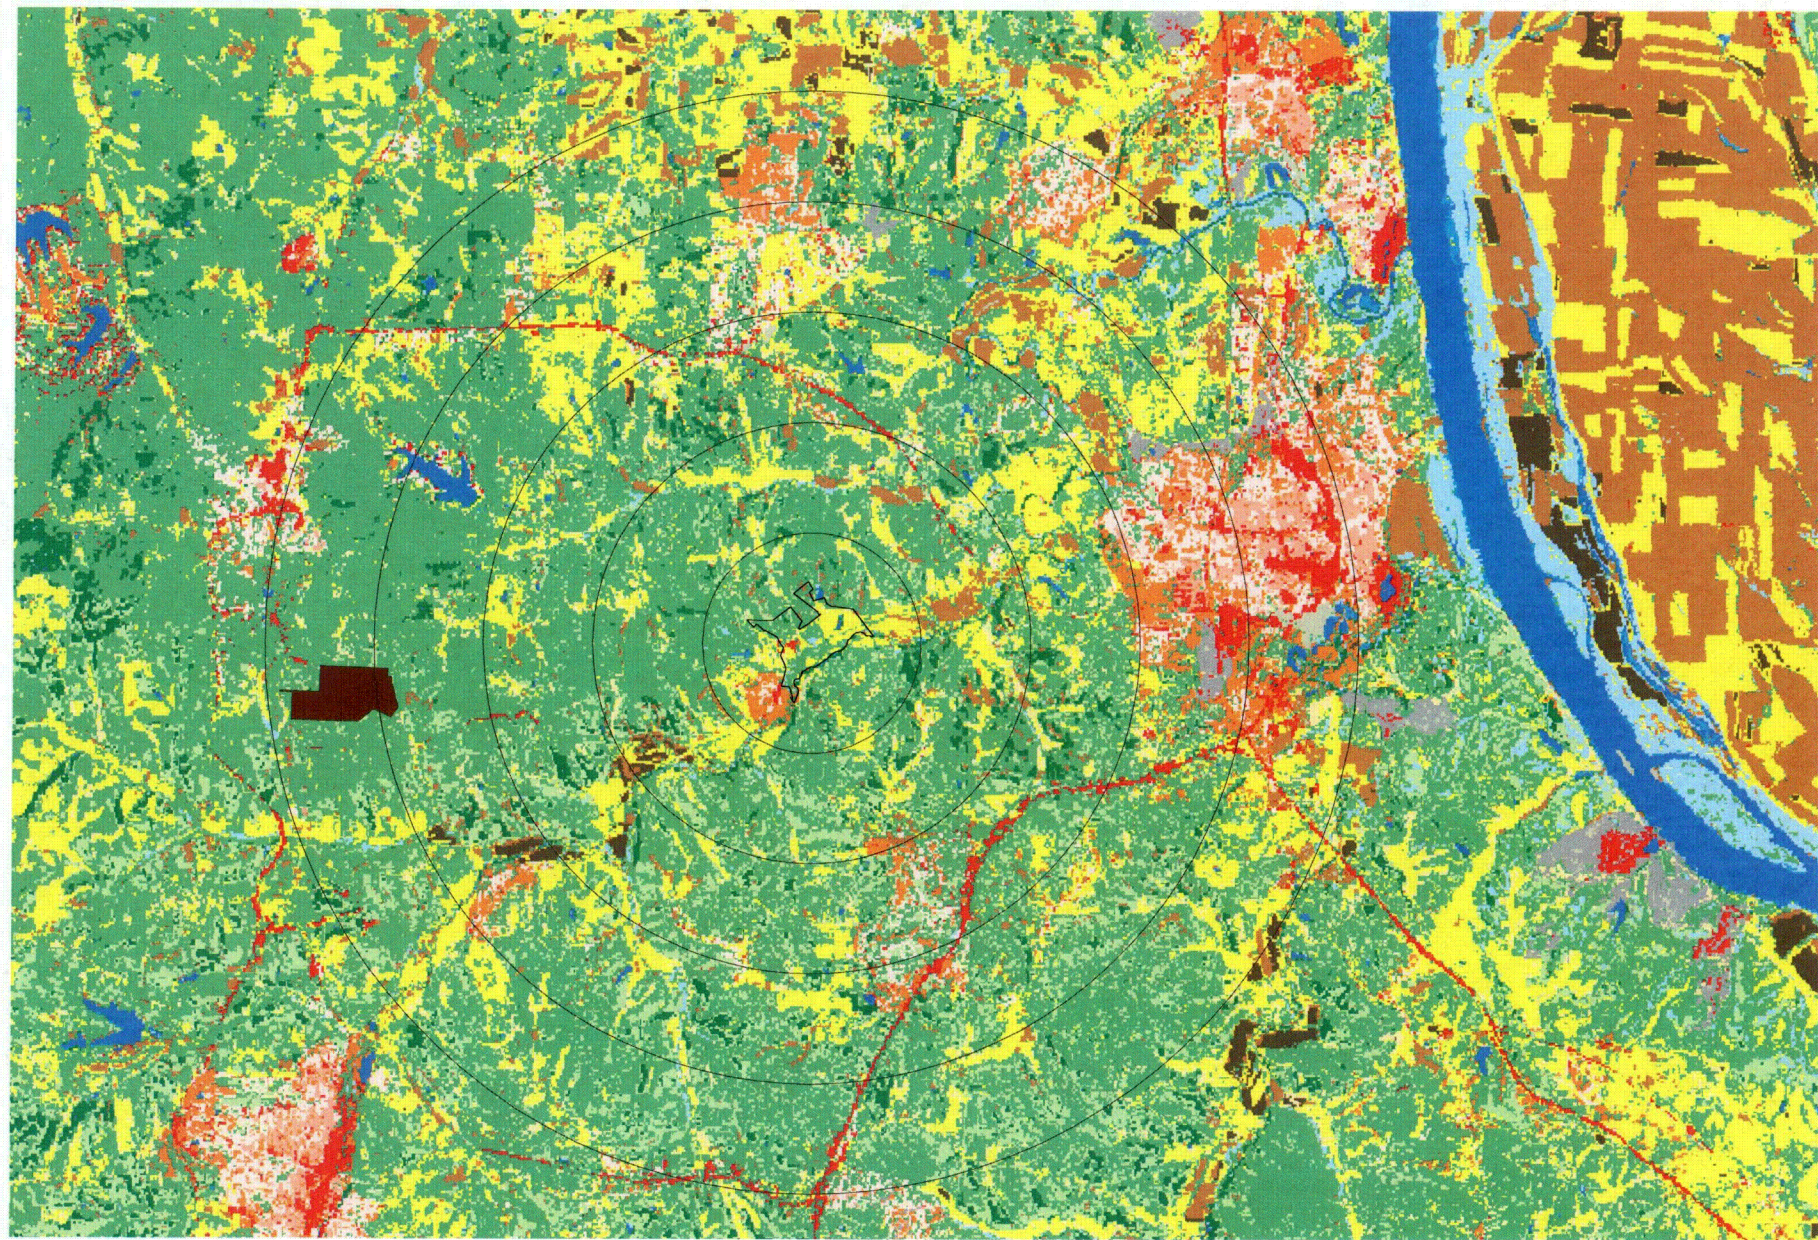
3.1.2 Hematite Former Fuel Cycle Facility

During operation of the facility, production activities were limited to the process buildings and grounds within an approximately 10-acre central site tract.

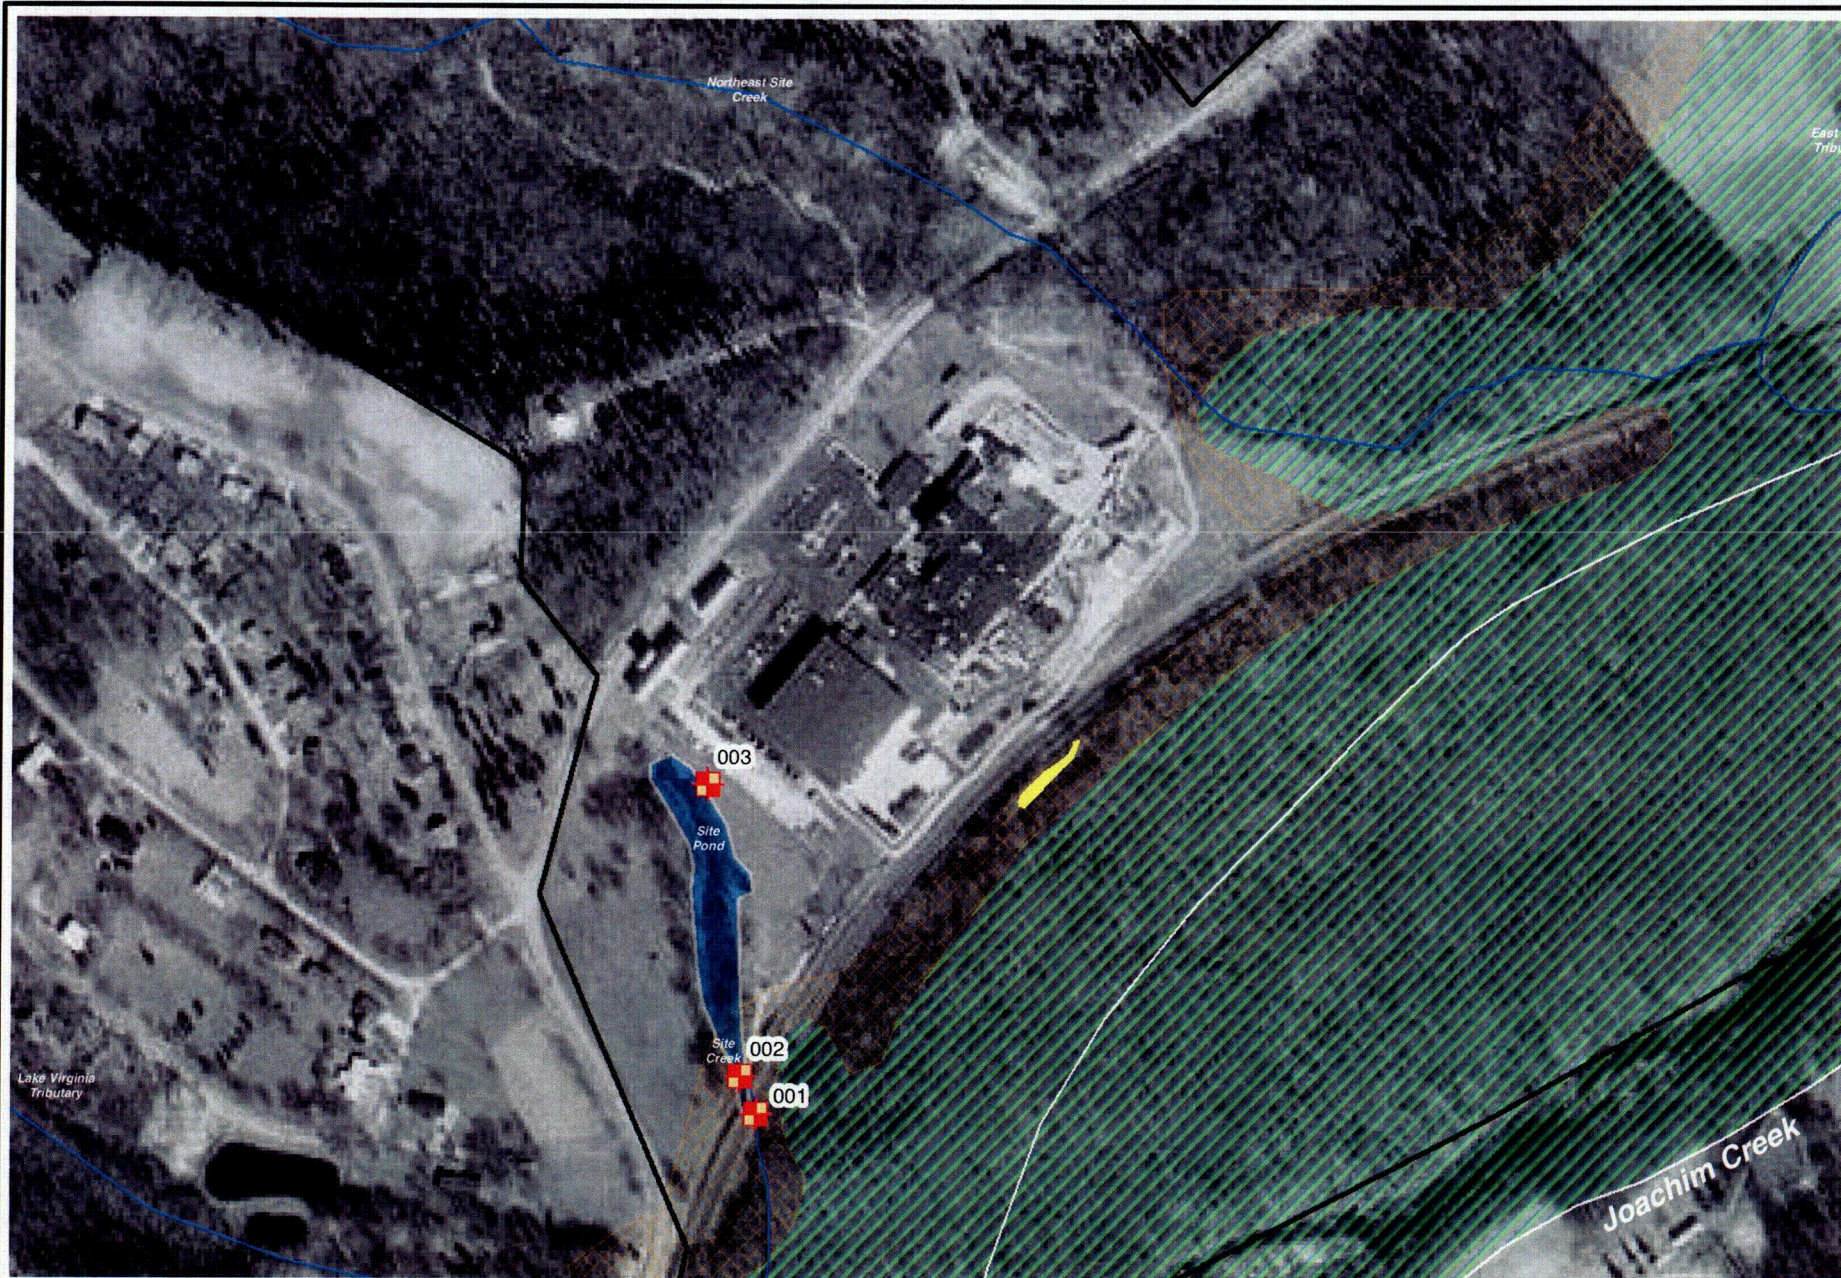
**FIGURE
6**

**NPDES Outfalls
Westinghouse Facility
Hematite, MO**

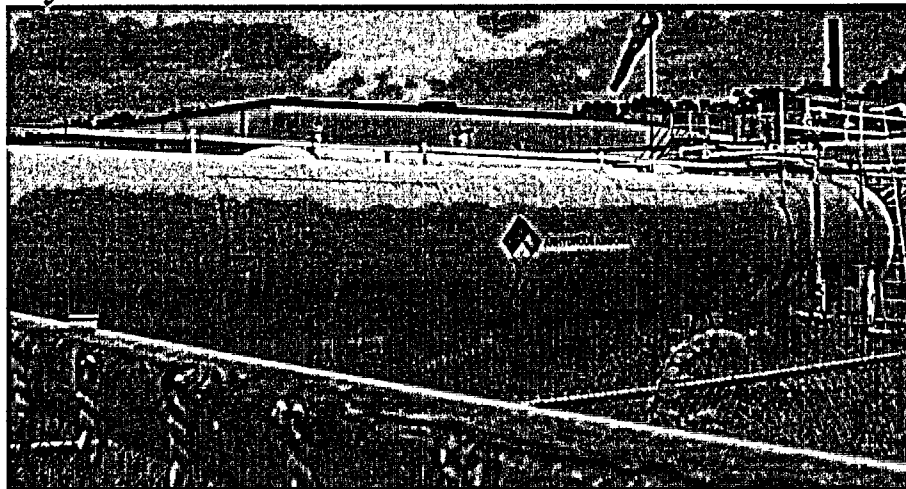
Photo 76: Anhydrous Ammonia tank south of building, facing west.

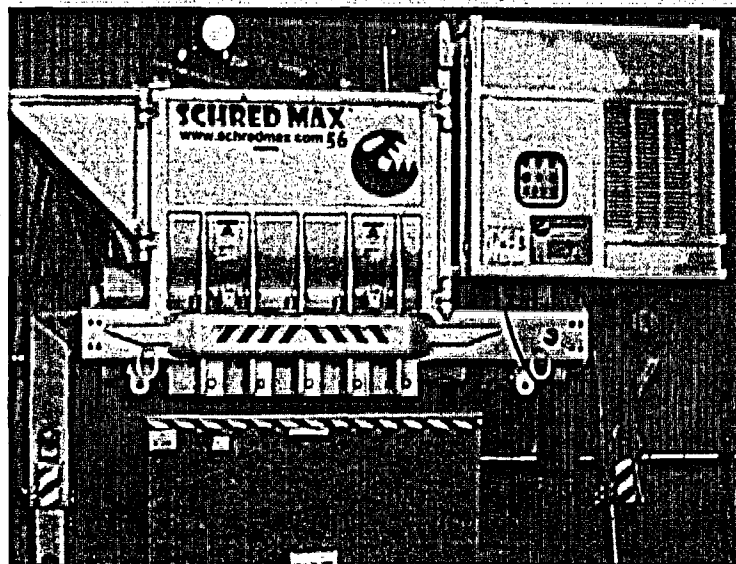
Photo 81: 261 Shredder, facing north.
