**Chemical Effects/Head–Loss Testing**  
**Quick Look Report, Tests 1 & 2**  
**September 16, 2005**

J. Oras, J.H. Park, K. Kasza, K. Natesan, and W. J. Shack  
Argonne National Laboratory

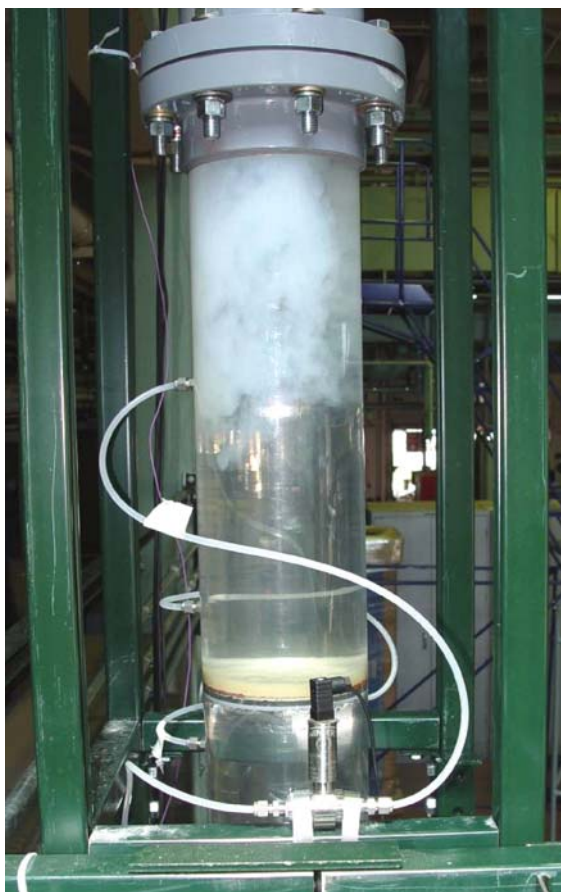
Figure 6.  
 $\text{Ca}_3(\text{PO}_4)_2$  forming after addition of  $\text{CaCl}_2$  and approaching the debris bed.

The  $\text{CaCl}_2$  was then added to the vertical part of the test loop just above the clear test section. A total of 400 ml of  $\text{CaCl}_2$  solution was added over a 4 minute period (the transit time around the loop at 0.1 ft/s) to obtain the 200 ppm dissolved Ca inventory. A fine, milky precipitate was observed as shown in Figure 6 just after the introduction of the  $\text{CaCl}_2$ . The pressure drop across the bed increased from 1.7 psi to greater than 7.0 psi within 10 minutes of introducing the  $\text{CaCl}_2$ . An accurate pressure drop measurement could not be obtained beyond this point, because the loop was running unpressurized, and the pump started to cavitate as the precipitate continued to accumulate on the bed. The flow rate and pressure drop as a function of time after  $\text{CaCl}_2$  addition are also shown in Fig. 4. As discussed previously, the 200 ppm Ca inventory is likely not sufficient to produce the full amount of  $\text{Ca}_3(\text{PO}_4)_2$  formed during ICET-3. However, no additional Ca was added to simulate the depletion of all the available phosphate as in ICET-3, since the pressure drop across the bed had already caused the pump to cavitate. Figure 7 shows the accumulation of the precipitate on the debris bed just before the pump was shut off.

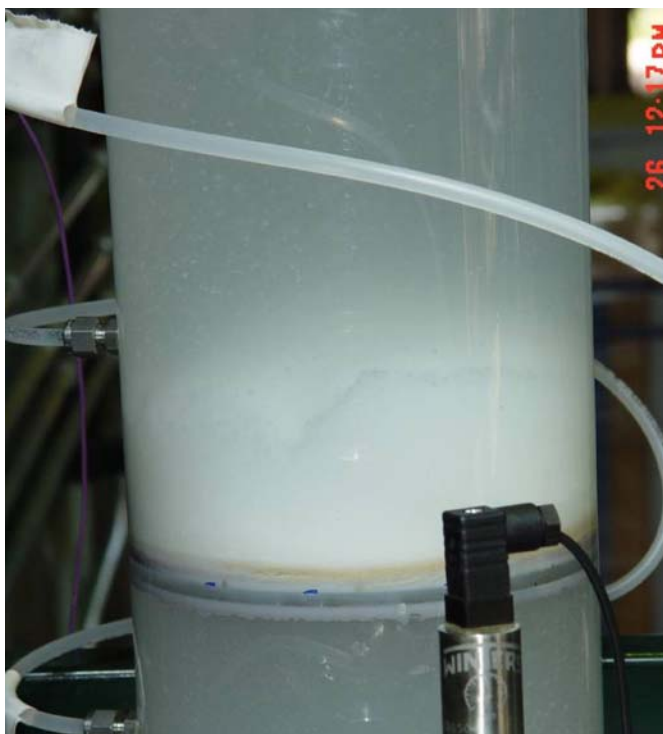
Figure 7.  
Precipitate buildup on the fiber debris bed just after the pump was turned off.

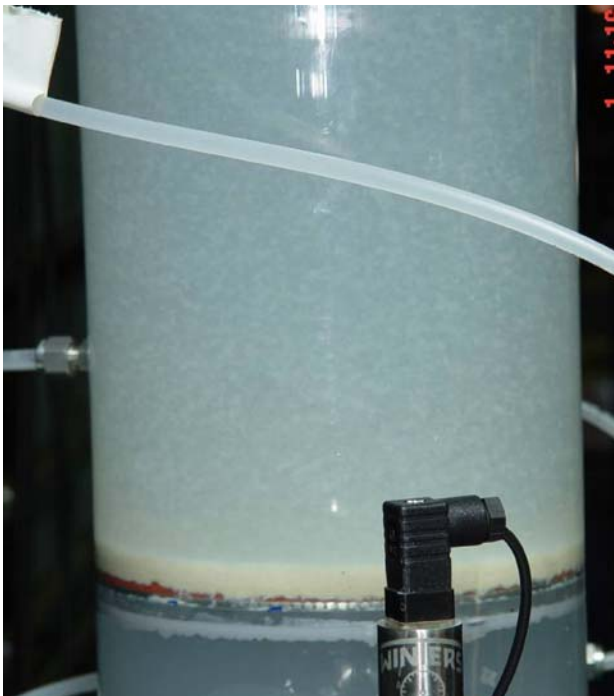
Figure 9.  
Flocculent precipitates observed at 0.01 ft/s in  
Test 2

An interesting qualitative difference was noted between the  $\text{CaCl}_2$  additions at flow rates of 0.1 ft/s and those at 0.01 ft/s. At 0.1 ft/s, the precipitate was a finely dispersed milky cloud. At 0.01 ft/s, these particles seemed to agglomerate into light, flocculent assemblies up to perhaps 0.25 in. in diameter as shown in Fig. 9. These larger assemblies appear similar to the material observed in the ICET-3 tank where velocities are likely lower than 0.1 ft/s.
