## **Screen Penetration Test Report**

**Los Alamos National Laboratory**

**U.S. Nuclear Regulatory Commission  
Office of Nuclear Regulatory Research  
Washington, DC 20555-0001**

# Screen Penetration Test Report

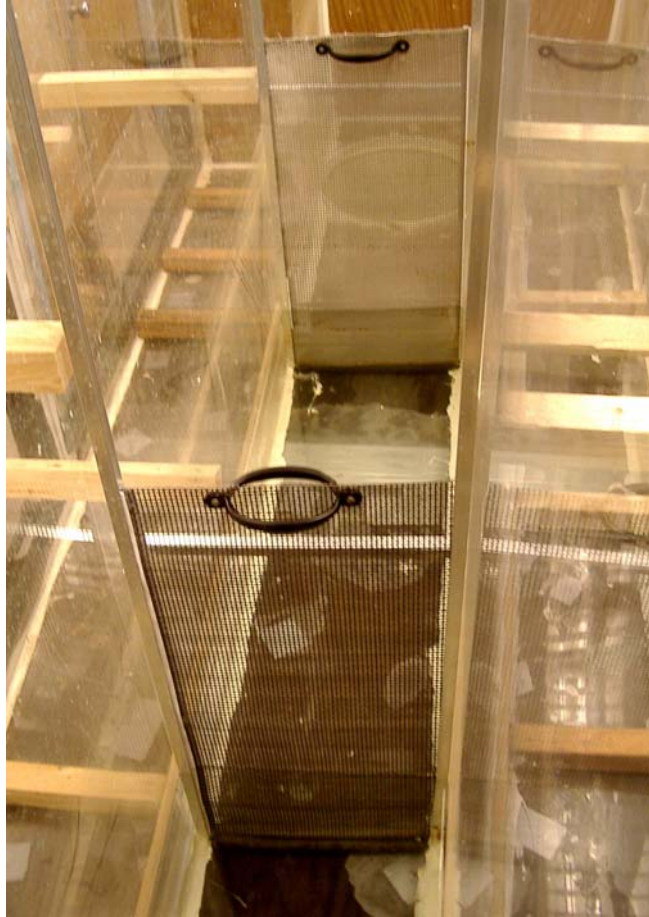
Figure 2-5a. Test screen and fine screen in the test section.

Figure 2-5a shows both the test screen and the fine screen located downstream of the test screen, which are used to retain the debris. A close-up of the 0.25-in. test screen is shown in Figure 2-5b. Note that the actual openings on the screen were approximately square in shape and not triangular, as may be incorrectly inferred from this photograph because of the three-dimensional (3D) weave of the wires and the angle at which this photo was taken. Figure 2-5b also shows the horizontal tray on the floor of the flume, which was used to remove and subsequently weigh the debris retained on the floor. A tray was placed on the floor of the test section immediately before each of the two screens. Each tray is 0.305 m (12 in.) wide and 0.41 m (16 in.) long, with a 1.3-cm (~1/2-in.)-high metal edge. Each tray consists of a fine (#200-sieve) screen attached adhesively to a stiffer screen. The size of the openings in the #200 screen is 0.075 mm, with approximately 200 openings per inch (79 openings per centimeter). These screens were removed vertically using attached nylon strings to collect the debris on the floor.

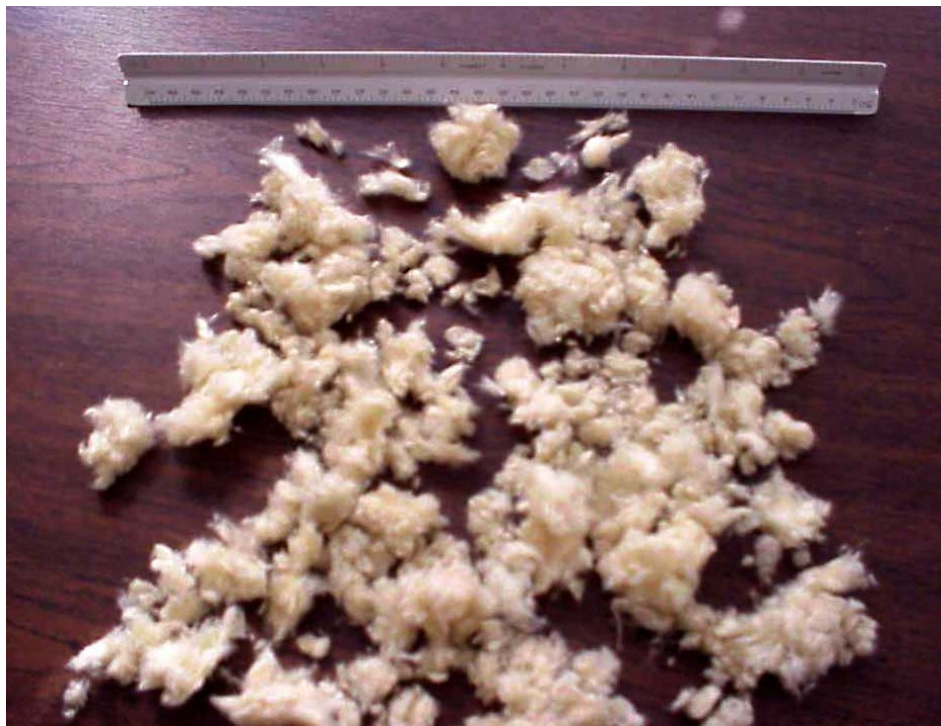
Figure 3-1. LS NUKON™.

The preparation procedure for the NUKON™ and CalSil debris test specimens was identical to previous studies [1, 8]. NUKON™ insulation debris was generated by using a leaf shredder to shred blanket insulation, followed by heating it to  $>90^{\circ}\text{C}$  to remove the coating on the surface of the glass fibers, which more accurately simulated post-LOCA fiber conditions. The NUKON™ then was stirred for 5 min using a kitchen blender to separate the fibers and prevent clumping. Figure 3-1 shows the NUKON™ after processing by a leaf shredder (LS NUKON™).

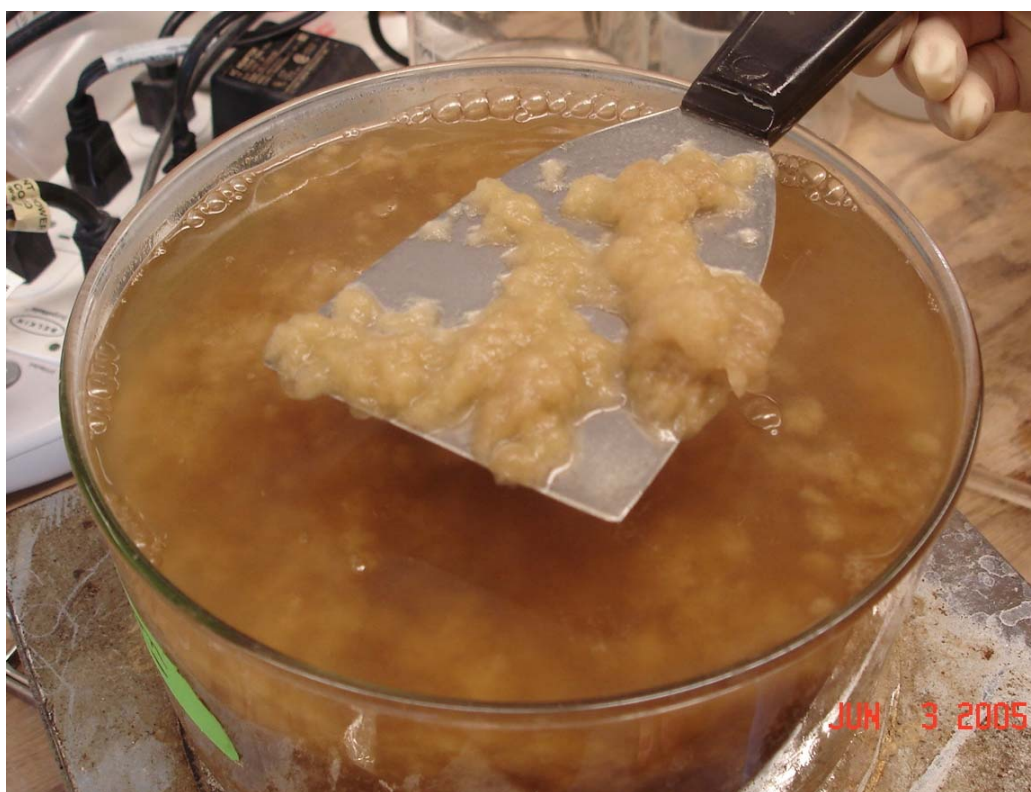
Figure 3-2. BP NUKON™.

The particle-, or clumping-, size distribution of the blender-processed NUKON™ (BP NUKON™), shown in Figure 3-2, has not been determined. Drying the wet BP NUKON™ to obtain a size distribution causes the fibrous debris to stick together, which leads to clumping that is not representative of the characteristics of hydrated NUKON™ under flowing conditions. The CalSil (Figure 3-3) was initially obtained as a mixture of clumps and fine powder. The CalSil was introduced in the experiment as obtained, with no attempt to break up the clumps. To quantify the particle-size distribution, a sample of the dry CalSil was sieved in accordance with the American Society for Testing and Materials international standard D422-63. The results are provided in Table 3-1.

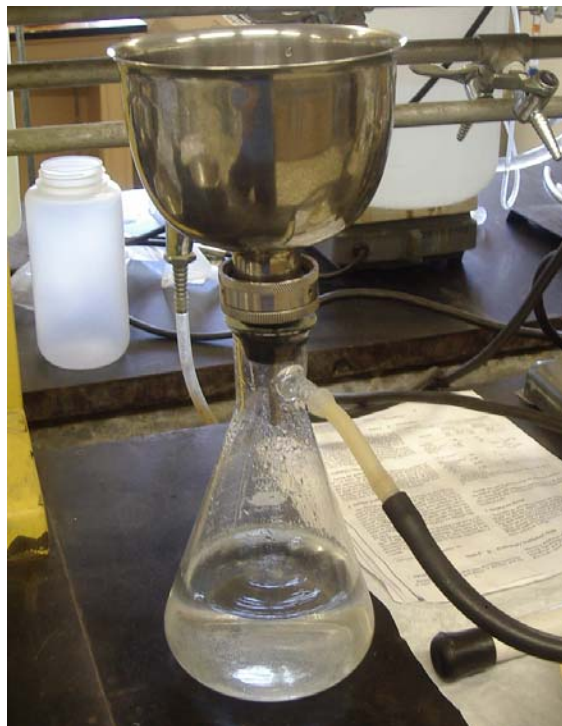
Figure 4-1. Filtration of NUKON™ to remove water.

The fraction of debris that does not pass through the screens is determined by weighing the amount of debris caught on the test screen and before the test screen on the flat tray. The amount that passes through the screen is measured by carefully removing the material on the fine (#100-sieve) screen downstream and the material between the two screens. To weigh the amount of NUKON<sup>™</sup>, the fibers must be separated from the water through a slow filtration process (Figure 4-1) before being dried in the oven. Small pieces of RMI that did not move to the trays must be removed by hand (Figure 4-2).

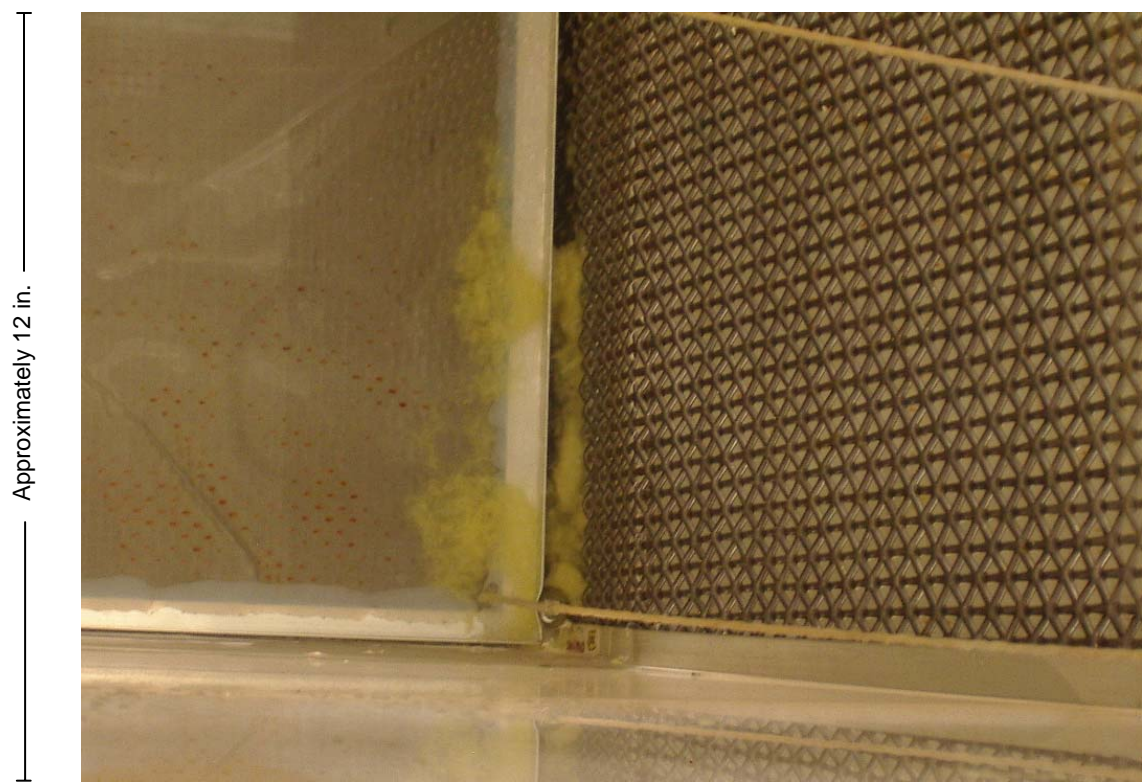
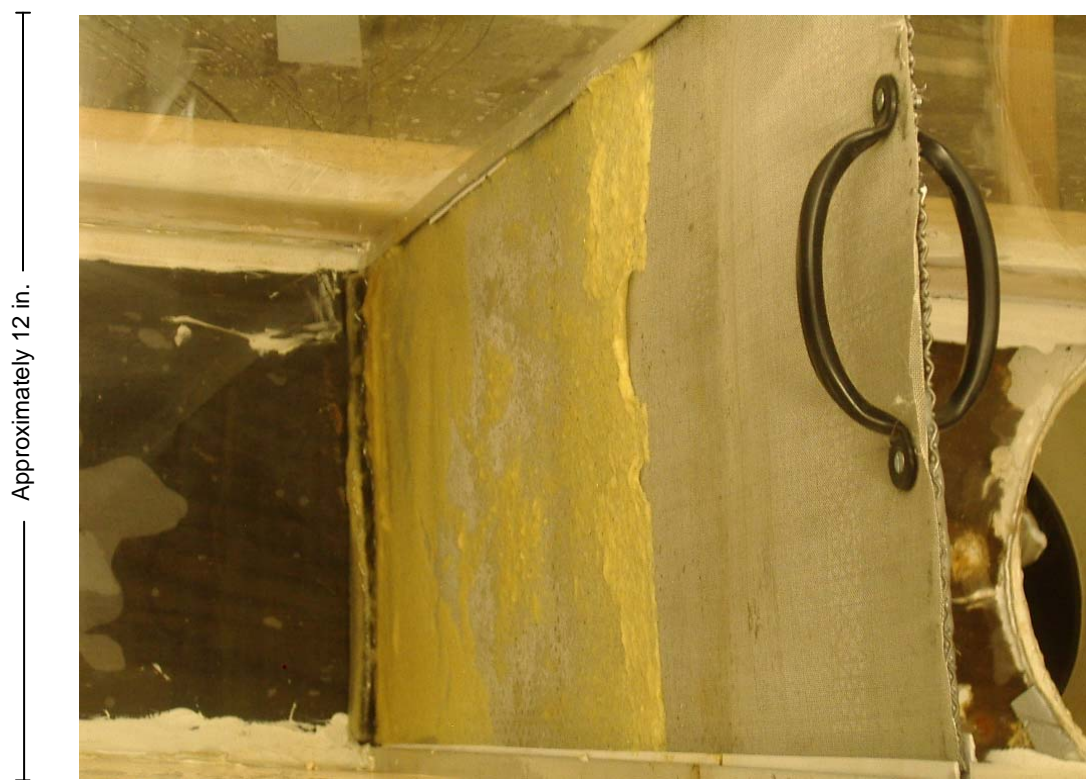
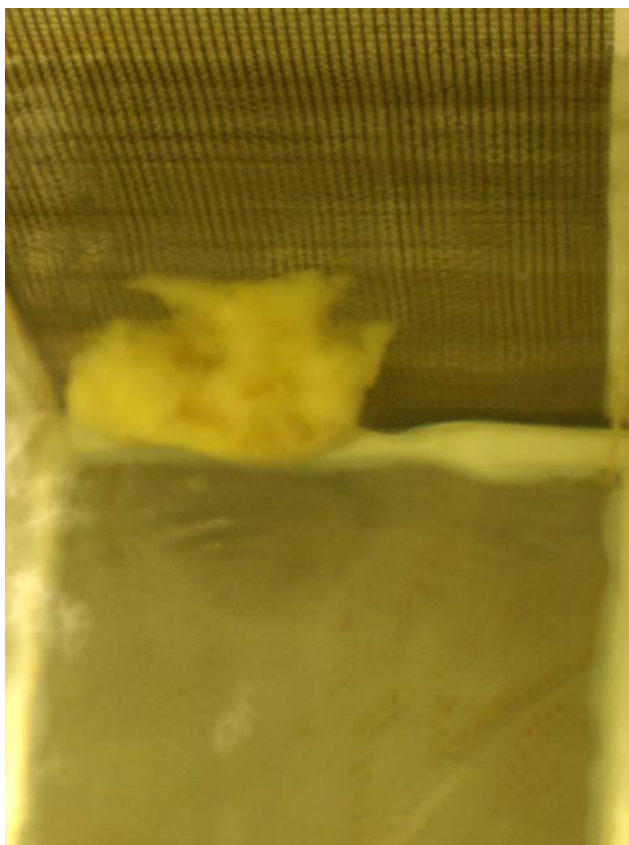
Figures 5-2 through 5-4 present photographs of the NUKON™ debris tests. The height indicated in Figures 5-2 and 5-3 represents ~30.48 cm (12 in.) in width, which is equal to the width of the test section. Figure 5-2 shows a small amount of BP NUKON™ remaining on the floor in front of the test screen following the test. Figure 5-3 shows a comparatively larger fraction of the finer-sized BP NUKON™ trapped on the fine screen downstream after passing through the test screen. In Figure 5-4 it can be seen that the individual pieces of LS NUKON™ simply aggregated at the test screen and did not pass through. No difference was noted in the transport of the NUKON debris on the floor between the Plexiglas® section and the test section with the screen on the floor. Any NUKON™ debris that transported went all the way to the test screen.

Figure 5-2. Larger pieces of BP NUKON™ on the floor.

Figure 5-3. Finer-sized BP NUKON™ collected on the fine screen located downstream.

Figure 5-4. LS NUKON™ forms clusters at the test screen.
