DOMINION NUCLEAR CONNECTICUT, INC.
MILLSTONE POWER STATION UNITS 2 AND 3
TECHNICAL SPECIFICATIONS ANNUAL REPORT

Millstone Unit 2
2005 Steam Generator Tube Inservice Inspection

**Millstone Power Station Unit 2
Dominion Nuclear Connecticut, Inc. (DNC)**

Steam Generator Tube Inspection

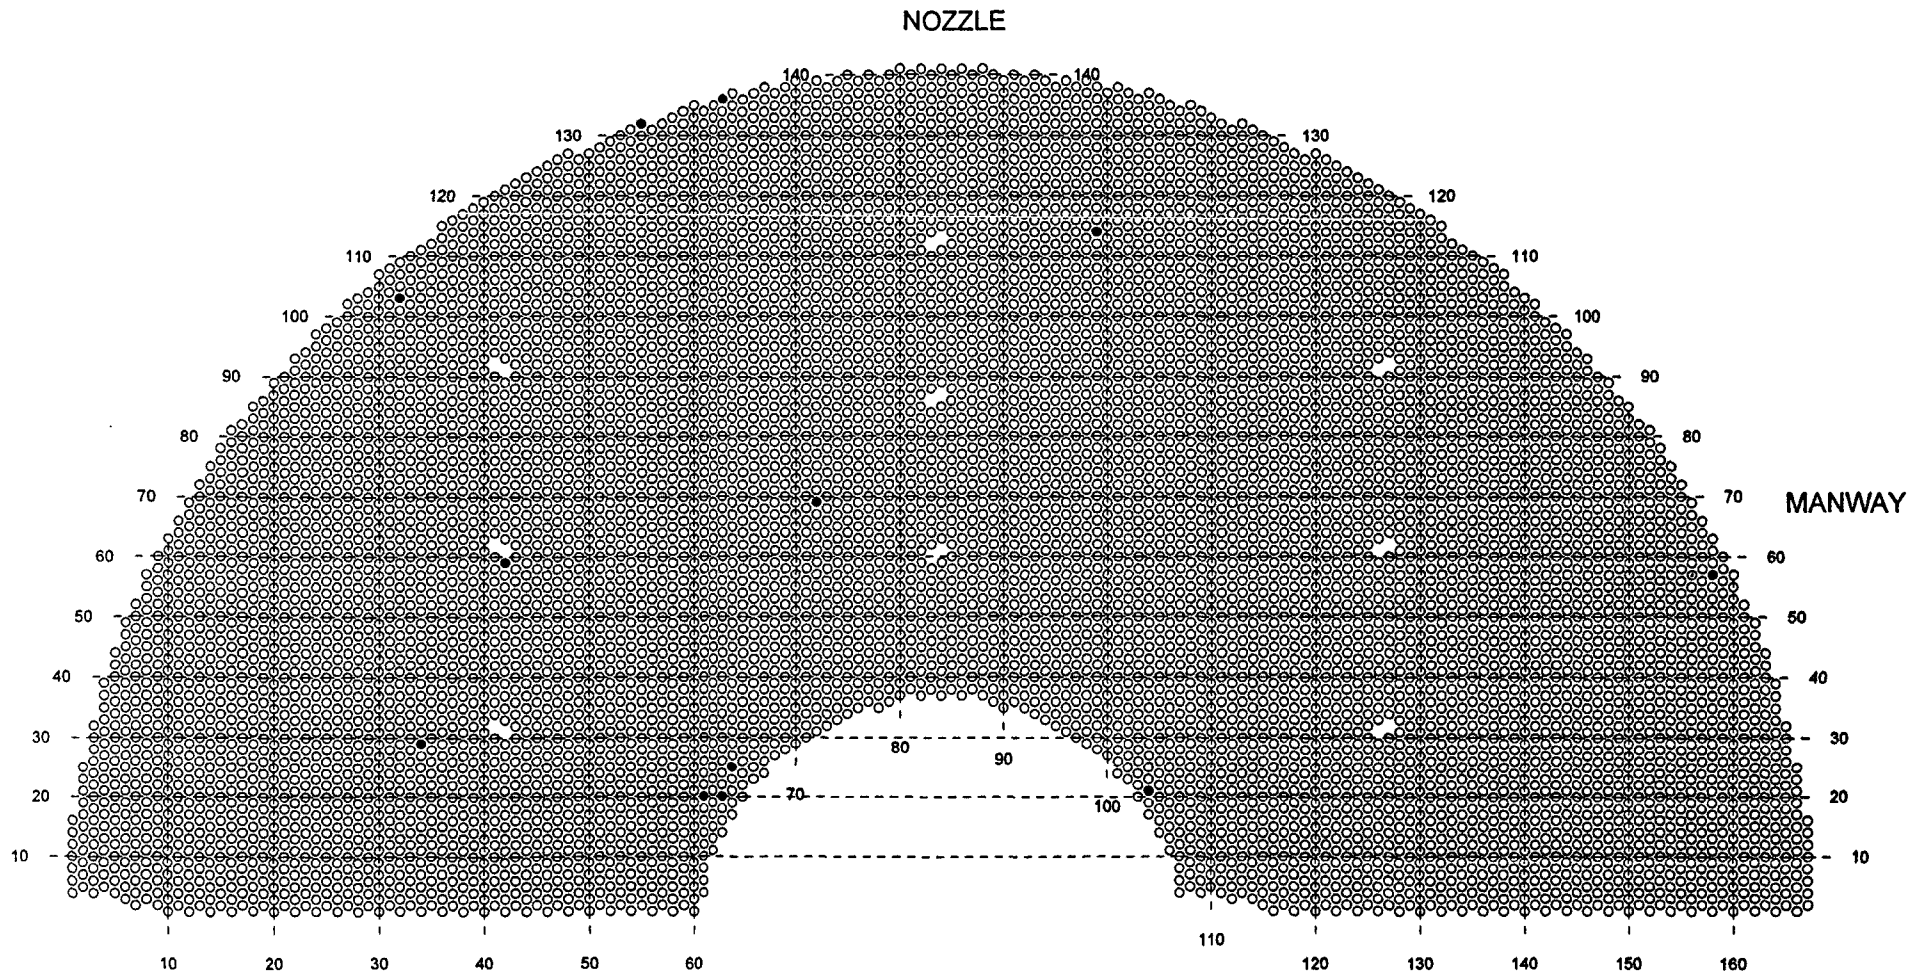
Attachment 2

DNG Indications

S/G 1
HOT
PRIMARY FACE

TOTAL TUBES: 8523
SELECTED TUBES: 12
OUT OF SERVICE (#): 1

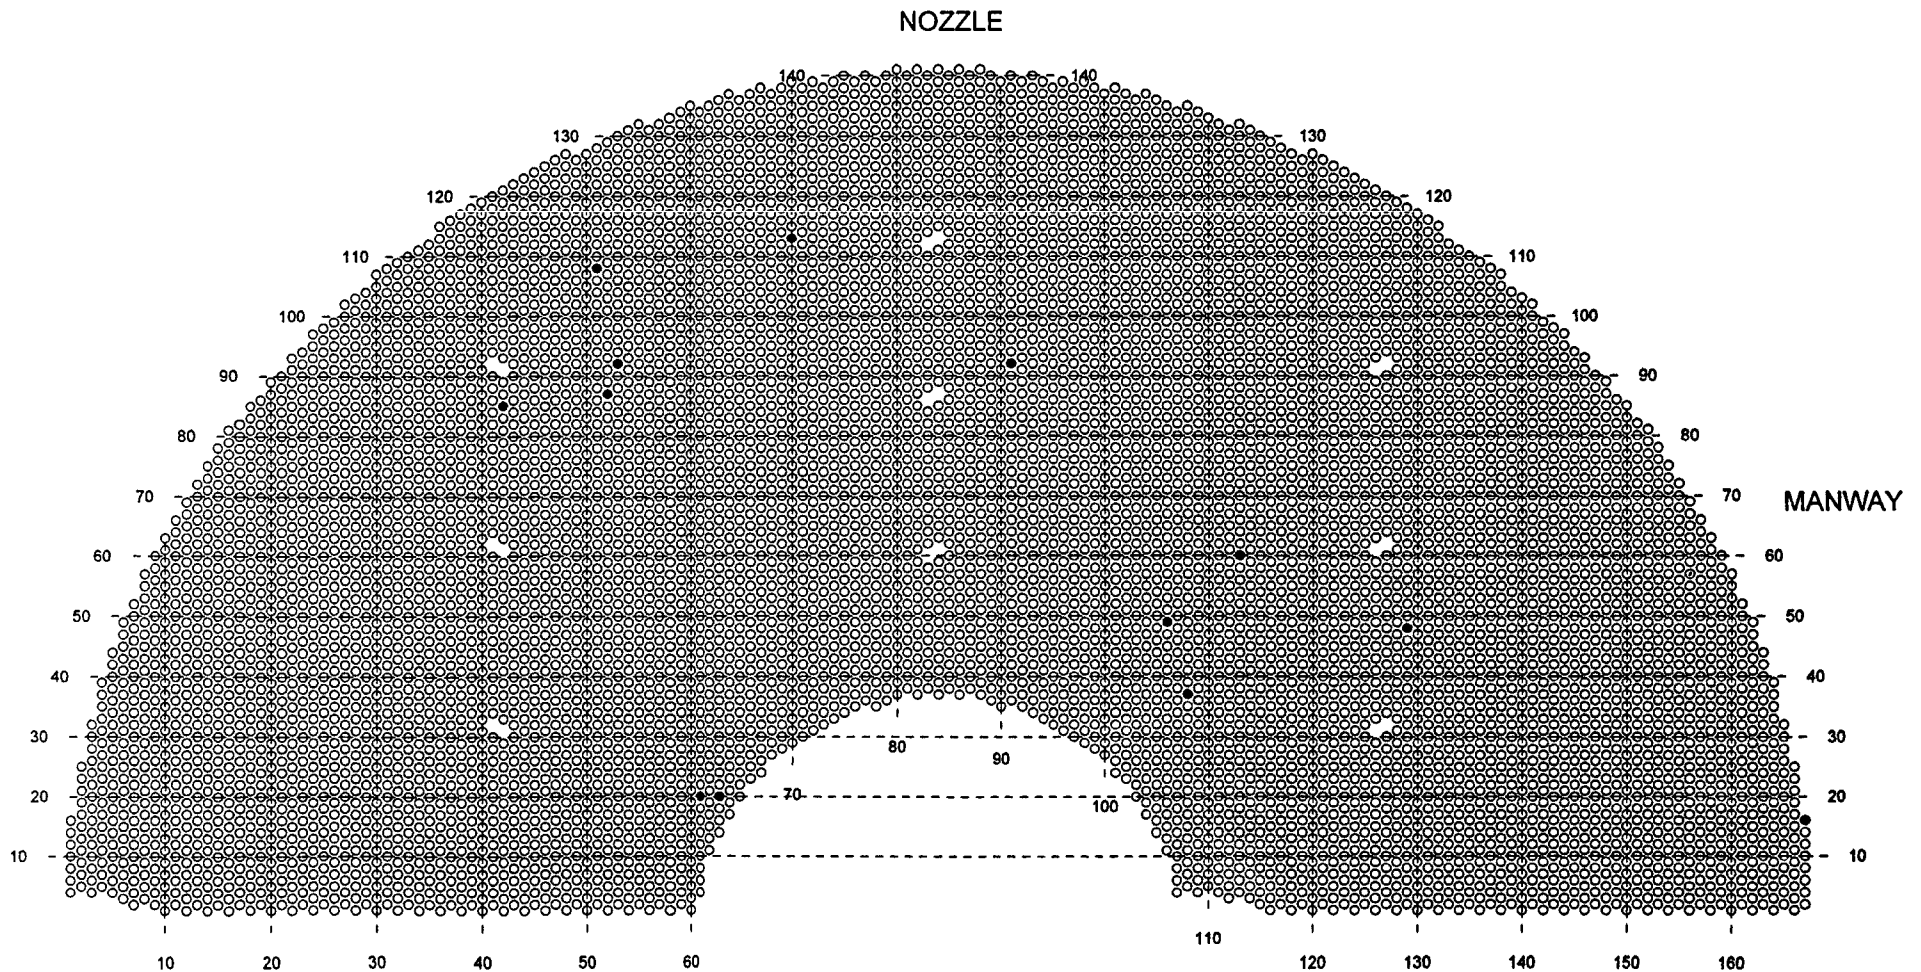
Attachment 3

DNT Indications

S/G 1
HOT
PRIMARY FACE

TOTAL TUBES: 8523
SELECTED TUBES: 13
OUT OF SERVICE (#): 1

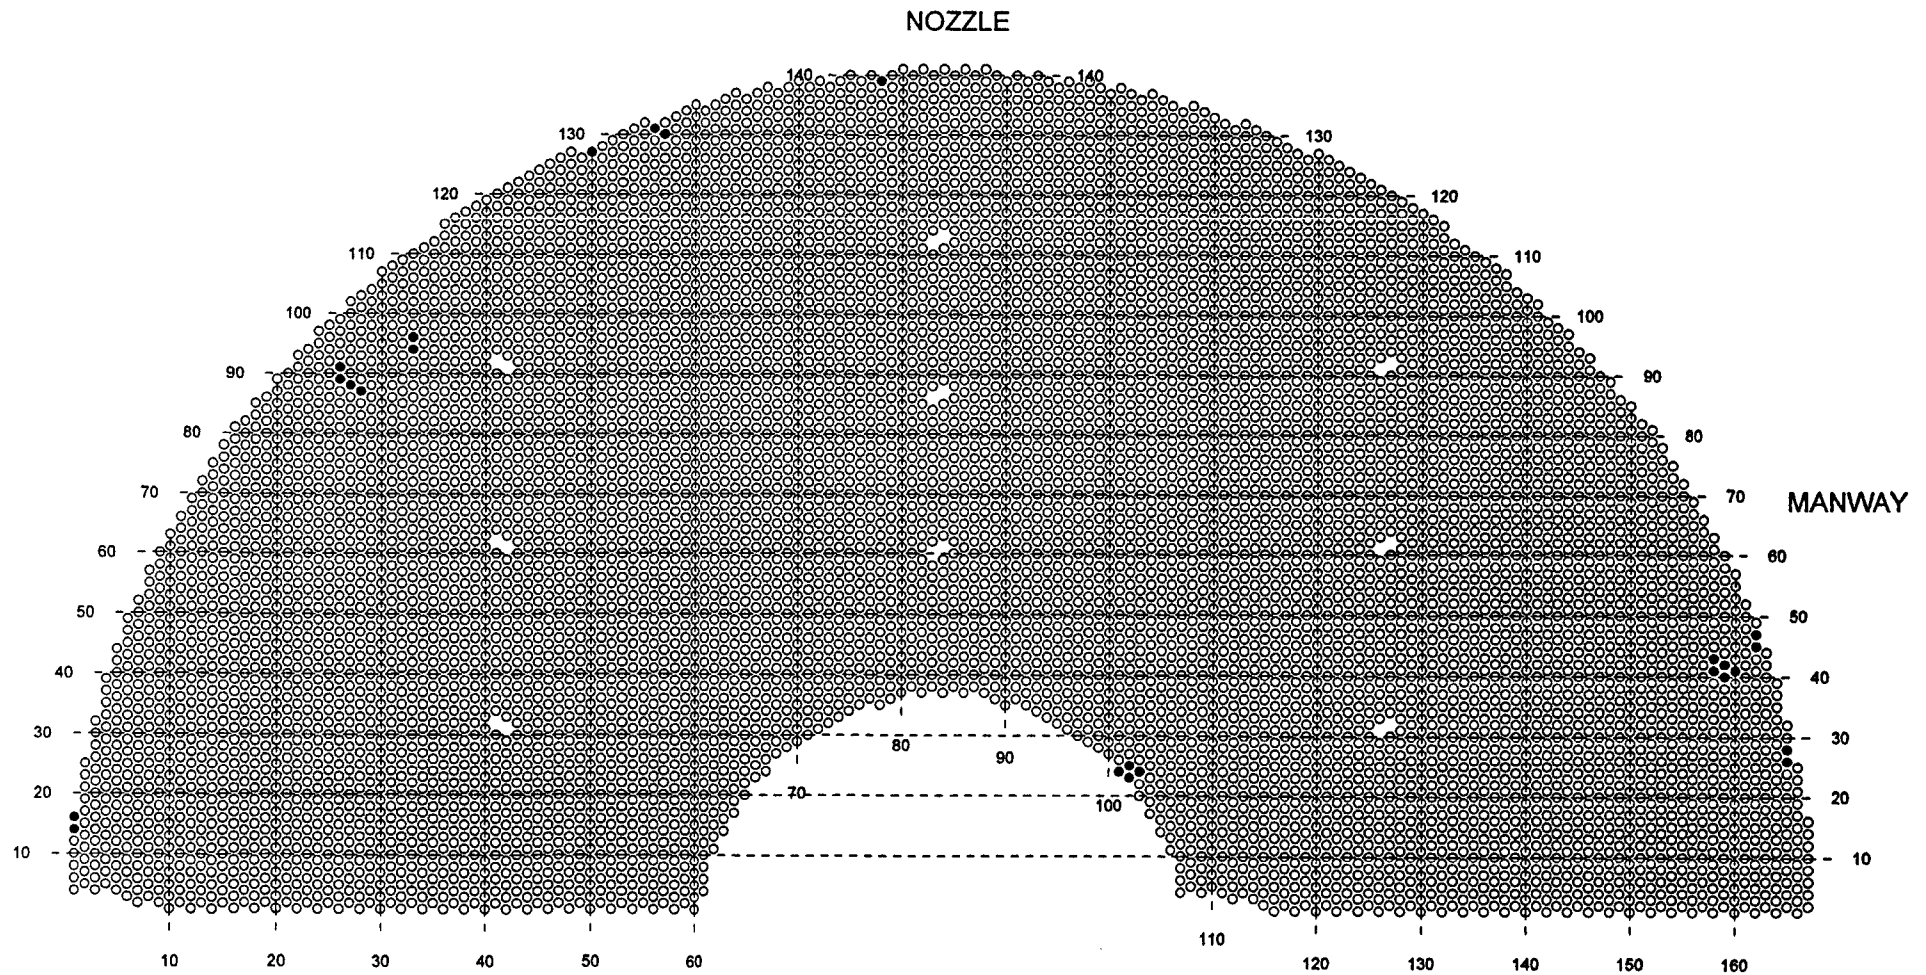
Attachment 4
PLP Indications

PLP Indications

S/G 1
HOT
PRIMARY FACE

TOTAL TUBES: 8523
SELECTED TUBES: 25
OUT OF SERVICE (#): NA

Twenty-five (25) PLP indications were also reported. These ECT reported indications were grouped in eleven (11) locations as shown in Attachment 4. Seventeen (17) of the indications were initially reported with the bobbin coil examination and eight (8) with the MRPC examination. Loose parts were observed in an additional three (3) locations during SSI. There were no indications of wear associated with any of the PLP indications or any of the loose parts that were reported. Additional information is included in Table 4.

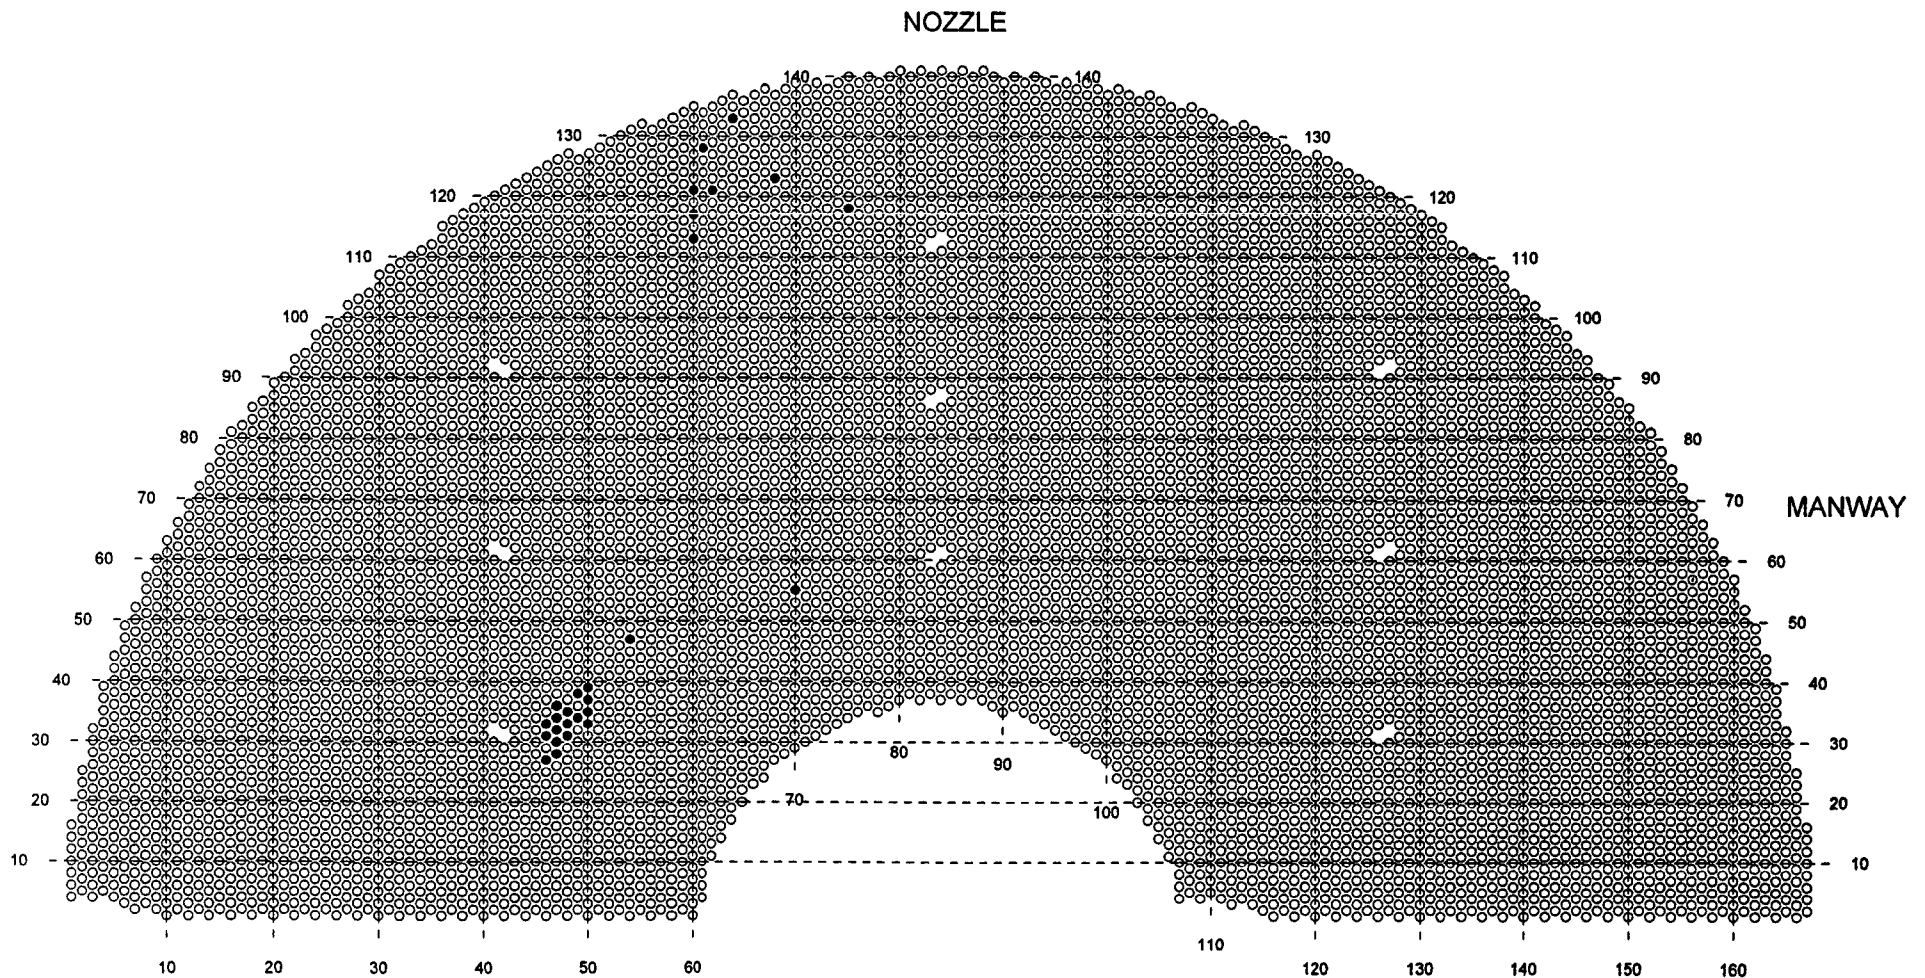
Attachment 5

SLG Indications

S/G 1
HOT
PRIMARY FACE

TOTAL TUBES: 8523
SELECTED TUBES: 27
OUT OF SERVICE (#): 1

locations selected for examination make up fifty percent (50%) of this total sludge region (284 tubes) identified from both SGs. Approximately seventy-four (74%) of the tubes in the sample had previously identified Sludge (SLG) indications in SG 1. SLG indications reported during the current inspection are mapped in Attachment 5. One tube with a historical Partial Tubesheet Expansion (PTE) indication was also examined TSH-TEH.

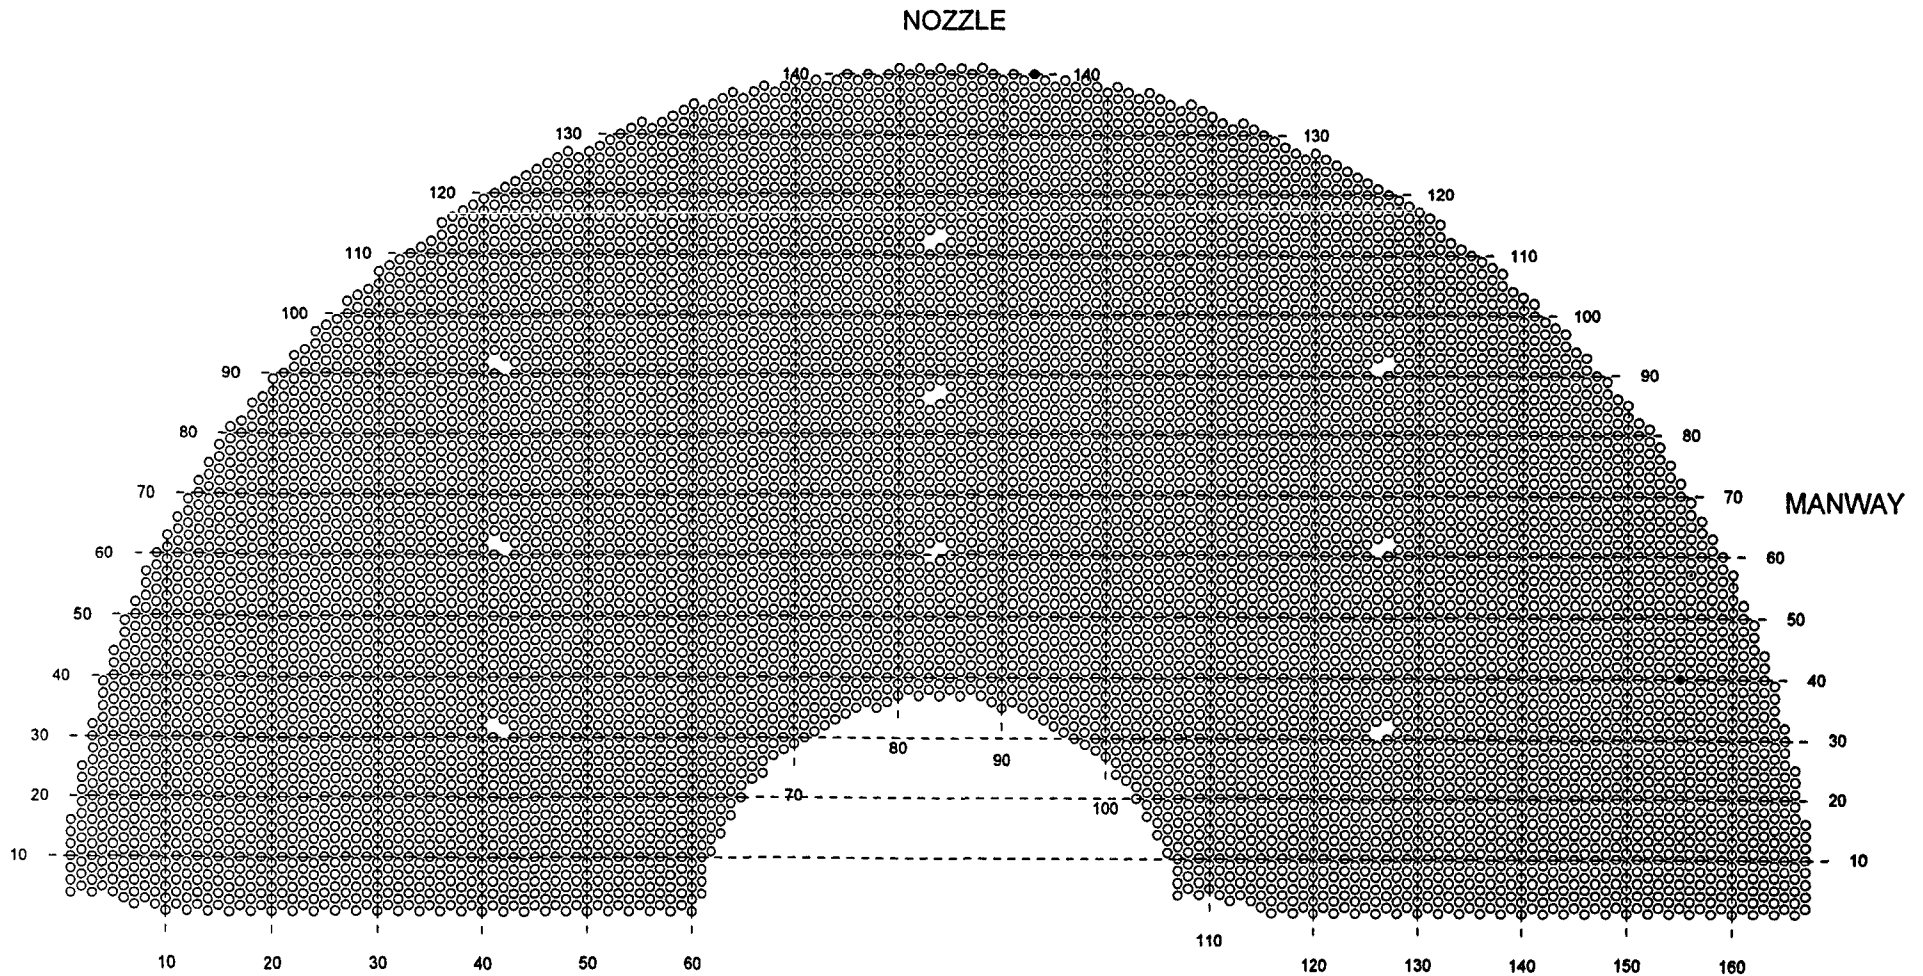
Attachment 6
% TW FB Indications

%TW (Bobbin Wear) Indications

S/G 1
HOT
PRIMARY FACE

TOTAL TUBES: 8523
SELECTED TUBES: 2
OUT OF SERVICE (#): 1

ECT reported two (2) tubes with nine (9) percent throughwall (%TW) fan bar wear. The ECT results from 2R14 also reported 9%TW wear on these tubes, thus the wear has not progressed over the past two operating cycles. Additional details on fan bar wear in both SGs are provided in Table 3 and Attachment 6.

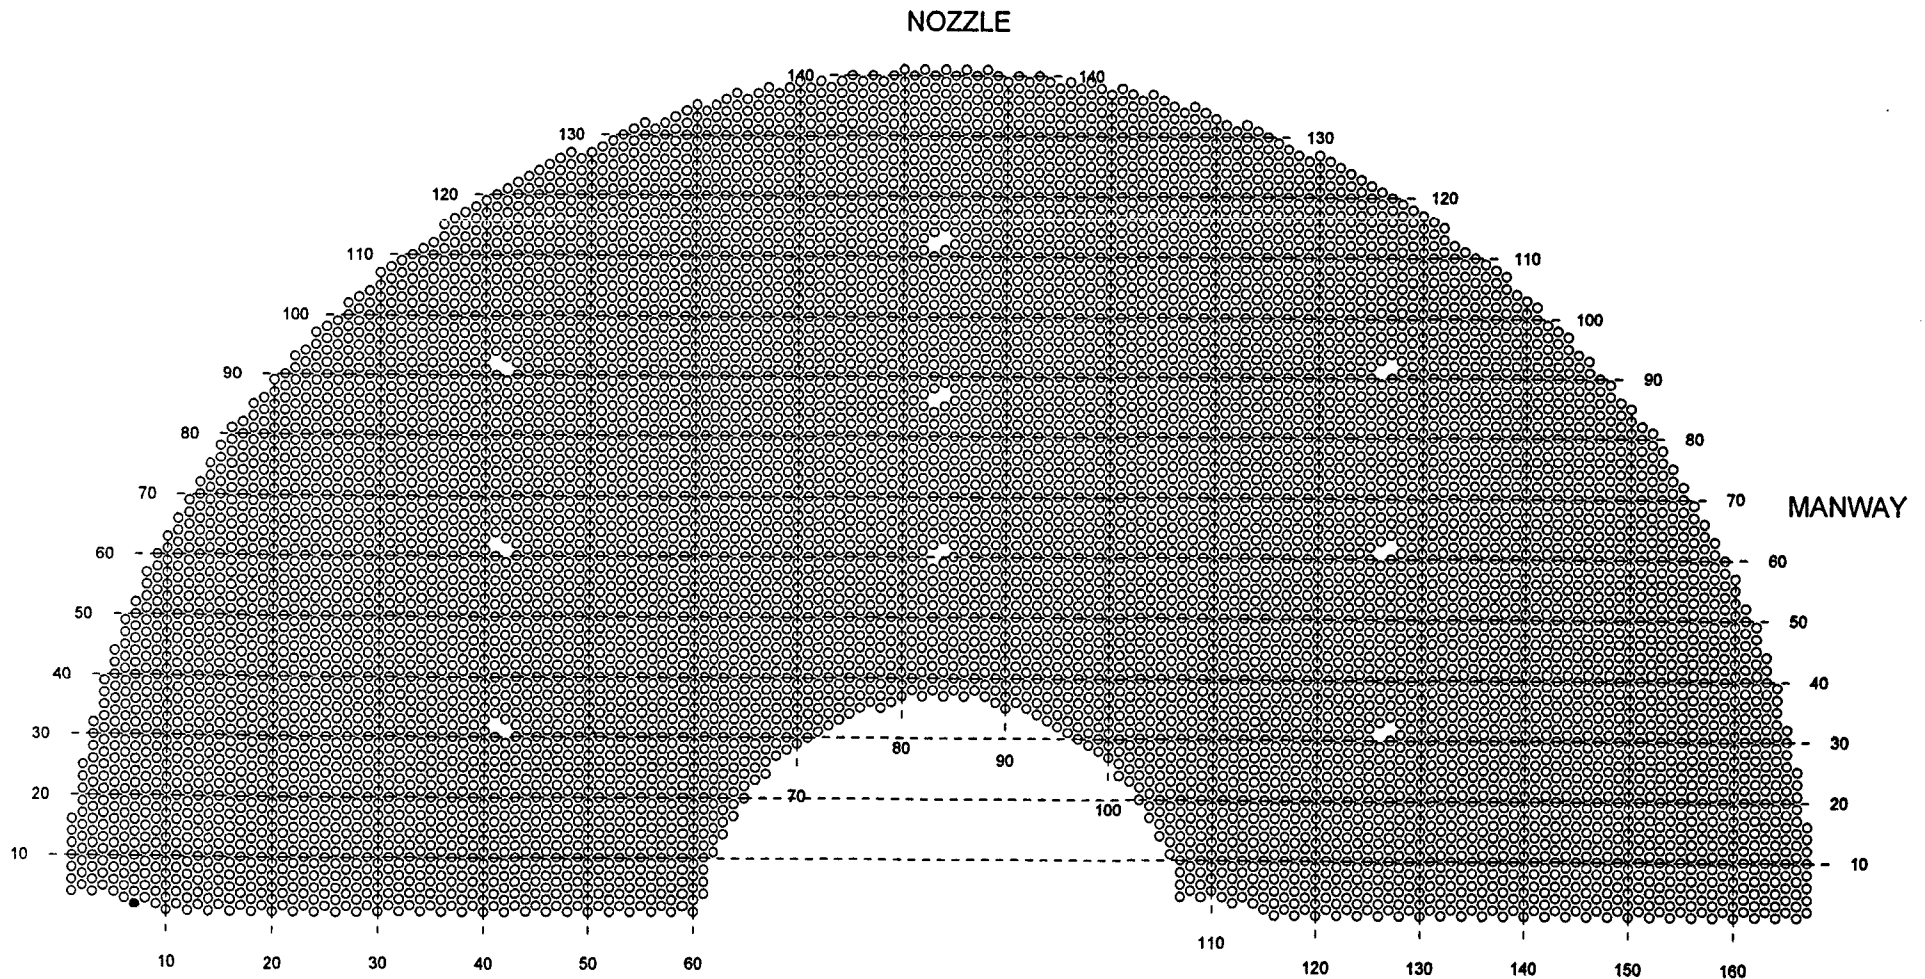
Attachment 7

VOL Indications

S/G 1
HOT
PRIMARY FACE

TOTAL TUBES: 8523
SELECTED TUBES: 1
OUT OF SERVICE (#): NA

One Volumetric Indication (VOL) was reported. This VOL indication has been reported since the June 1997 examination with MRPC. It is believed to be associated with a Manufacturing Buff Mark (MBM) and exhibits no change since first reported. Additional details are provided in Attachment 7.
