SUBJECT: FOREIGN TRAVEL TRIP REPORT—NRC STAFF VISIT TO CHALK
RIVER LABORATORIES TO OBSERVE SUMP STRAINER HEAD LOSS
TESTING PERFORMED BY ATOMIC ENERGY OF CANADA, LIMITED

NRC FOREIGN TRIP REPORT

NRC Staff Visit to the Chalk River Laboratories to Observe Head Loss Testing of the Atomic Energy of Canada, Limited, Finned Strainer Design for Surry Power Station, Units 1 and 2, and Millstone Power Station, Unit 2

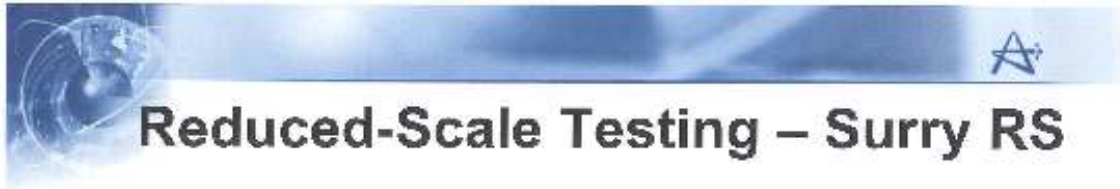
Reduced-Scale Testing – Surry RS

Surry RS strainer sizing

- Thin-bed head loss test
- Strainer = 6000 ft² Test section = 22.5 ft²
- Flow rate = 52.6 gpm
- Water temperature = 104°F
- Particulate = Walnut shell flour (3.1 lb)
- Fiber/(1/16th) = TempMat (0.72 lb), Cerafiber (0.46 lb), Paroc (0.15 lb), Nukon (0.01 lb)

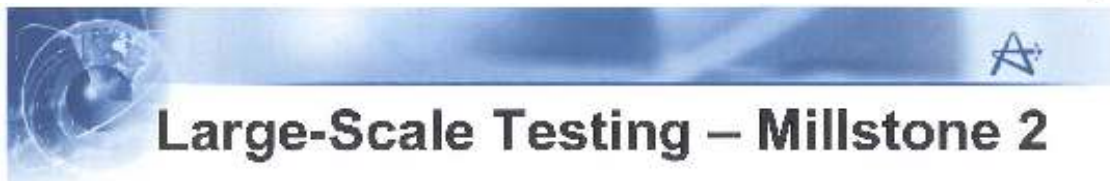
Millstone 2 strainer sizing verification

- Thin-bed head loss test
- Strainer = 5620 ft² Test section = 358 ft²
- Flow rate = 433 gpm
- Water temperature = 104°F
- Particulate = Walnut shell flour (246 lb)
- Fiber/(1/16th) = Knauf (4.37 lb), Nukon (2.86 lb), Fibrex (2.34 lb)

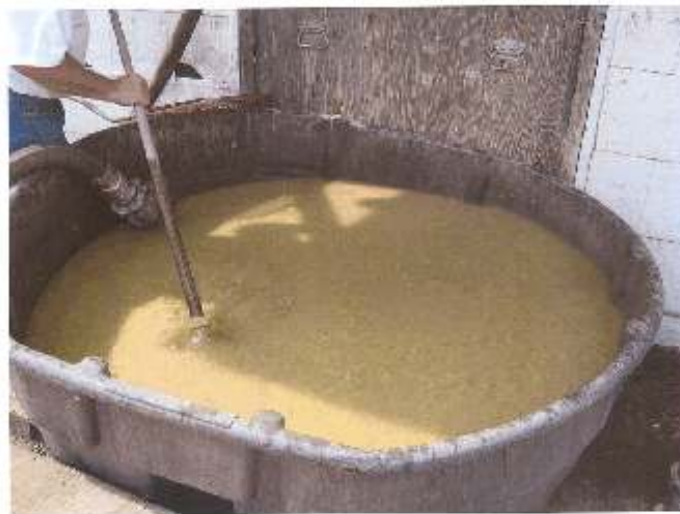
Large-Scale Testing – Millstone 2

The large-scale test observed by the staff was a thin bed test with a general procedure analogous to that previously described for the reduced-scale test. That is, the entire load of particulate was first added to the test tank, and 1/16-inch batches of fiber were subsequently added at intervals determined by stabilization criteria provided in the test plan (which were similar to the criteria described for the reduced-scale test) until a theoretical fiber loading of 3/8 inch was added to the test tank. According to the thin bed test procedure, only fibrous debris and particulate debris were added to the test tank (i.e., RMI was not included). The fibrous debris used for the test included Nukon, Knauf pipe insulation, and mineral wool. Walnut shell flour was used as a surrogate for qualified coatings, unqualified coatings, and for latent particulate debris. As for the reduced-scale test, the staff did not review in detail whether the surrogate debris was representative of the actual plant debris.
