CORROSION OF SIMILAR AND DISSIMILAR METAL CREVICES IN THE ENGINEERED BARRIER SYSTEM OF A POTENTIAL NUCLEAR WASTE REPOSITORY

X. He^{1,2} and D.S. Dunn²

Abstract

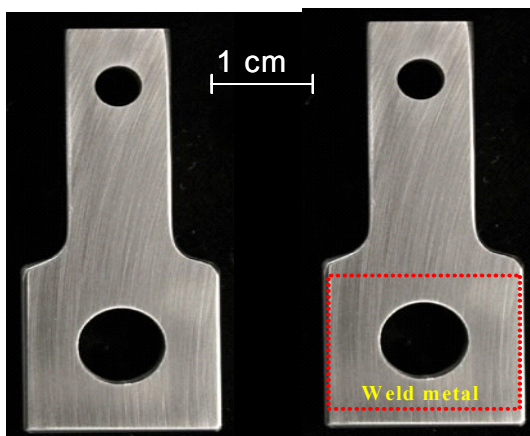
(a) Alloy 22 crevice specimen, mill-annealed and welded plus solution annealed. Surface area = 11.6 cm^2 [1.80 in^2].

Figure 1. Optical photographs of crevice specimen and test fixtures (crevice washers, bolts, and nuts) used to assemble crevices

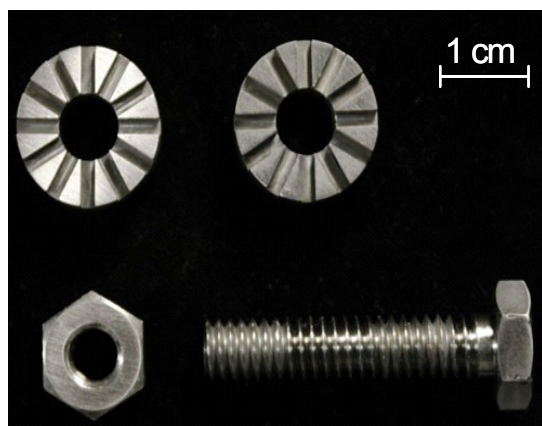
(b) Titanium Grade 7 washers, bolt, and nut. Combined surface area = 39.3 cm^2 [6.09 in^2].

The tests conducted in 4 M NaCl solution at 95 °C [203 °F] have shown that no significant effects of crevice tightness and area ratio of crevice specimen to crevice washer were observed. Except for stainless steel and several tests on Alloy 22 (Tests 7, 19, 22, and 31 in Table 2), the crevice specimens remained passive during polarization. In the potential repository, the chloride concentration in waters contacting the waste package could range from very dilute water to very concentrated brines due to evaporation (Dunn, et al., 2005a). Additional tests to measure E_{corr} and E_{rcrev} of mill-annealed Alloy 22 to Titanium Grade 7 and welded plus solution annealed Alloy 22-to-Titanium Grade 7 were performed in 0.5 M NaCl and 4 M MgCl₂ solution at 95 °C [203 °F]. All the Titanium Grade 7 washers, bolts, and nuts were descaled before use (American Society for Testing and Materials International, 2005b). In addition, the plateaued surface of the crevice washer was polished after descaling. The test results are summarized in Table 4. Tests 39–42 were performed in 0.5 M NaCl solution and Tests 43–50 were performed in 4 M MgCl₂ solution. Since no significant effect of area ratio was observed in 4 M NaCl solution, only small crevice washers [Figure 1(b)] were used in these tests in Table 4.

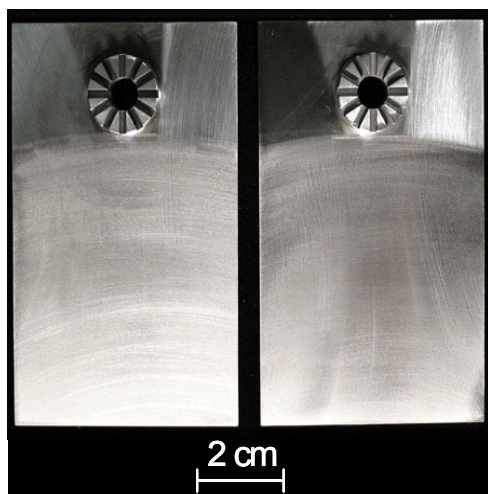
(c) Large Titanium Grade 7 washers. Surface area = 186 cm^2 [28.8 in^2].

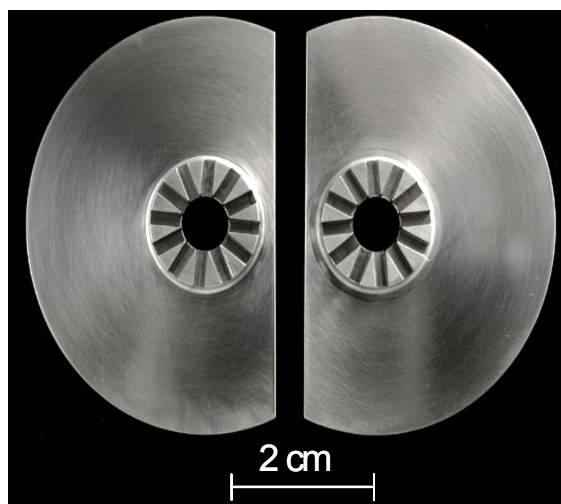
(d) Large Alloy 22 washers. Surface area = 87.2 cm^2 [13.5 in^2].

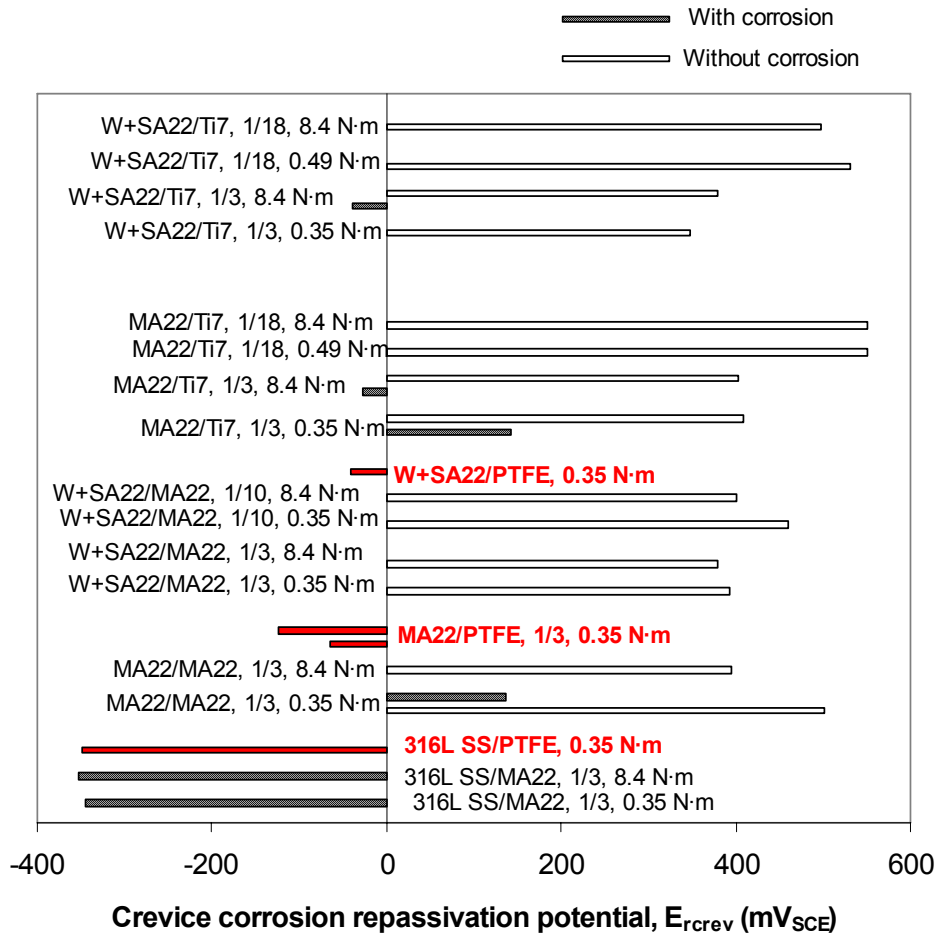
Figure 2. Measured repassivation potentials for crevice corrosion in 4 M NaCl solution at 95 °C [203 °F] for different specimens with different torque levels (Tables 2 and 3). (Note: SS—stainless steel, MA 22—mill-annealed Alloy 22, W+SA 22—welded plus solution annealed Alloy 22, Ti7—Titanium Grade 7, PTFE—polytetrafluoroethylene, 1 N·m = 8.93 in·lb)

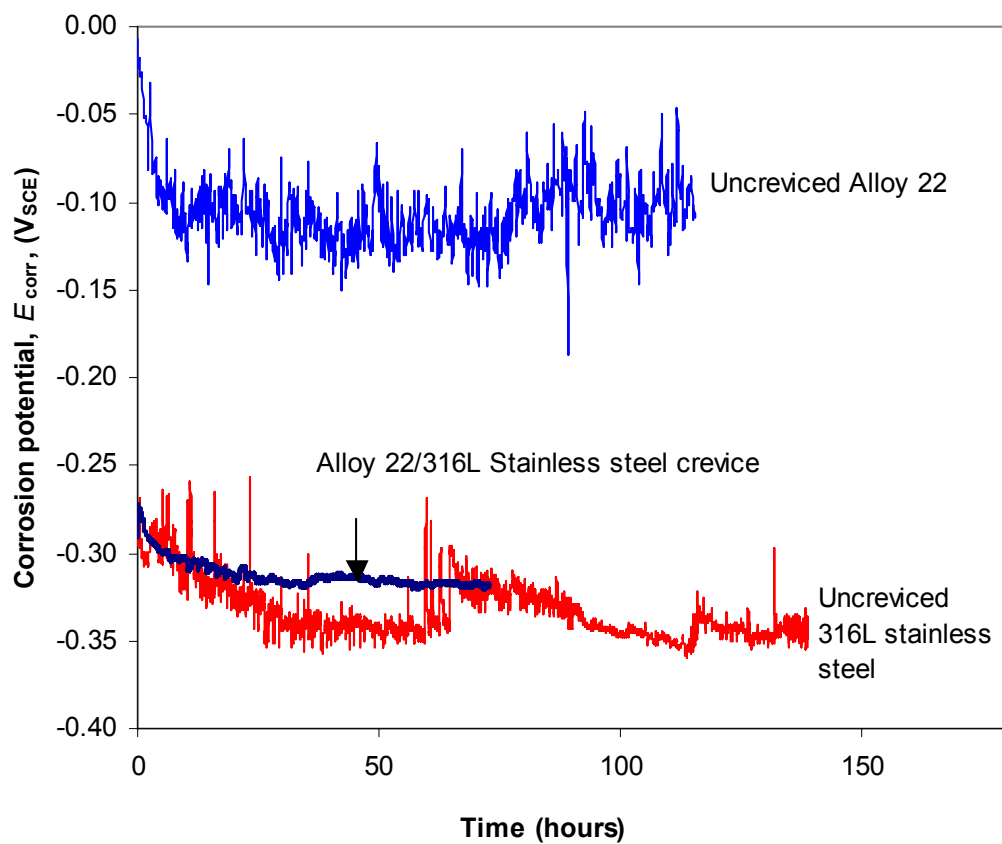
Figure 3. Open circuit potential of uncreviced Alloy 22, 316L stainless steel, and Alloy 22-to-316L stainless steel crevice assembly measured in 4 M NaCl solution at 95 °C [203 °F]

Figure 3 shows the corrosion potential measured from uncreviced Alloy 22 and Type 316L stainless steel, and Type 316L stainless steel-to-Alloy 22 crevice. The E_{corr} of uncreviced Alloy 22 was higher than that of Type 316L stainless steel, which is consistent with the reported galvanic series in flowing sea water (ASM International, 1987). The E_{corr} of the crevice couple was close to that of the uncreviced Type 316L stainless steel, which suggests that the corrosion potential of the crevice couple is dominated by the behavior of stainless steel under this condition.

Post-test examination revealed that crevice corrosion was limited to the Type 316L stainless steel specimen. This result is consistent with the more noble corrosion potential observed on Alloy 22 in 4 M NaCl solution (Figure 3). Figure 9 shows Type 316L stainless steel specimens with crevice corrosion. For the specimen with Alloy 22 as crevice forming material, crevice corrosion occurred in the creviced region on 22 out of 24 crevice sites with varying penetration depths, as listed in Table 5. For the Type 316L stainless steel specimen with polytetrafluoroethylene as the crevice washer, crevice corrosion led to penetration through the specimen with a thickness of 5 mm [0.2 in]. In addition to crevice corrosion, there was also pitting corrosion inside and outside of the crevice for the stainless steel specimen using polytetrafluoroethylene as the crevice washer.

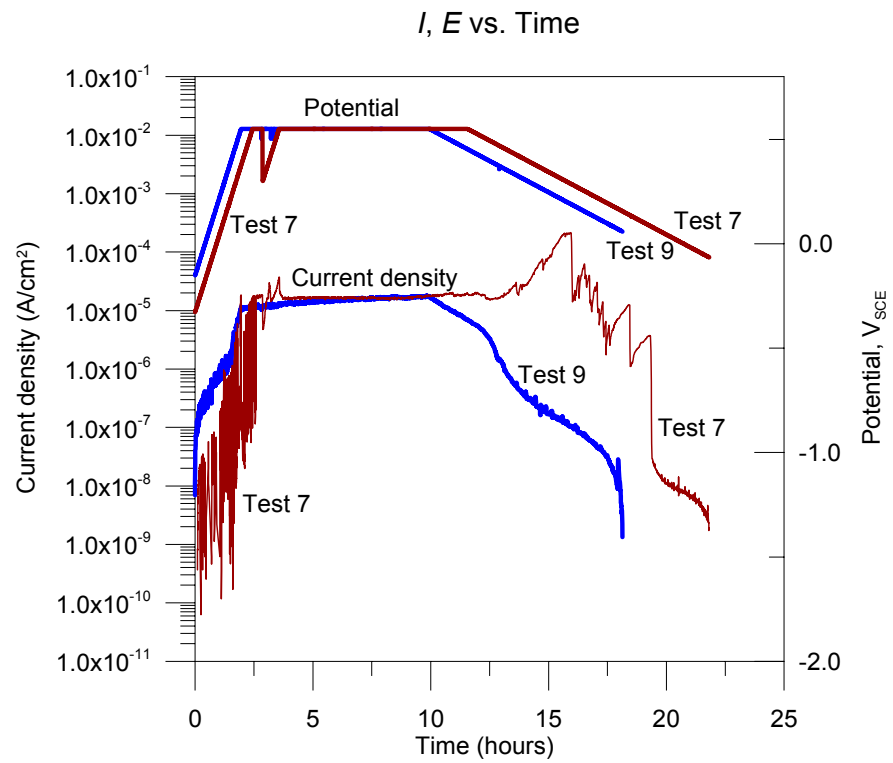
Figure 4. Potentiodynamic polarization and potentiostatic hold curves of Alloy 22 to Alloy 22 crevices (Tests 7 and 9 in Table 2) in N₂ deaerated 4 M NaCl solution at 95 °C [203 °F]

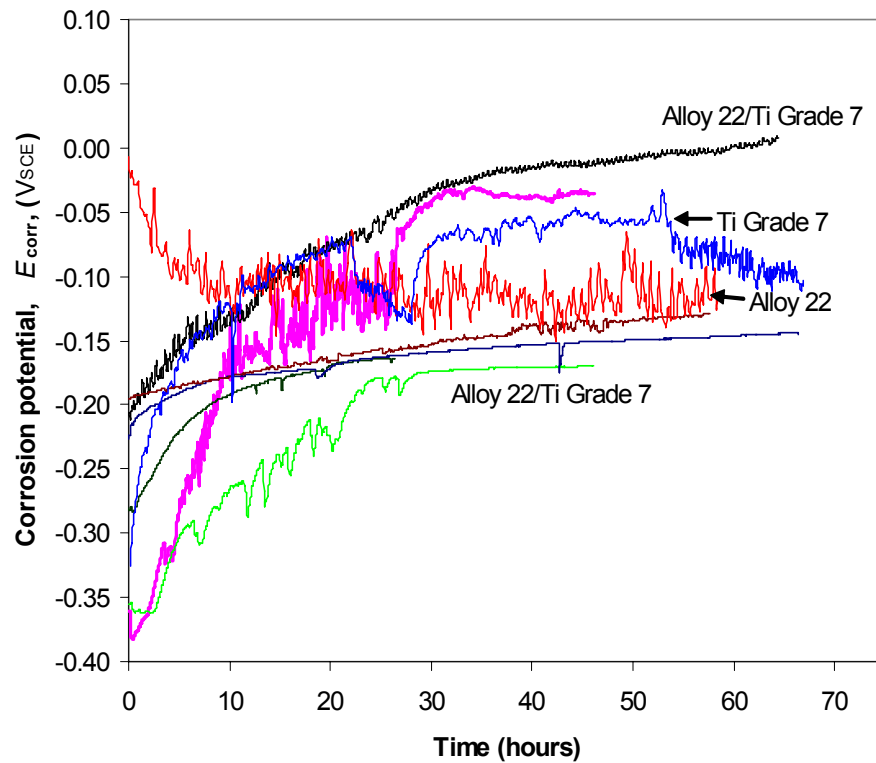
Figure 5. Open circuit potential of uncreviced Alloy 22 and Titanium Grade 7 specimens, and Alloy 22 to Titanium Grade 7 crevice couples (Tests 20, 21, 22, 23, 25, and 27 in Table 2) measured in 4 M NaCl solution at 95 °C [203 °F]. For clarity, only one set of data for uncreviced Alloy 22 and Titanium Grade 7 are shown. Other data are shown for Alloy 22 to Titanium Grade 7 crevice couples.

Figure 5 shows the E_{corr} of mill-annealed Alloy 22 to Titanium Grade 7 crevice couples (Tests 20, 21, 22, 23, 25, and 27 in Table 2) measured in air-saturated solution, along with E_{corr} of uncreviced Alloy 22 and Titanium Grade 7 (for clarity, only one set of data is shown in Figure 5 for uncreviced Alloy 22 and Titanium Grade 7). After the crevice couples were immersed in solution, the corrosion potential shifted to more noble values for all tests. The end potentials were in a range of $-200 \text{ mV}_{\text{SCE}}$ to $0 \text{ mV}_{\text{SCE}}$ after several days. The E_{corr} values of the uncreviced Alloy 22 and Titanium Grade 7 specimens were within E_{corr} range of the crevice couples. No obvious difference was observed between the E_{corr} of uncreviced Alloy 22 and Titanium Grade 7 specimens or the Alloy 22 to Titanium Grade 7 couples.

The E_{corr} of mill-annealed Alloy 22 and welded plus solution annealed Alloy 22 was not affected by coupling to Titanium Grade 7 as shown in Table 2 and Figure 5. In all tests, no crevice corrosion of the Titanium Grade 7 crevice washers was observed. Ikeda and Quinn (2003) reported that the corrosion potential of Alloy 22 to Titanium Grade 7 or Alloy 22 to Titanium Grade 16 tight crevice was $-500 \text{ mV}_{\text{SCE}}$ in simulated concentrated water at 90 °C [194 °F], which was more negative than that of each uncreviced Alloy 22, uncreviced Titanium Grade 7, or uncreviced Titanium Grade 16. Ikeda and Quinn (2003) attributed this potential

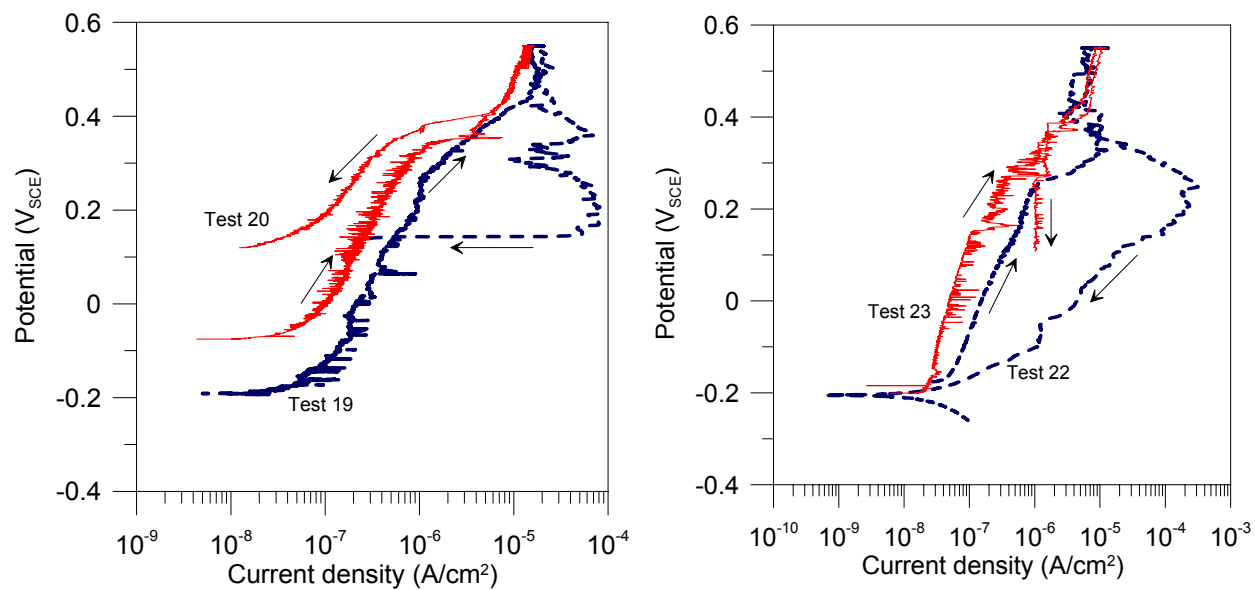
Figure 6. Potentiodynamic polarization curves of Alloy 22 to Titanium Grade 7 crevices (Tests 19, 20, 22, and 23 in Table 2) in N_2 deaerated 4 M NaCl solution at 95 °C [203 °F]

Figure 6 shows the potentiodynamic polarization curves for Tests 19, 20, 22, and 23 in Table 2. No positive hysteresis was observed for Tests 20 and 23 in the high potential region. The corrosion observed for Tests 19 and 22 was probably due to the current peak observed at approximately $200 \text{ mV}_{\text{SCE}}$ during the reverse scan. Subsequent tests (Tests 20, 21, 23, and 24 in Table 2) with a fresh specimen and repolished Titanium Grade 7 crevice washers did not result in crevice corrosion and no such peak was observed. The only difference between these tests is that Tests 19 and 22 were assembled with unused and freshly polished Titanium Grade 7 crevice washer, bolt, and nut, whereas Tests 20, 21, 23, and 24 were assembled with previously used crevice washers, bolts, and nuts. Only the plateaued surface of the crevice washer that contacts the crevice specimen was freshly polished. No such peak was observed after the Titanium Grade 7 washers, bolts, and nuts were descaled with hydrofluoric acid solution following the recommended procedure (Tests 21, 24, 33, and 38 in Table 2) (American Society for Testing and Materials International, 2005b).

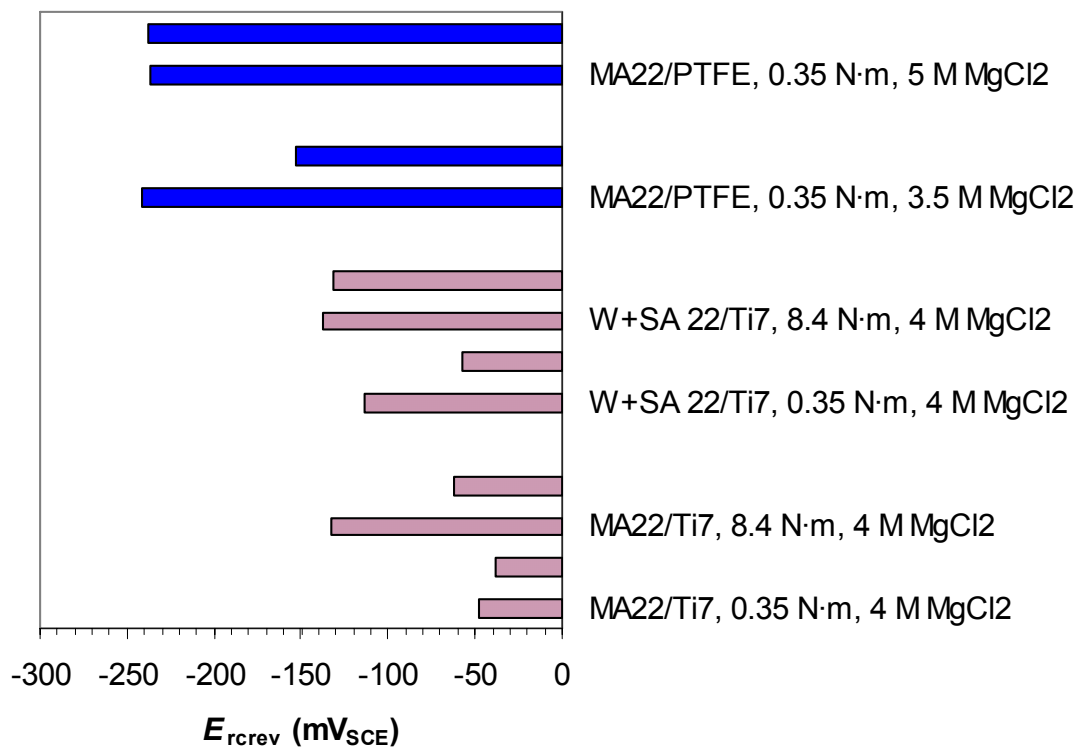
Figure 7. Comparison of crevice corrosion repassivation potential, E_{rcrev} , for mill-annealed Alloy 22 and welded plus solution annealed Alloy 22 to Titanium Grade 7 crevices measured in 4 M MgCl₂ solution with Alloy 22 to polytetrafluoroethylene crevices measured in 3.5 M and 5 M solutions (Dunn, et al., 2005a) at 95 °C [203 °F]. Duplicate tests were performed at all test conditions. Crevice corrosion was observed in all cases using Titanium Grade 7 or polytetrafluoroethylene as crevice-forming material. (Note: MA22—mill-annealed alloy 22, Ti7—Titanium Grade 7, W+SA 22—welded plus solution annealed Alloy 22, PTFE—polytetrafluoroethylene, MgCl₂—MgCl₂)

Figure 7 shows the E_{rcrev} values measured in 4 M MgCl₂ solution in Table 4, along with the E_{rcrev} values measured previously in 3.5 M MgCl₂ and 5 M MgCl₂ solution at 95 °C [203 °F] from Alloy 22-to-polytetrafluoroethylene crevices (Dunn, et al., 2005a). In all cases represented in Figure 7, crevice corrosion was observed on crevice specimens. However, no crevice corrosion was observed on Titanium Grade 7 washers for tests listed in Table 4. Figure 7 shows that the E_{rcrev} values for metal-to-metal crevices were higher than those measured from the corresponding metal-to-polytetrafluoroethylene crevices in 3.5 M MgCl₂ and 5 M MgCl₂, indicating less susceptibility of metal-to-metal crevices to crevice corrosion. However, the E_{rcrev} values measured in 4 M MgCl₂ solution (Tests 43–50 in Table 4) were lower than those measured in 4 M NaCl solution when crevice corrosion was observed (Tests 7, 19, 22, and 31 in Table 2). This result is consistent with the increasing susceptibility of Alloy 22 to crevice corrosion with increasing chloride concentration. Another feature noticed from Table 4 is that the difference between E_{corr} and E_{rcrev} was within 100 mV, except for one test (Test 46 in Table 4). If we consider the uncertainty in the measurement of E_{corr} and E_{rcrev} (typically ± 100 mV), the small difference suggests that crevice corrosion might occur under such test conditions. In addition, it appears that the E_{rcrev} values were lower for welded plus solution annealed Alloy 22 than for mill-annealed Alloy 22.

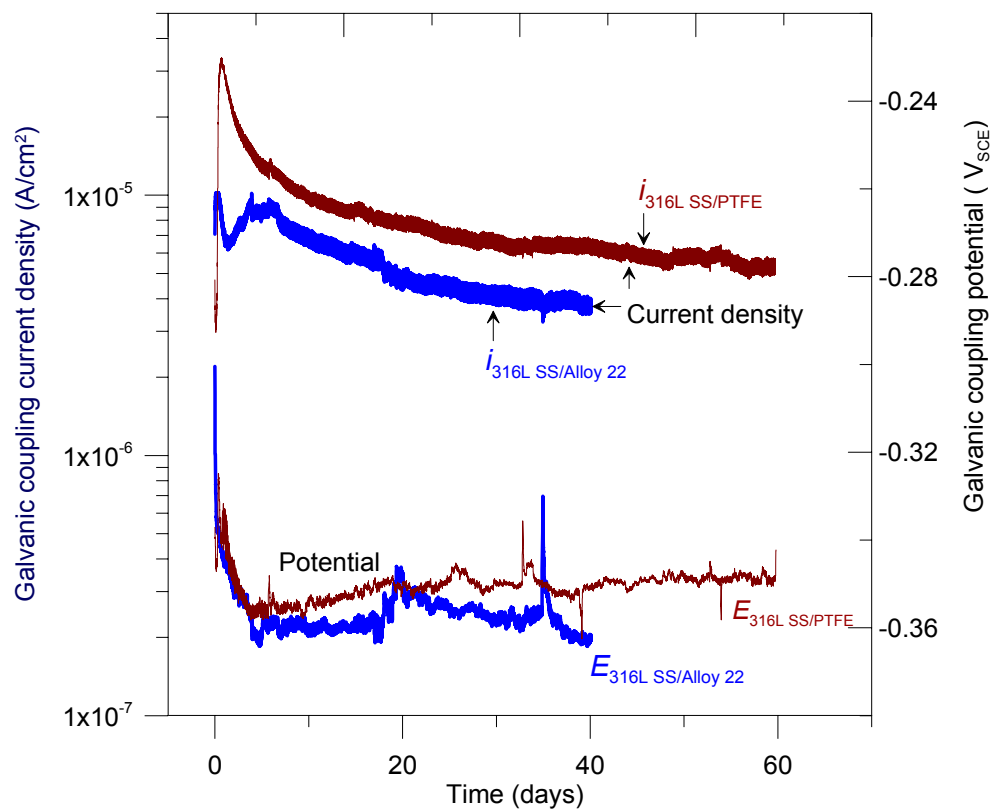
Figure 8. Measured galvanic coupling current density and potential for 316L stainless steel crevice specimen galvanically coupled to Alloy 22 using Alloy 22 or polytetrafluoroethylene as crevice-forming material in 5 M NaCl solution at 95 °C [203 °F] (Tests G1 and G2 in Table 5)

For tests on Type 316L stainless steel using Alloy 22 or polytetrafluoroethylene as the crevice forming material, crevice corrosion was initiated under an open-circuit condition. Figure 8 shows the galvanic coupling current density and potential as a function of time. (In the current setup, positive current corresponds to anodic current from crevice specimen.) After coupling, crevice corrosion initiated instantaneously, resulting in a current density peak. This was followed by current density decay and potential drop. After a period of crevice corrosion propagation, tests were terminated at 40 and 60 days, respectively. For these two tests, no repassivation was observed in the testing period.

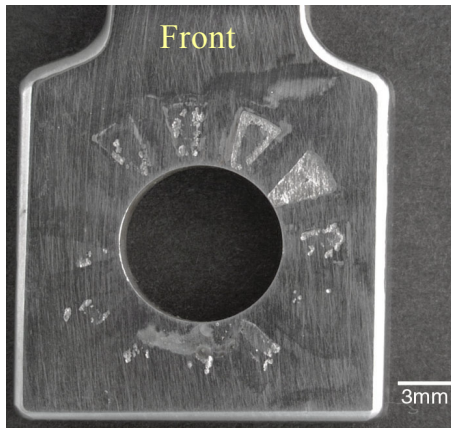
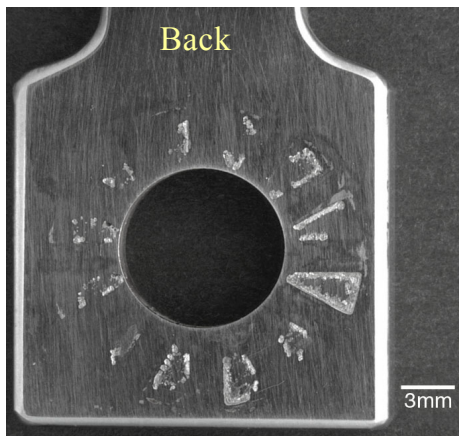
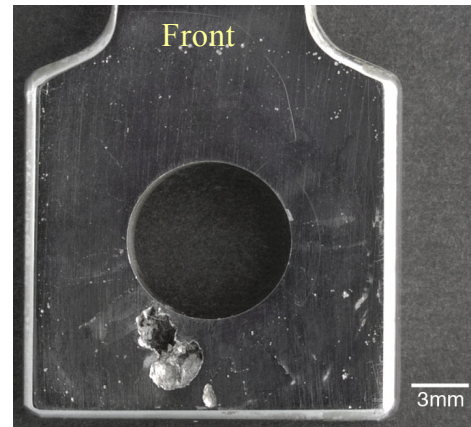
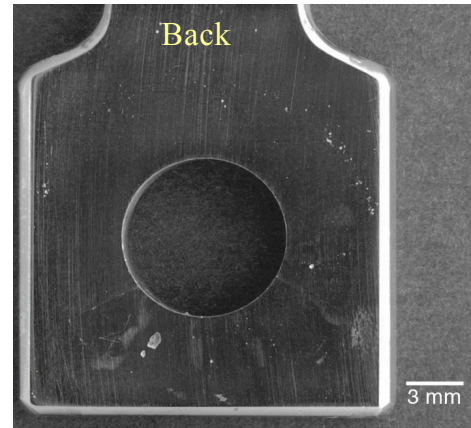
Figure 9. Crevice corroded 316L stainless steel after being coupled to Alloy 22 in 5 M NaCl solution at 95 °C [203 °F] (a) using Alloy 22 as crevice washer (Test G1 in Table 5) and (b) using polytetrafluoroethylene as crevice washer (Test G2 in Table 5)

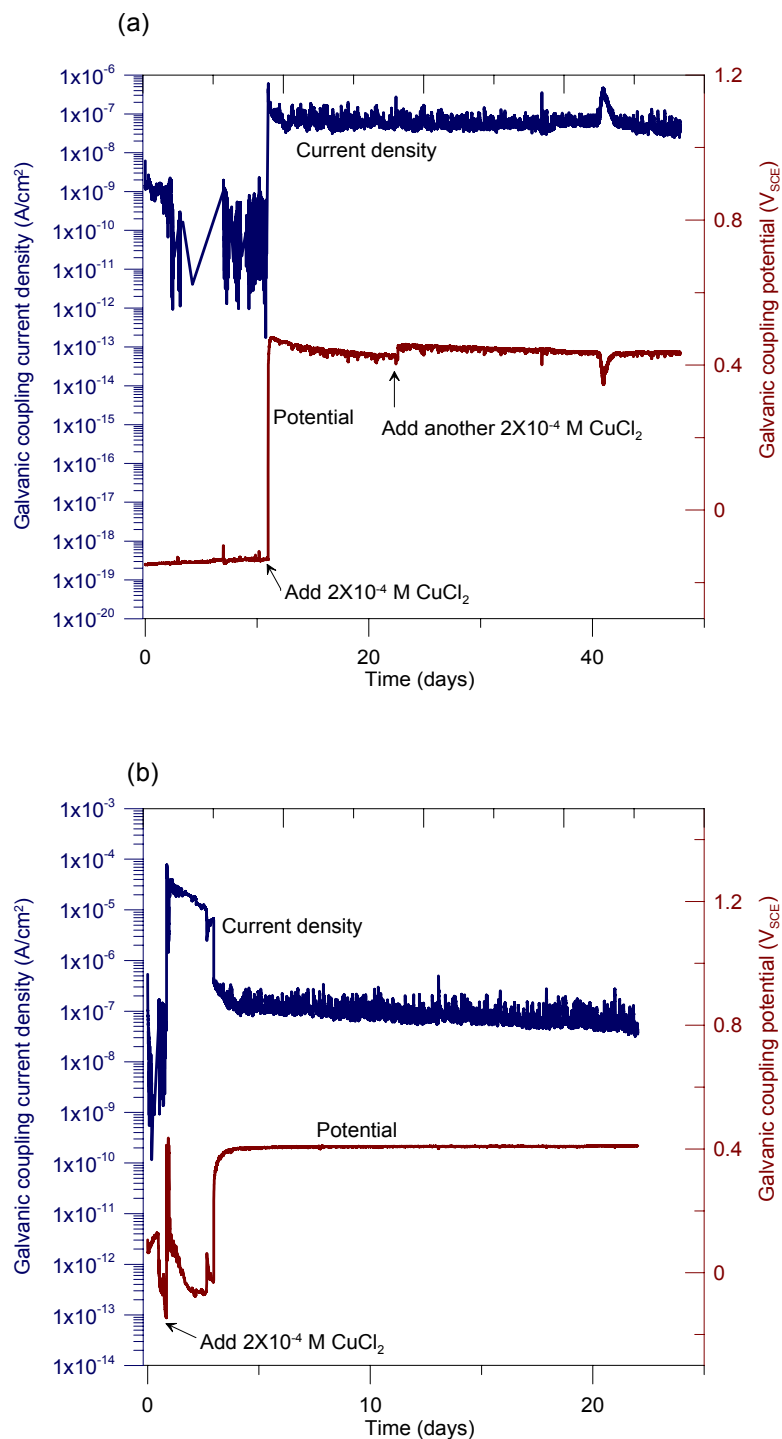
Figure 10. Measured galvanic coupling current density and potential for welded plus solution annealed Alloy 22 crevice specimen galvanically coupled to Alloy 22 using (a) Alloy 22 as crevice forming material (Test G6 in Table 5) or (b) polytetrafluoroethylene as crevice forming material (Test G8 in Table 5) in 5 M NaCl at 95 °C [203 °F]

Figure 10 shows the galvanic coupling current density and potential obtained from Tests G6 and G8, which represent tests of a metal-to-metal crevice and a metal-to-polytetrafluoroethylene crevice. (In the current setup, positive current corresponds to anodic current from the crevice specimen.) For Test G6, where welded plus solution annealed Alloy 22 was galvanically coupled to Alloy 22, the corrosion potential remained at $\sim -200 \text{ mV}_{\text{SCE}}$ and the current density remained at values of $10^{-10} \text{ A}\cdot\text{cm}^{-2}$ [$9.5 \times 10^{-8} \text{ A}\cdot\text{ft}^{-2}$] after coupling, which indicates that no crevice corrosion was initiated. After the galvanic couple remained passive for ~ 10 days, a

small amount of CuCl_2 solution was added into the solution as an oxidant. The addition of CuCl_2 raised the coupling potential by 600 mV and increased the current density to $10^{-7} \text{ A}\cdot\text{cm}^{-2}$ [$9.5 \times 10^{-5} \text{ A}\cdot\text{ft}^{-2}$]. However, no active metal dissolution current was observed after the initial current increase. Another equal amount of CuCl_2 was added to raise the corrosion potential further. The corrosion potential increased slightly; however, the current remained at the same values. The test was terminated at ~50 days. For the tests where crevice corrosion was initiated, large potential drops resulting from active dissolution in the occluded crevice washers were observed, as shown in Test G8 in Figure 10. Test G5 in Table 5 was terminated by power disruption. The other test (G8 in Table 5) arrested after crevice corrosion propagated for a period of 5 days.

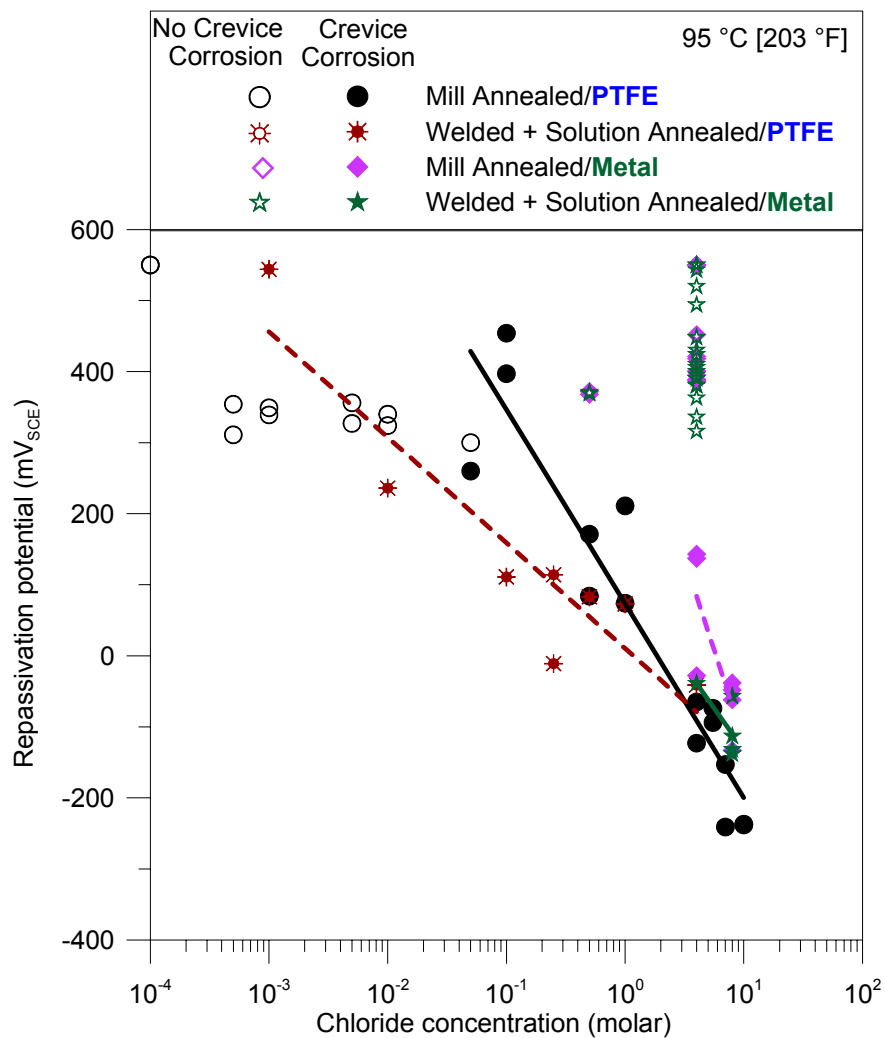
Figure 11. Crevice corrosion repassivation potentials for mill-annealed, welded plus solution annealed Alloy 22 in chloride solutions at 95 °C [203 °F] using polytetrafluoroethylene or metal (Alloy 22 or Titanium Grade 7) as crevice forming material. The lines are log linear regression lines of the repassivation potential with chloride concentration.

Tests conducted in this study showed that, except for 316L stainless steel, all other realistic metal-to-metal crevices were less susceptible to crevice corrosion than the corresponding metal-to-polytetrafluoroethylene crevices. Figure 11 summarizes the E_{rcrev} values for mill-annealed Alloy 22 and welded plus solution annealed Alloy 22 obtained over a wide range of chloride solutions at 95 °C [203 °F] using polytetrafluoroethylene or metal (Alloy 22 or Titanium Grade 7) as the crevice-forming material. Results of tests where no crevice corrosion was initiated are indicated in Figure 11 as open symbols. Also included in Figure 11 are log-linear regression lines of the repassivation potential with chloride concentration. Despite the fact that crevice corrosion was not consistently observed in the 4 M NaCl solution, the regression lines for metal-to-metal crevices were above those of the metal-to-polytetrafluoroethylene crevices. This result suggests that the metal-to-metal crevices are less susceptible to localized corrosion than the metal-to-polytetrafluoroethylene crevices. The E_{rcrev} values of metal-to-metal crevices where crevice corrosion was initiated were higher than those for metal-to-polytetrafluoroethylene crevices, especially at chloride concentrations of 4 M. This observation is consistent with a large difference between E_{corr} and E_{rcrev} (Table 2) and far less corrosion observed on crevice specimens after potentiodynamic polarization. The difference in crevice corrosion susceptibility is a result of a difference in crevice washers. Upon torque, polytetrafluoroethylene washers may deform and fill the small voids created by the surface roughness of the specimen, which results in a better occluded region on the specimen. Conversely, in Alloy 22 to other metal contact, due to the rigidity of the crevice forming metals (Alloy 22 and Titanium Grade 7) used in this study, the crevice is not as tight as the Alloy 22-to-polytetrafluoroethylene crevices, resulting in less crevice corrosion susceptibility. Consistently, no crevice corrosion initiation of Alloy 22 by galvanic coupling was observed when metal was used as a crevice washer to form metal-to-metal crevices in 5 M NaCl solution, even with the addition of CuCl_2 as an oxidant. This result suggests that the Alloy 22 crevice corrosion resistance is not degraded by coupling to metals in the potential engineered barrier system.
