Betty Garrett - Fw: New Kerosene Seep - West Wall

From: "Oscar Paulson" <paulson@tribcsp.com>
To: "Stephen Cohen" <SJC7@nrc.gov>
Date: 07/17/2006 11:16 AM
Subject: Fw: New Kerosene Seep - West Wall
CC: <shelley@tribcsp.com>

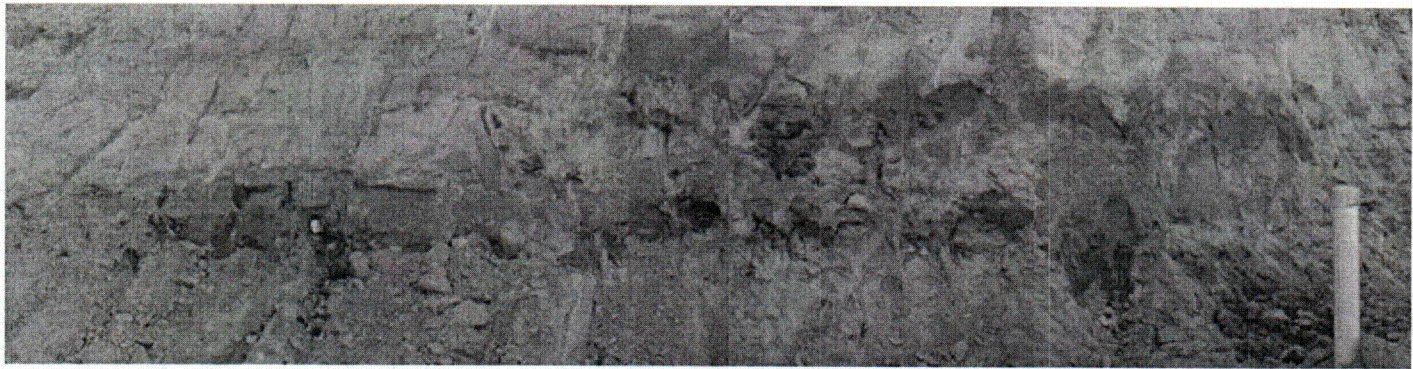
Below is an image of a new kerosene seep on the West wall around TWM-90 the perched monitor well from which substantial organics were recovered. Clearly this seep was feeding the well. The remains of the monitor well (basal section of slotted pipe) are on the right hand side of the image. The seep extends from the leftmost red pin flag to the rightmost red pin flag (behind monitor well TMW-90) with a length of approximately thirty-four (34) feet. On the left side of the seep a pocket cellular telephone has been inserted for scale.

All of the darkened sandstone contains some level of kerosene. The darker the staining the higher the kerosene concentration.
