Subject: Addendum 1 to Reading Slag Pile Site Decommissioning Plan
Design of Riprap Cover
License No. SMC-1562
Docket Number 40-9027

**READING SLAG PILE SITE
DECOMMISSIONING PLAN (Revision 4)
Design of Riprap Cover**

**ST Environmental Professionals Inc.
114 Lutz Road
Boyertown, PA 19512**

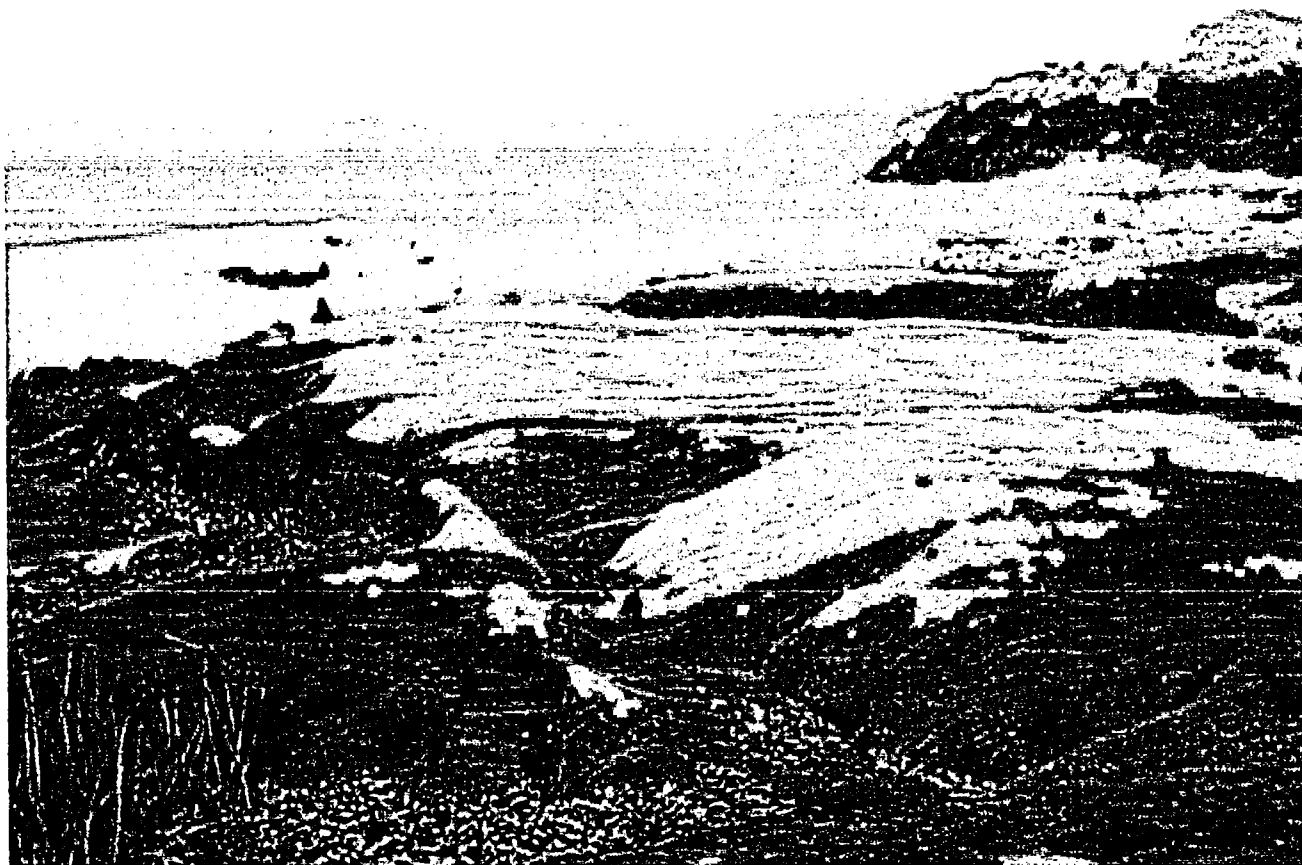
FIGURE 3-8
Glacial Striations (front to back) on metavolcanics
Chebeague Island, Maine

An additional natural analog was also obtained as an example of the general durability of mafic crystalline rocks. The following two pictures from Chebeague Island, Maine (Figure 3-8 and 3-9) show glacial striations. The bedrock consists of metavolcanics with a mafic composition. The rock has foliation and planes of weakness along micaceous partings. The glaciation that caused the striations

occurred approximately 10,000 years ago. Despite aggressive frost wedging affects and foliation the striations are still evident after 10,000 years.

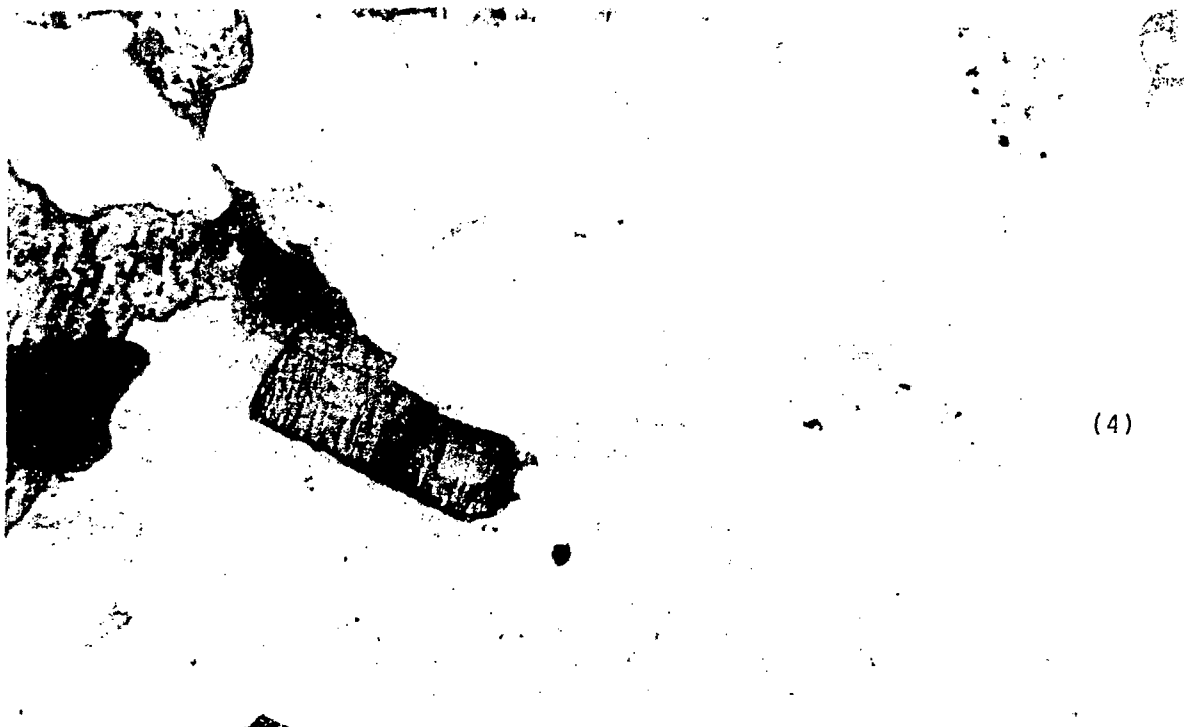
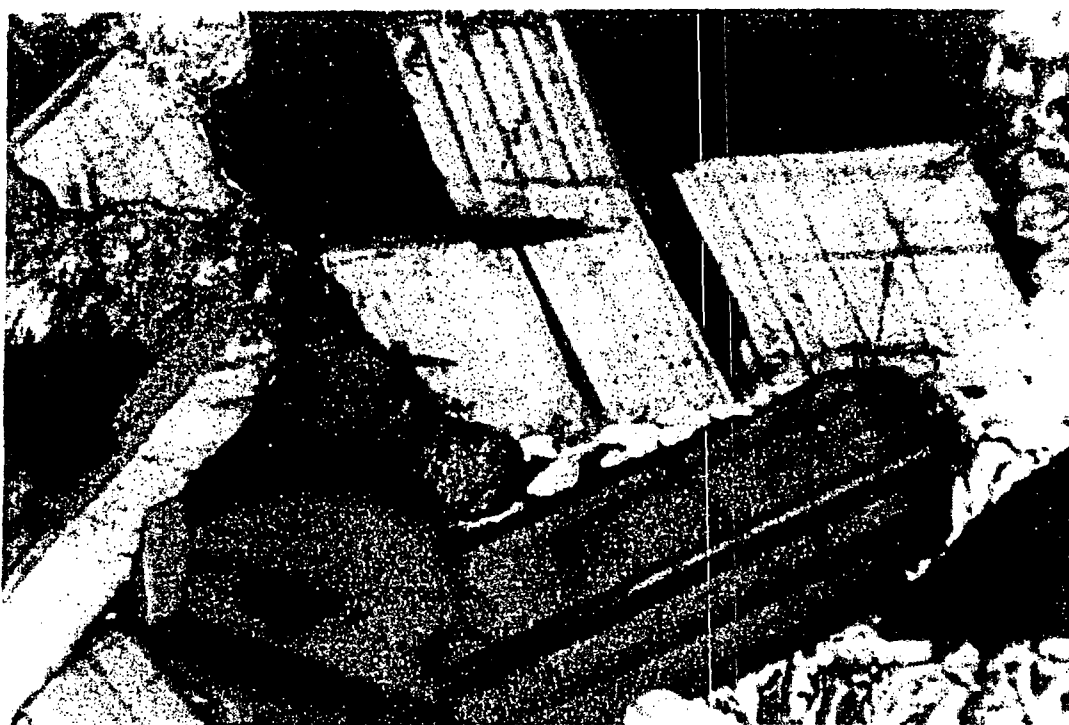
Photos 4 and 5. Photomicrographs taken from a thin section of the diorite, representing a "typical" section of the rock and illustrating its mineralogy. They are the same photograph, but taken in different lighting. Length of field = $\sim 4\text{-}1/3$ mm. Description follows on next page.
