TRIP REPORT

SUBJECT: Field Examination of Lithophysal Rocks at Yucca Mountain
Project No. 20.06002.01.262
AI No. 20.06002.01.262.609

DATE/PLACE: July 17–18, 2006
Yucca Mountain, Nevada

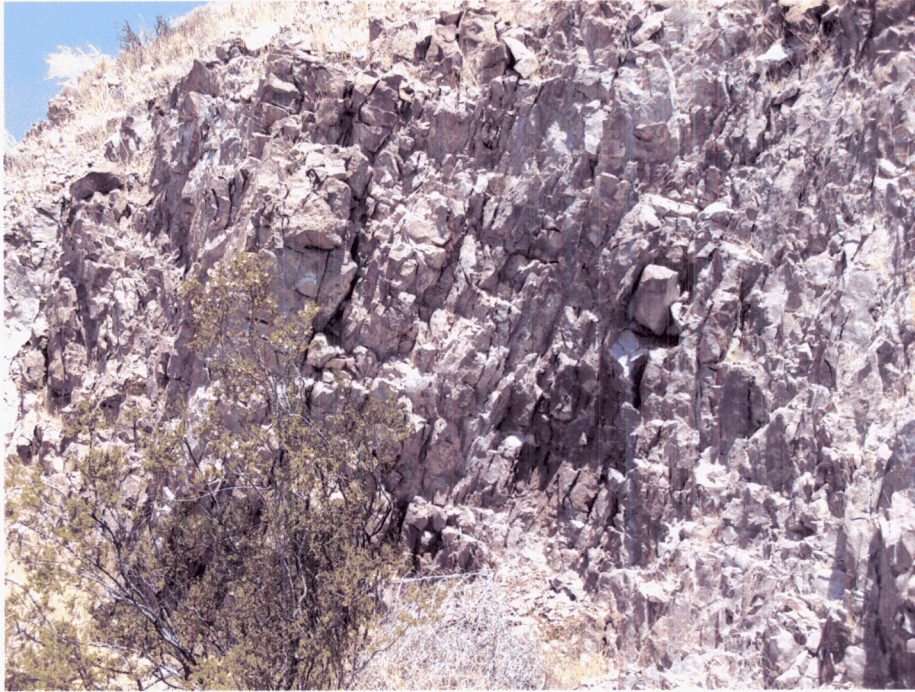
- (1) Staff compared surface exposures of the Topopah Spring Tuff upper and lower lithophysal rocks on Fran Ridge and concluded that these two intervals were distinctly different in terms of both lithophysal and fracture characteristics. As such, staff believe that it would be inappropriate to use upper lithophysal rock samples as a proxy for the lower lithophysal zone in future seepage or infiltration experiments. However, staff feel that it may be possible to gain a semiquantitative understanding of rubble size distributions by examining talus piles of lower lithophysal rock adjacent to fractured exposures and comparing the fracture characteristics to the clast size distribution (Figures 1, 2). Staff noted that the majority of clasts were inequant or platy in shape.

**Figure 1. Surface Exposure of Fractured Topopah Spring Tuff
Lower Lithophysal Interval on South End of Fran Ridge**

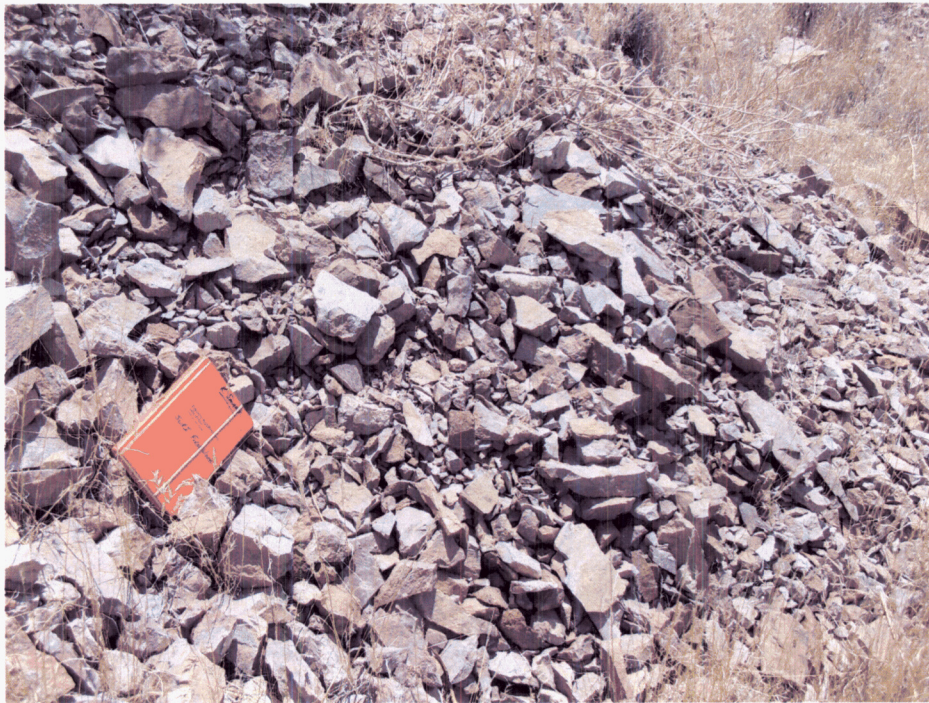
**Figure 2. Talus Pile of Lower Lithophysal Rocks Adjacent to
Exposure Shown in Figure 1**

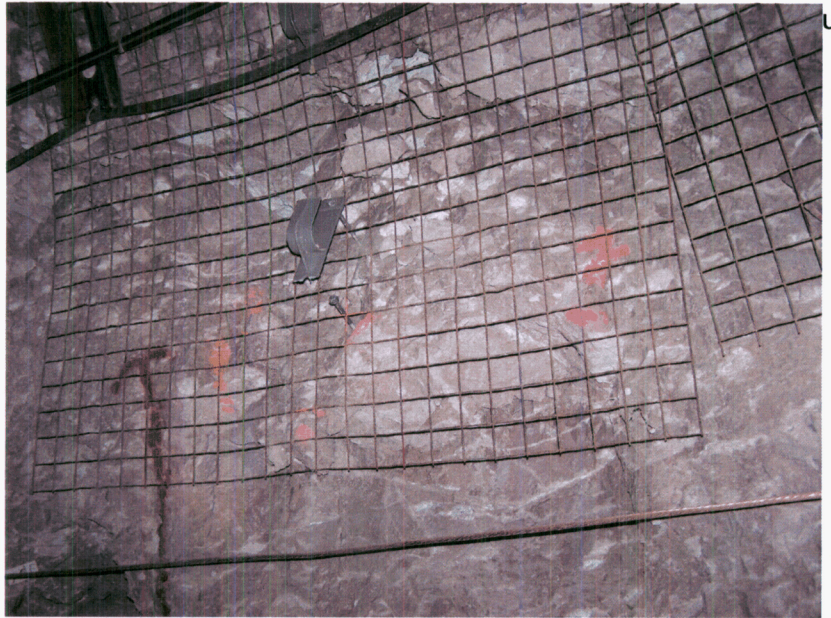
- (4) Ground support along the lower lithophysal section of the enhanced characterization of the repository block was generally the minimum amount required by the mining rules (i.e., ribs holding up wire mesh immediately above the ventilation duct). However, several locations were noted where more extensive wire mesh was needed (Figure 3). At these locations, sparse loose fragments were resting on the wire mesh and possibly related fragments on the side of the invert. Ground support and spalled rock in the enhanced characterization of the repository block was much less than that in the Exploratory Studies Facility. Sizes varied up to a few tens of centimeters in diameter, but staff noted that most clasts were inequant or platy in shape.

- (5) Staff learned that Yucca Mountain Project personnel periodically remove fallen rock from behind the wire mesh in the Exploratory Studies Facility and enhanced characterization of the repository block. This material could be a source for the samples needed for seepage and infiltration experiments. If NRC staff and management are unaware that this activity is taking place at Yucca Mountain, it may be necessary for NRC to seek further clarification including the timing, location, and extent of the rockfall removal.

Figure 3. Photograph of Topopah Spring Tuff Lower Lithophysal Rocks That Have Fallen and Are Supported by Wire Mesh in the Enhanced Characterization of the Repository Block

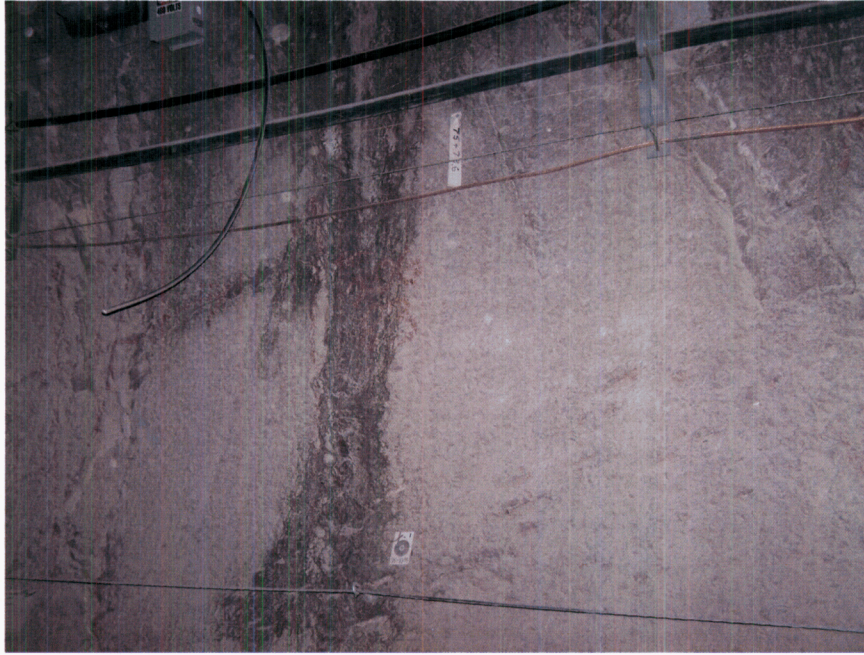
- (7) Seepage patterns on the tunnel walls near the south portal (Figure 4) were still present from the February 2005 seepage event, which occurred during a particularly strong El Niño-related winter precipitation period (Fedors, et al., 2006). Yucca Mountain Project operations staff indicated that they inspect the Exploratory Studies Facility weekly for spalled rock on the tracks or in the rock support mesh or ribs. Thus, it is unlikely that other seepage events in the tunnel were missed. In addition, the seepage patterns on the walls caused by washing dust buildup are still prominent after more than 1.5 years. These patterns have not been noted elsewhere in the tunnel. It is not known how often the enhanced characterization of the repository block is inspected for spalled rock, particularly the area beyond the 17 + 63 bulkhead.

Figure 4. Photograph of Seepage Patterns on the Tunnel Walls at Exploratory Studies Facility Station 75 + 73.6 Produced by the February 2005 Seepage Event
