SOURCE PRODUCTION AND EQUIPMENT CO., INC.
113 Teal Street St. Rose. Louisiana 70087

CONSOLIDATED APPLICATION
for
NRC CERTIFICATE OF COMPLIANCE
USA/9263/B(U)

Model SPEC-150
Type B(U) Radioactive Material Package
April 22, 1999

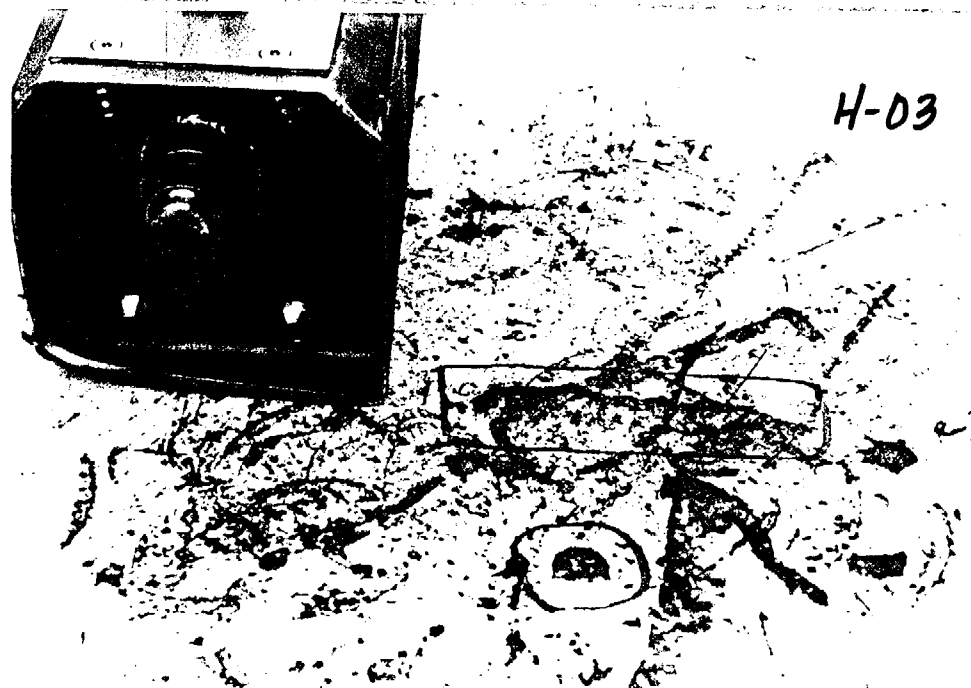
The test package was suspended from two points at the outlet end with the center of gravity positioned directly over the lock cap. See Photographs G-09 through G-11. Photograph G-12 shows the package positioned 30 feet above the target. Photographs H-01 through H-04 show the damage from the 1st 30-foot drop test on the lock cap. With the possible exception of the source assembly release plunger (which was the point of impact of the previous 30-foot drop test in August 1994) the lock cap is the point of impact most likely to damage the lock. The lock is located inside the lock module which is located behind the lock end plate of the package. There is no direct access to impact the lock itself. The lock cap is located slightly off of the geometrical center of the lock end of the package and was the initial point of impact. The test dented the end of the lock cap in approximately 1/4 inch. See Photograph H-02. The impact damaged the lock cap threads and prevented it from being able to be removed from the package. The end of the bottom plate was the secondary point of impact. Photograph H-03 shows the marks of the lock cap and bottom edge on the target outlined in red colored borders. Besides superficial scratches there was no measurable additional damage to the bottom edge. See Photograph H-04.
