In the Matter of)
)
AMERGEN ENERGY COMPANY, LLC)
)
(License Renewal for the Oyster Creek)
Nuclear Generating Station))

PRE-FILED DIRECT TESTIMONY OF DR. RUDOLF H. HAUSLER

**AFFIDAVIT OF DR. RUDOLF H. HAUSLER
REGARDING HIS PREFILED TESTIMONY
IN SUPPORT OF
CITIZENS' DRYWELL CONTENTION**

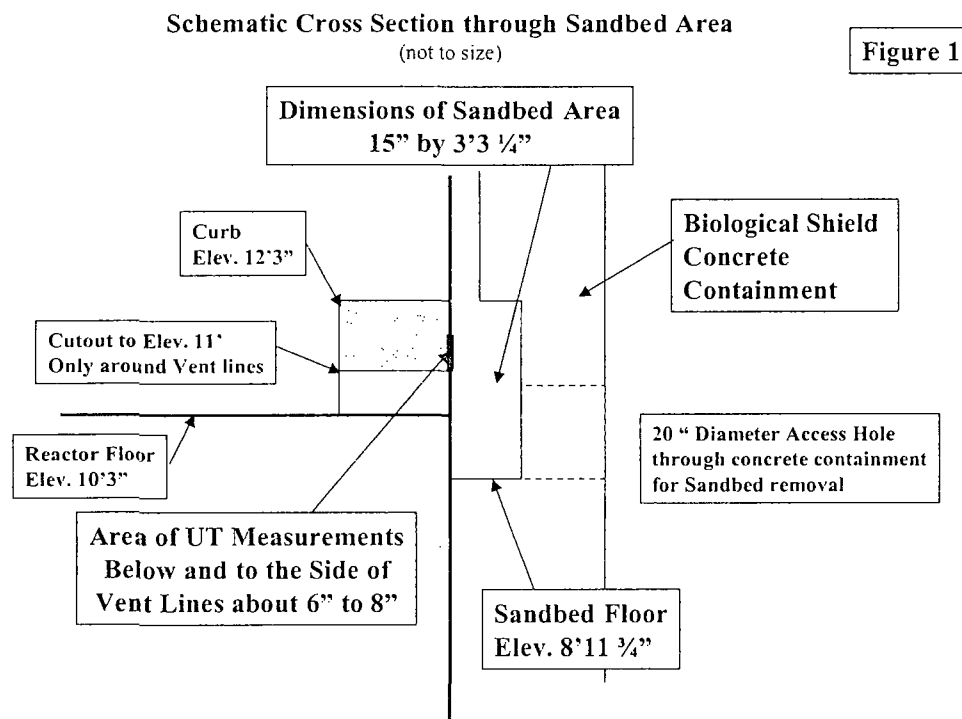
We take issue with this statement. In support of this contention, an effort was made to show graphically the remaining wall thickness observed in all of these various locations. Thus Figure 2 shows, by way of example, the remaining wall thickness from the 2006 UT measurements made with the help of 6 by 6 inch grids as a function of elevation in the **trench of Bay 17**. It is understood, as is described in Ref. 3 that 6 such grids were placed one on top of the other in the trench in order to capture the corrosion from the bottom to the top of the sandbed. Hence, if the bottom of the trench had the elevation about 9 feet, then the top of the 6 grids would have had an elevation of about 12 feet, which according to Figure 1 corresponds to the top of the sandbed and is at least 9 inches higher than the top of the grid used for UT measurements from the inside. (Note, none of these elevations is terribly accurate, however, the top of the trench measurements were definitely lower (deeper pits) by a good margin than the inside grid measurements). Figure 2 plots all individual 2006 measurements from the trench in bay 17. The 6 traces represent the variation of the wall thickness in the horizontal direction while the traces themselves extend from the bottom of the trench (left hand side) to the top of the trench (right hand side). The

undulations of the 6 traces, which are at times (at the same elevation) in synch and at other times out of phase clearly depict the nature of the "golf ball type" surface described in AmerGen literature (Ref. 1 pg. 4). Where the undulations are in synch one can estimate that the extent of the pit at that location extends over an area larger than just one inch in diameter ³⁾. It should also be noted that the average amplitude of the undulations in Fig. 2 are of the order of 0.1 inch, i.e. the roughness of the surface at this point is only of that order of magnitude. AmerGen estimated the "roughness" of the surface to be rather of the order of 0.2 inches (Ref. 5 pg. 5).

The most striking observation is that the corrosion is most severe at the top, almost uniform in severity over most of the depth of the sandbed and again somewhat more severe at the very bottom.

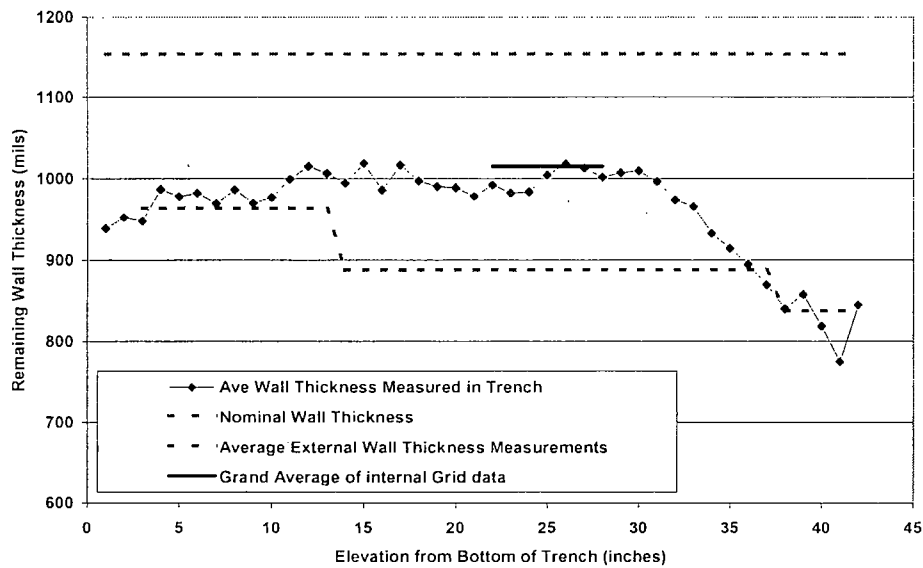
Figure 4

Comparison of Various Thickness Measurements in Bay 17
2006 data

Conclusion: What the superposition of the UT measurements in Bay 17 demonstrates is that wall loss ranges from zero to 33 percent, however, only the trench and outside measurements come close to represent the most severe corrosion at the highest elevations. It should also be remembered that the grid measurements at the inside curb cutout as well as those in the trench are only 6 inches wide. One does not have, therefore any indications as to how far serious corrosion may have spread laterally around the circumference of the bay.

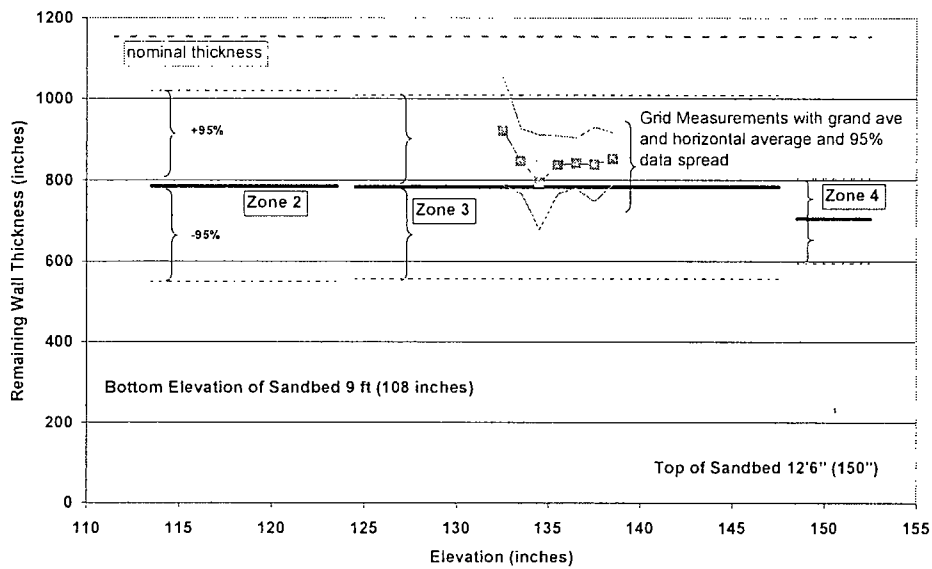
Figure 6

External UT Measurements 2006 in Bay 1
Averages and 95% limits of data spread

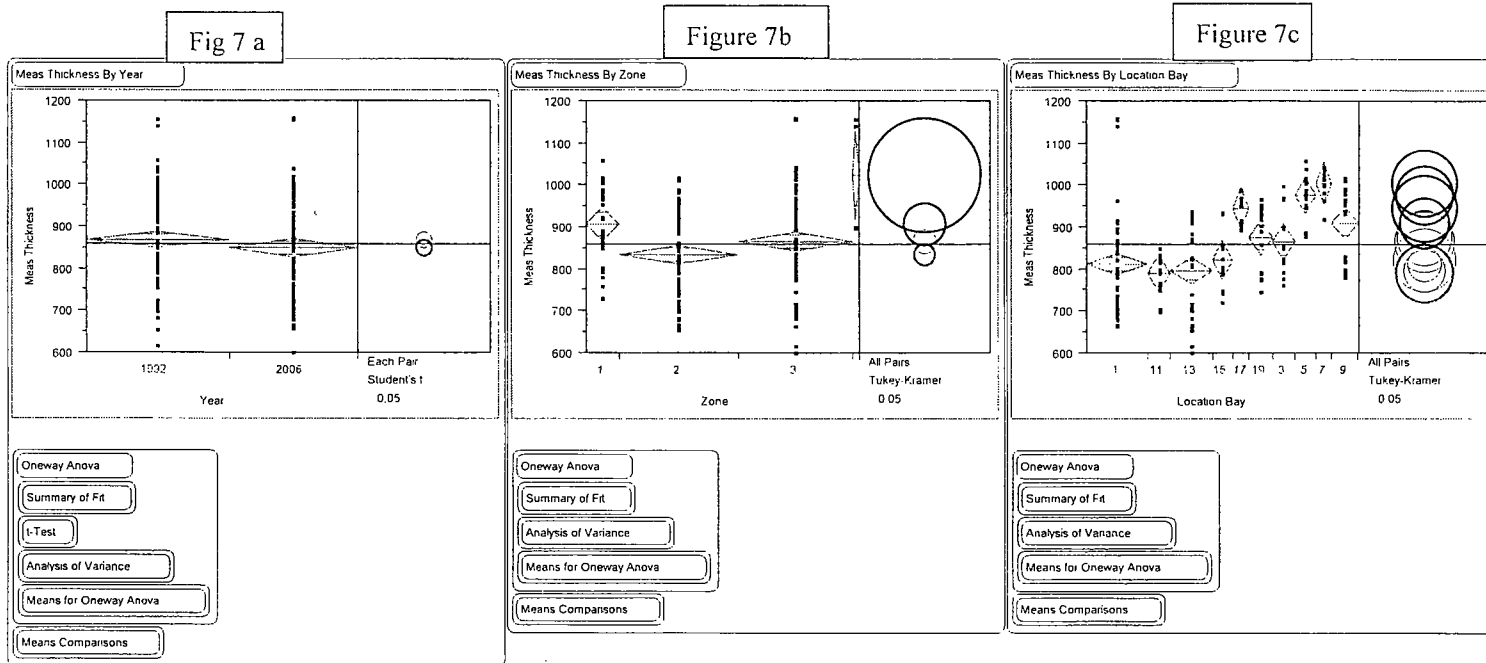
Figure 7a: Comparison between measurements I 1992 and 2006 show no significant difference. The means from 1992 and 2006 show a bias of 0.018 inches, but the bias is statistically not significant despite of the many data points. Fig. 7b: The comparison between the “zones” (elevations) is significant. Zones 1 is significantly different from zones 2 and 3. For zone 4 there are not enough data for statistical significance. Fig. 7c: Some bays, red ones, are significantly different from the black ones.

It was found that there is no significant effect of the time (Fig.7a). While there is a decrease of 19 mils between 1992 and 2006, this difference is not statistically significant within the variability of the data. The differences between the zones, however are significant. Zone 2 is by far the most corrosive zone. When the bays are compared, one finds as expected that some bays have experienced little corrosion in contrast to others. The importance of these observations is obvious: they point again to the fact that the intensity of corrosion is a clear function of elevation and bay. Hence, averaging data and generalization may lead to doubtful conclusions.

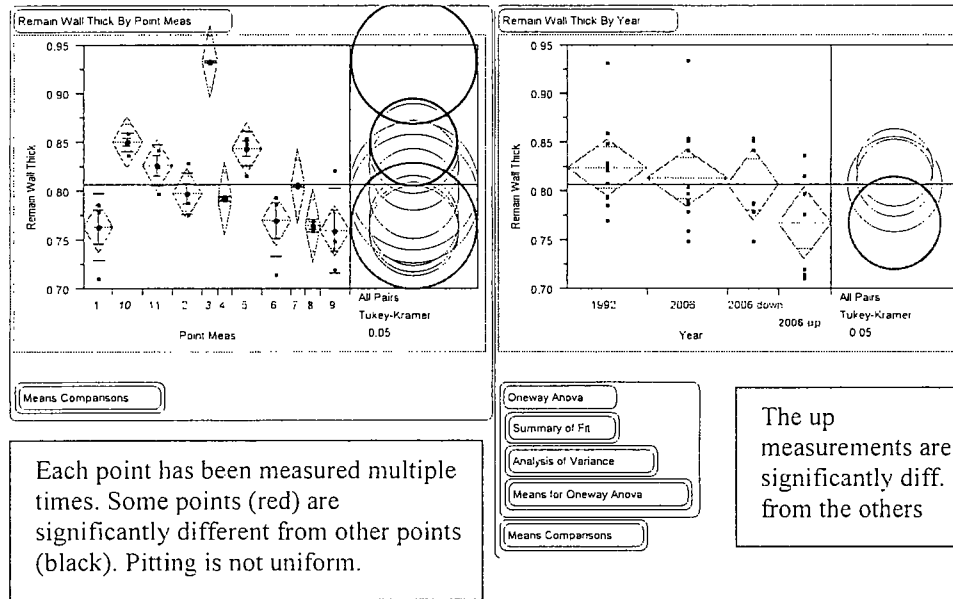
Figure 8: External UT Measurements in Bay 15

In this sense the external measurements of Bays 1, 15, and 19 have been reexamined, and as Table 1 shows, at least in Bay 15 there is no additional margin for continued corrosion in the areas that have been monitored to this point.

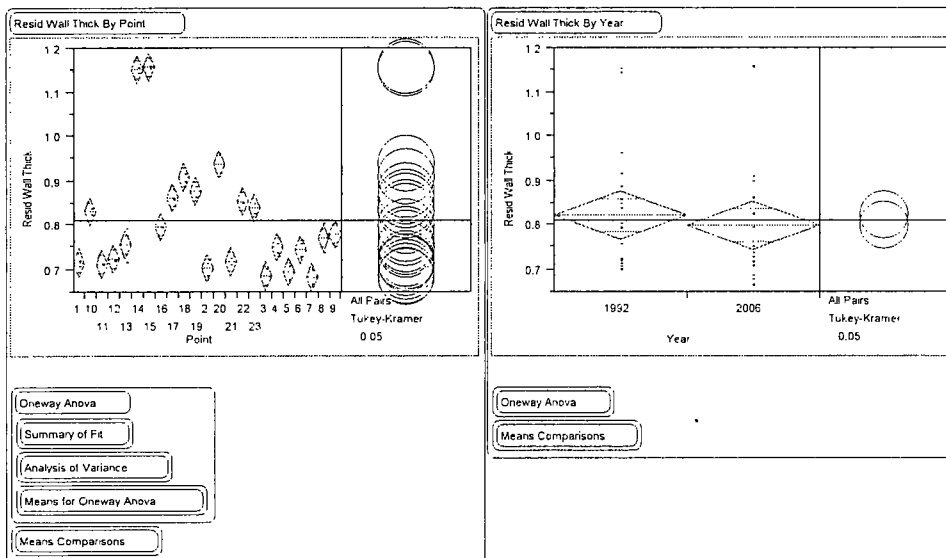
Figure 9: External UT Measurements in Bay 1.

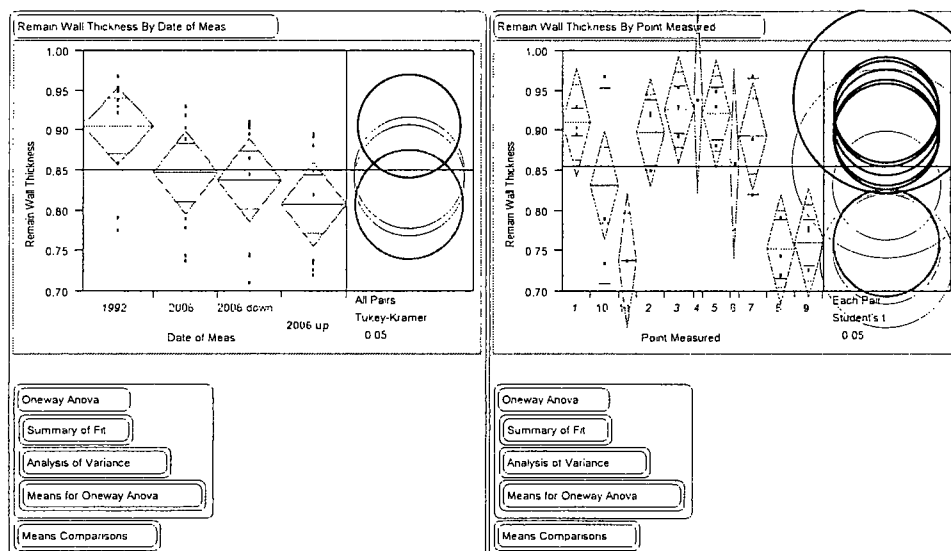
Figure 10: External UT measurements in Bay 19

Again one finds that the “up” measurements are significantly lower from the 1992 measurements.

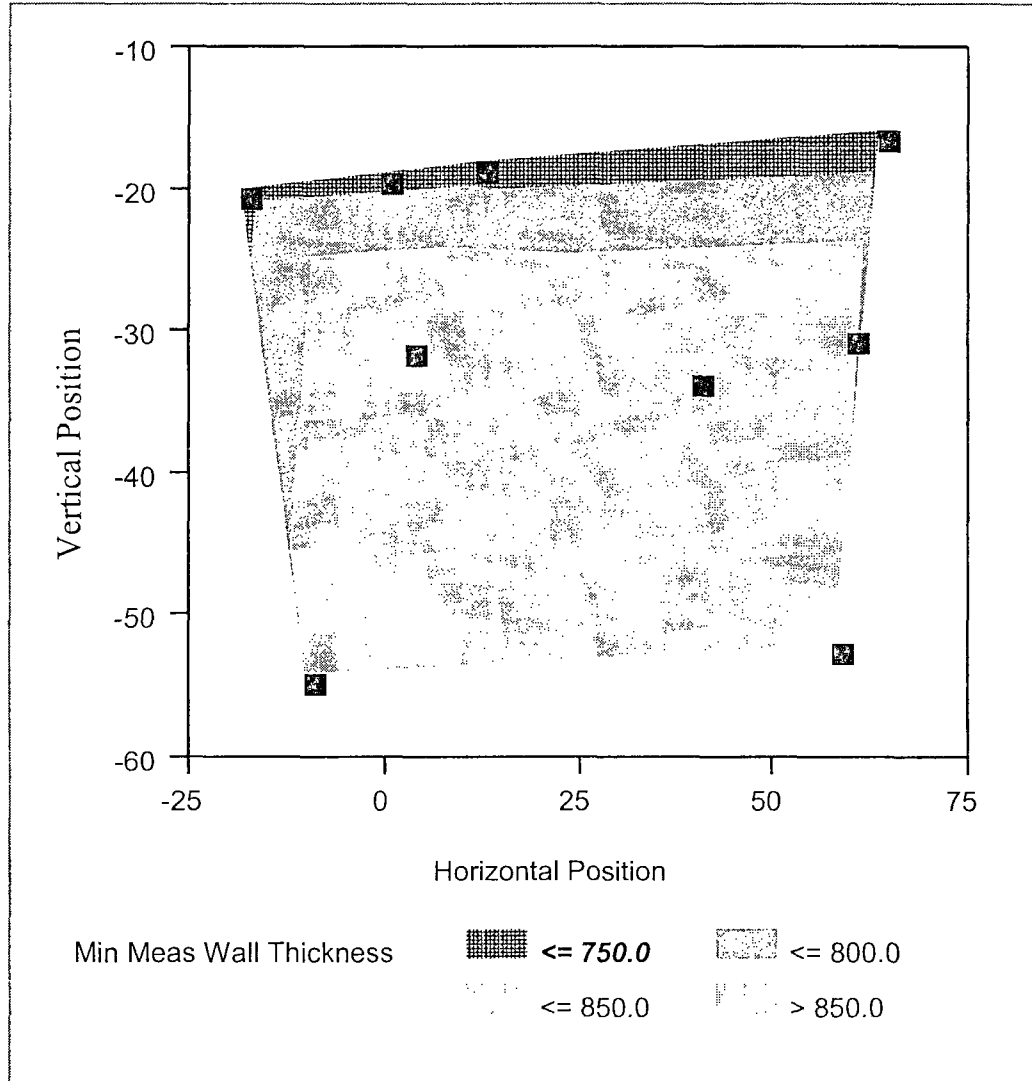
Figure 1

Bay 19 External 2006 UT Measurements, Minimum Values

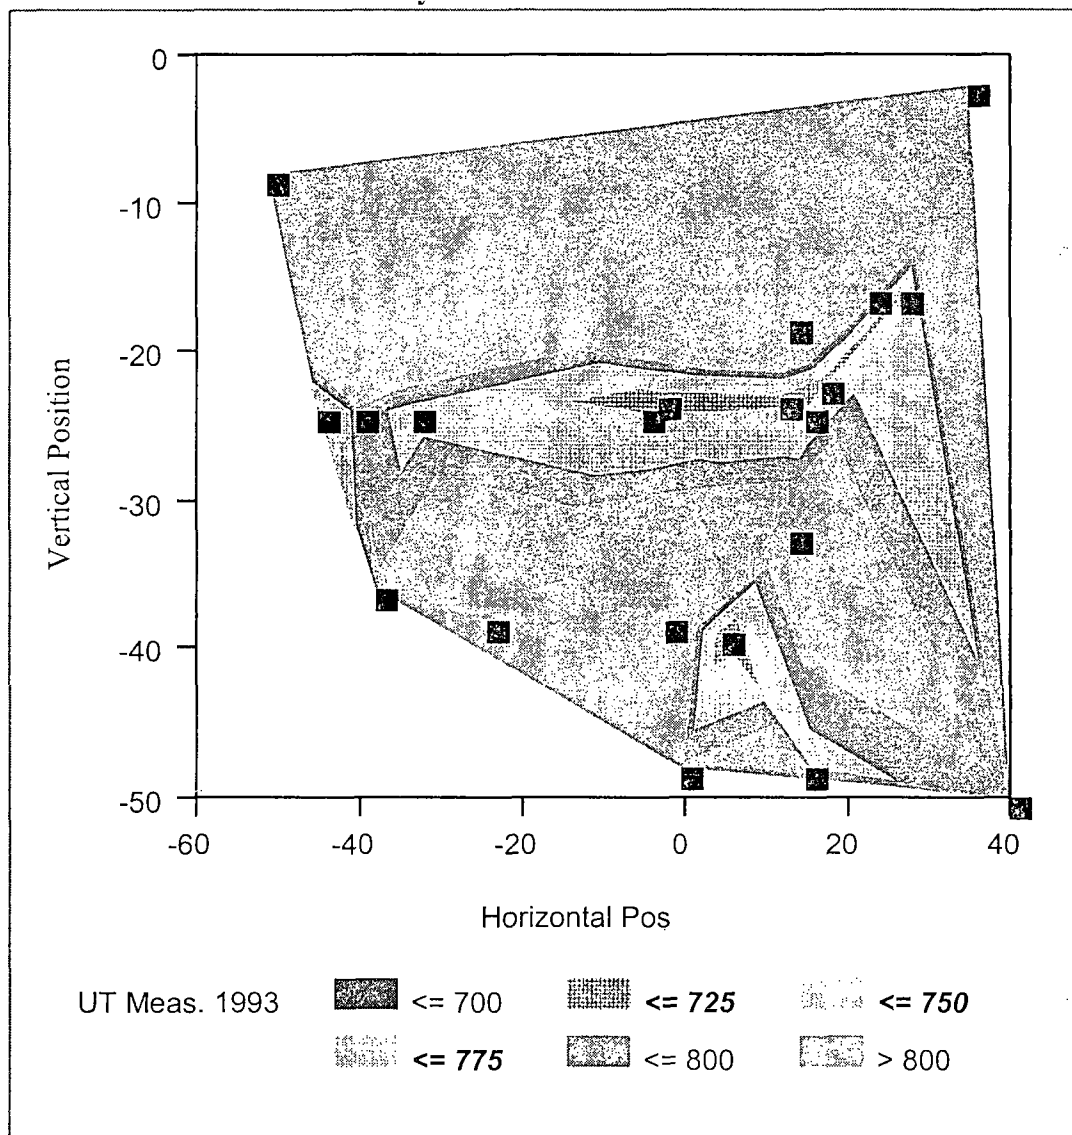
Figure 2
 Bay 1 Remaining Wall thickness
 External UT Measurements 1992/1993

Contour Plot For Bay 1: 1992/1993 External UT Measurements

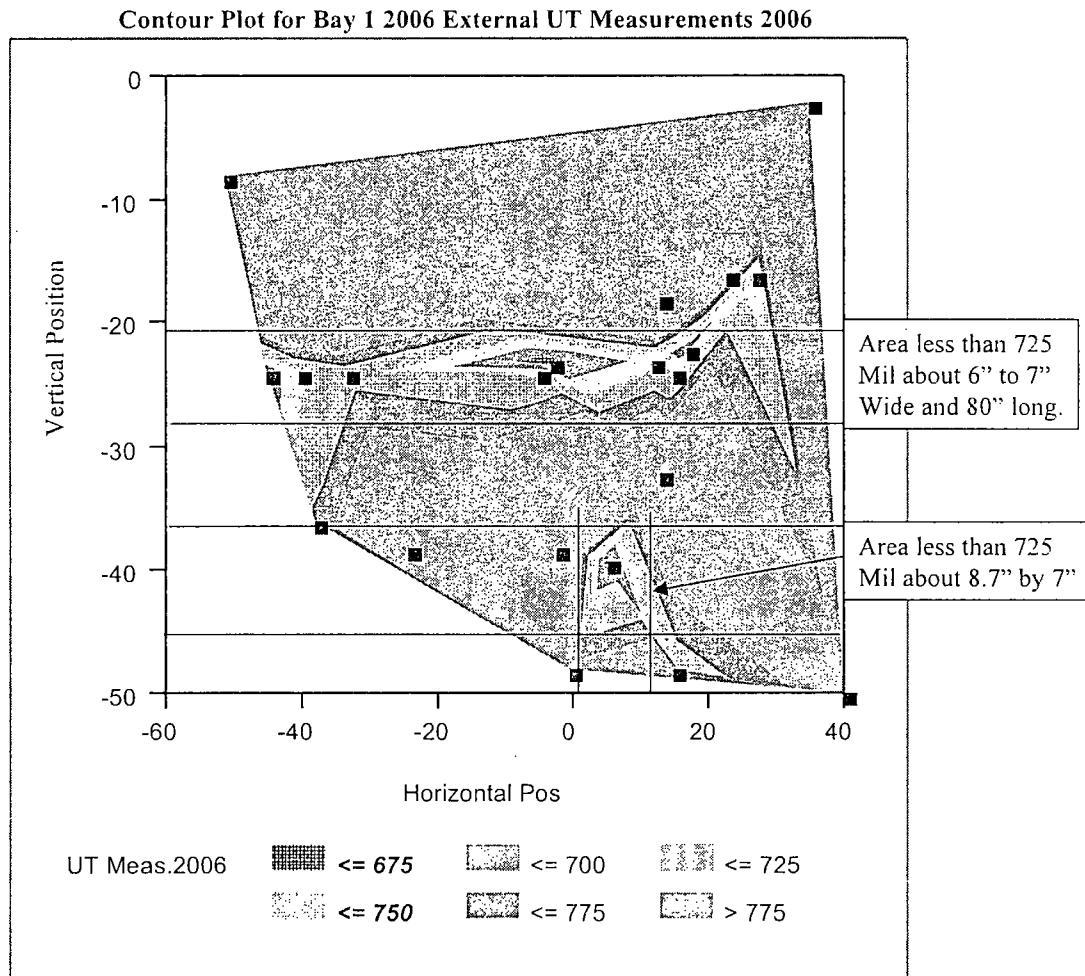
Figure 3

Bay 1 Remaining Wall thickness
External UT Measurements 2006

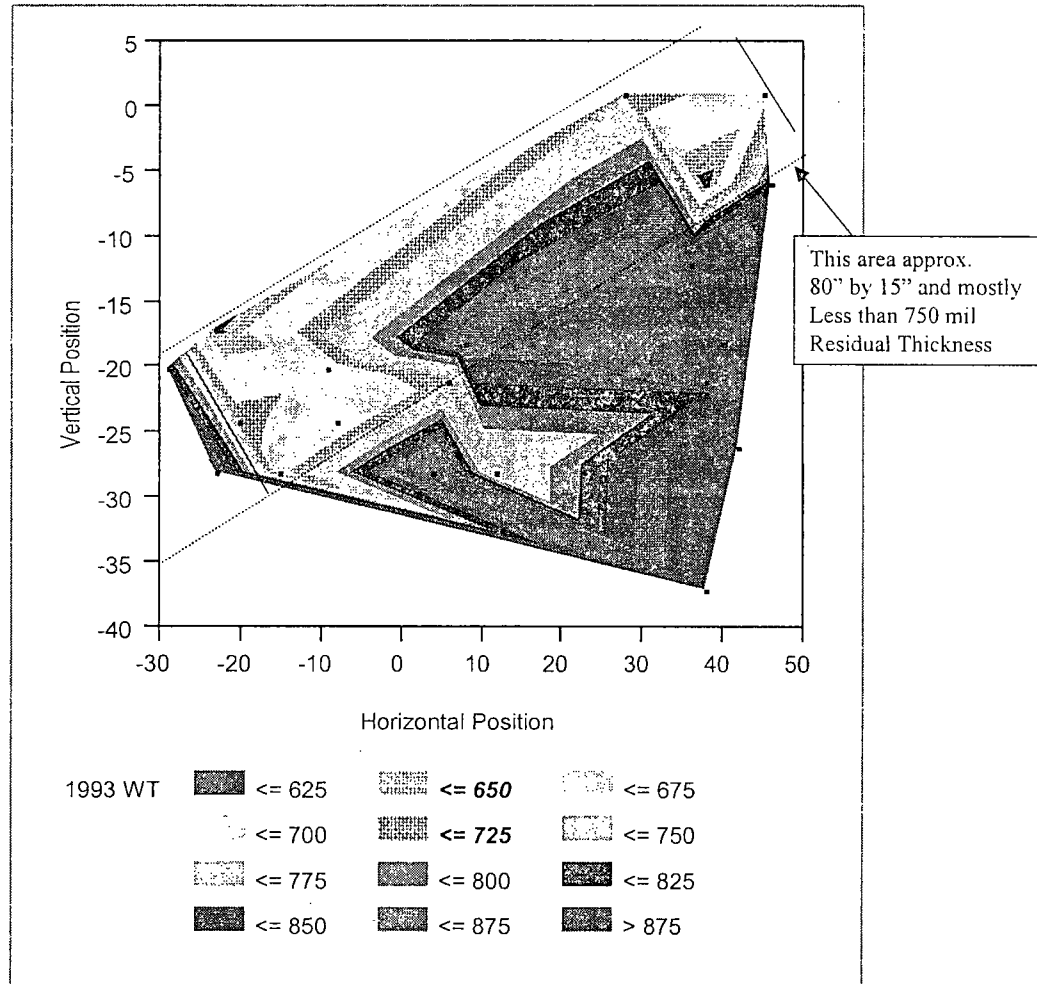
Figure 4

Bay 13 Remaining Wall Thickness
External UT Measurements 1992/1993

Contour Plot for Bay 13 1992/1993 External UT Data

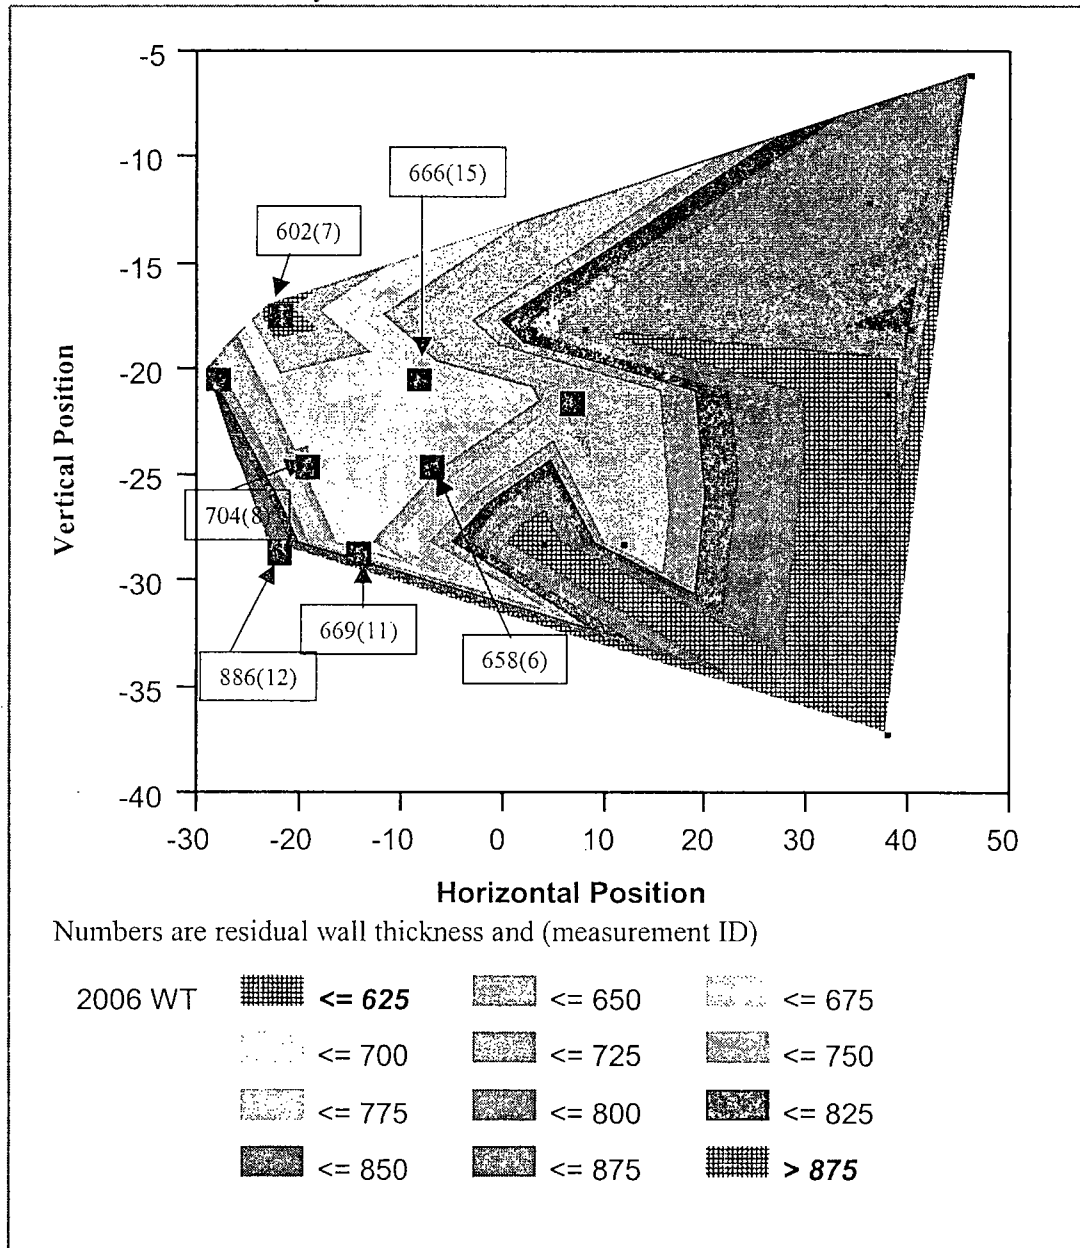
Figure 5

Bay 13 Remaining Wall Thickness
External UT Measurements 2006

Bay 13 Contour Plot 2006 UT Data

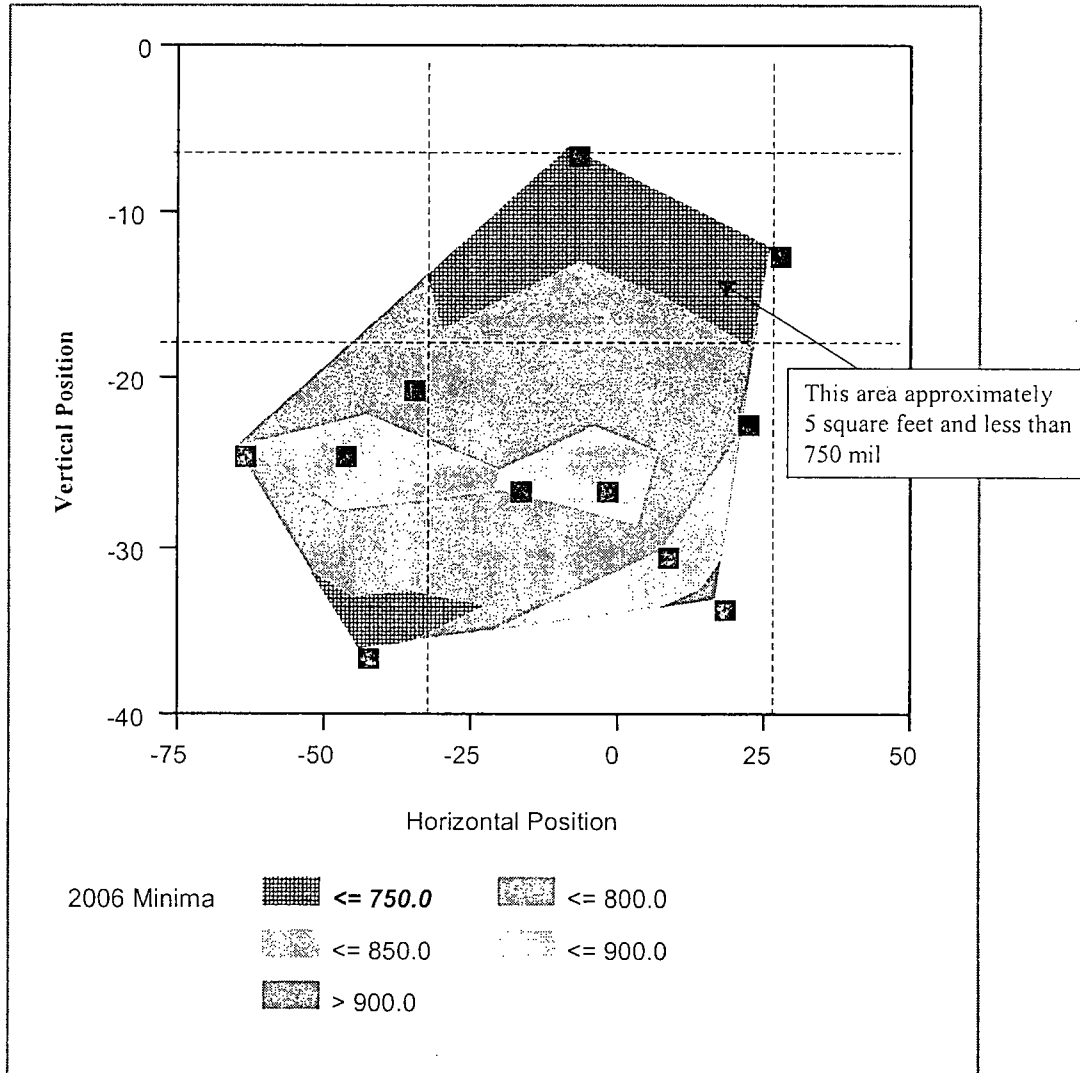
Figure 6

Contour Plot for Bay 15 2006 External UT Measurements

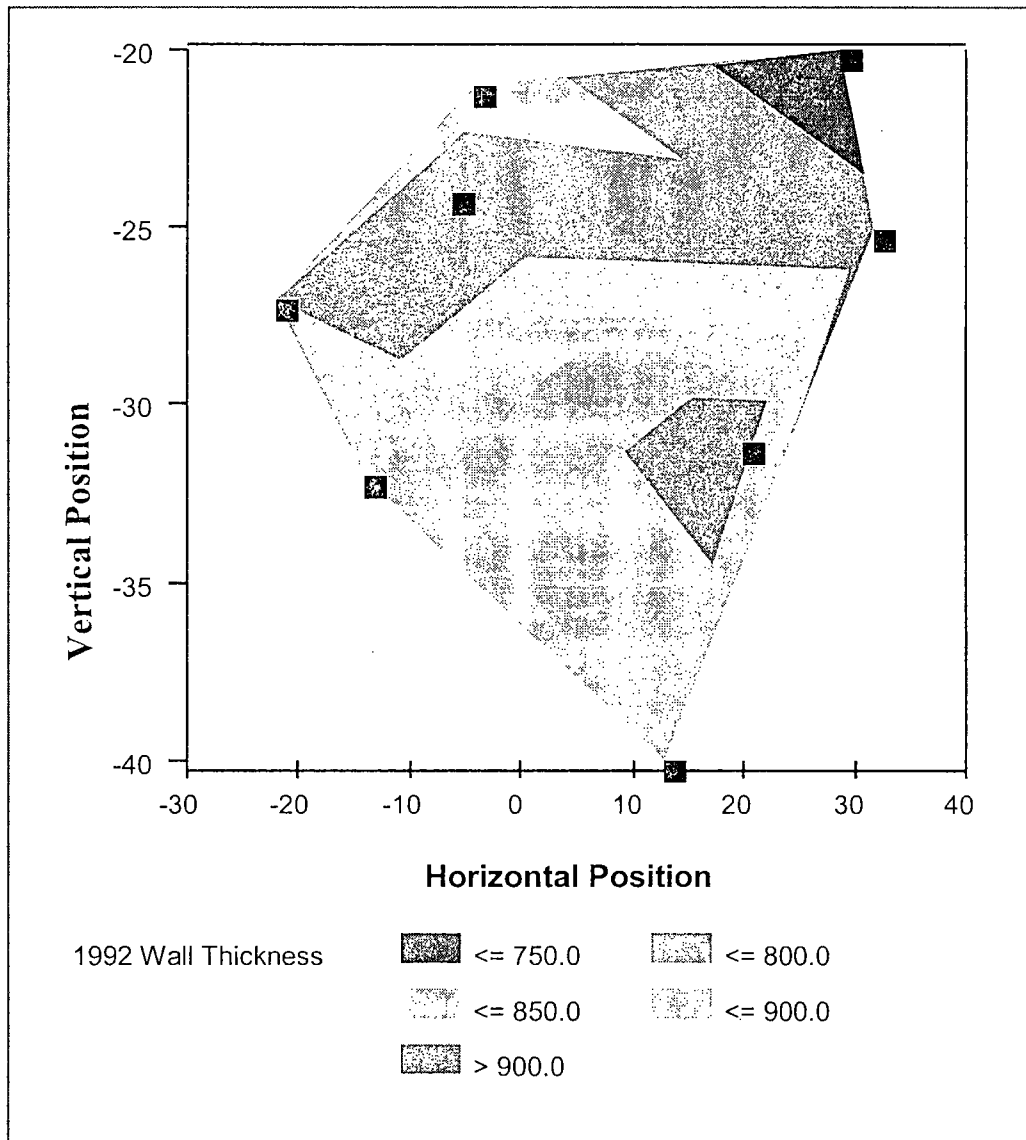
Figure 7
 Contour Plot for External UT 1992 Data Bay 11
