**Final Construction Completion Report  
Gas Hills, Wyoming Site**

**VOLUME III  
ABOVE-GRADE TAILINGS IMPOUNDMENT  
DESIGN ENHANCEMENT**

**June 2007**

Umetco Minerals Corporation  
2754 Compass Drive, Suite 280  
Grand Junction, Colorado 81506

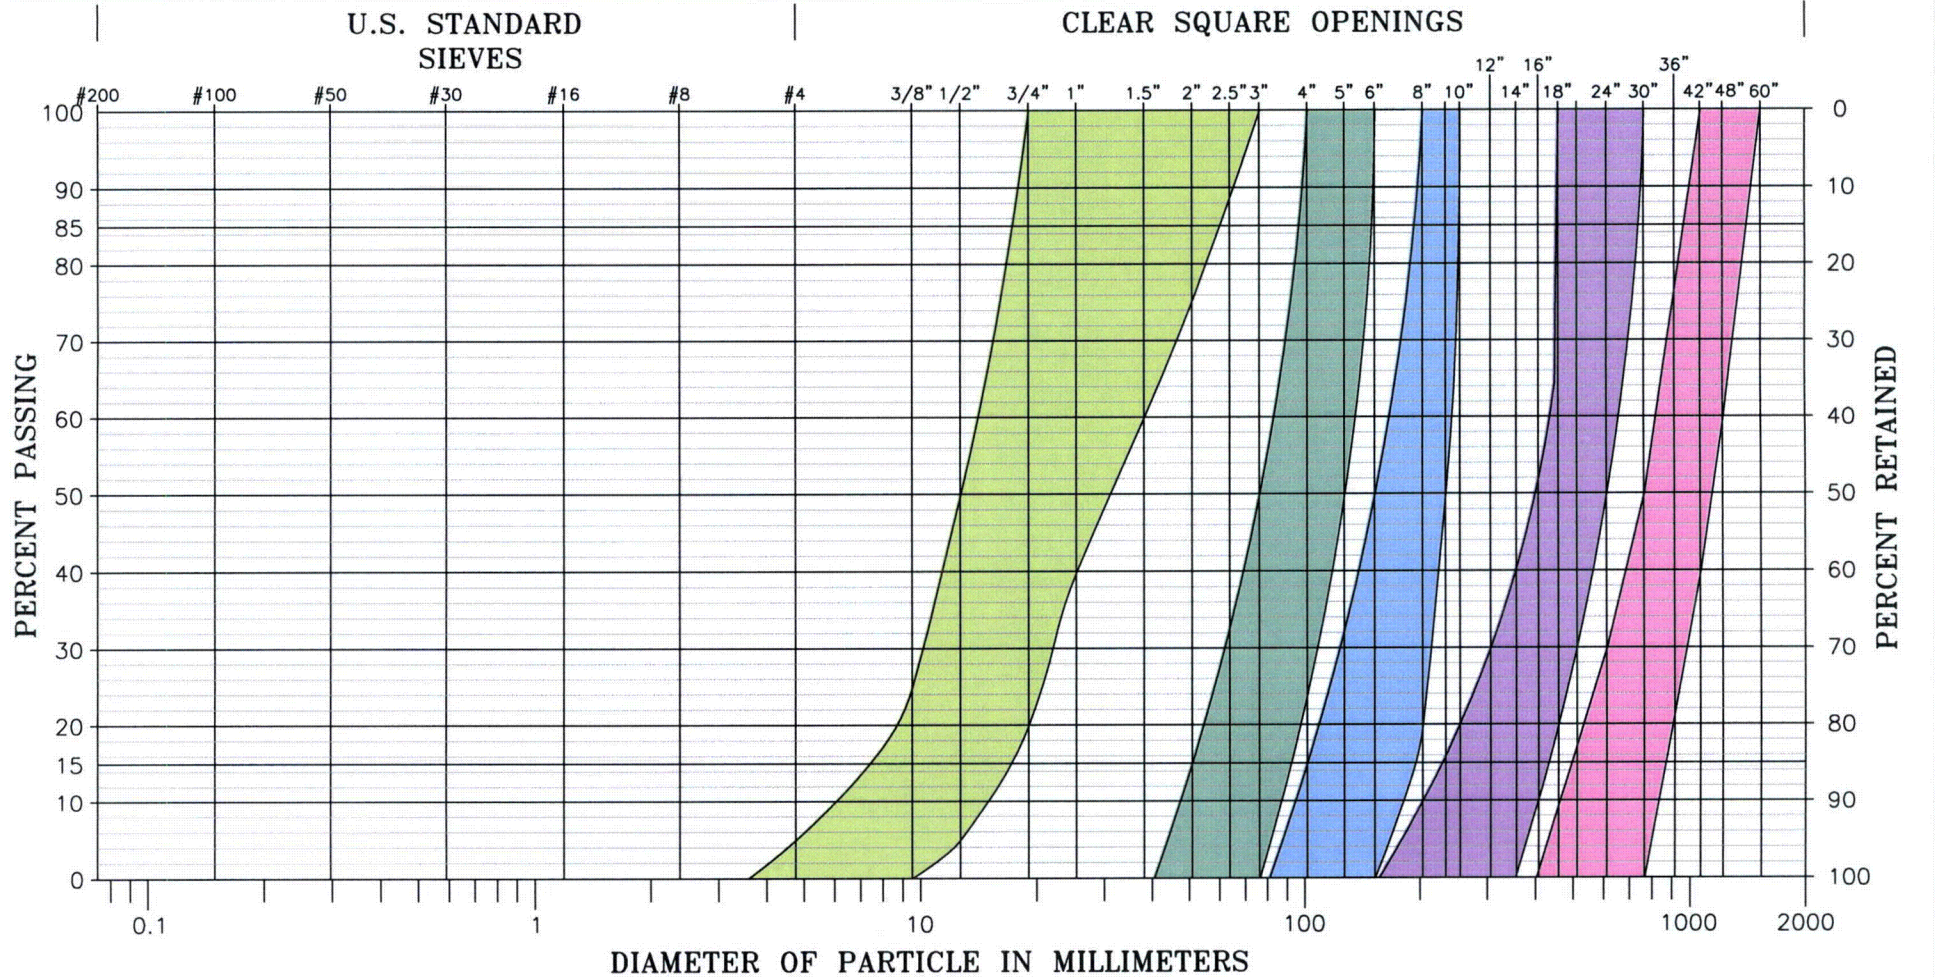
Additional details regarding the design and underlying assumptions are documented in detail in the 1997 enhanced reclamation plan, the 2000 modification submittal, and in the technical evaluation reports accompanying the NRC's approval of those designs (Attachments 1 and 2). Corresponding gradation curves are shown on Figure 6.1.

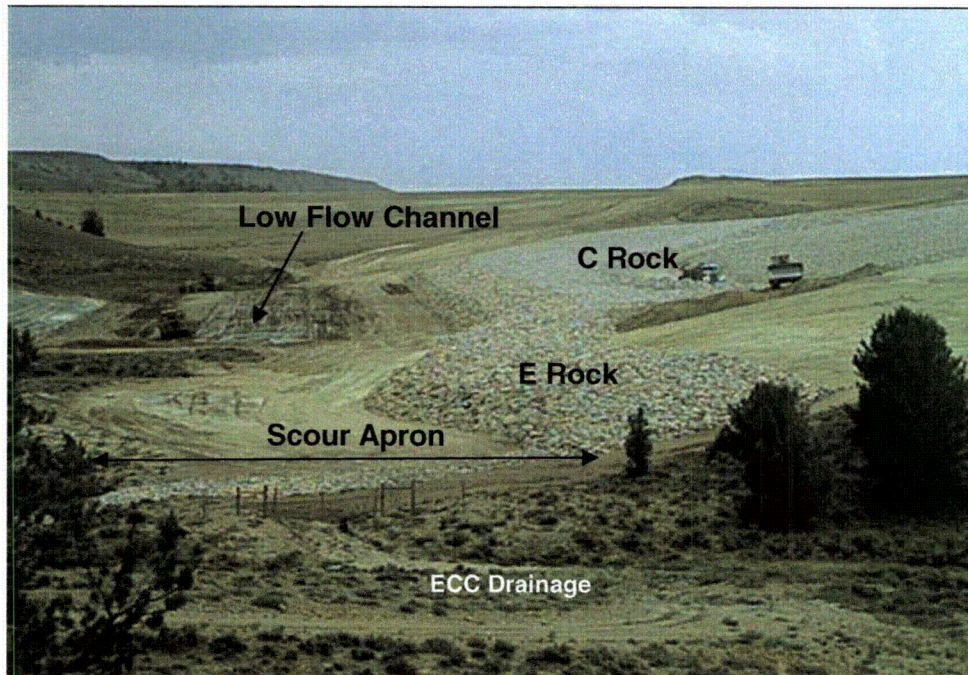
**Figure 6.2. Photographs of 2002 East Canyon Creek (ECC) Rock Placement and Scour Apron Above-Grade Tailings Impoundment Design Enhancement**

August 23, 2002, showing scour apron and low flow channel.

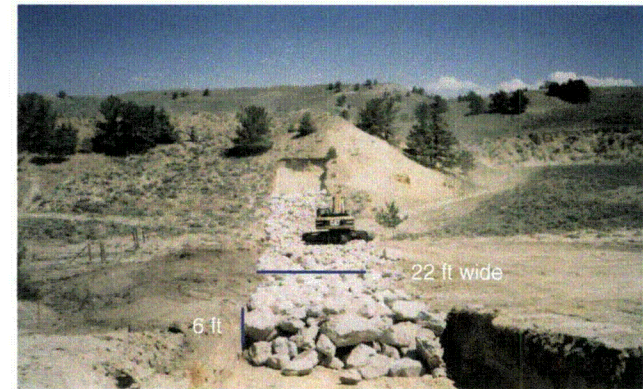
Placing Rock in Scour Apron (22 ft x 6 ft)

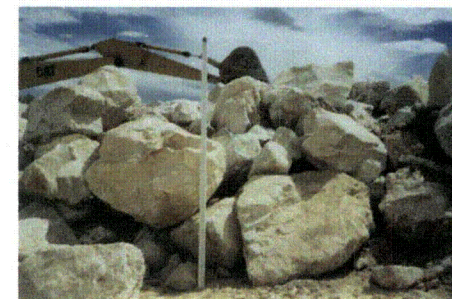
Type E Rock Depth Verification (6 feet)

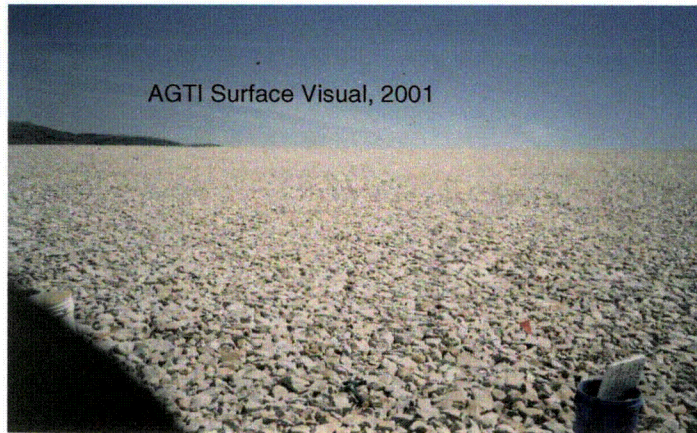
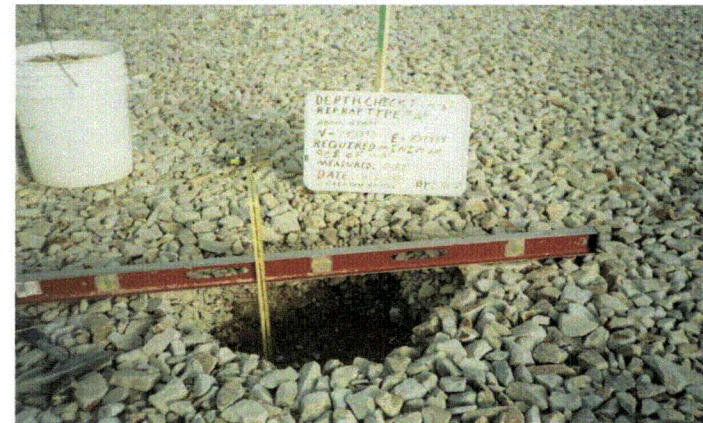
**Figure 6.3. Photographs of 2001 Surface Visual and Depth Check Testing:  
Above-Grade Tailings Impoundment Design Enhancement**

A Rock: Required Thickness  $\geq 0.45$  ft

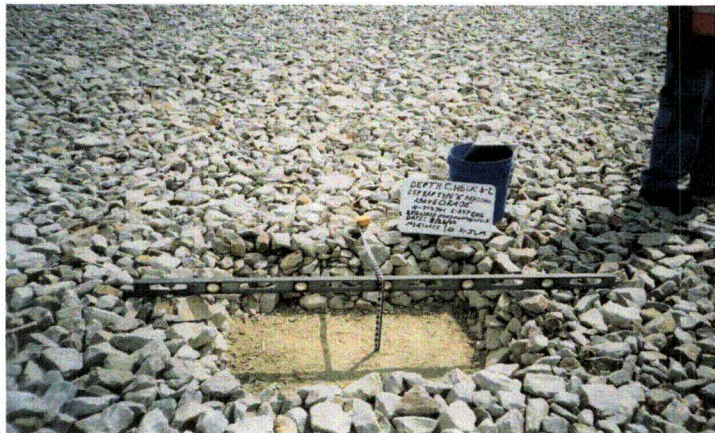
B Rock: Required Thickness  $\geq 0.45$  ft

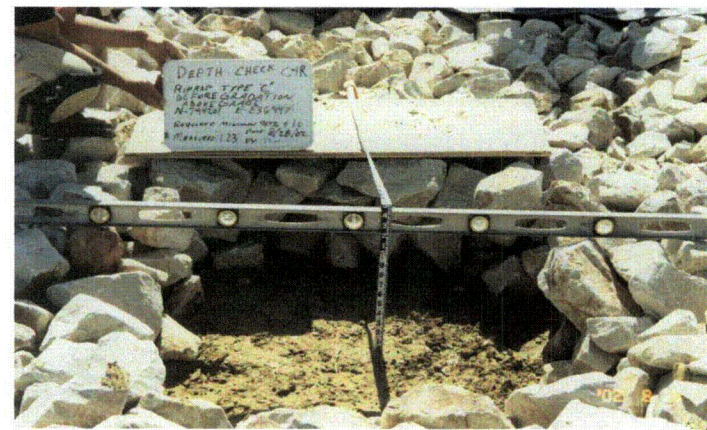
C Rock: Required Thickness  $\geq 0.90$  ft

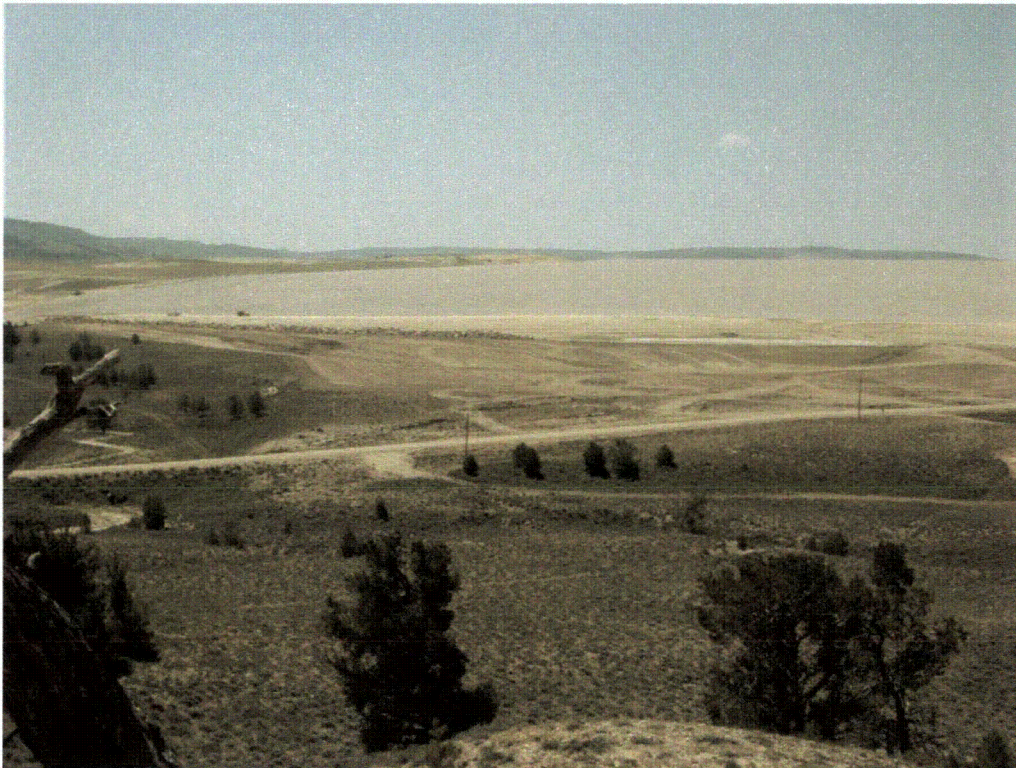
Completed AGTI cover – July 2002.

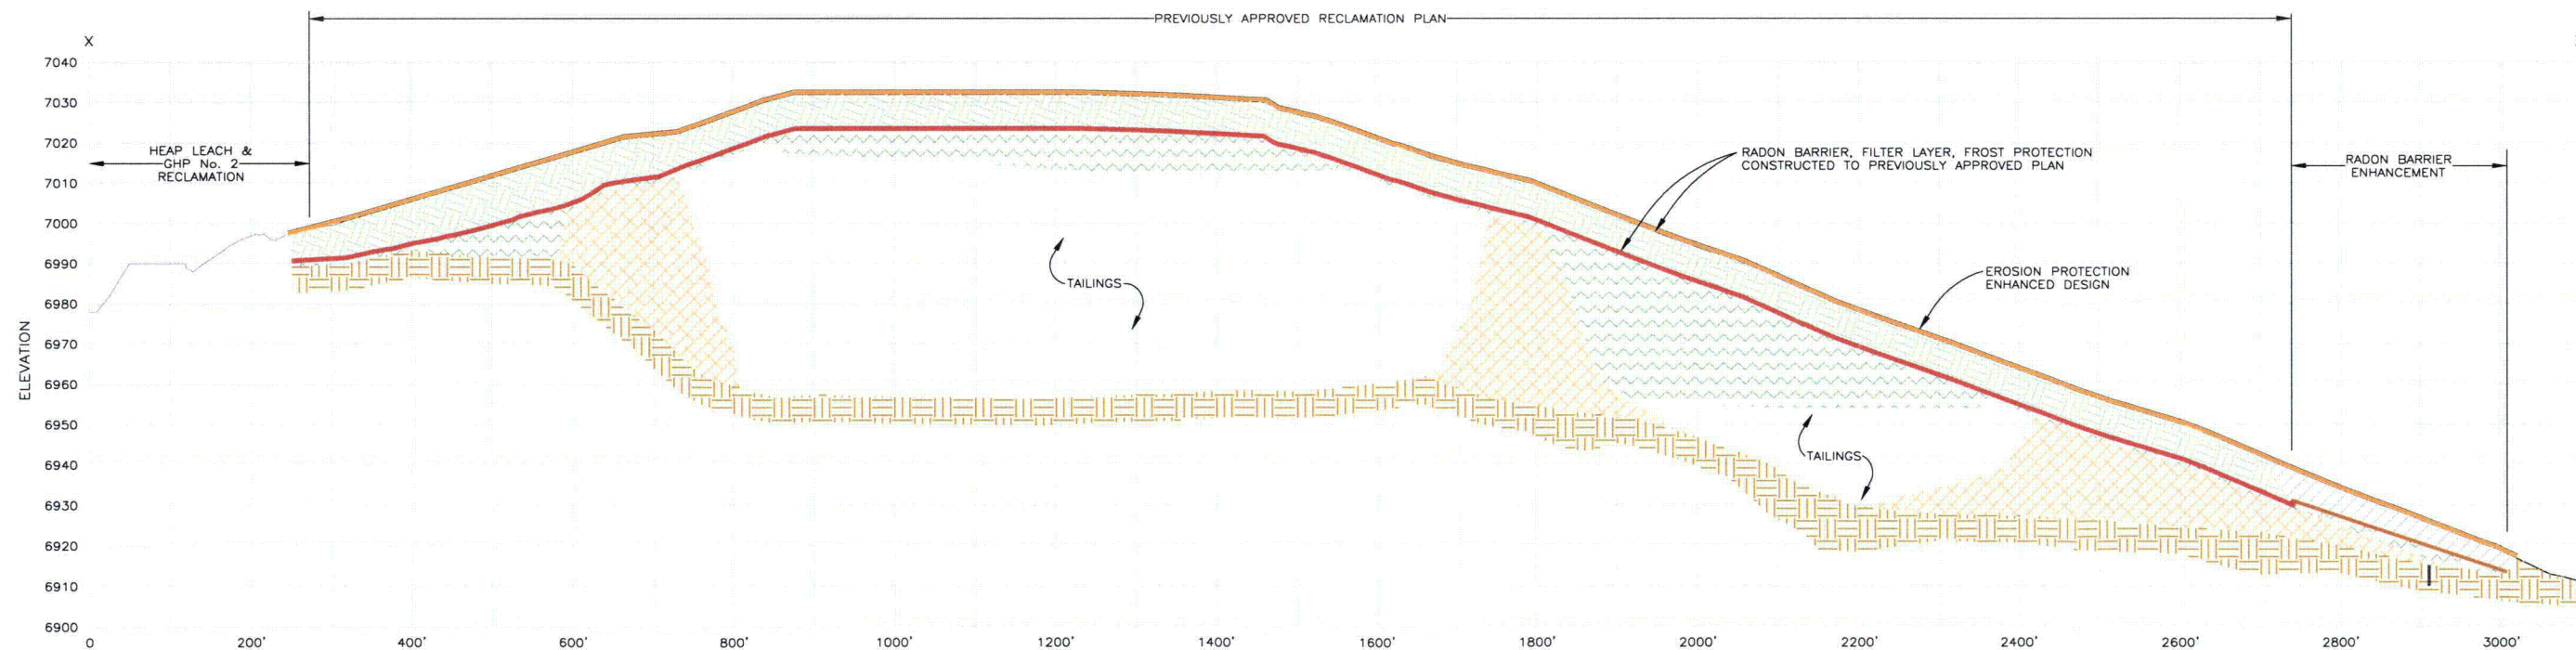
SECTION X-X'  
SCALE: HORIZ. 1" = 100'  
VERT. 1" = 20'

THE ENHANCED RECLAMATION DESIGN INCLUDED (WITH SUBSEQUENT NRC APPROVAL) EVALUATION OF EXISTING RECLAMATION COVER CONSTRUCTION COMPLETED IN ACCORDANCE WITH THE PREVIOUSLY APPROVED RECLAMATION DESIGN, I.E., SEISMIC DESIGN, SLOPE STABILITY, LIQUEFACTION POTENTIAL, SETTLEMENT, RADON BARRIER COVER CRACKING POTENTIAL, AND RADON ATTENUATION. (REFER TO LICENSE AMENDMENT 41, TER DATED JUNE 21, 1999, TRANSMITTED BY LETTER FROM NRC DATED JULY 16, 1999)

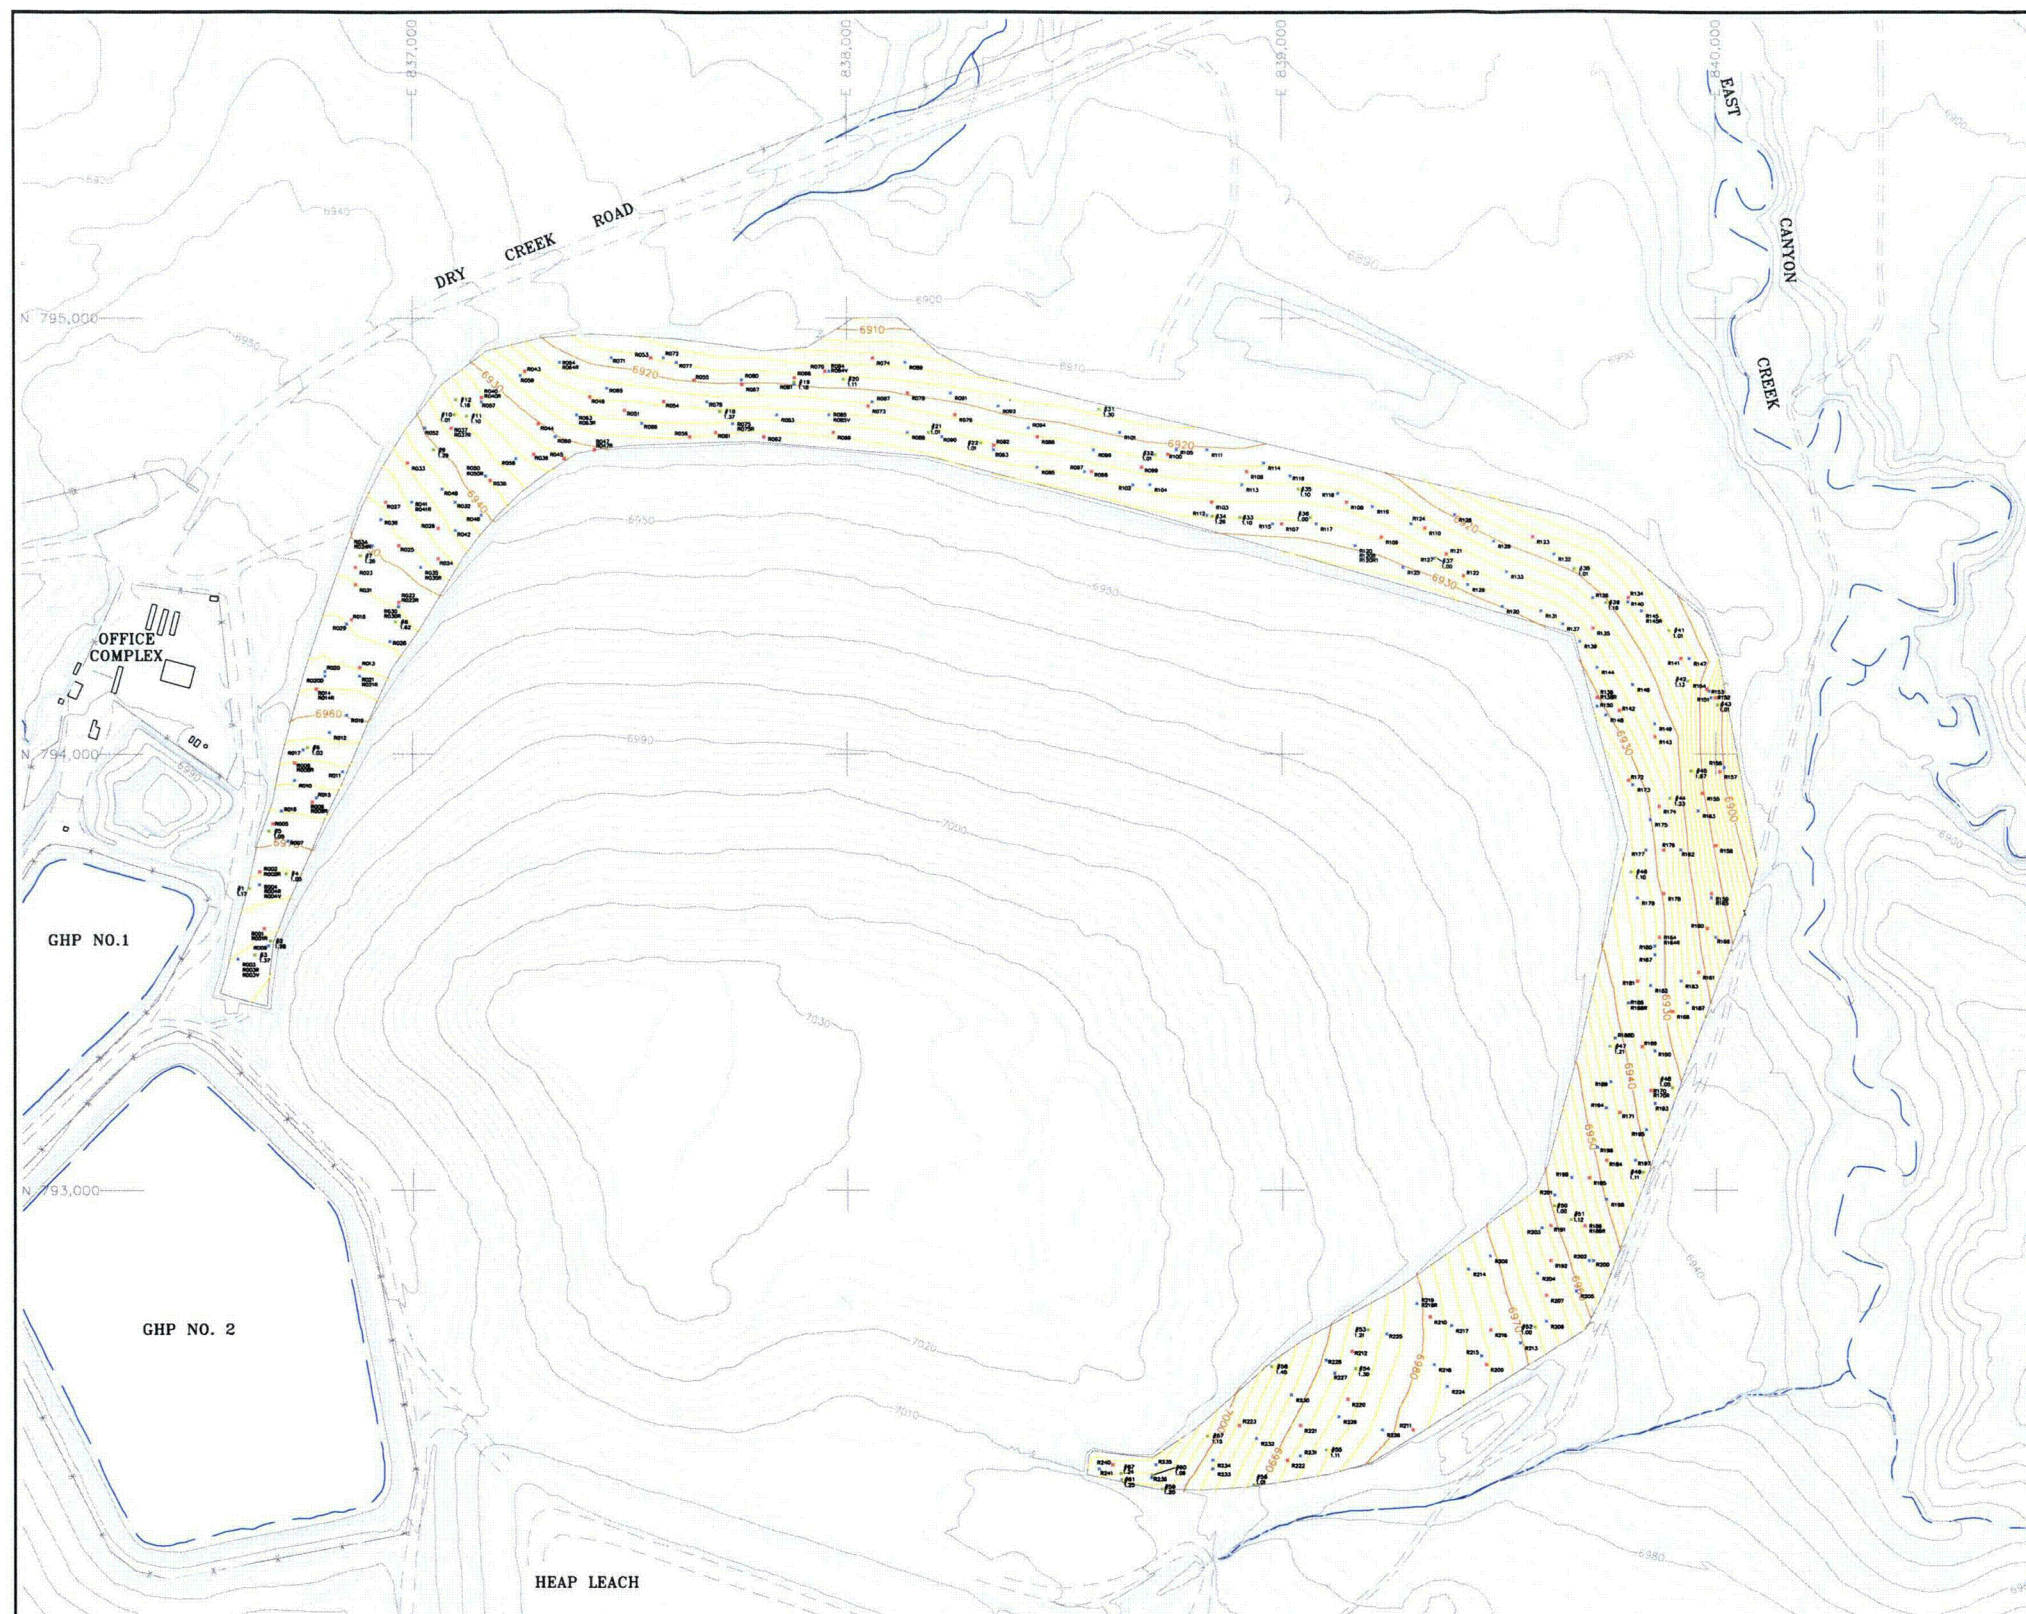
SHEET 5 OF 15

- EXISTING 1997 AERIAL TOPOGRAPHY
- DRAINAGE PATH/PONDED WATER
- UN-PAVED ROADS
- UMETCO 1000' SITE GRID
- FINISH GRADE TOPOGRAPHY
- RADON BARRIER FILL AREA
- RADON BARRIER FILL COMPACTION TEST LOCATION - FIRST LIFT
- RADON BARRIER FILL COMPACTION TEST LOCATION - SECOND LIFT
- RADON BARRIER FILL VISUAL DEPTH VERIFICATION TEST LOCATION
- #46 INDICATES VISUAL DEPTH CHECK I.D.
- 1.10 INDICATES DEPTH MEASURED IN FEET

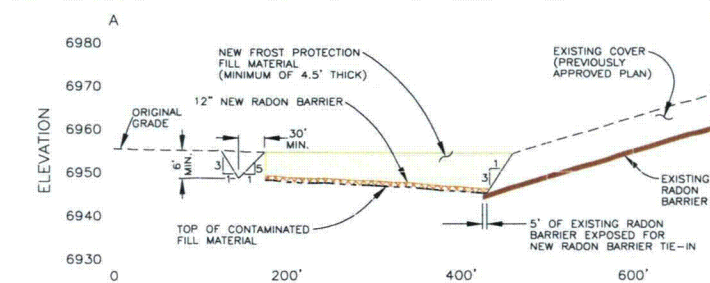
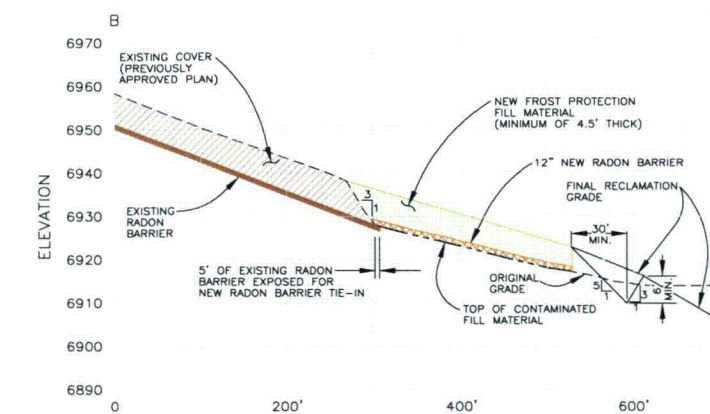
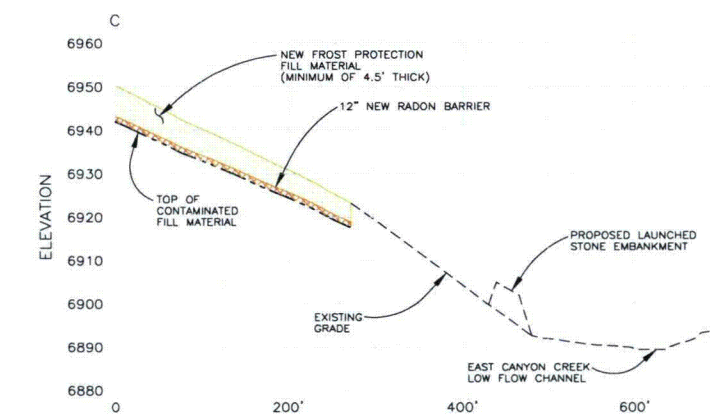
**SECTION A-A'**  
SCALE: HORIZ. 1" = 100'  
VERT. 1" = 20'

**SECTION B-B'**  
SCALE: HORIZ. 1" = 100'  
VERT. 1" = 20'

**SECTION C-C'**  
SCALE: HORIZ. 1" = 100'  
VERT. 1" = 20'

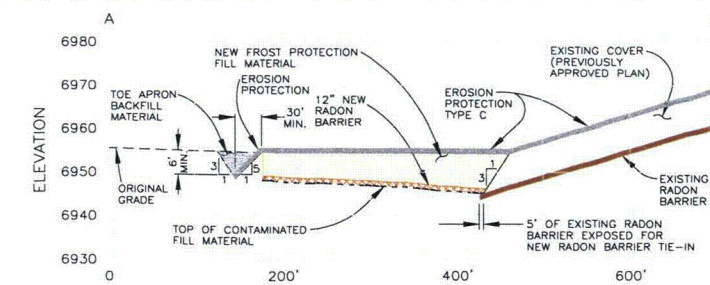
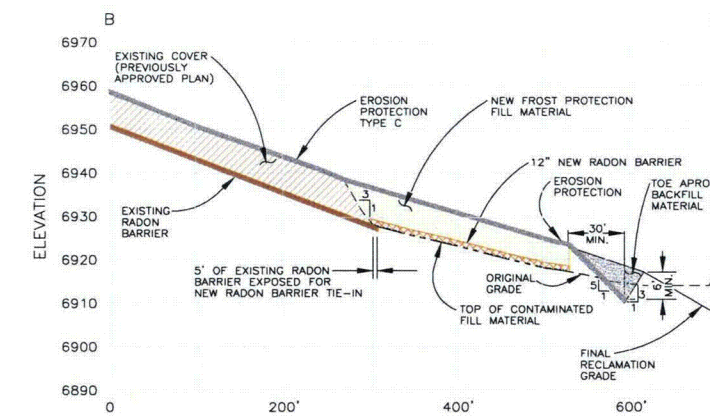
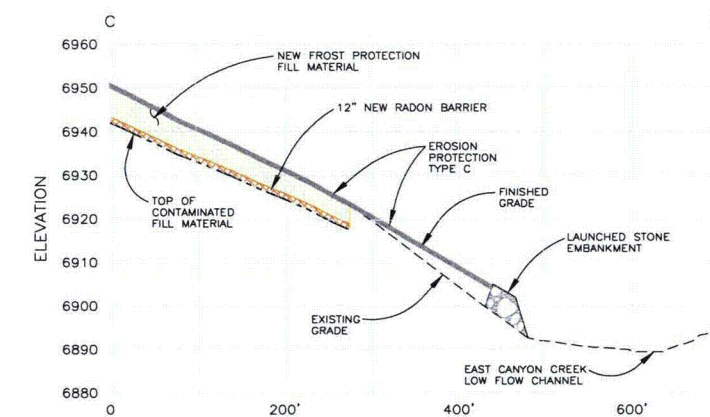
| | ABOVE GRADE<br>RIPRAP PLACEMENT<br>VERIFICATION POINT | | LAUNCHED STONE EMBANKMENT<br>TYPE "E" D <sub>50</sub> = 30.0 INCH |
| | CARBIDE DRAW BURIED EROSION<br>PROTECTION ROCK LAYER<br>12-INCHES OF TYPE "C" RIPRAP<br>D <sub>50</sub> = 6.0 INCH | | SCOUR APRON (22' WIDE & 6' DEEP)<br>TYPE "E" D <sub>50</sub> = 30.0 INCH |
