AS BUILT

A-9 REPOSITORY  
2001, 2002 AND 2003  
COMPACTION TEST LOCATIONS  
CONTAMINATED FILL AREA

GAS HILLS, WYOMING

DATE: JUNE 2007    DWG: GH-A9-04-AB    SHEET 4 OF 12

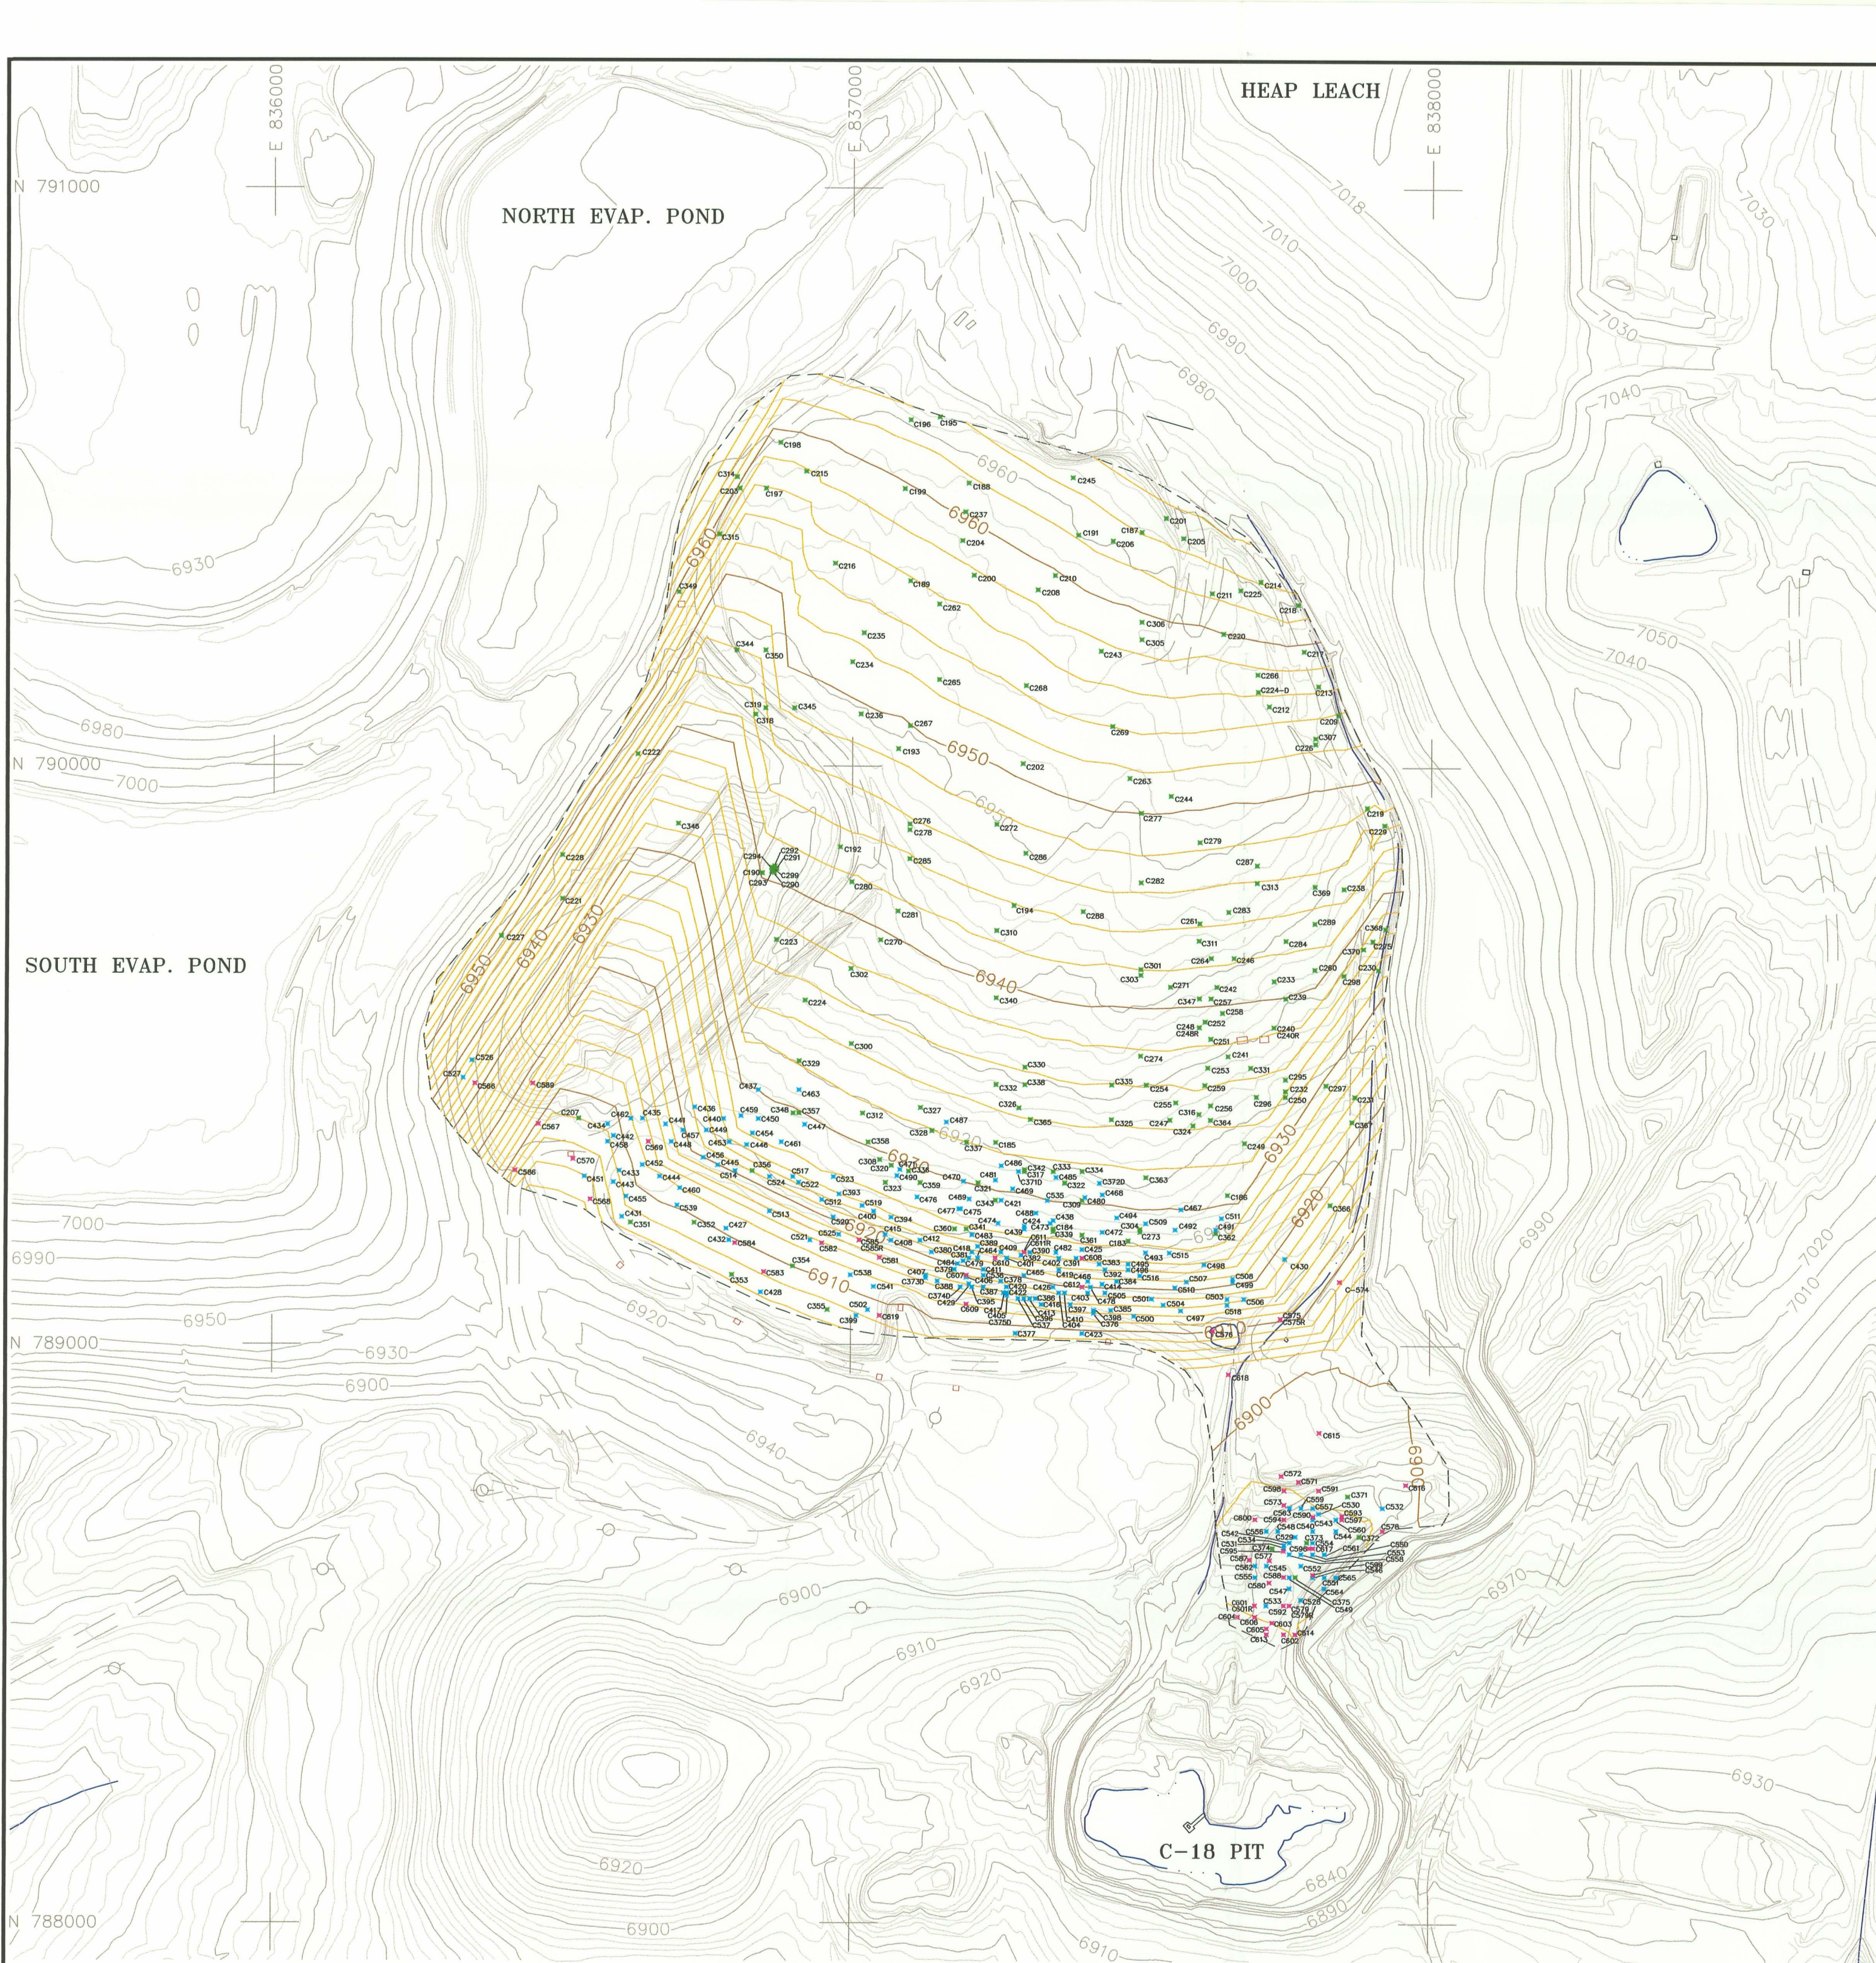
- CONTAMINATED FILL COMPACTION TEST LOCATIONS. 2001 FILL MATERIAL FROM THE RESHAPING OF THE EXISTING A-9 REPOSITORY CONTAMINATED FILL, THE STOCKPILED FILL FROM THE GHP-1 LINER REMOVAL, AND THE WINDBLOWN CLEANUP MATERIAL. FILL MATERIAL PLACED, COMPACTED AND TESTED IN 1 FOOT LIFTS - APPROX. 8 LIFTS

- CONTAMINATED FILL COMPACTION TEST LOCATIONS. 2002 FILL MATERIAL FROM THE RESHAPING OF THE EXISTING A-9 REPOSITORY CONTAMINATED FILL, CONTAMINATED FILL FROM THE CONSTRUCTION WATER PIPELINE TRENCH CLEANUP, THE GHP-1 CLEANUP AREA AND THE WINDBLOWN CLEANUP MATERIAL. FILL MATERIAL PLACED, COMPACTED AND TESTED IN 1 FOOT LIFTS - APPROX. 22 LIFTS

- CONTAMINATED FILL COMPACTION TEST LOCATIONS. 2003 FILL MATERIAL FROM THE RESHAPING OF THE EXISTING A-9 REPOSITORY CONTAMINATED FILL. FILL MATERIAL PLACED, COMPACTED AND TESTED IN 1 FOOT LIFTS - APPROX. 8 LIFTS
